## Second Update Geotechnical Investigation

### Proposed Kensho Housing Residential Apartments Lado De Loma Drive, Vista, California

NOVA Project No. 2021172  
April 25, 2022

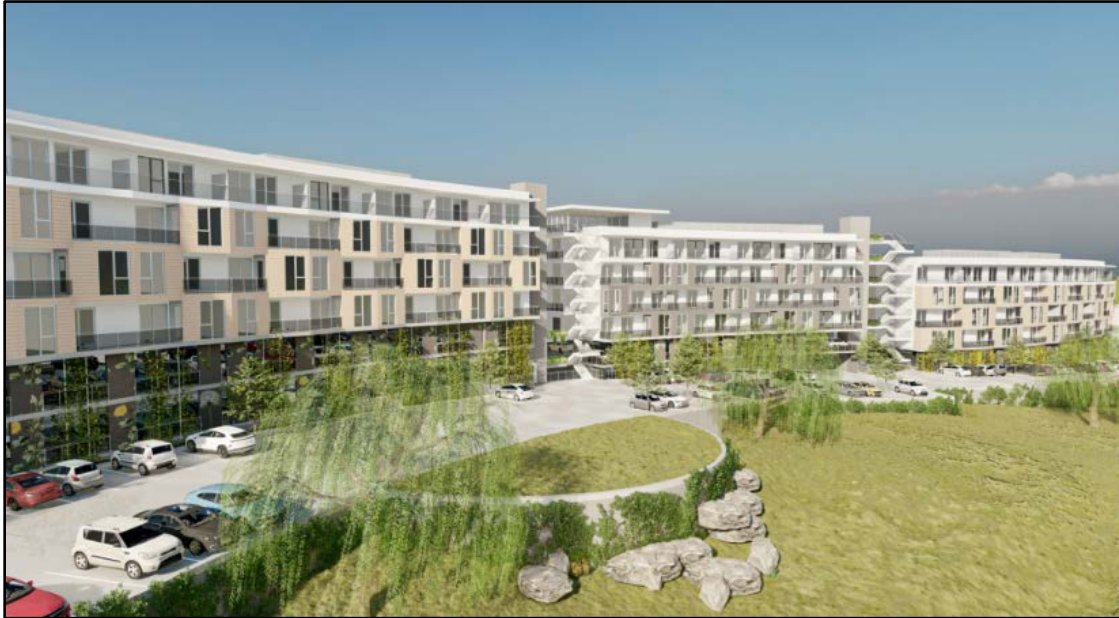
**Figure 2-4. Planned Development**  
 (source: SRA 2022)

Structural design has not been initiated for the planned apartment building. As is evident by review of Figure 2-4, current planning envisions the planned apartment building will include four levels of residences above two levels of parking.

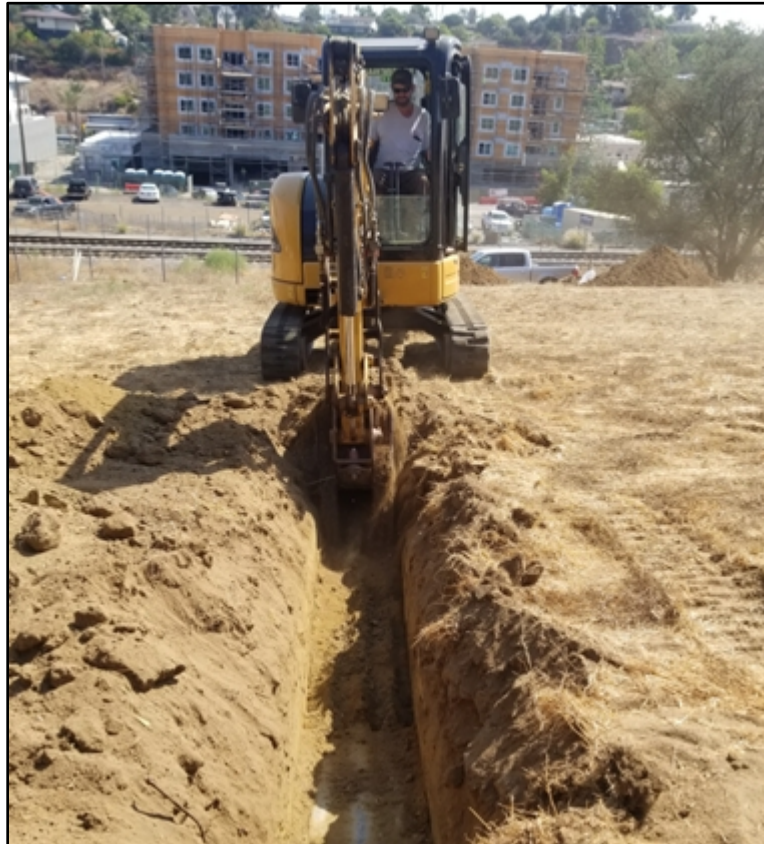
**Figure 3-2. Test Pit Excavation (TP-5, August 2021)**

Following excavation and logging, the test pits were backfilled with the excavated soil and lightly compacted. Test pit logs by NOVA are presented in Appendix B. Figure 3-2 depicts test pit excavation operations.

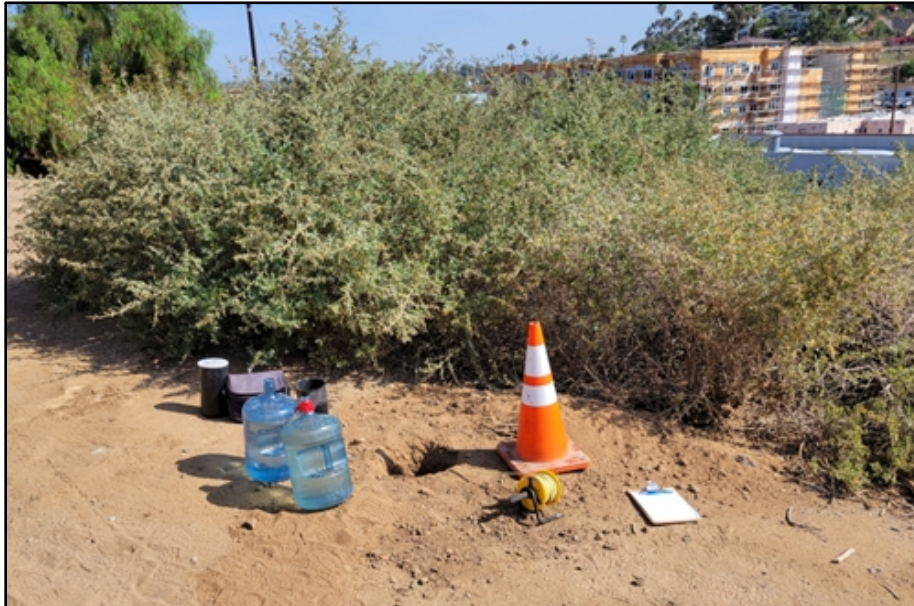
Figure 3-3. Percolation Testing, August 2021

Figure 3-3 (following page) depicts the percolation test well setup.

At the conclusion of the percolation testing, the upper sections of the PVC pipe were removed and the resulting holes backfilled with soil cuttings to match the existing surface.

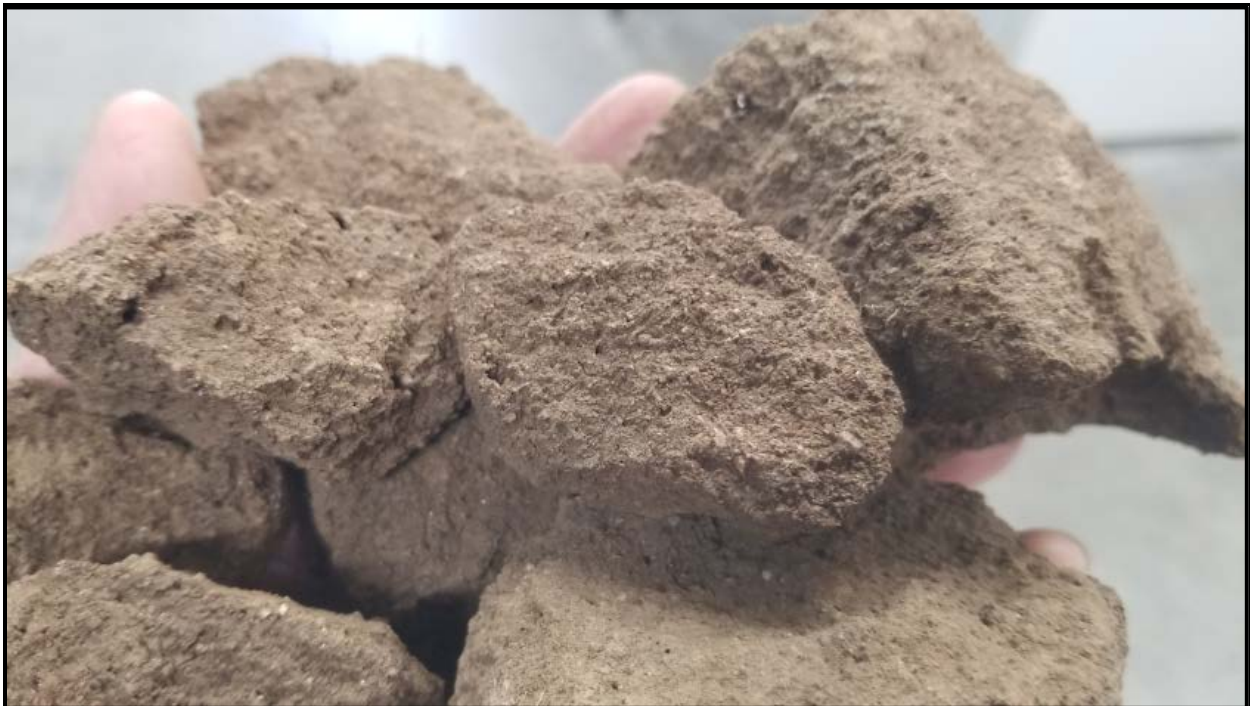
Figure 4-4. Colluvium

Quaternary Colluvium (Qcol). The colluvium was encountered either below the fill or from the surface in all borings except TP-21. This unit was generally observed to be olive to reddish-brown silty sand and brown to dark brown clayey sand and sandy clay of loose/soft to medium dense in consistency/relative density. The unit was generally porous with some gravel and cobbles encountered. The colluvium is depicted on Figure 4-4.

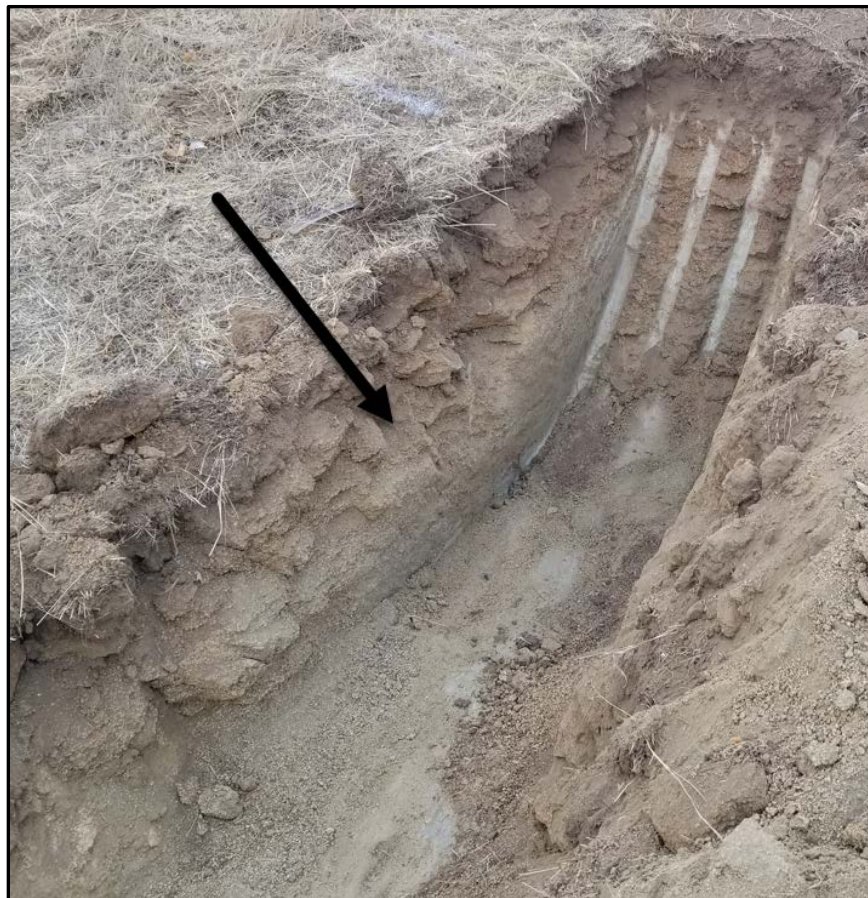
**Figure 4-5. Highly Weathered Tonalite**

Figure 4-5 depicts the highly weathered tonalite at the bottom of Test Pit TP-5 and Figure 4-6 (following page) presents a sample of the less weathered tonalite encountered during the investigation.

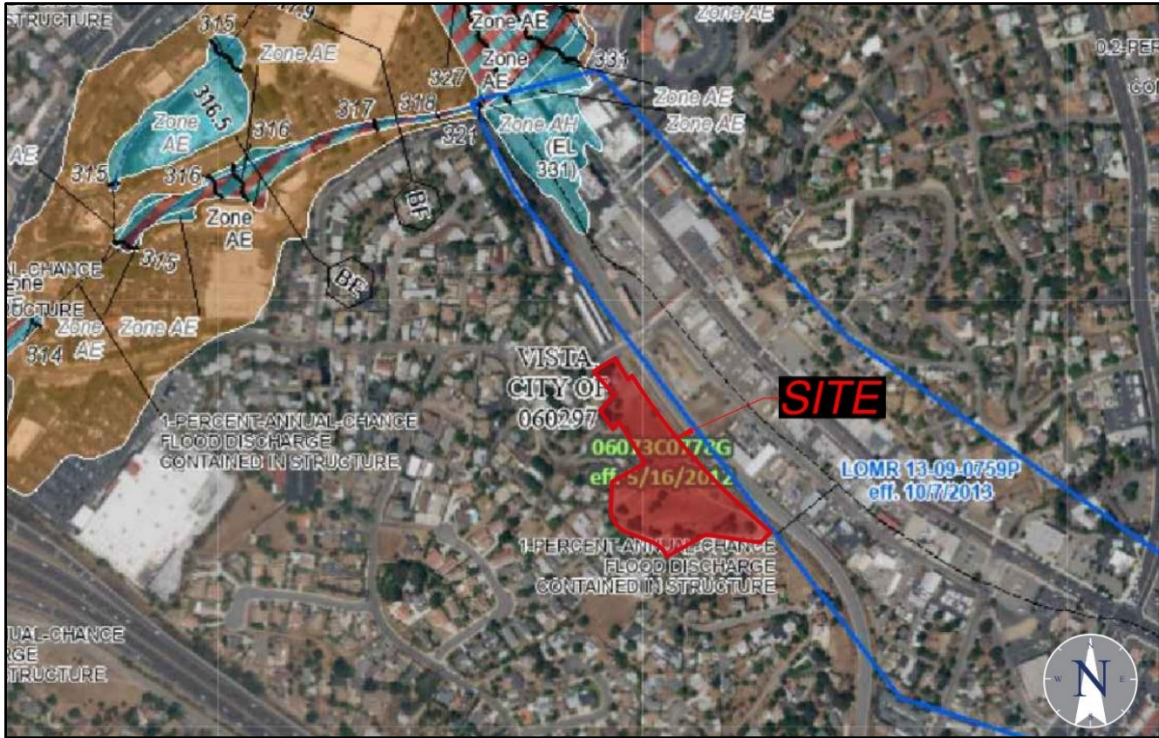
Figure 5-3. Flood Mapping of the Site Area

Figure 5-3 (following page) reproduces flood mapping of the site vicinity.

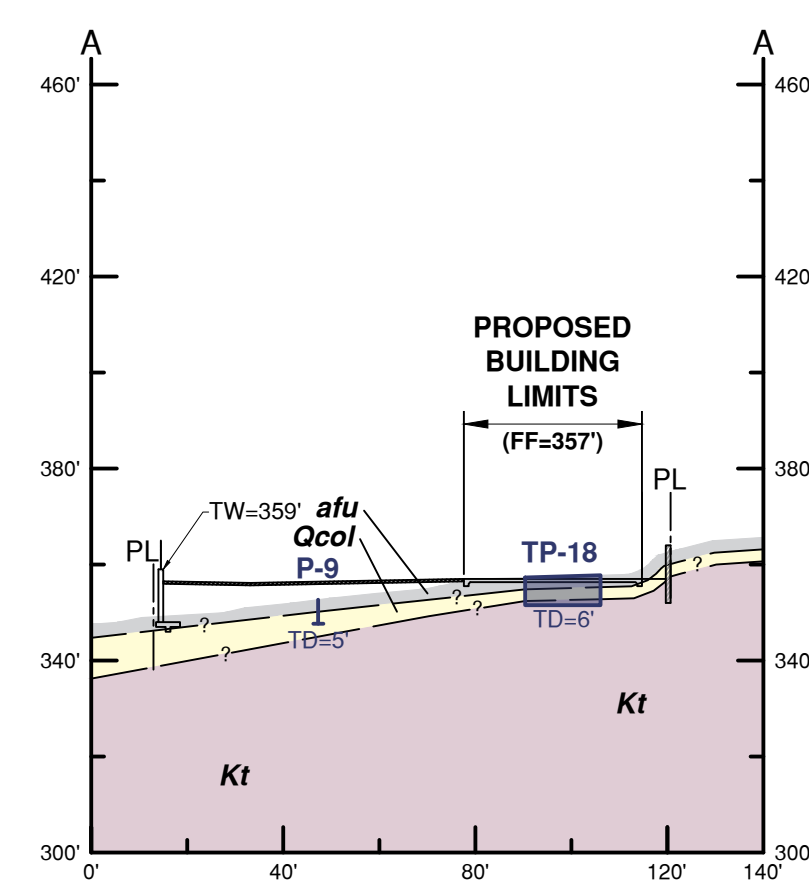
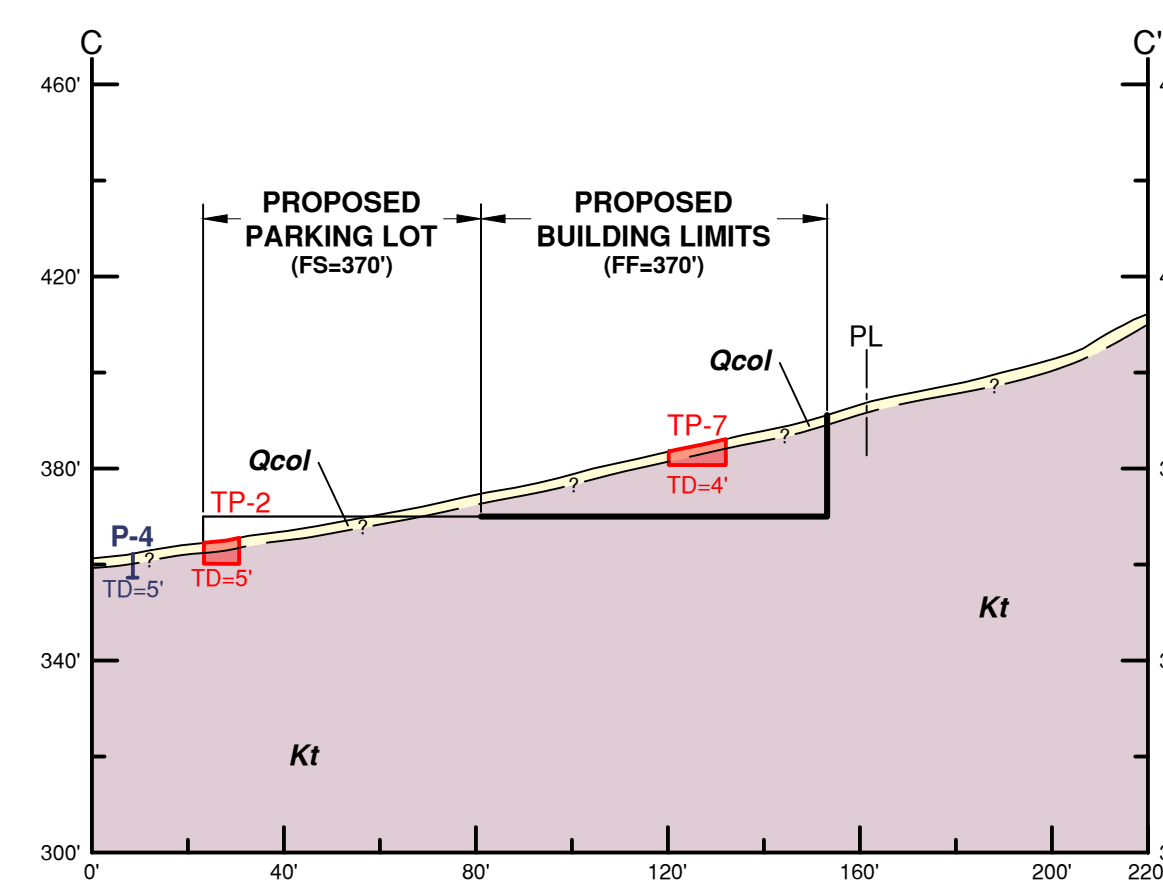
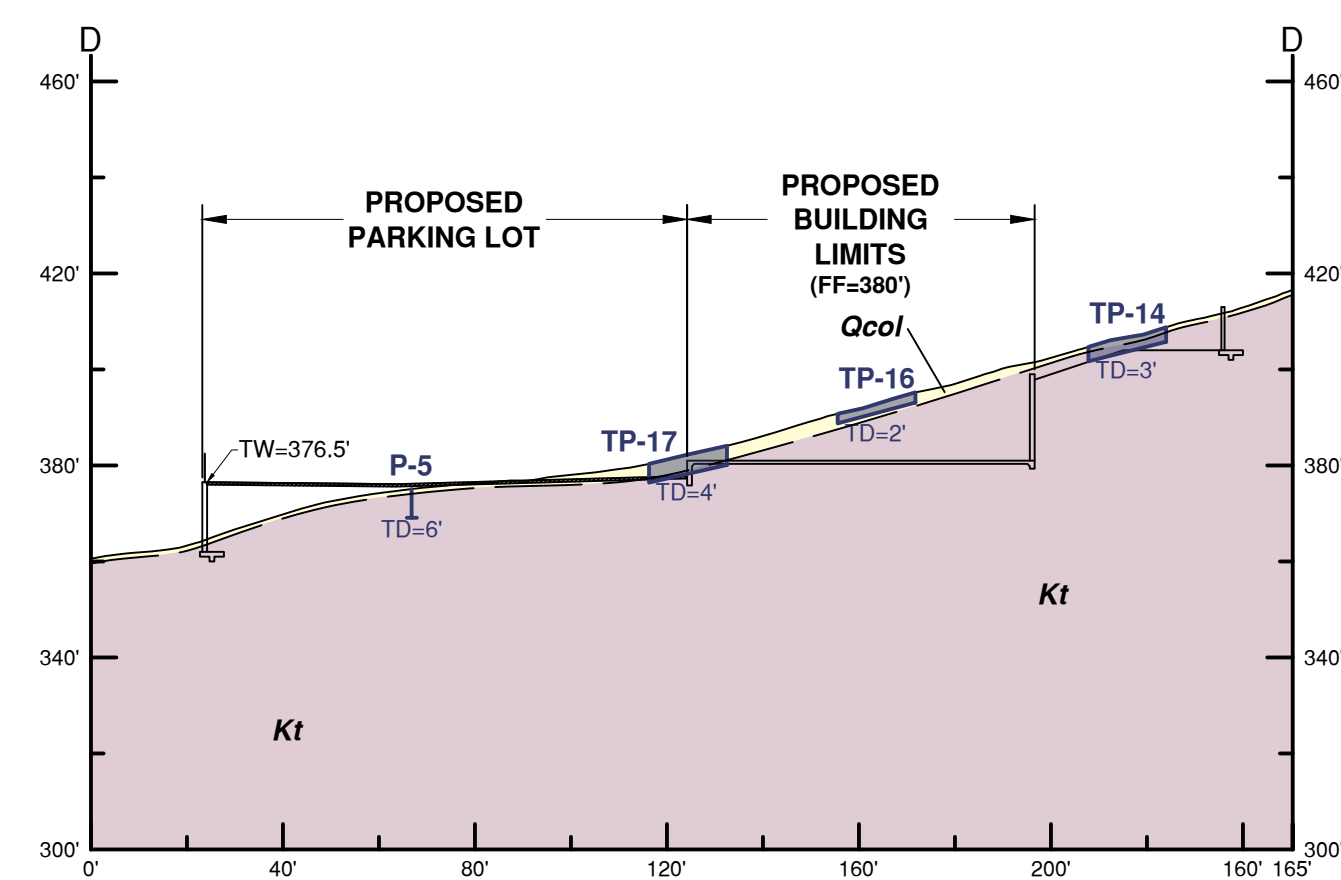
<b>afu</b>	FILL
<b>Qcol</b>	COLLUVIUM
<b>Kt</b>	TONALITE
<b>TP-17</b>	TEST PIT (NOVA)
<b>TP-7</b>	TEST PIT (GSI, 2016)
<b>P-9</b>	PERCOLATION TEST BORING
	GEOLOGIC CONTACT, QUERIED WHERE UNCERTAIN

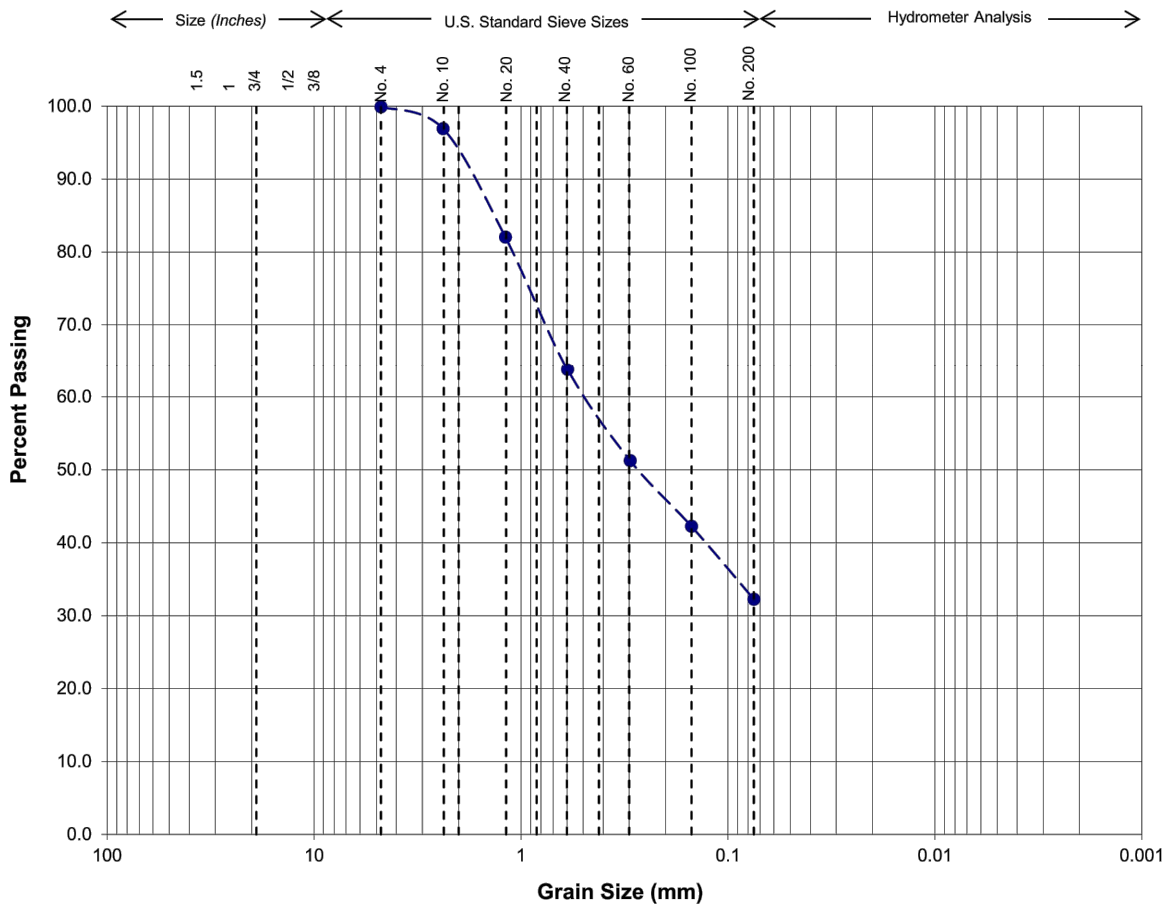
APPENDIX: C.7

Sample Location: TP-25  
 Depth (ft): 1-4  
 USCS Soil Type: SM  
 Passing No. 200 (%): 32

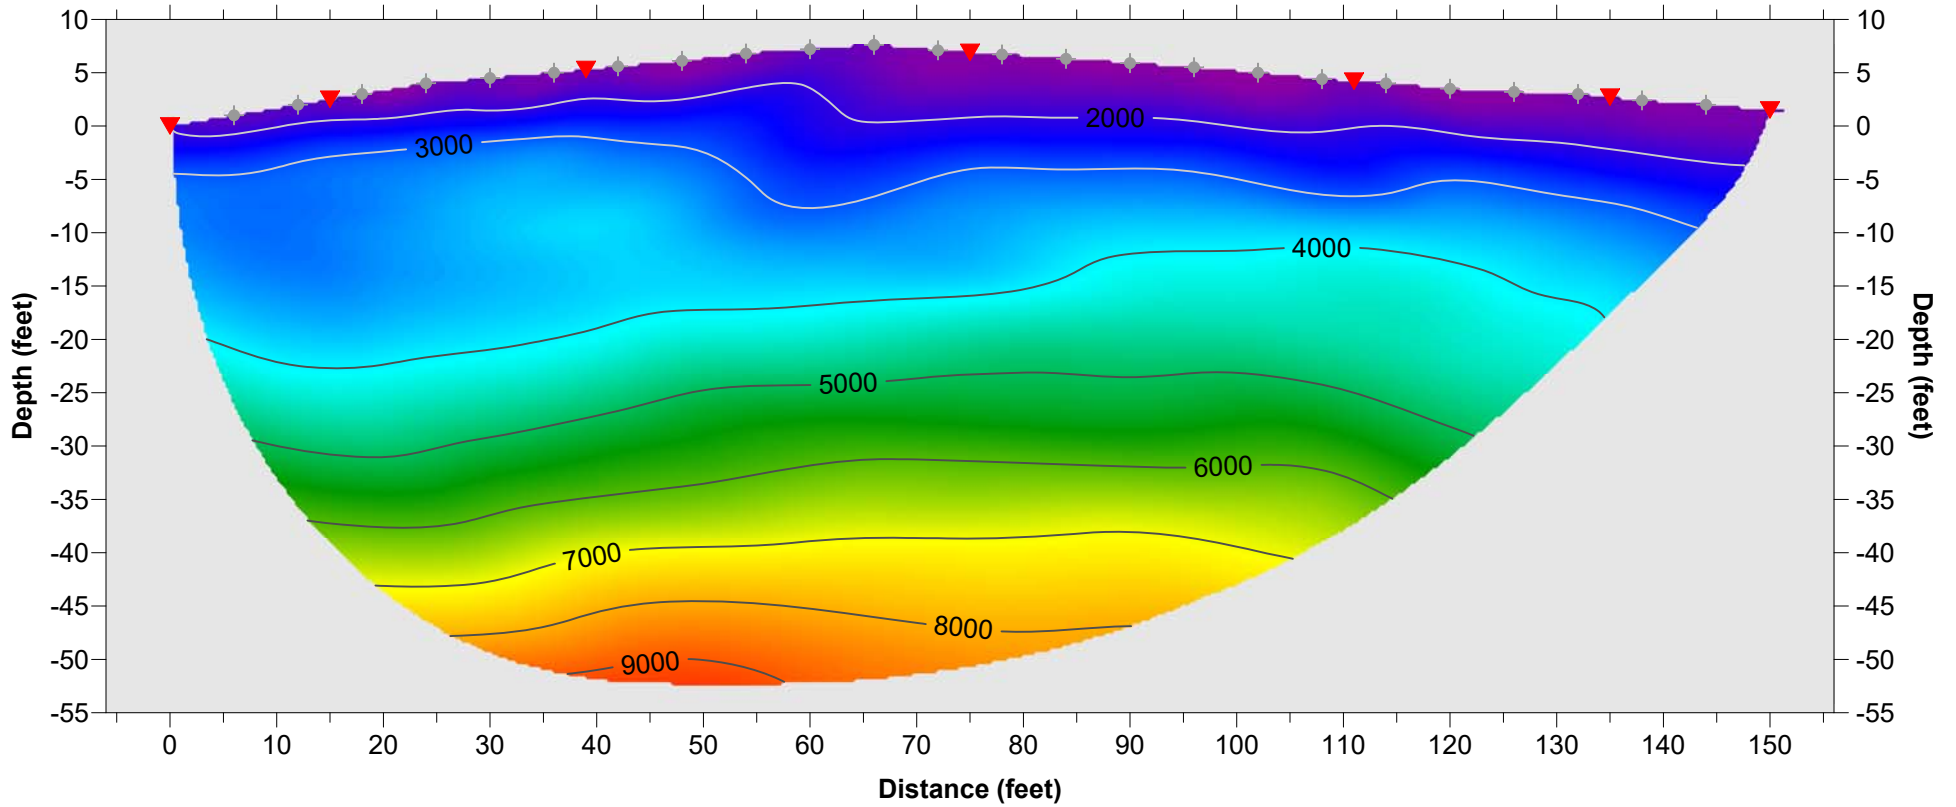
## REFRACTION TOMOGRAPHIC MODEL

- ▼ Seismic Source
- ◆ Geophone Receiver
