Phelan Piñon Hills CSD
Proposed Park Site
South of Phelan Road and East of
Sheep Creek Road
Phelan, California

Geotechnical Investigation Report

Prepared For: Phelan Piñon Hills CSD

Prepared By: Merrell Johnson

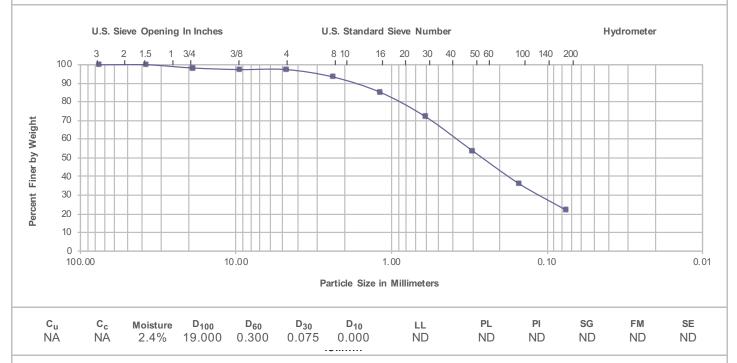
Classification, ASTM D2487: (SM) Silty sand Sample Origin: Boring Two at 0' to 5'

Method / Procudure Used: D422, D1140 Size of Initial Dry Mass (g): 5176.7 **Determination of Dry Mass:** D2216 Particles; Shape, Hardness: ND Manual/2 hr Dispersion Device/Period:

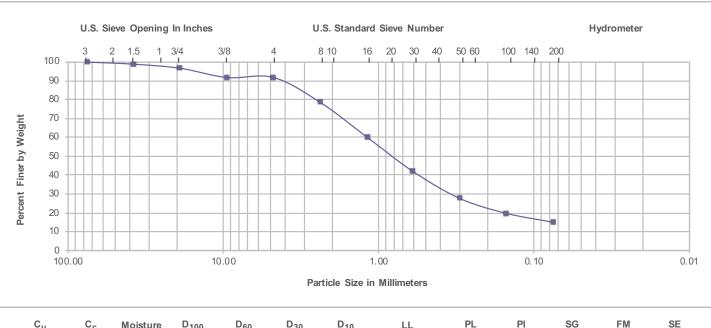
Sample Origin: Boring Three at 10' to 15'

c_c D₁₀ $D_{100} \\$ $\mathbf{C}_{\mathbf{u}}$ D_{60} D_{30} Moisture NA NA 1.4% 37.500 1.180 0.300 0.000 ND ND ND ND ND ND

Method / Procudure Used: D422, D1140 10602.5 Size of Initial Dry Mass (g): **Determination of Dry Mass:** D2216 Particles; Shape, Hardness: ND Dispersion Device/Period: Manual/2 hr Type & Amount of Agent: Defloc. & 1.0

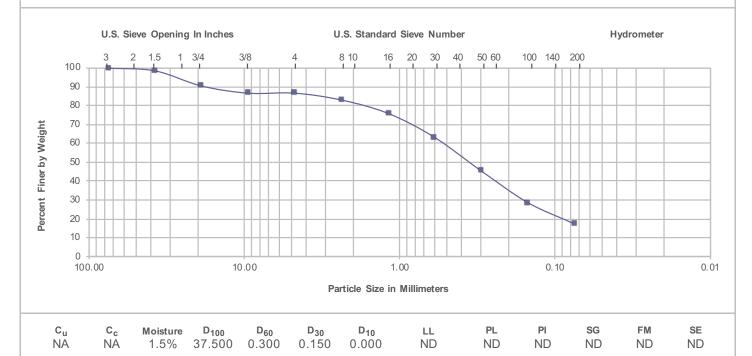
Classification, ASTM D2487: (SM) Silty sand Sample Origin: Boring Five at 0' to 5'

Method / Procudure Used: D422, D1140 Size of Initial Dry Mass (g): 11557.7 **Determination of Dry Mass:** D2216 Particles; Shape, Hardness: ND Dispersion Device/Period: Manual/2 hr
