GEOTECHNICAL EXPLORATION AND GEOHAZARD REPORT

**PATRIOT HIGH SCHOOL – STADIUM IMPROVEMENTS
4355 CAMINO REAL
JURUPA VALLEY, CA**

September 20, 2022

Fenagh Job 6484

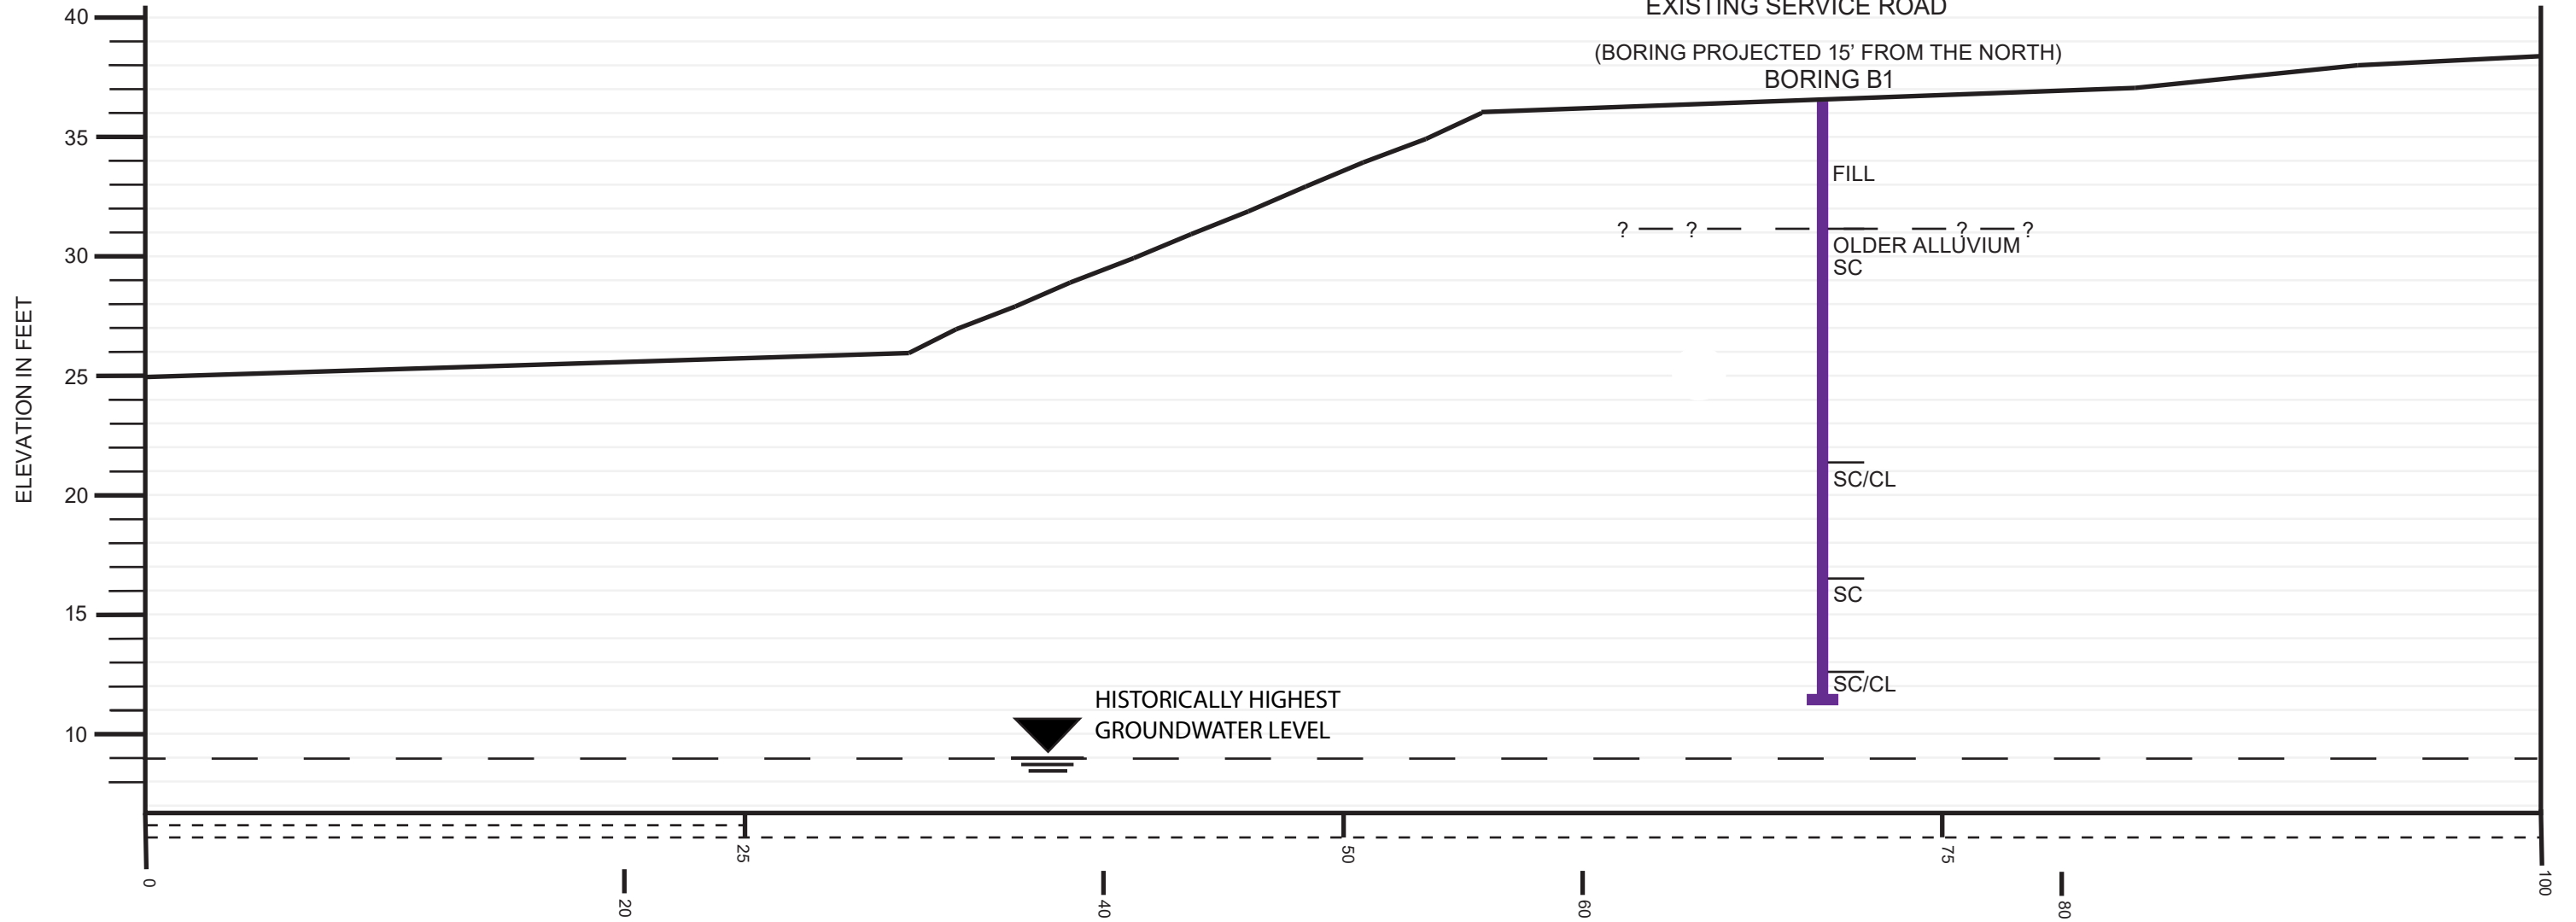
(BORING PROJECTED 15' FROM THE NORTH)

BORING B1

HISTORICALLY HIGHEST
GROUNDWATER LEVEL

FILL

The project site is in the southcentral section of the playfield area within the Patriot High School Campus as indicated on the attached Boring Location Maps, Plates 2 and 3. Embankments which descend to the west and range in height from approximately 6 feet to 11 feet are located along the western perimeter of the project site as indicated on Cross Section A-A' and B-B' (Plates 4 and 5).

Plates 2 and 3 indicate the locations of the borings. Plates 4 and 5 provide cross-sections of the subsurface conditions encountered near the west perimeter of the site including embankment profiles. Graphical presentations of the boring logs are provided in Appendix A.

California Building Code (CBC, 2019) Section 1808A.7, Foundations on or Adjacent to Slopes, indicates the placement of buildings and structures on or adjacent to slopes steeper than one unit vertical (V) in three units horizontal (H) (33.3-percent slope) shall comply with Section 1808A.7.1 through 1818A.7.5. Section 1808A.7.2 states, where the slope is steeper than 1 unit vertical in 1 unit horizontal (100-percent slope), the required setback shall be measured from an imaginary plane 45 degrees to the horizontal, projected upward from the toe of the slope. An appropriate survey and calculation should be performed to determine the actual percent slope of the embankments located to the west and south of the football field area. Based on contour drawings provided by the client and onsite field measurements, it is the assessment of this firm that the gradient of the embankments within the site generally range from 2H:1V to 3H:1V. See Cross-Sections A-A' (Plate 4) and B-B' (Plate 5) for critical embankment profiles affecting the development.

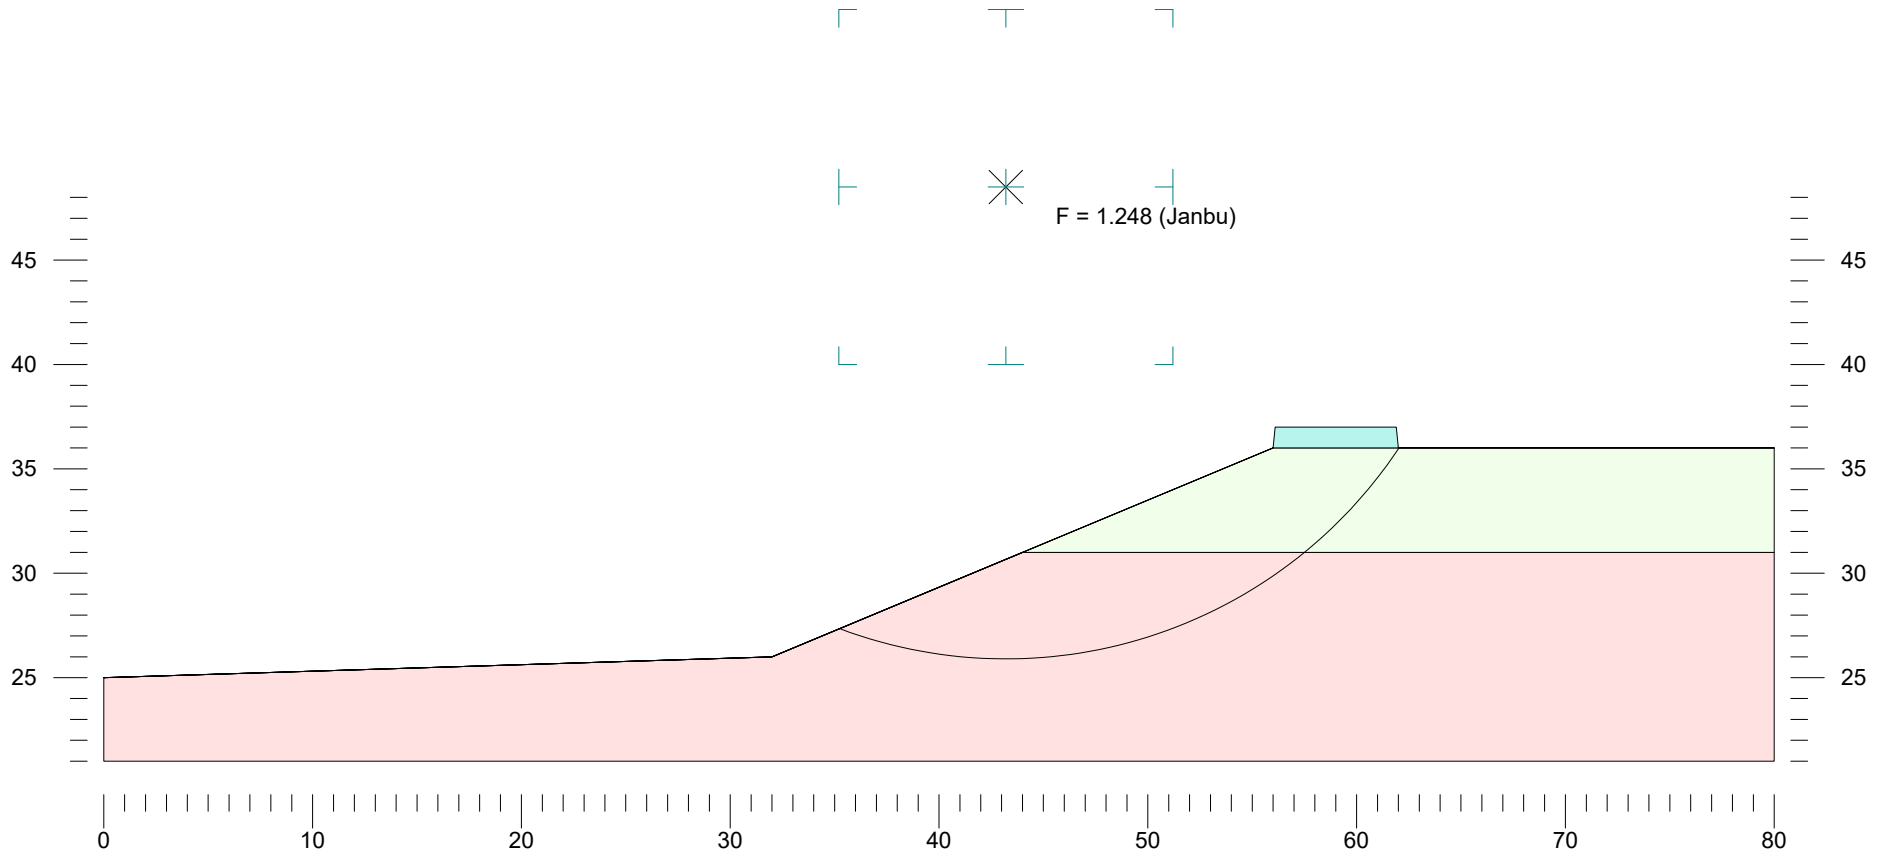
Fenagh Engineering & Testing
 Project No. 6484
 Patriot H.S., Jurupa Valley
 September 6, 2022
 Cross Section B-B'
 Janbu, Pseudo-Static

Gamma pcf	C psf	Phi deg	Piezo Surf.
Footing Surcharge	1000	0	0	0
Fill Soils	129.5	200	29	0
Older Alluvium	133.1	250	30	0

Seismic coefficient = 0.27
