**GEOTECHNICAL INVESTIGATION
THE PETALUMAN HOTEL
2 PETALUMA BOULEVARD SOUTH
PETALUMA, CALIFORNIA**

January 28, 2022

Project 1927.01

Prepared for:
EKN Development Group
220 Newport Center Drive, Suite 11-262
Newport Beach, California 92660

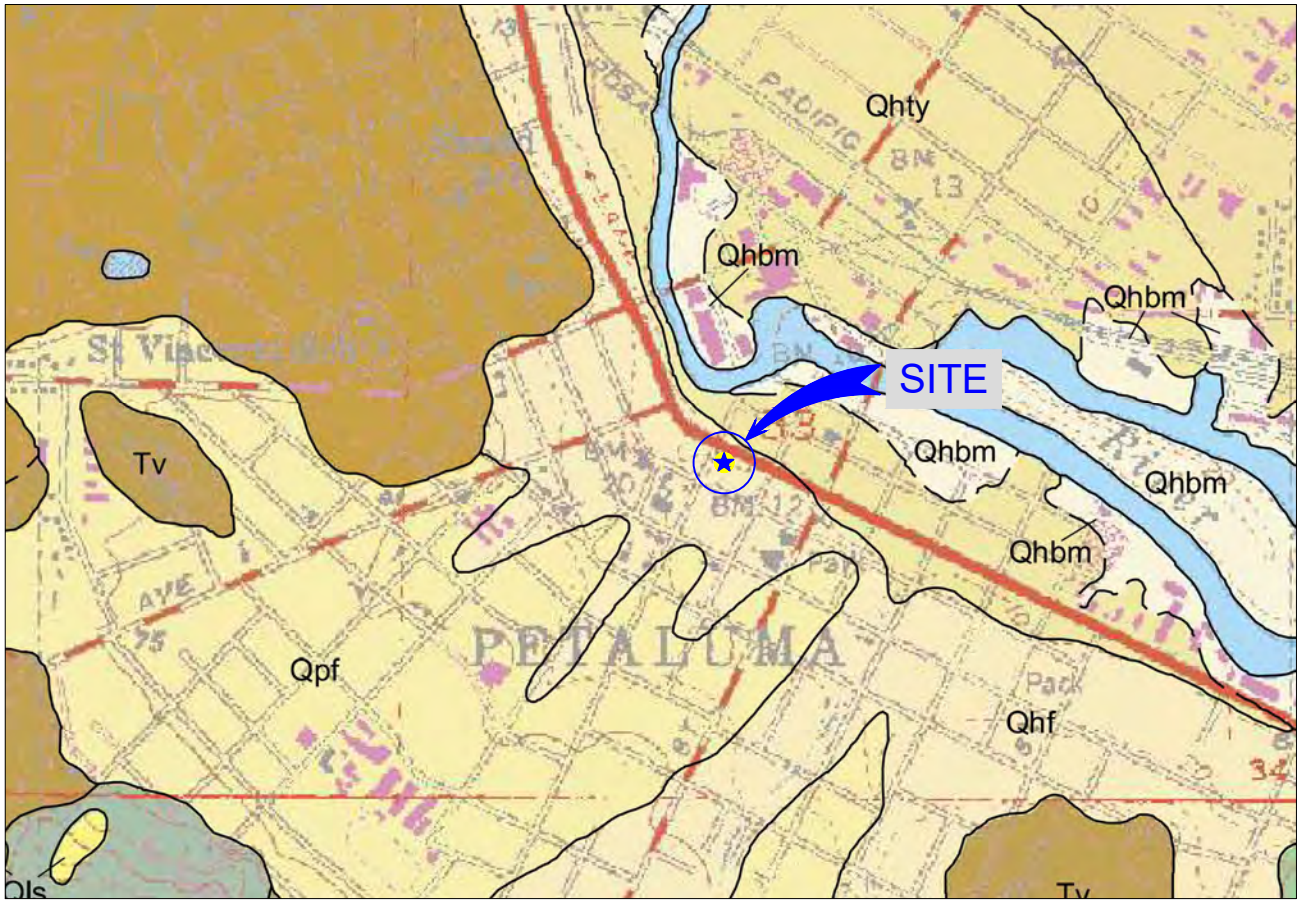
3

REGIONAL GEOLOGIC MAP

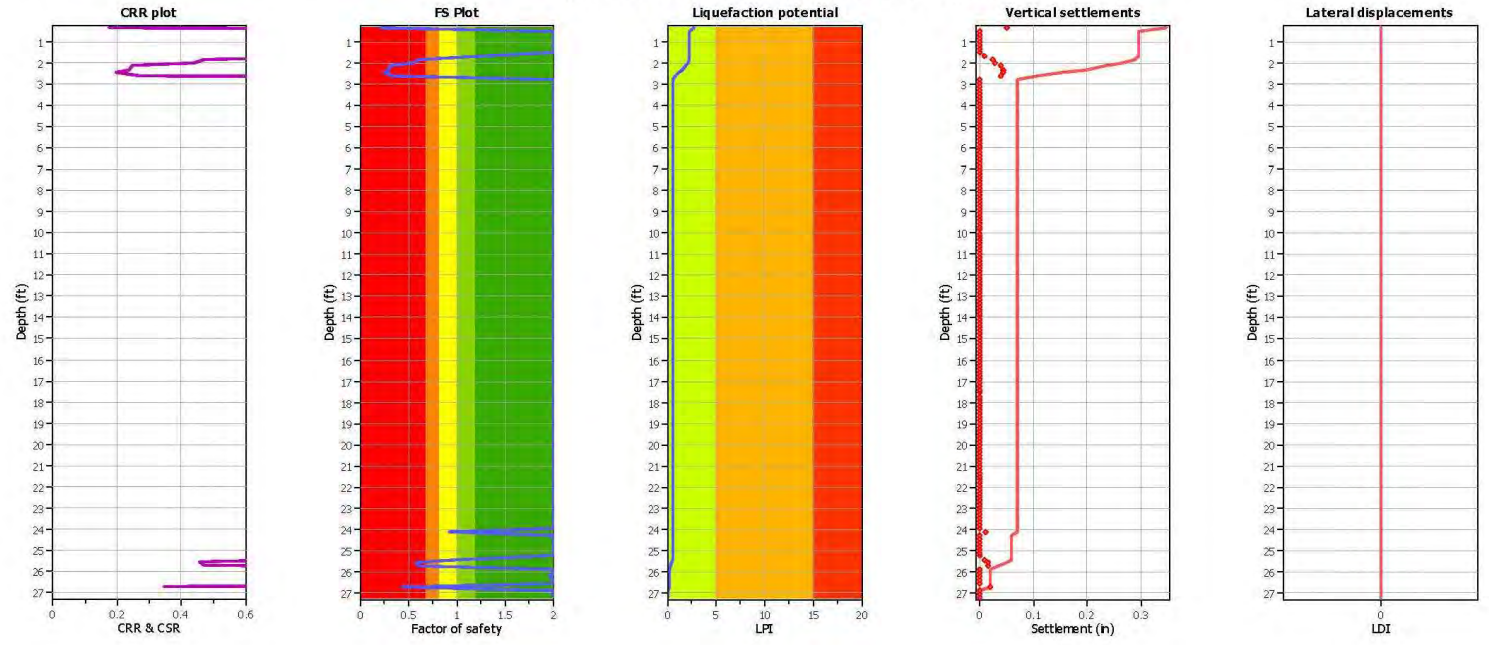
CPT name: CPT-01

Liquefaction analysis overall plots

Input parameters and analysis data

Analysis method:	B&I (2014)	Depth to GWT (earthq.):	0.00 ft	Fill weight:	N/A
Fines correction method:	B&I (2014)	Average results interval:	3	Transition detect. applied:	Yes
Points to test:	Based on I _c value	I _c cut-off value:	2.50	K _v applied:	Yes
Earthquake magnitude M _w :	7.30	Unit weight calculation:	Based on SBT	Clay like behavior applied:	Sands only
Peak ground acceleration:	0.72	Use fill:	No	Limit depth applied:	No
Depth to water table (insitu):	5.00 ft	Fill height:	N/A	Limit depth:	N/A

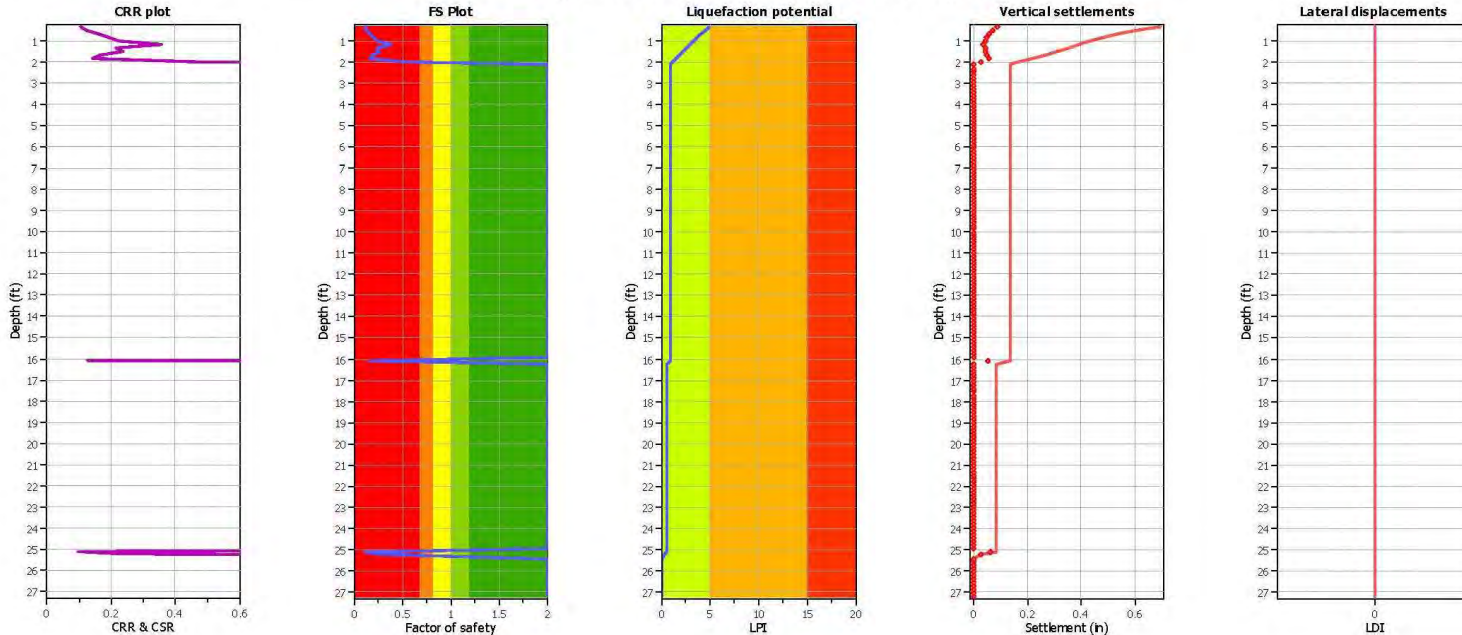
CPT name: CPT-03

Liquefaction analysis overall plots

Input parameters and analysis data

Analysis method:	B&I (2014)	Depth to GWT (erthq.):	0.00 ft	Fill weight:	N/A
Fines correction method:	B&I (2014)	Average results interval:	3	Transition detect. applied:	Yes
Points to test:	Based on I _c value	I _c cut-off value:	2.50	K _r applied:	Yes
Earthquake magnitude M _w :	7.30	Unit weight calculation:	Based on SBT	Clay like behavior applied:	Sands only
Peak ground acceleration:	0.72	Use fill:	No	Limit depth applied:	No
Depth to water table (insitu):	11.00 ft	Fill height:	N/A	Limit depth:	N/A

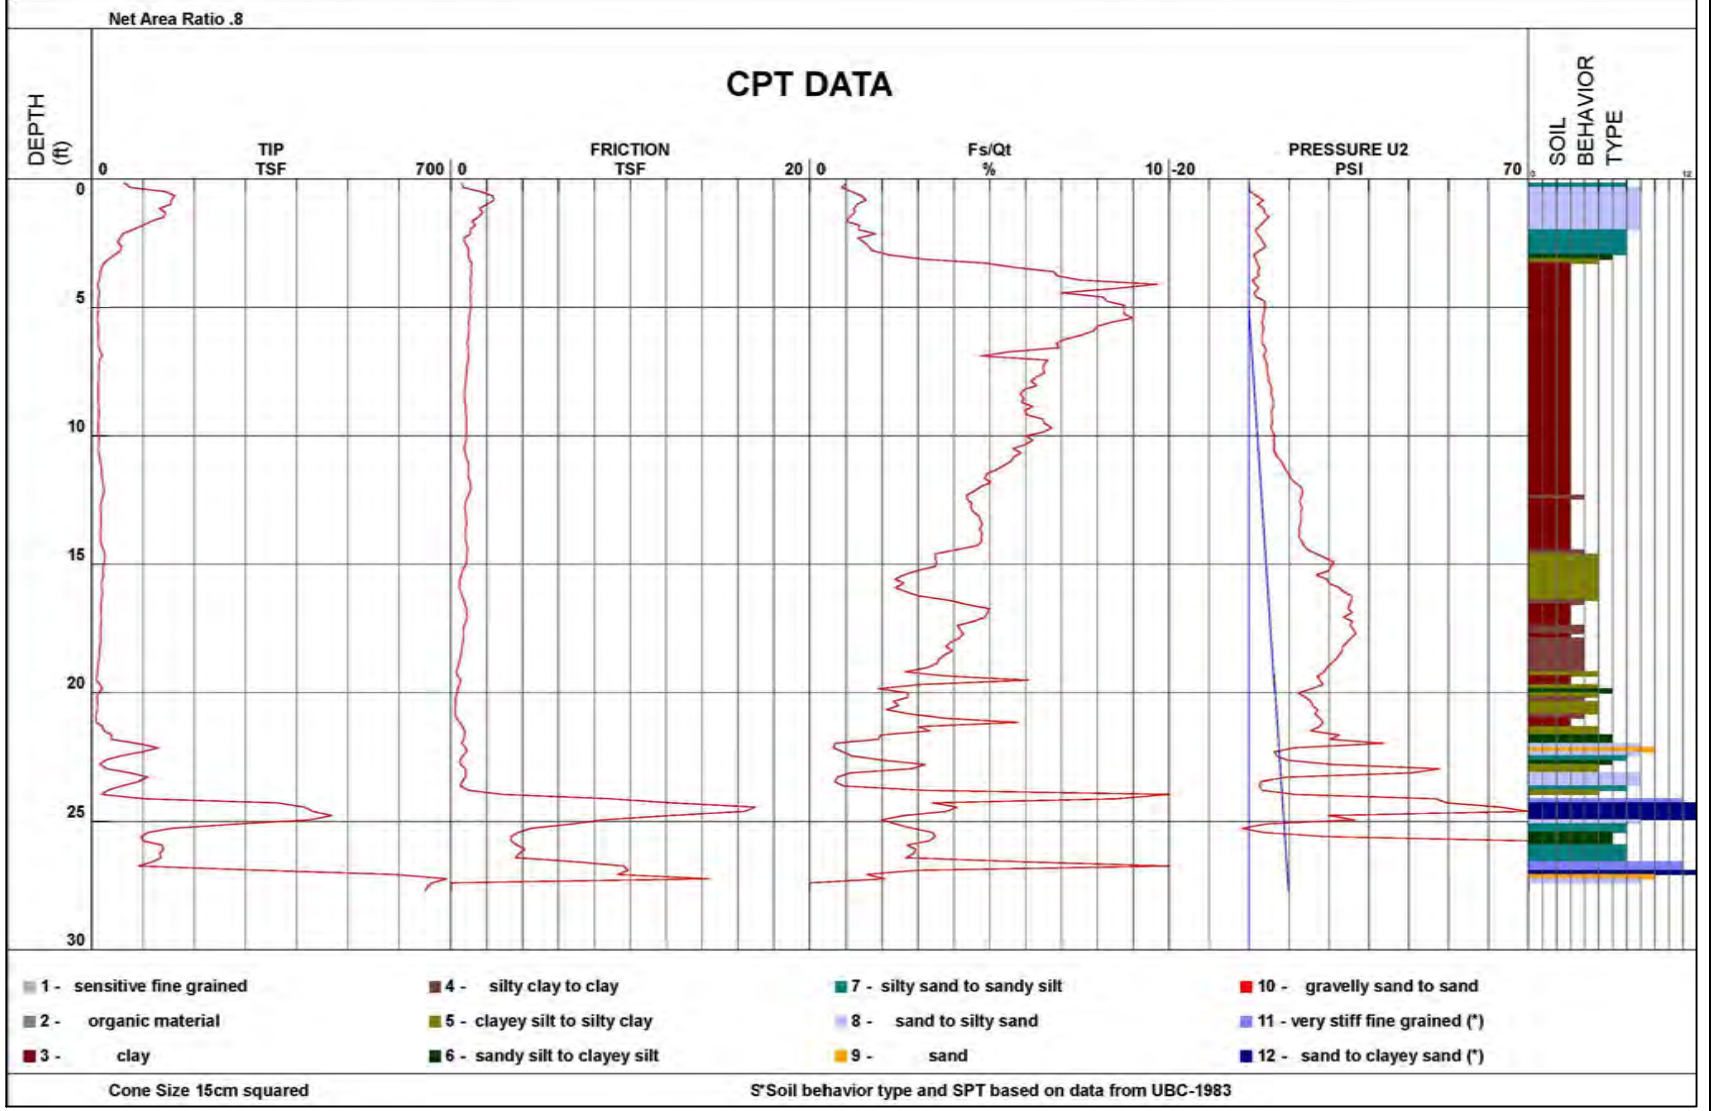
Project Petaluma Hotel Operator AJ-00
 Job Number 1927.01 Cone Number DDG1596
 Hole Number CPT-01 Date and Time 8/25/2021 7:39:57 AM
 EST GW Depth During Test 5.00 ft

Filename SDF(872).cpt
 GPS _____
 Maximum Depth 27.72 ft

The recorded data is transferred to an in-office computer for reduction and analysis. The analysis of cone bearing and sleeve friction (i.e., friction ratio) indicates the soil type, the cone bearing alone indicates soil density or strength, and the pore pressure indicates the presence of clay. Variations in the data profile indicate changes in stratigraphy. This test method has been standardized and is described in detail by the ASTM Standard Test Method D3441 "Deep, Quasi-Static Cone and Friction Cone Penetration Tests of Soil." The interpretation of CPT data is illustrated on Figure B-1, and the CPT data logs are presented on Figures B-2 through B-5.

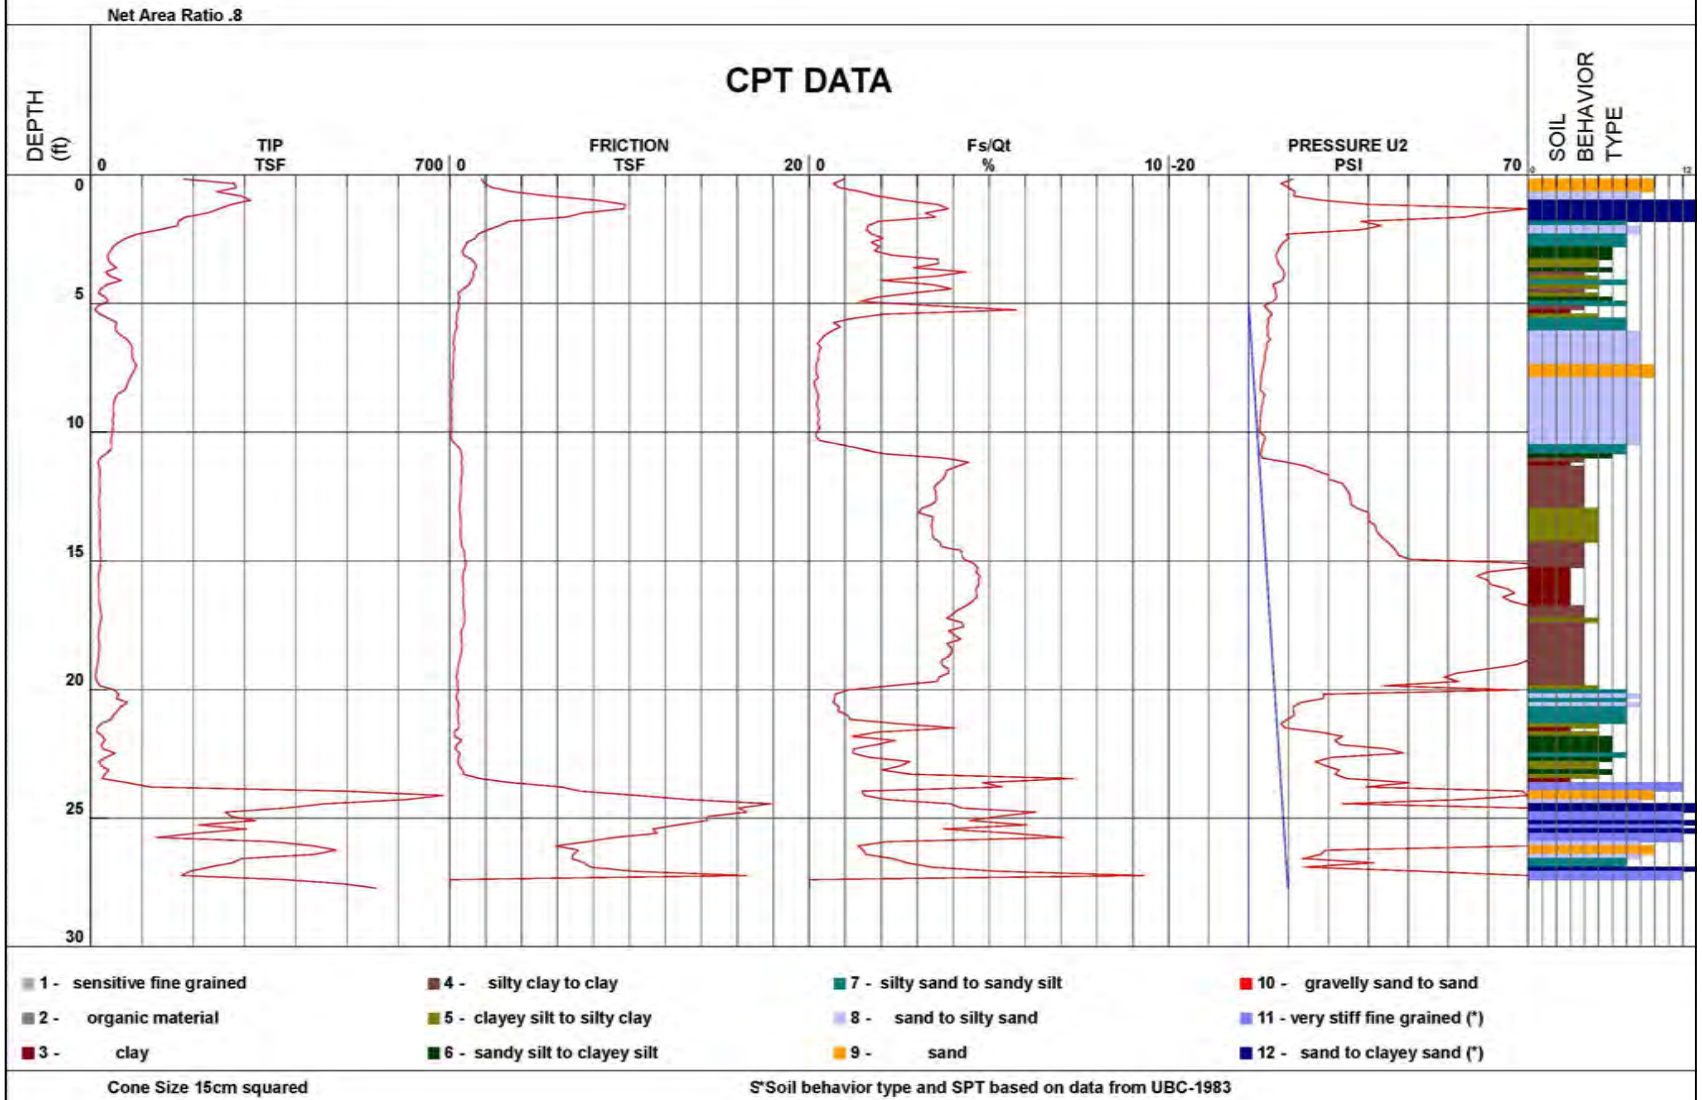
Project Petaluma Hotel Operator AJ-00
 Job Number 1927.01 Cone Number DDG1596
 Hole Number CPT-02 Date and Time 8/25/2021 8:14:49 AM
 EST GW Depth During Test 5.00 ft

Filename SDF(873).cpt
 GPS _____
 Maximum Depth 27.72 ft
