GEOTECHNICAL STUDY

**FIFTH CROW FARM
DIAZ FLATS
4309 CLOVERDALE ROAD
PESCADERO, CALIFORNIA**

Subject: Geotechnical Report for proposed Farm Labor Housing:
4309 Cloverdale Road – Diaz Flats, Pescadero, California.
Sigma Prime Job No. 22-108

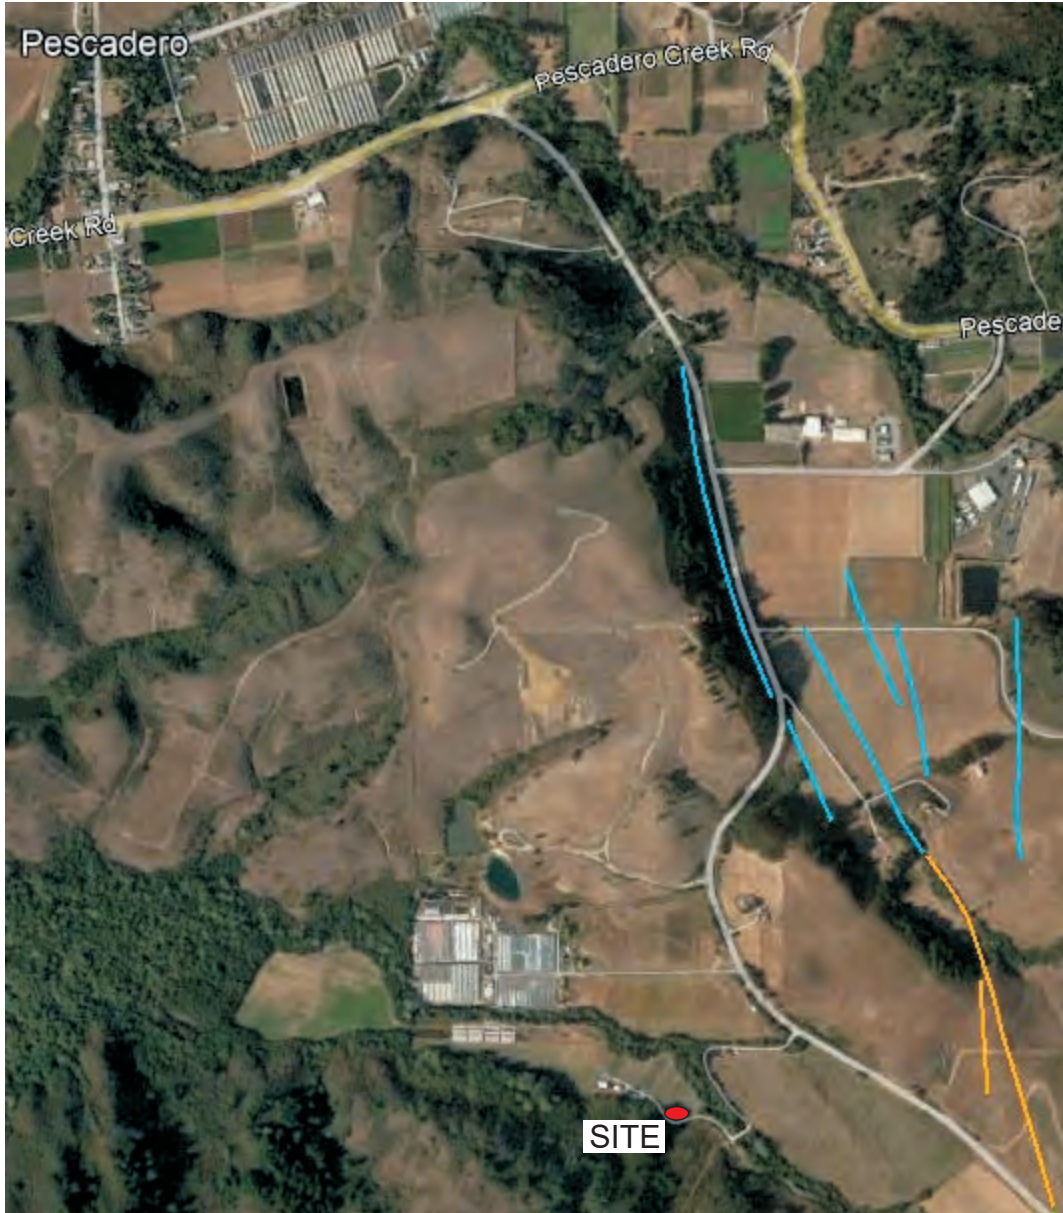
| Figure | 1 |

Location Map

Fifth Crow Farm, Diaz Flats, 4309 Cloverdale Rd., Pescadero

We are pleased to present this geotechnical study report for the proposed Farm Labor Housing at 4309 Cloverdale Road in Pescadero, California at the location shown in Figure 1. The proposed development site is in an area of Fifth Crow Farm known as Diaz Flats. The purpose of this investigation was to evaluate the subsurface conditions at the site, and to provide geotechnical design recommendations for the proposed construction.

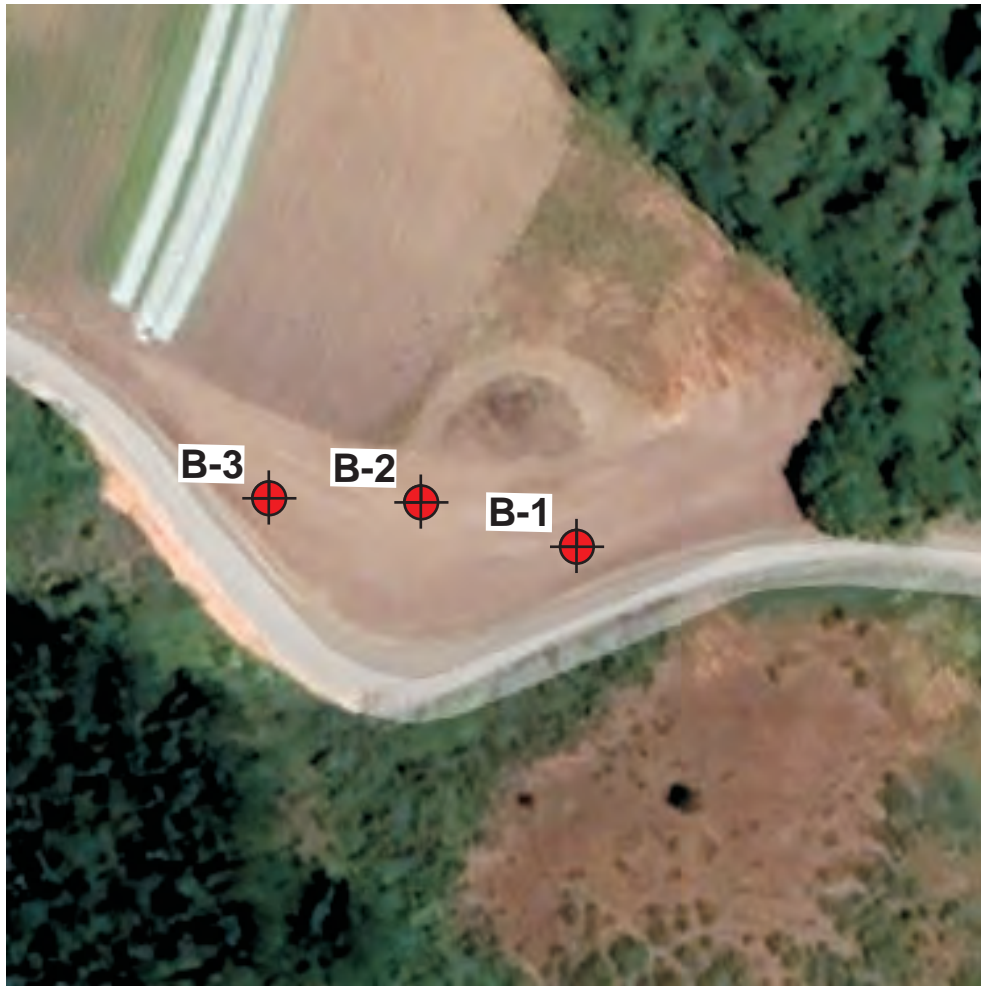
EXPLANATION

| B-1 Soil Boring, Drilled, 2/7/22 |
