3Roots San Diego Project
Environmental Impact Report
SCH No. 2018041065; Project No. 587128

**UPDATE
GEOTECHNICAL INVESTIGATION
FOR VESTING TENTATIVE MAP**

**3ROOTS
SAN DIEGO, CALIFORNIA**

**NOVEMBER 10, 2017
PROJECT NO. G2070-42-02**

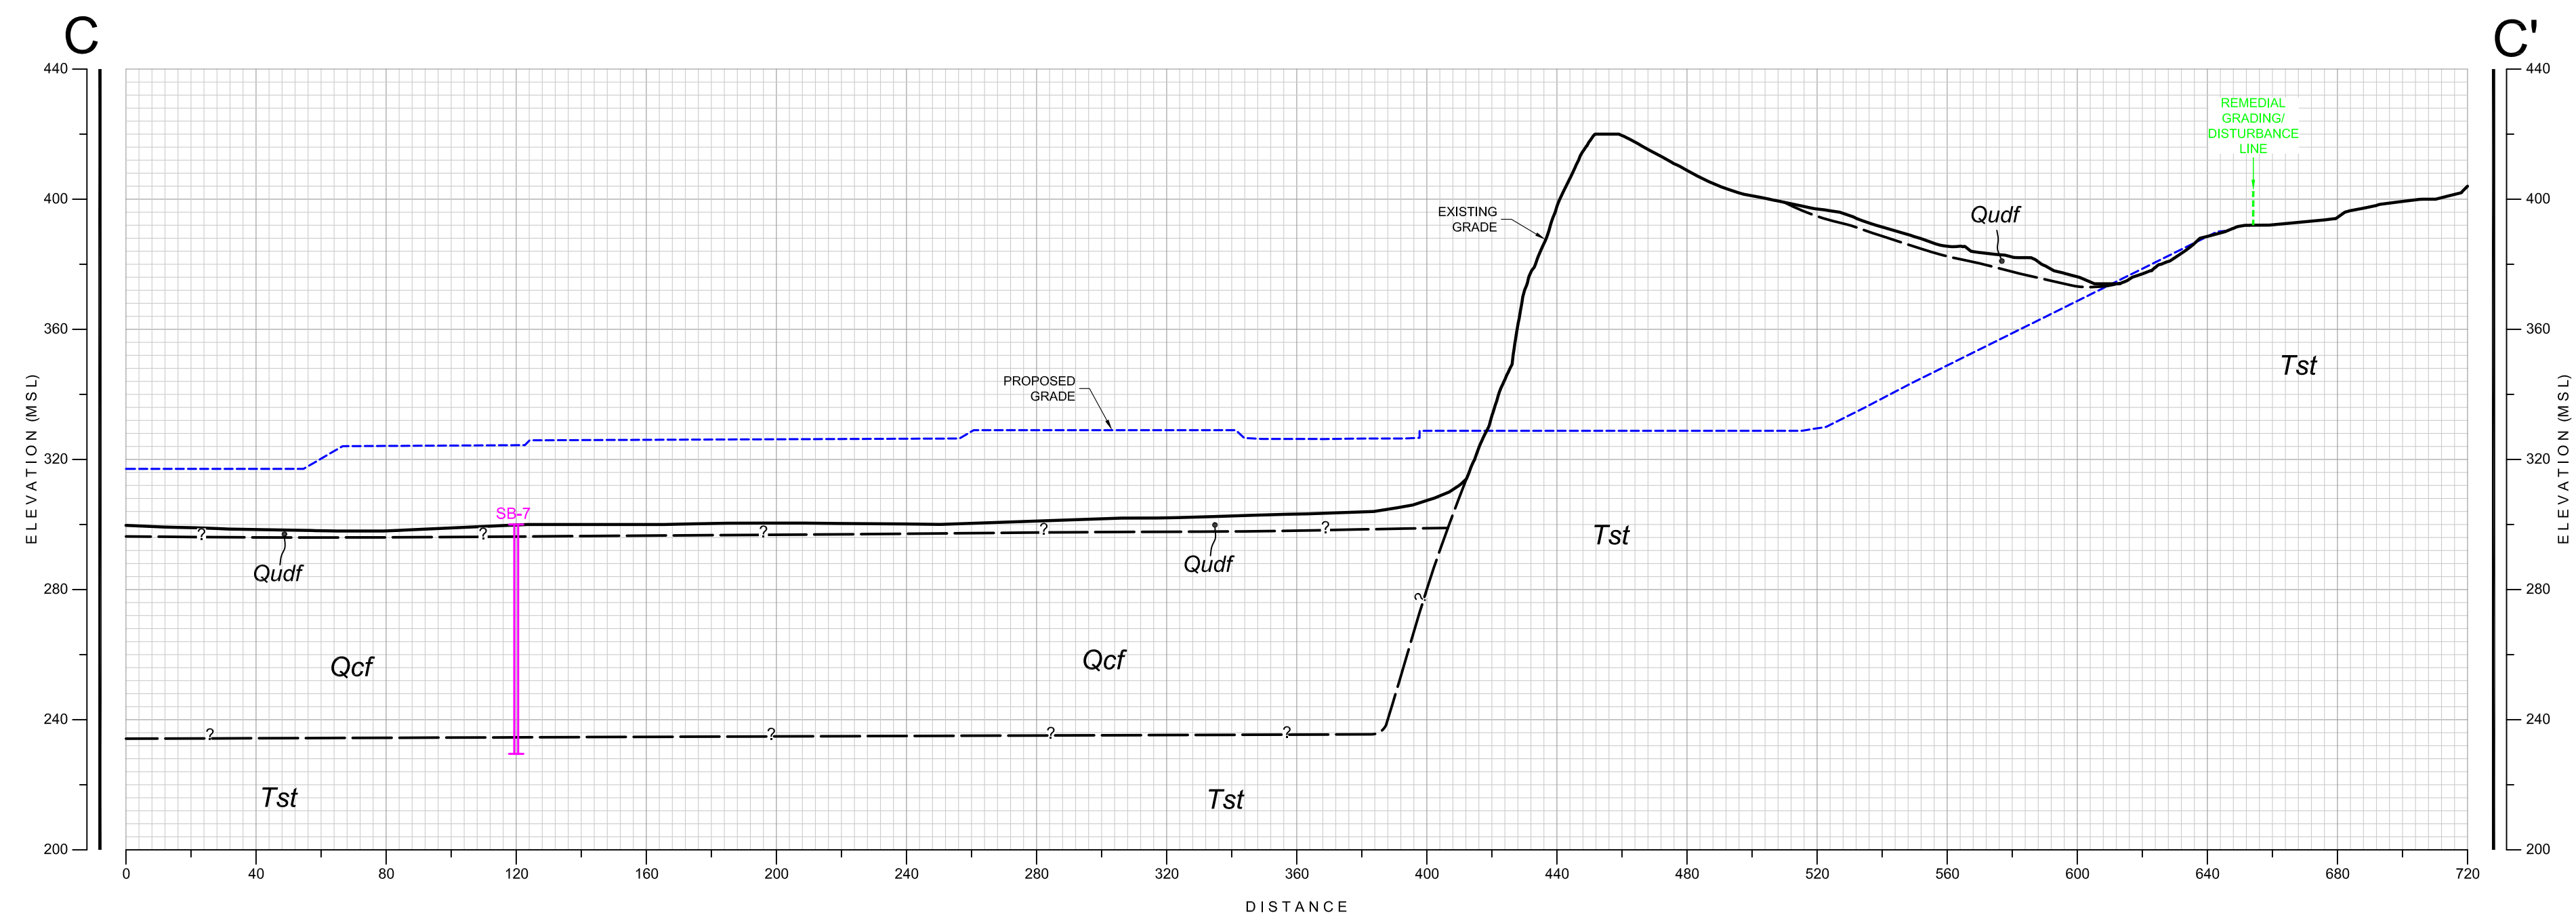
GEOLOGIC CROSS SECTION		
3ROOTS SAN DIEGO, CALIFORNIA		
GEOCON INCORPORATED	SCALE 1" = 40'	DATE 11 - 10 - 2017
GEO TECHNICAL ■ ENVIRONMENTAL ■ MATERIALS 6940 SANDERS DRIVE - SAN DIEGO, CALIFORNIA 92121 - 2974 PHONE 858.558-6900 - FAX 858.558-6159	PROJECT NO. G2070 - 42 - 02	FIGURE 4
SHEET 2 OF 5

GEOLOGIC CROSS-SECTION C-C'
SCALE: 1" = 40' (Vert. = Horiz.)

GEOLOGIC CROSS-SECTION D-D'
SCALE: 1" = 40' (Vert. = Horiz.)

Site geologic conditions depicted on the *Geologic Map* were plotted on an AutoCAD base map provided by Project Design Consultants. The plan depicts the proposed grading, existing topography, mapped geologic contacts, base of compacted fill elevations and the approximate locations of the exploratory excavations. *Geologic Cross-Sections A-A'* through *K-K'* (Figures 3 through 7) represent our interpretation of the geologic conditions across the site.

units are shown on the *Geologic Map. Geologic Cross-Sections A-A'* through *K-K'* (Figures 3 through 7) represent our interpretation of the geologic conditions across the site.

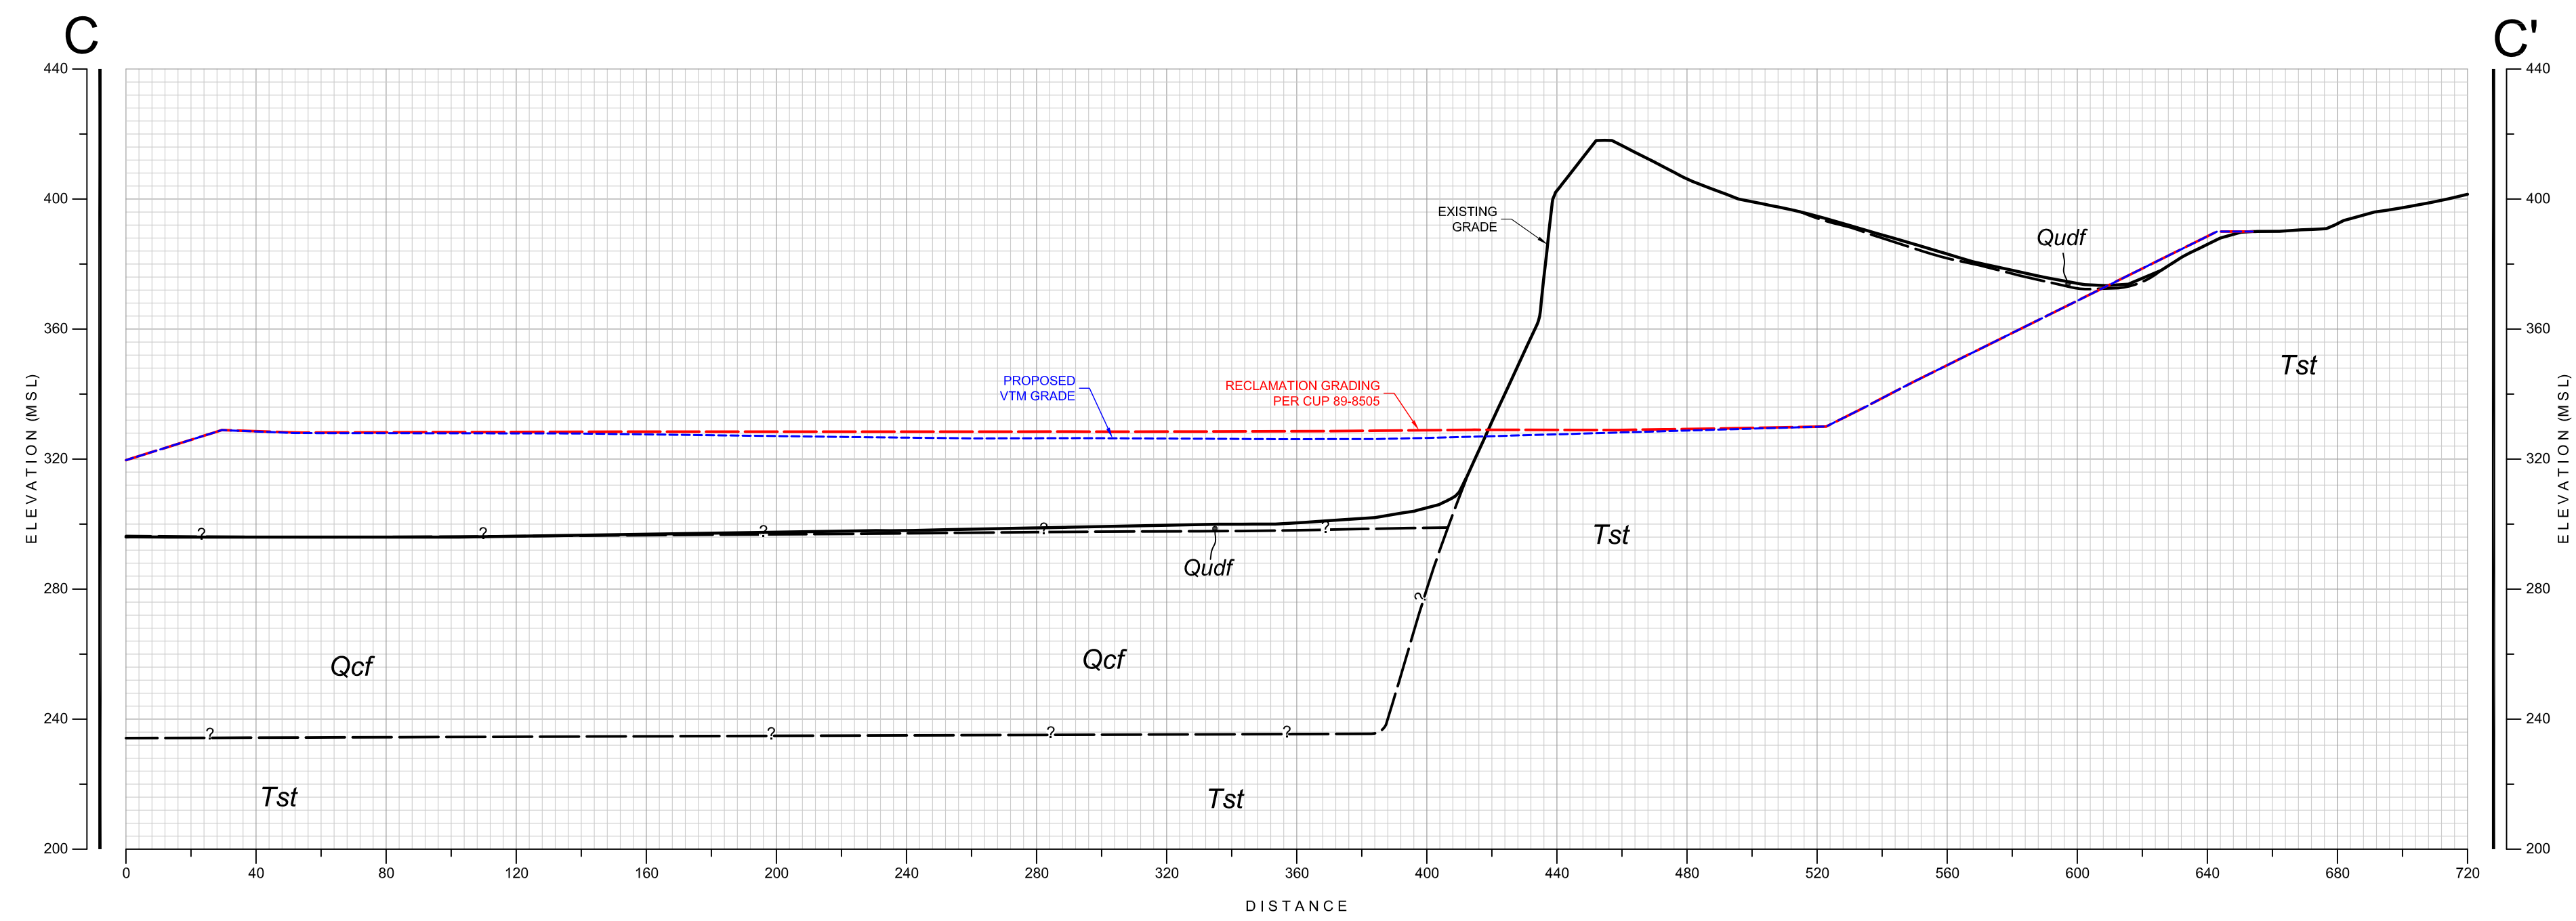
GEOLOGIC CROSS-SECTION C-C'
SCALE: 1" = 40' (Vert. = Horiz.)

GEOLOGIC CROSS-SECTION D-D'
SCALE: 1" = 40' (Vert. = Horiz.)

Site geologic conditions depicted on the *Geologic Map* (Figure 2) were plotted on an AutoCAD base map provided by Project Design Consultants. The plan depicts ground surface elevations based on flown topographic information from a December 2016 survey, reclamation grading topography from the CUP – 89-8505, geologic contacts, and finish grades based on the VTM. Geologic cross sections are provided on Figures 3 through 8 and represent our interpretation of the geologic conditions across the site.
