Revised Biological Resources Survey Report

for the **Proposed Truck Rack Project Lompoc Oil Field Santa Barbara County, California**

AECOM 300 South Grand Avenue Los Angeles, CA 90071

Revised July 2023

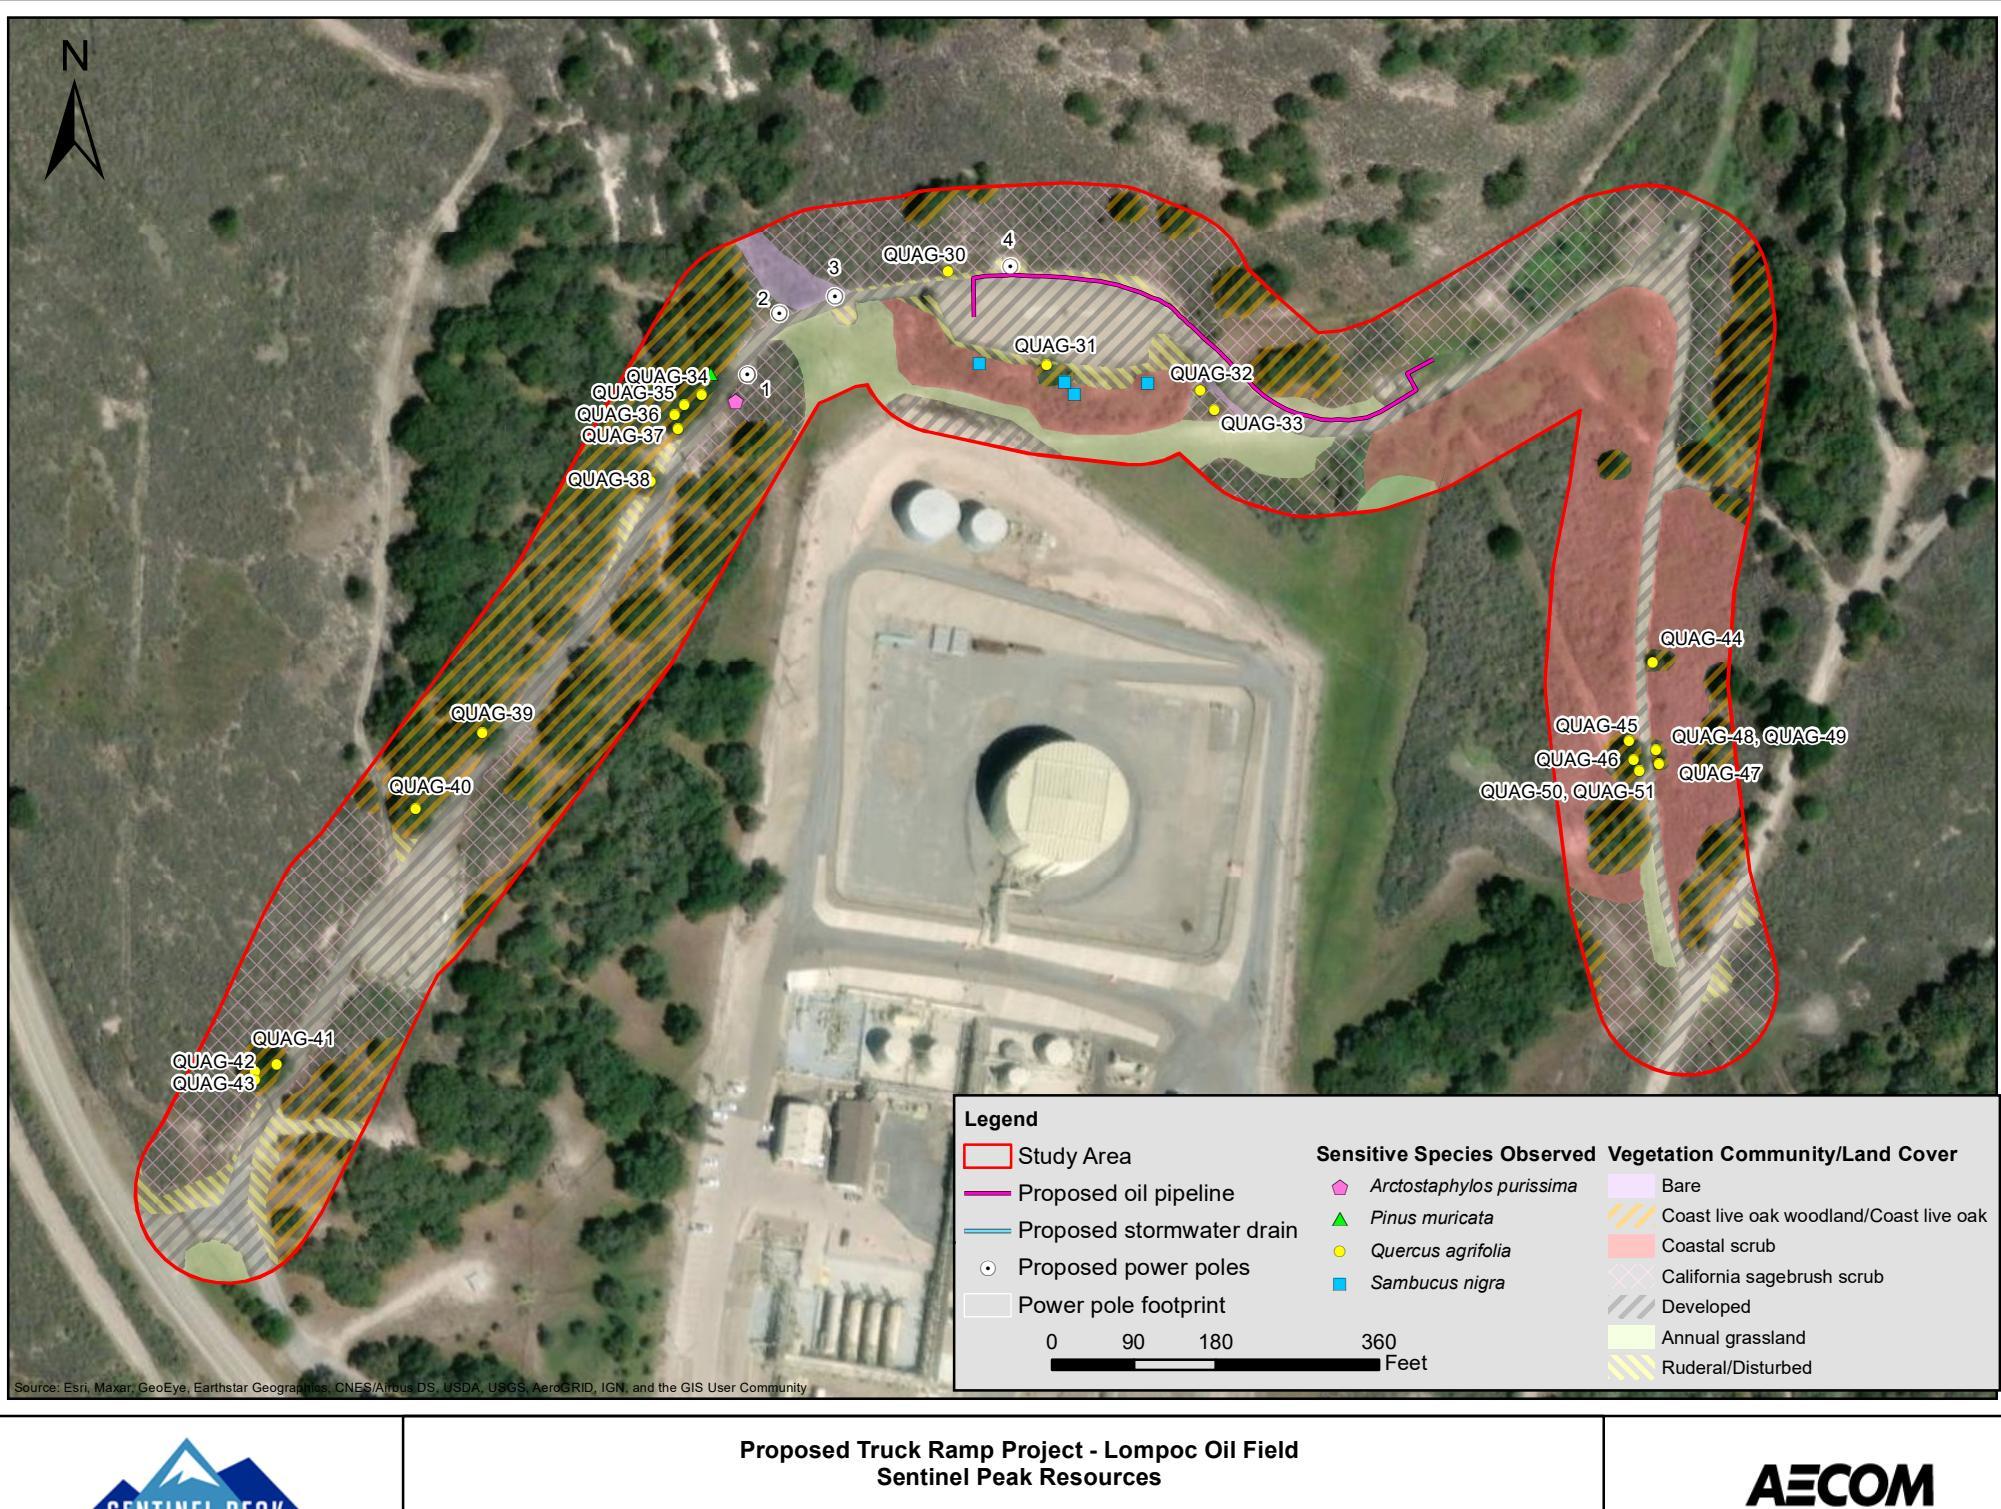
Figure 3 - Biological Survey Results

related to the proposed project or SPR's operations at the oilfield. These areas are designated as Bare on **Figure 3.** One of the four new power poles, Pole 3, occurs entirely within this bare area.

The following sections described the special-status species observed during the survey and potential impacts to these species due to Project-related activities. **Figure 3** provides a graphic representation of the locations of observed special-status species.

One La Purisima manzanita was observed during the survey, located off the edge of the western access road near Purisima 33 (**Figure 3**). Because of its position off the road edge, no impacts to the

Four blue elderberry shrubs were observed in the scrubland south of Purisima 33 (**Figure 3**). All were in poor condition during the survey, appearing mostly or completely dead; this may have been due to the season. One shrub is located near the edge of the production pad but is outside the proposed secondary containment berms and will not be disturbed. One shrub is located south of the proposed storm drain pipeline; this shrub will also be avoided during construction. The other shrubs are downslope within the scrubland. There will be no trimming or removal of any blue elderberry shrubs.

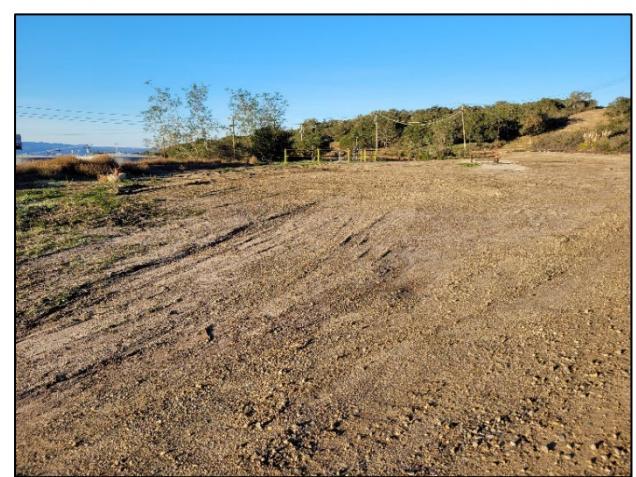
Photograph 1. View of Pad Purisima 33, facing west from the east access road to the production pad.

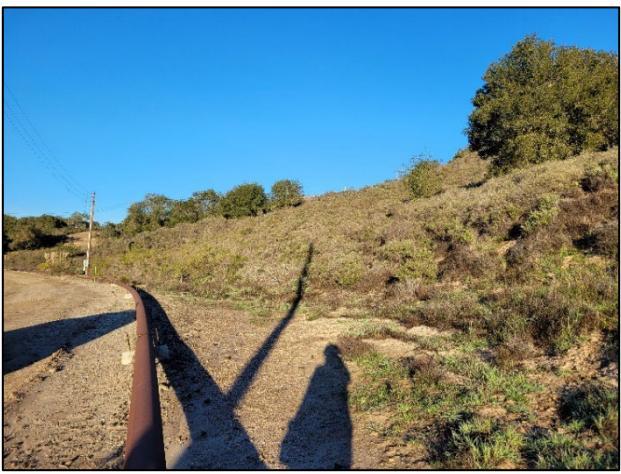
Photograph 2. View of the northern boundary of Pad Purisima 33, facing northwest, showing the existing pipelines at the edge of the production pad, with California sagebrush scrub and scattered coast live oaks (Quercus agrifolia).

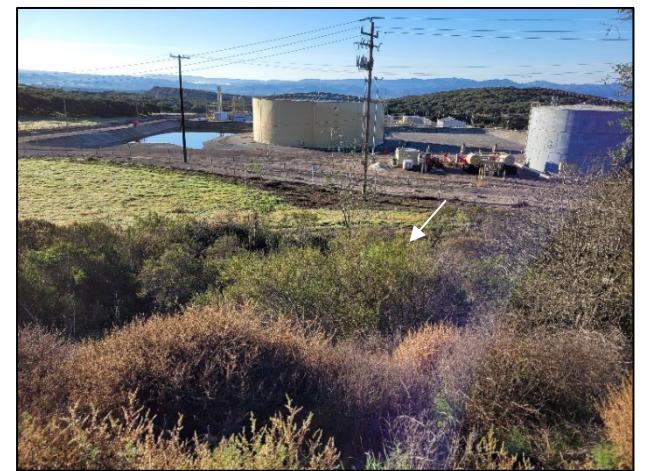
Photograph 3. View of ruderal (foreground) at edge of production pad, with a thin band of coastal scrub that includes scattered blue elderberry (*Sambucus nigra*, white arrow), with annual grassland and the Lompoc Oil and Gas Plant in the background.

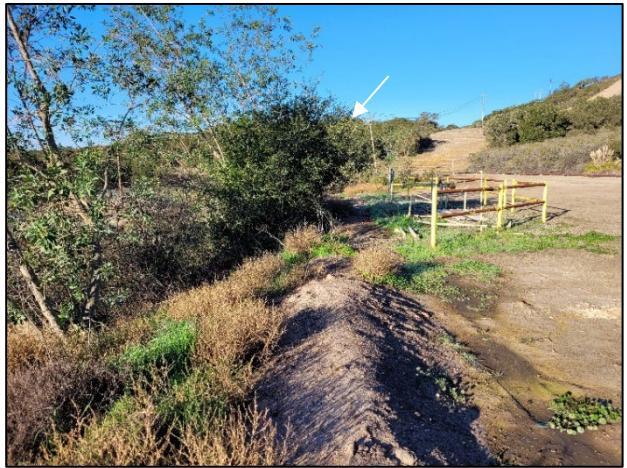
Photograph 4. View of the southern boundary of Pad Purisima 33. Quag-31 is shown with a white arrow; this tree occurs at the edge of the pad but is protected by existing infrastructure and would not be impacted by the proposed Project.

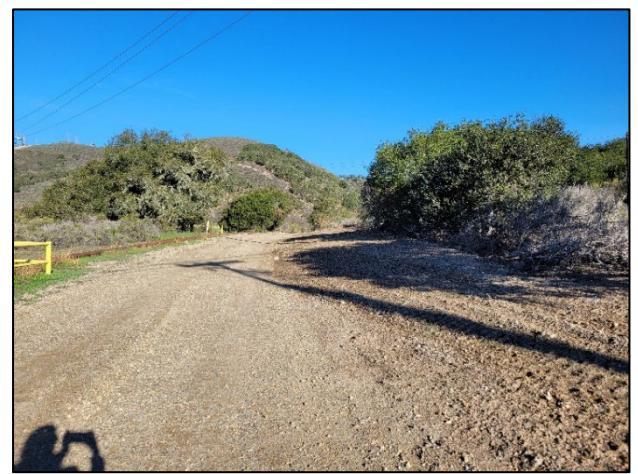
Photograph 5. View north from the eastern end of the existing access road, showing coast live oaks on edge of road. No trimming is anticipated for these trees.

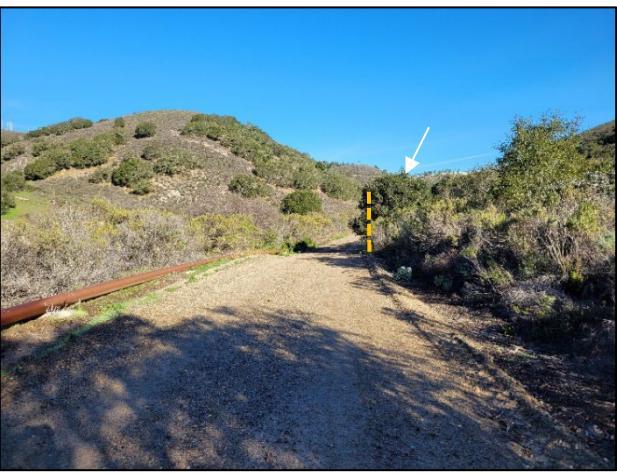
Photograph 6. View north along the eastern access road, with coastal scrub habitats along road edge. Quag-44 is shown with a white arrow, and the potential extent of trimming is delineated.

Trimming of protected oaks will be minimized and will be conducted only on oaks overhanging the existing roadways. Where trimming must occur to maintain clearance over existing roadways, trimming will be minimized to the extent necessary to attain sufficient protection from fire hazards and vehicular clearance. No more than 20 percent of the canopy of any individual protected tree will be removed by the proposed project.

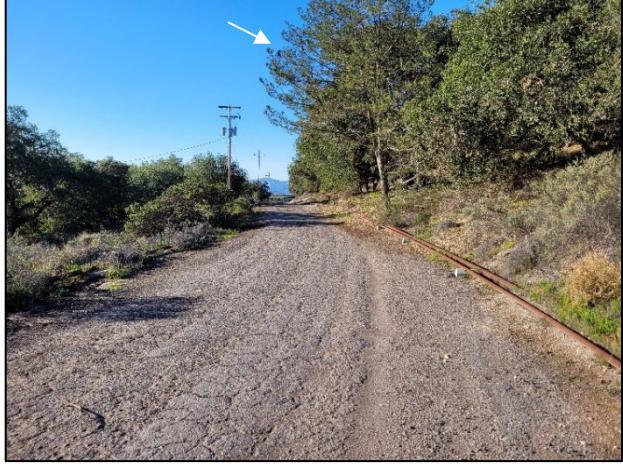
Photograph 11. View along western access road. Bishop pine indicated with a white arrow.

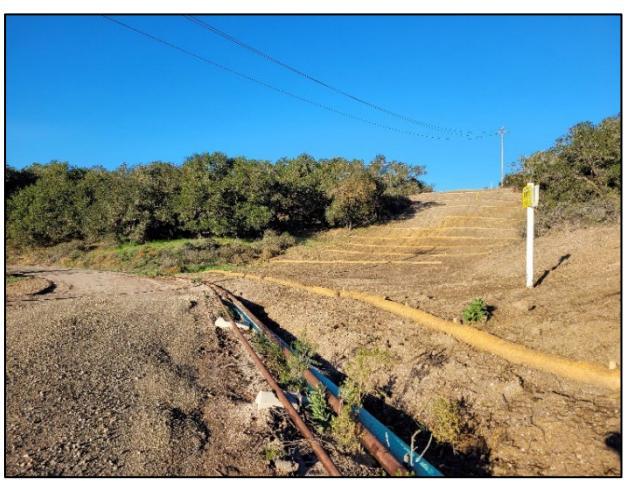
Photograph 10. View of existing barren area associated with powerline corridor, located west of Pad Purisima 33.

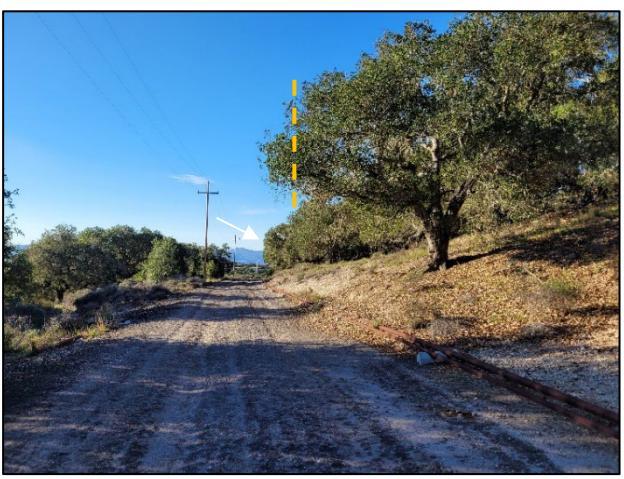
Photograph 12. View of Quag-38 along western access road, with potential trimming highlighted with a dashed orange line. Trimming will be minimized and will not extend passed the edge of the existing road. Quag-39 is indicated by the white arrow.

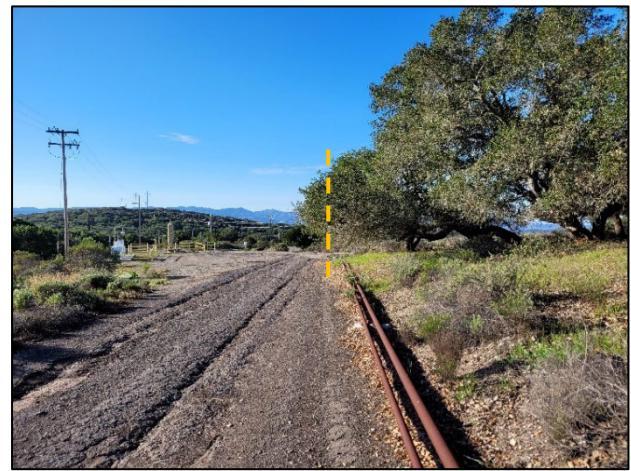
Photograph 13. View south along western access road, showing Quag-40 (white arrow), with potential trimming lines.

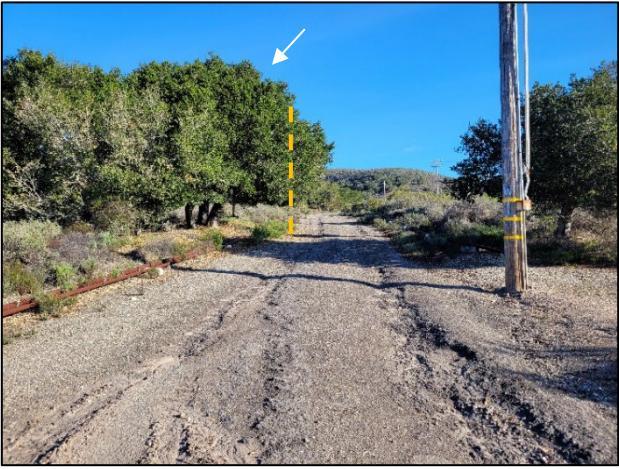
Photograph 14. View north along western access road from the existing gate at the end of the road, showing Quag-41 (white arrow). Quag-42 and Quag-43 are smaller and located to the left of Quag-41, growing close together and set further back from the road.

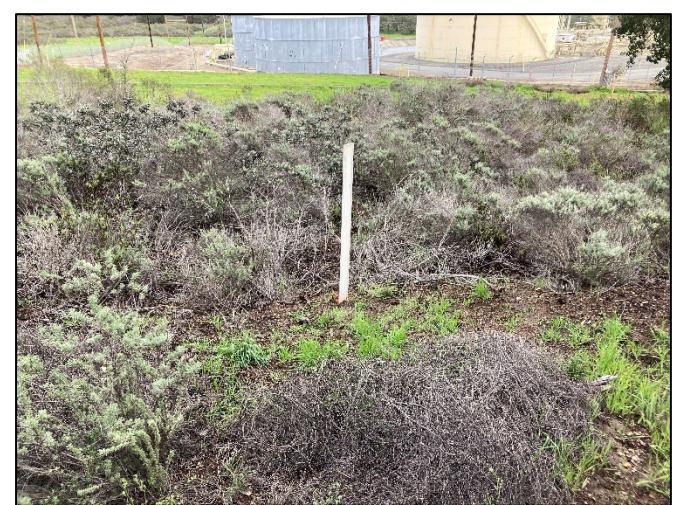
Photograph 15. View of pole location 1 (white stake), within California sagebrush scrub.

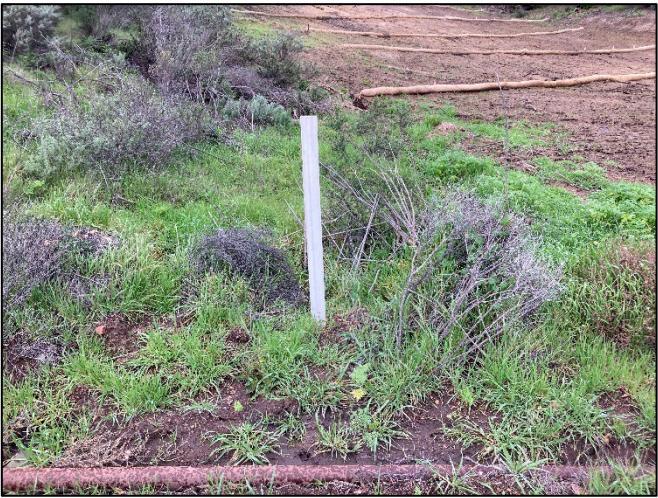
Photograph 16. View of pole location 2 (white stake) at the edge of California sagebrush scrub.

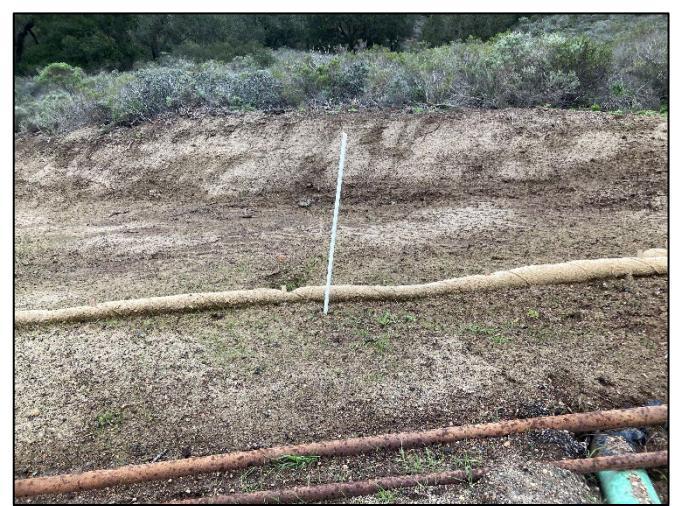
Photograph 13. View of pole location 3 (white stake), within an area that was previously cleared by Southern California Gas and is considered bare ground.

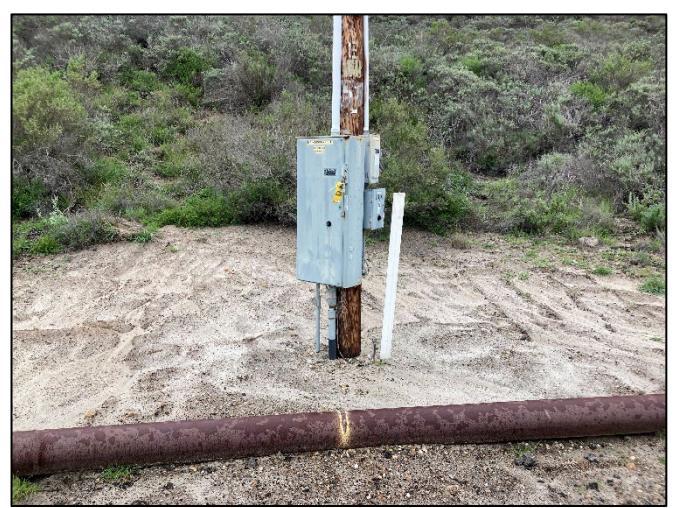
Photograph 14. View of pole location 3 (white stake), adjacent to an existing pole and within the bare ground and ruderal footprint of the existing pole.
