FIMARINE TAXONOMIC SERVICES, LTD.

Coastal Bluff Stabilization Project at the Inn at Sunset Cliffs: Intertidal Biological Assessment

January 23, 2020 (Revised September 29, 2021)

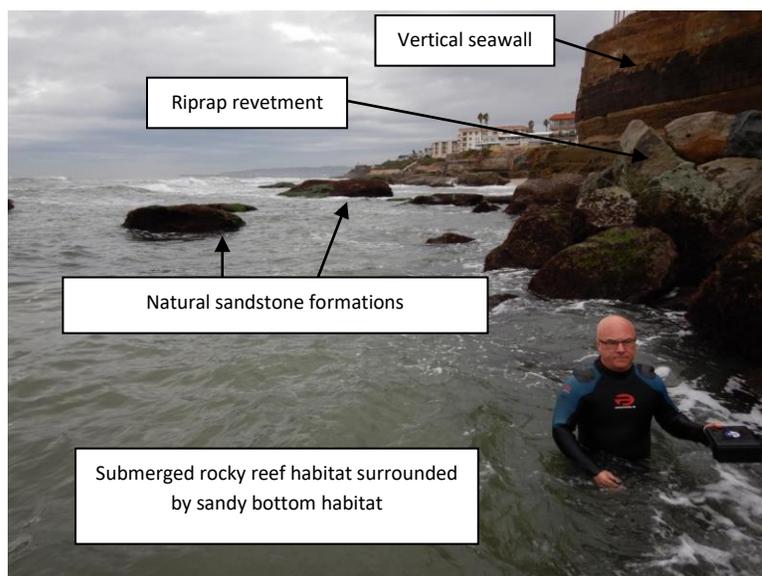
The Project area consists of intertidal habitat made up of rocky reefs, scattered sandstone formations, and a riprap revetment leading up to the existing cast-in-place concrete seawall (Figure 2). Submerged rocky reefs were surrounded by coarse sand, characteristic of other nearby San Diego beaches. A previous survey conducted by Merkel & Associates Inc. (2005) had revealed a small cave and several other openings within the vicinity of the vertical seawall within the proposed Project area. The previously surveyed cave, plus nearly all of the previously documented openings in the vicinity of the vertical seawall were no longer present as they were filled as part of previous bluff stabilization efforts. The only exception observed by MTS

Figure 2. Project area at 1200 hours (0' MLLW).

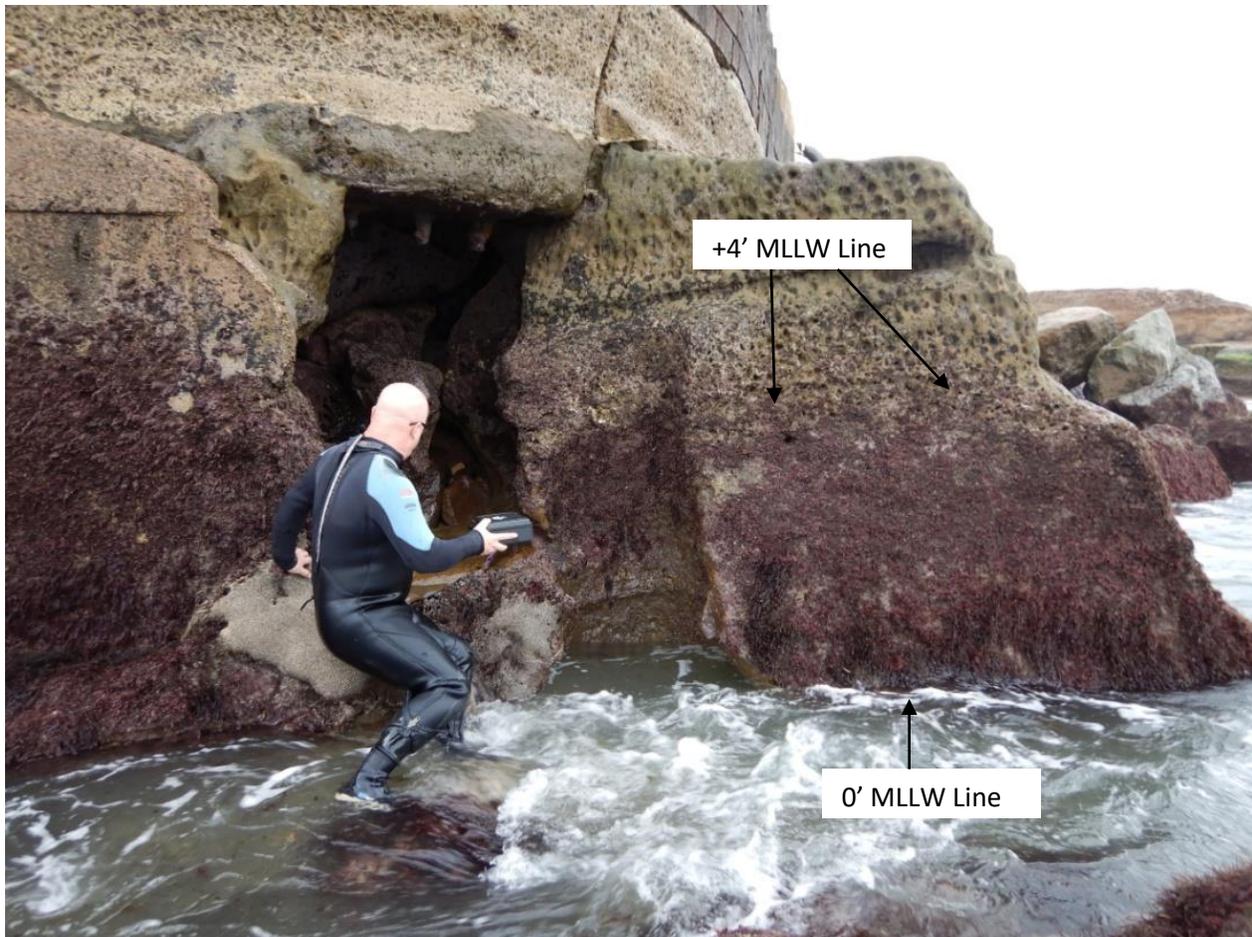
biologists was a small, partially filled opening located along the northwest facing section of the existing vertical seawall (32.441166°N, -117.152045°W) (Figure 3).

Figure 3. Small opening observed along the existing vertical seawall. The vertical limit of marine algae growth along the vertical seawall as shown here marks the +4' MLLW elevation boundary. Elevations are approximate and based on rough measurements to the water line and observed tidal elevations at Scripps Pier (NOAA Tidal Station 9410230).

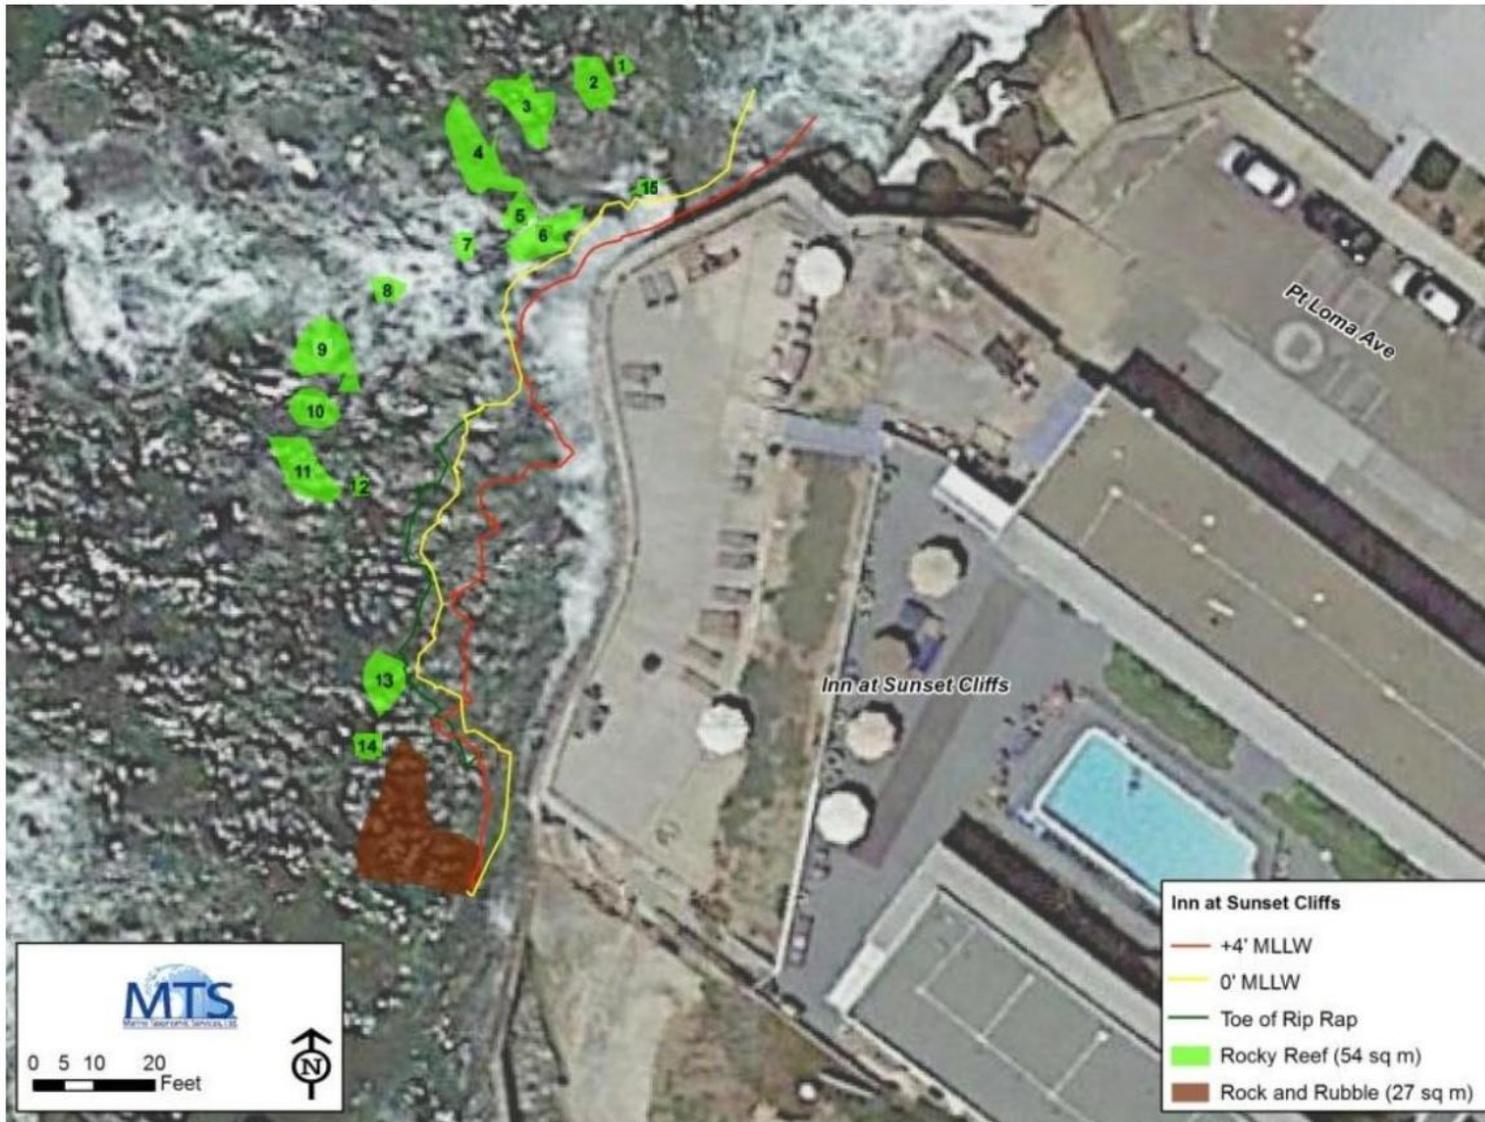
Submerged areas surrounding the riprap revetment consisted primarily of coarse sand with wave-cut bedrock lying underneath. The riprap revetment itself contained numerous crevices within which small marine invertebrates could seek refuge. Occurring just offshore from the toe of rocky revetment was a small system of rocky reefs that stretched the full length of the survey area (Figure 4). In all, 54 square meters of rocky reef habitat was surveyed between 15 distinct rocky reef “microhabitats”. These rocky reefs consisted of gently sloping wave-cut sandstone and were exposed to high wave energy and ocean swells. Each rocky reef microhabitat supported turf forming algae species, surfgrass, or a mixture of turf and surfgrass. The limits of each rocky reef microhabitat surveyed, along with the relative composition turf algae and surfgrass within each of these rocky reef microhabitats is listed in Table 2.

Figure 4. Tidal zones and rock reef habitat mapped within the marine biological survey area.

Any unanticipated damage or loss of rocky intertidal habitat mapped in Figure 4 of this report would be considered a significant impact and would require mitigation. Mitigation measures are provided below that would reduce the impacts to less than significant (refer to Section 6.3).

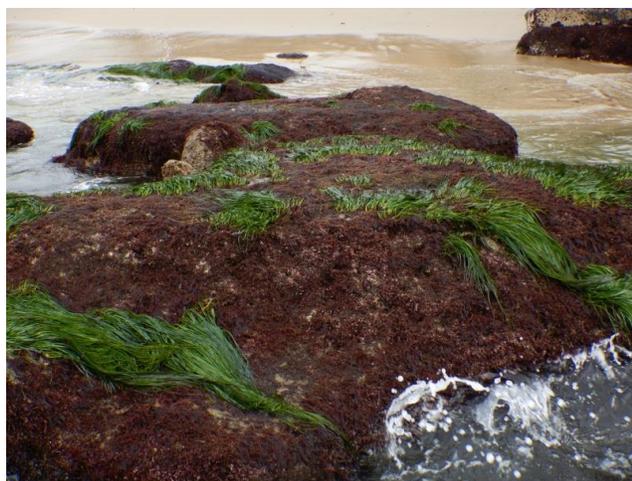
Figure 5. Reef ID #2 (90% turf algae/10% surfgrass).
