CENTRAL COAST LAYOVER FACILITY
Preliminary Geotechnical Design Report
San Luis Obispo, California

Subject: Preliminary Geotechnical Design Report
LOSSAN Central Coast Layover Facility Project

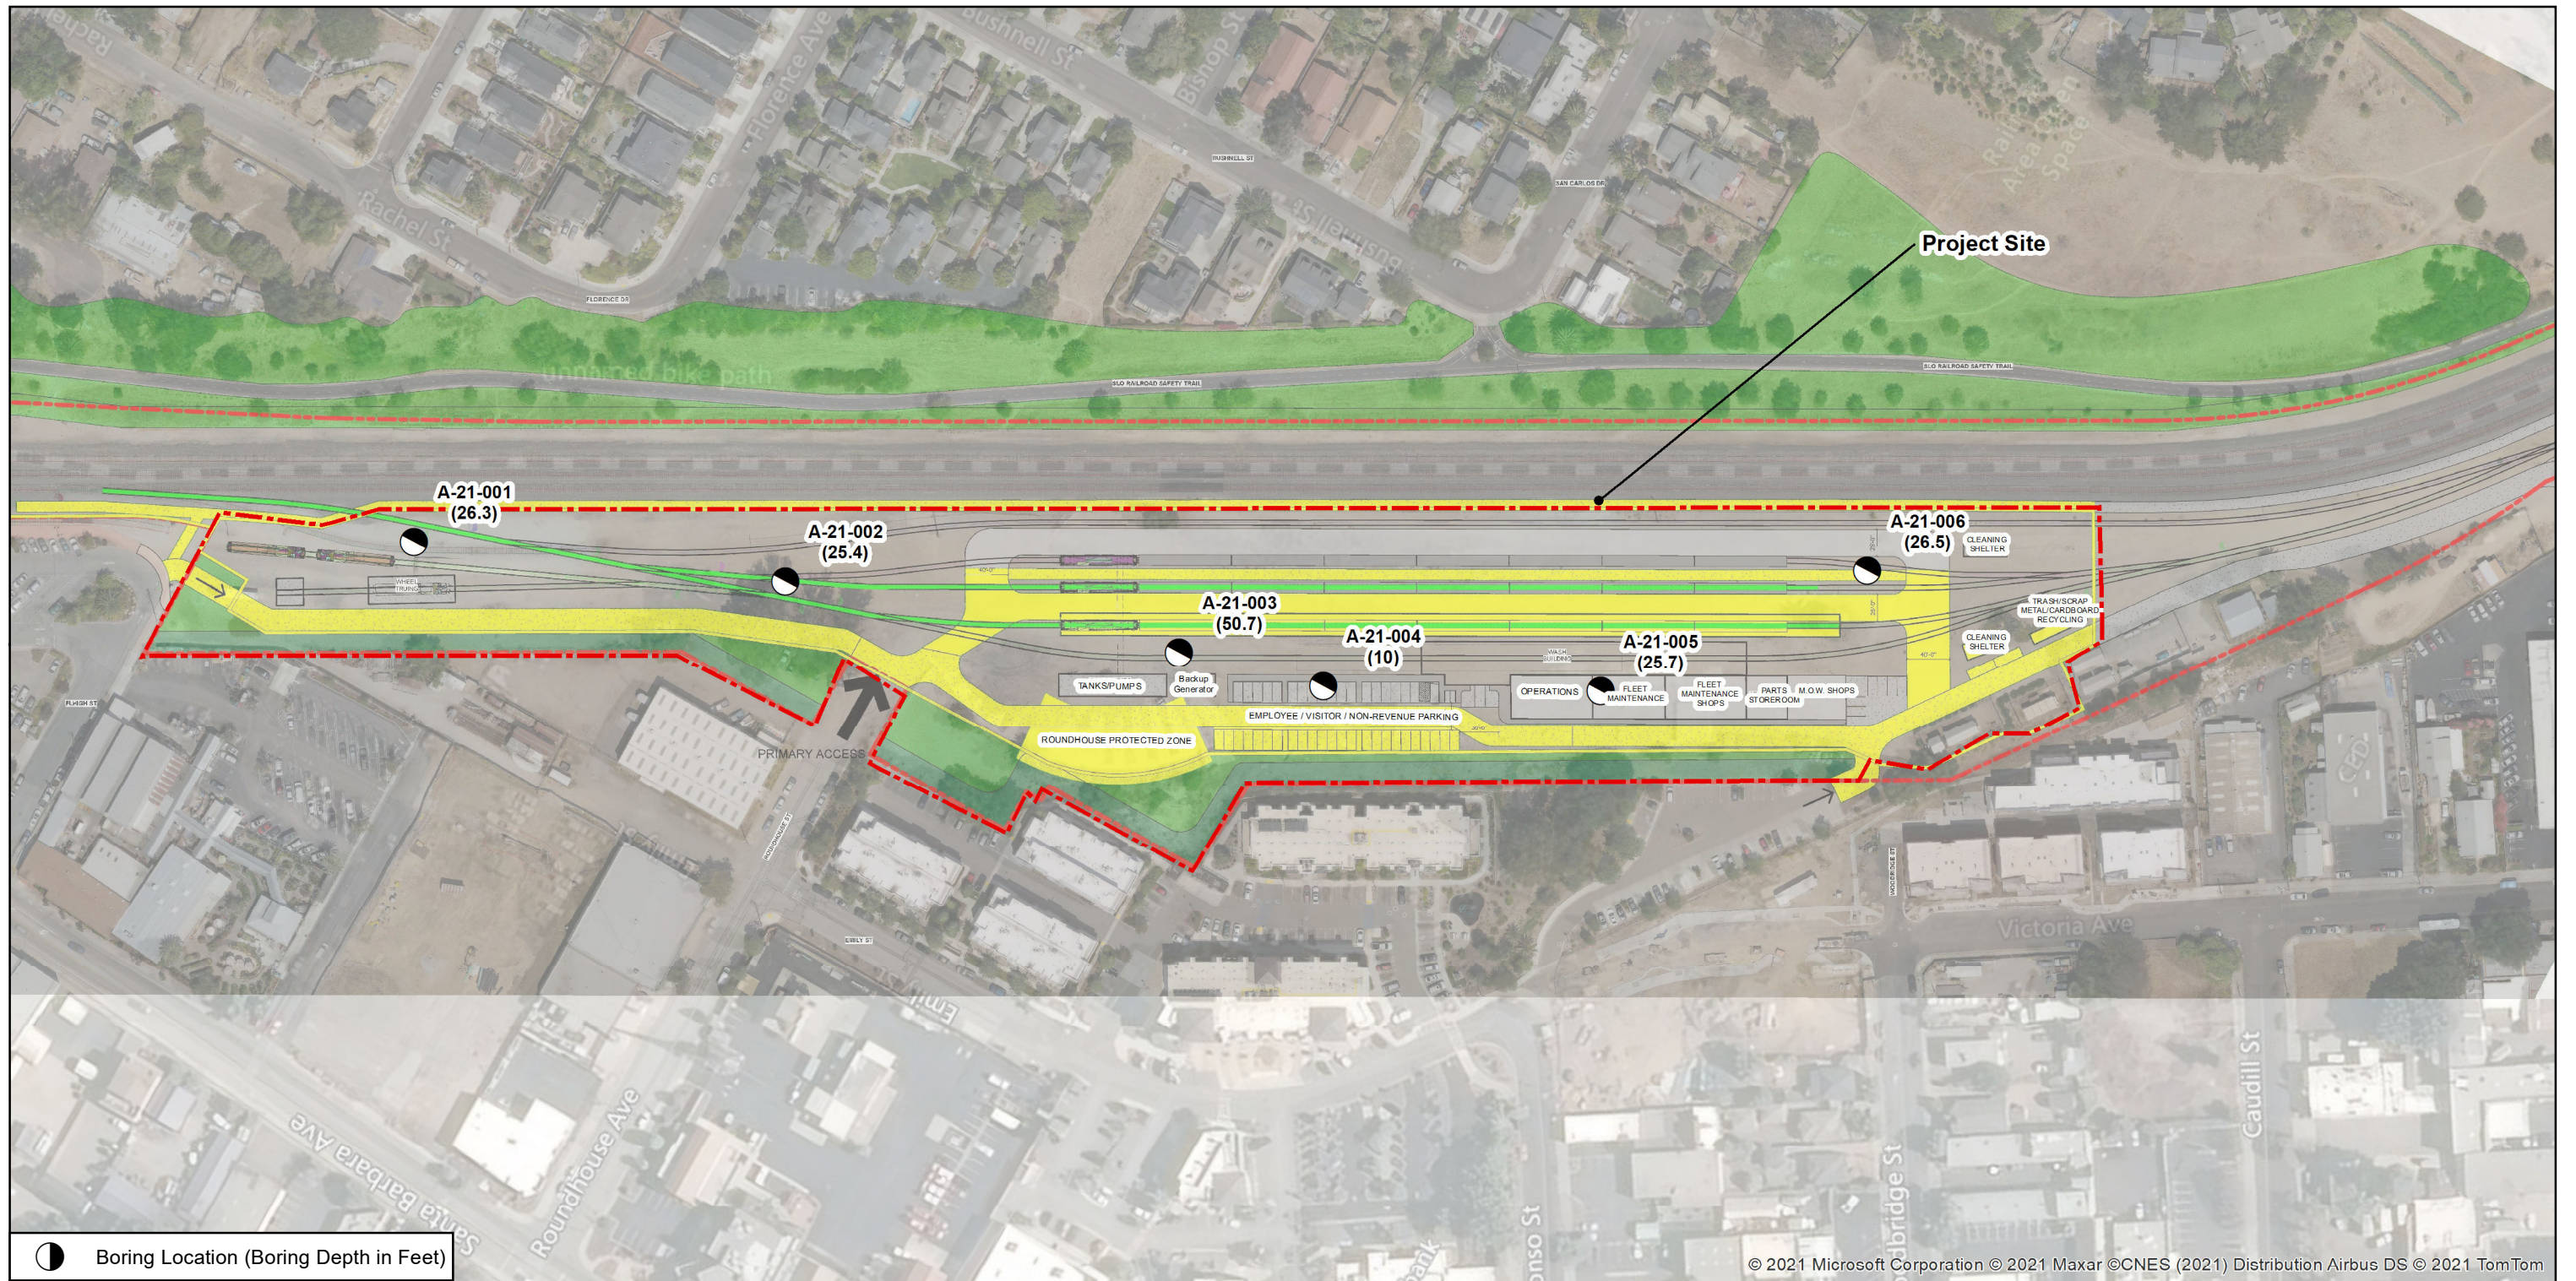
**BORING LOCATION MAP
LOSSAN CENTRAL COAST LAYOVER FACILITY
SAN LUIS OBISPO, CALIFORNIA**

Subsurface exploration consisted of advancing six (6) 8-inch diameter HSA borings to a maximum depth of approximately 50 feet bgs. The borings are located within a currently undeveloped parcel adjacent to the existing railroad right-of-way. Infiltration testing was performed in Boring A-21-004 to assess infiltration capabilities where basins are proposed. The approximate locations of the borings are shown in Figure 2 in Appendix A. Approximate boring coordinates, ground surface elevations, and depths explored are summarized in Table 2-1.

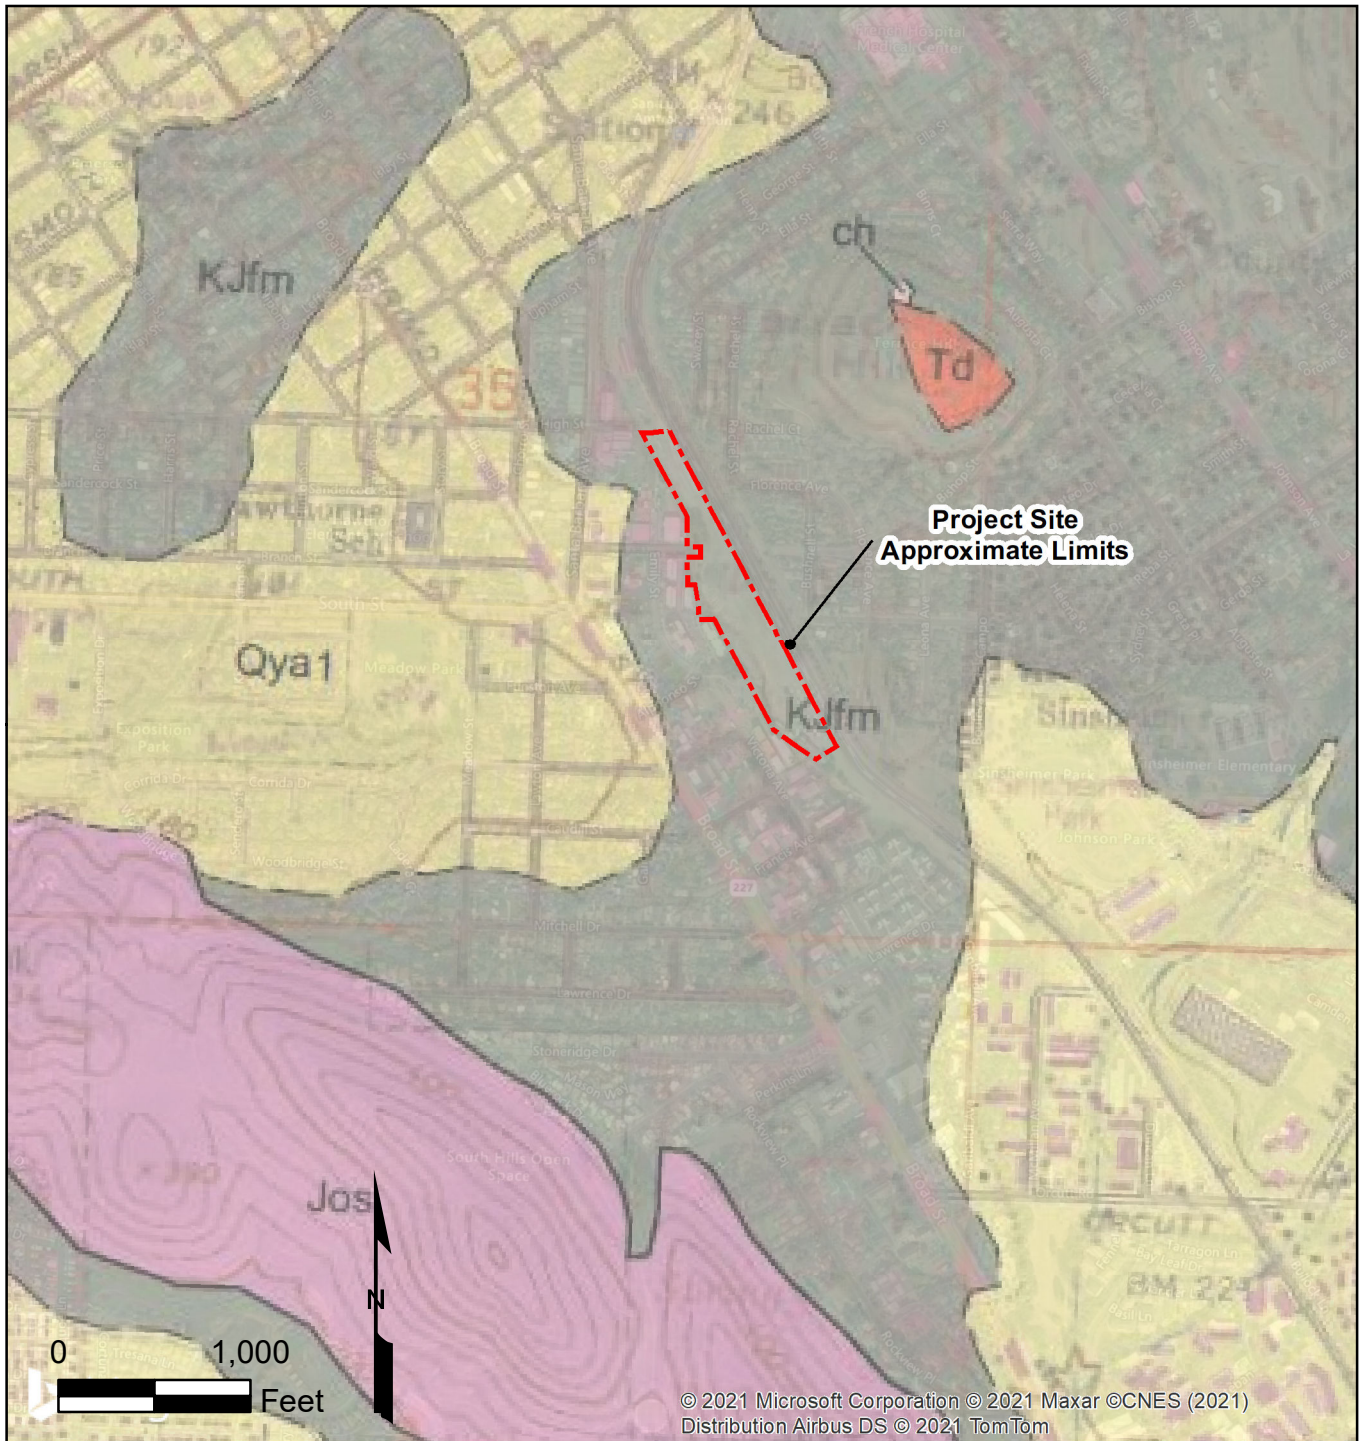
- Qya** Young alluvial flood-plain deposits, undivided (Holocene to late Pleistocene) – Unconsolidated sand, silt, and clay-bearing alluvium deposited on flood-plains and along valley floors. Locally divided by relative age (2 = youngest, 1 = oldest):

- Td** Morro Rock – Islay Hill volcanic intrusive complex (Oligocene) – Porphyritic dacite. Approximately 50% of rock consists of phenocrysts with a typical composition of 65% andesine, 15% biotite and clay, 10% hornblende, 5% quartz, and 5% magnetite, apatite, and zeolites. Groundmass consists of altered plagioclase, biotite, glass, quartz and hornblende (Hall and Prior, 1975). These rocks are exposed in a series of volcanic plugs and lava domes that form distinctive peaks between Morro Bay and San Luis Obispo. Flow banding is common. Radiometric dates range from 27 to 23 Ma (Stanley and others, 2000).

**REGIONAL GEOLOGIC MAP
LOSSAN CENTRAL COAST LAYOVER FACILITY
SAN LUIS OBISPO, CALIFORNIA**

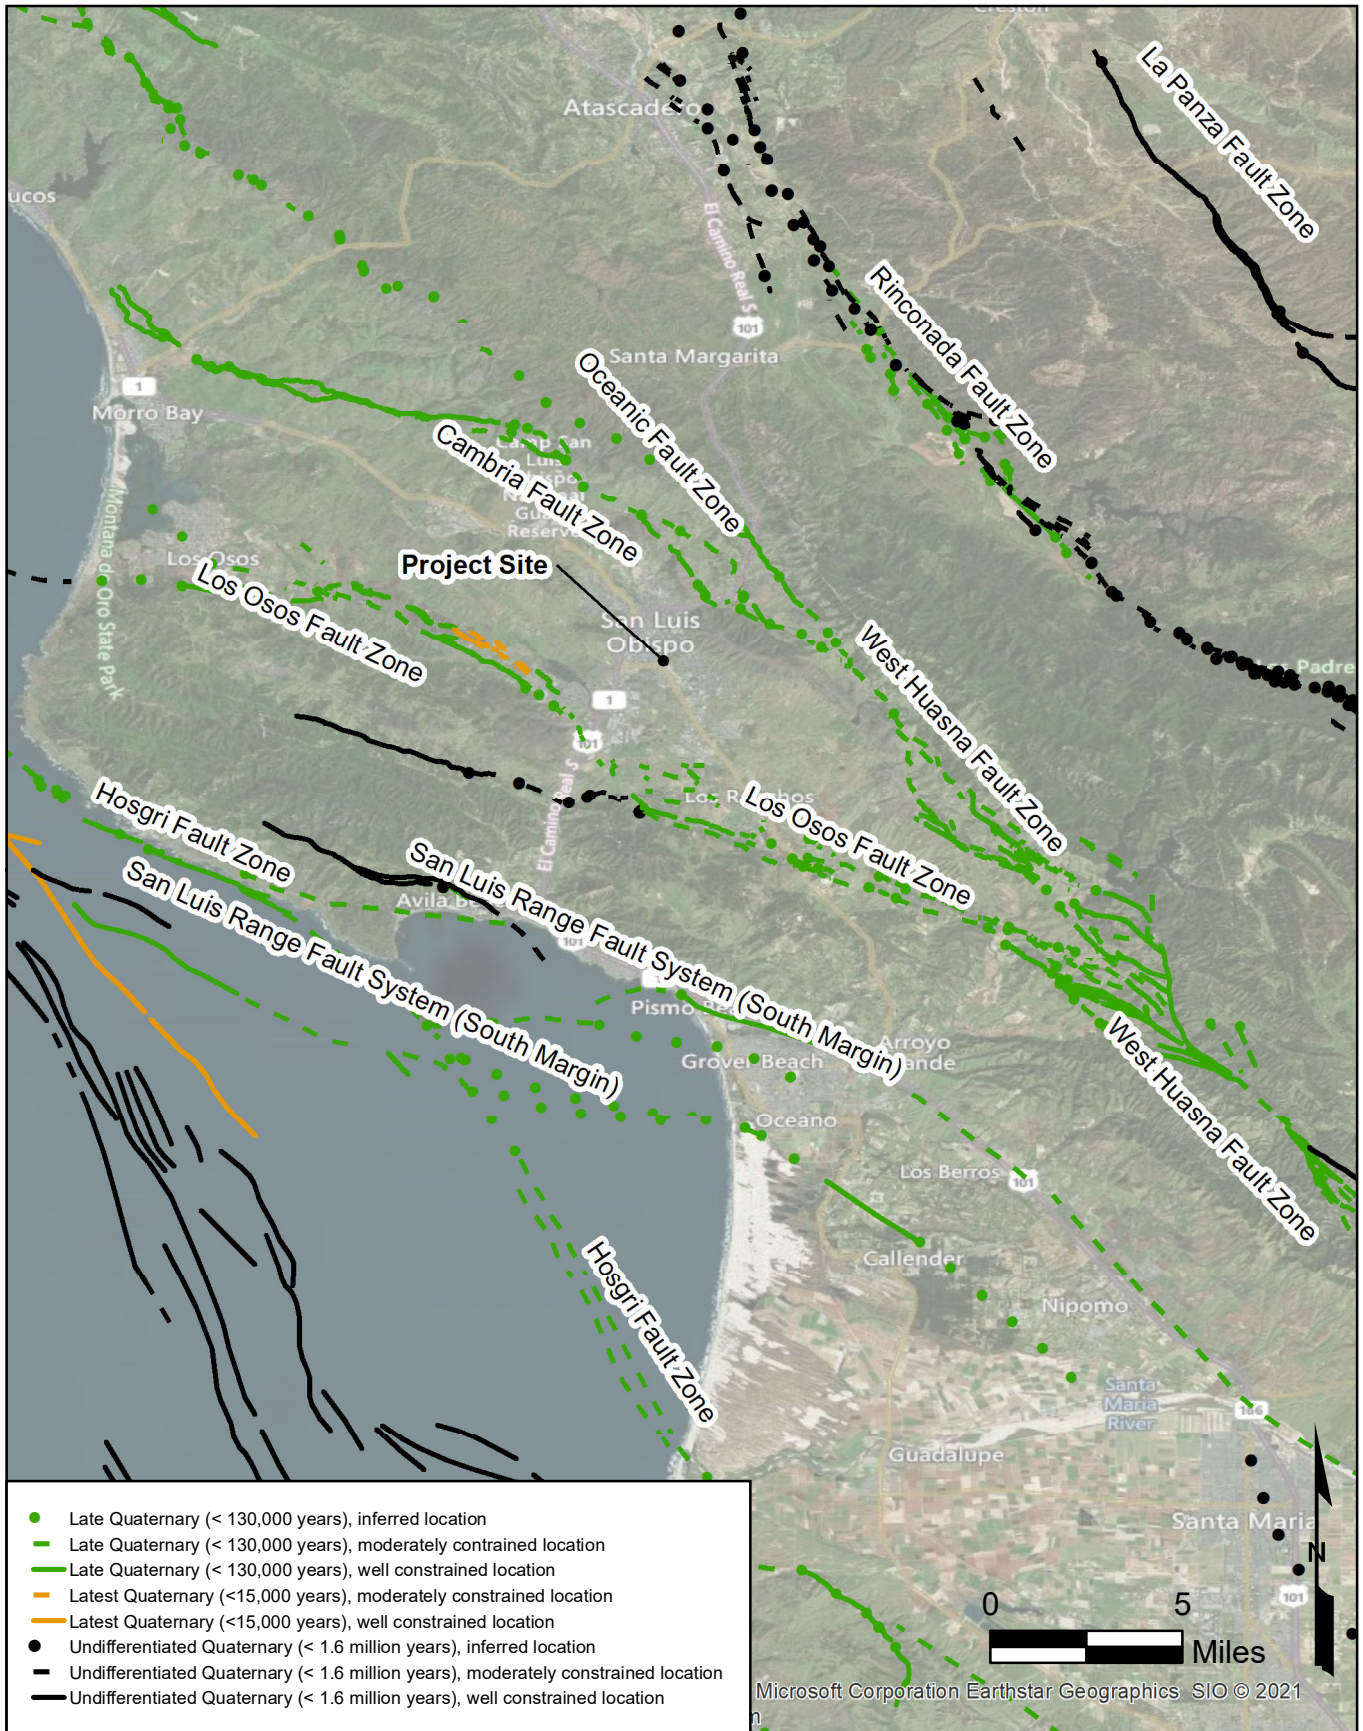
**REGIONAL FAULT MAP
LOSSAN CENTRAL COAST LAYOVER FACILITY
SAN LUIS OBISPO, CALIFORNIA**

The principal seismic hazard that could affect the Project site is ground shaking resulting from an earthquake occurring along one of several major active or potentially active faults in the vicinity of the Project site. Table 3-1 lists faults with a risk contribution greater than 1 percent, along with pertinent data such as fault type, distance to fault, and maximum magnitude. Other nearby faults are shown in Figure 4.

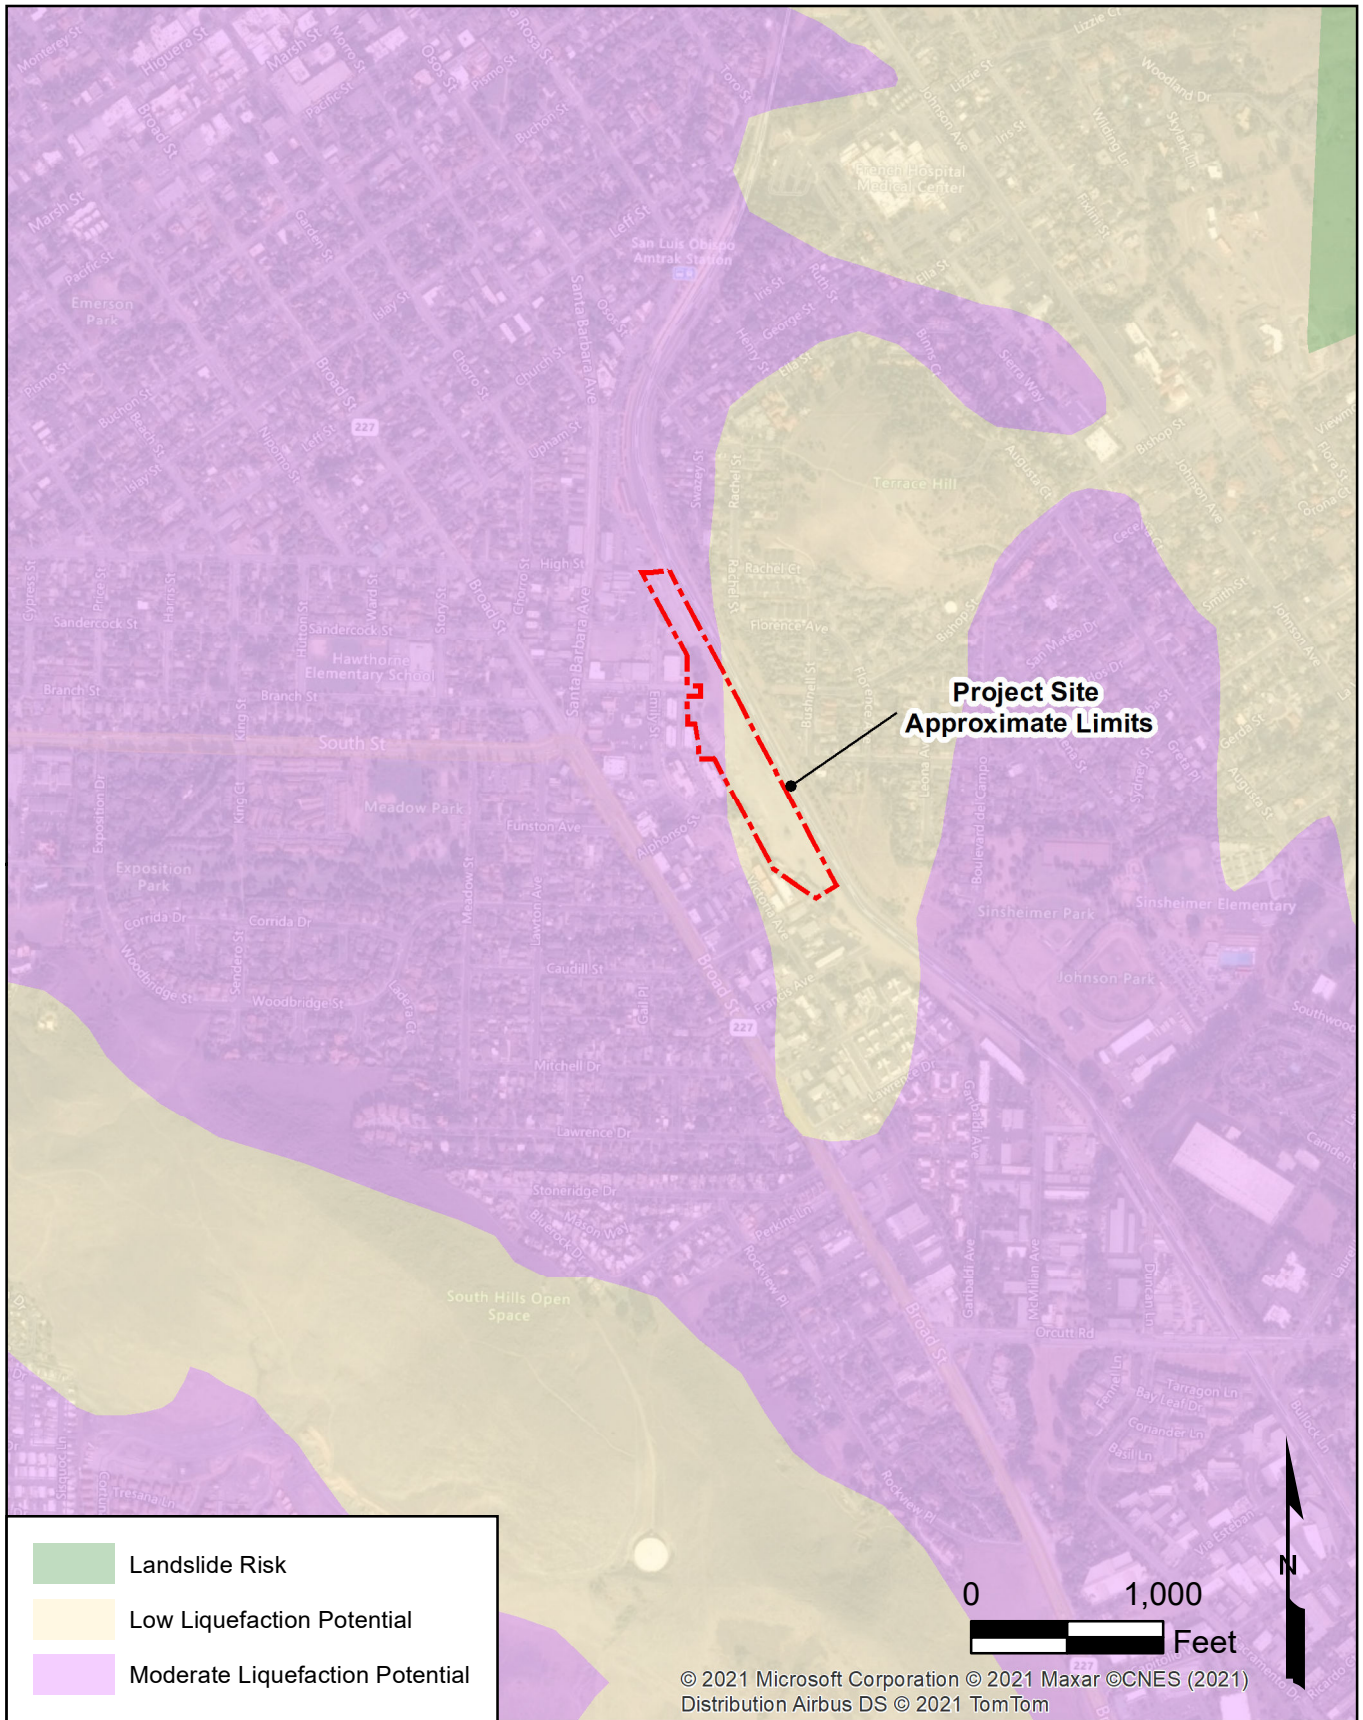
**SEISMIC HAZARD MAP
LOSSAN CENTRAL COAST LAYOVER FACILITY
SAN LUIS OBISPO, CALIFORNIA**

As mentioned in Section 3.3, the Project alignment is not traversed by known active or potentially active faults. Therefore, the potential for fault rupture within the Project site is considered low. Based on the information available on EQ Zapp (CGS, 2021), the nearest special study zone is the Los Osos fault zone which is approximately 3 miles to the west of the Project site. This Special Studies Zone is shown on Figure 5 in Appendix A.

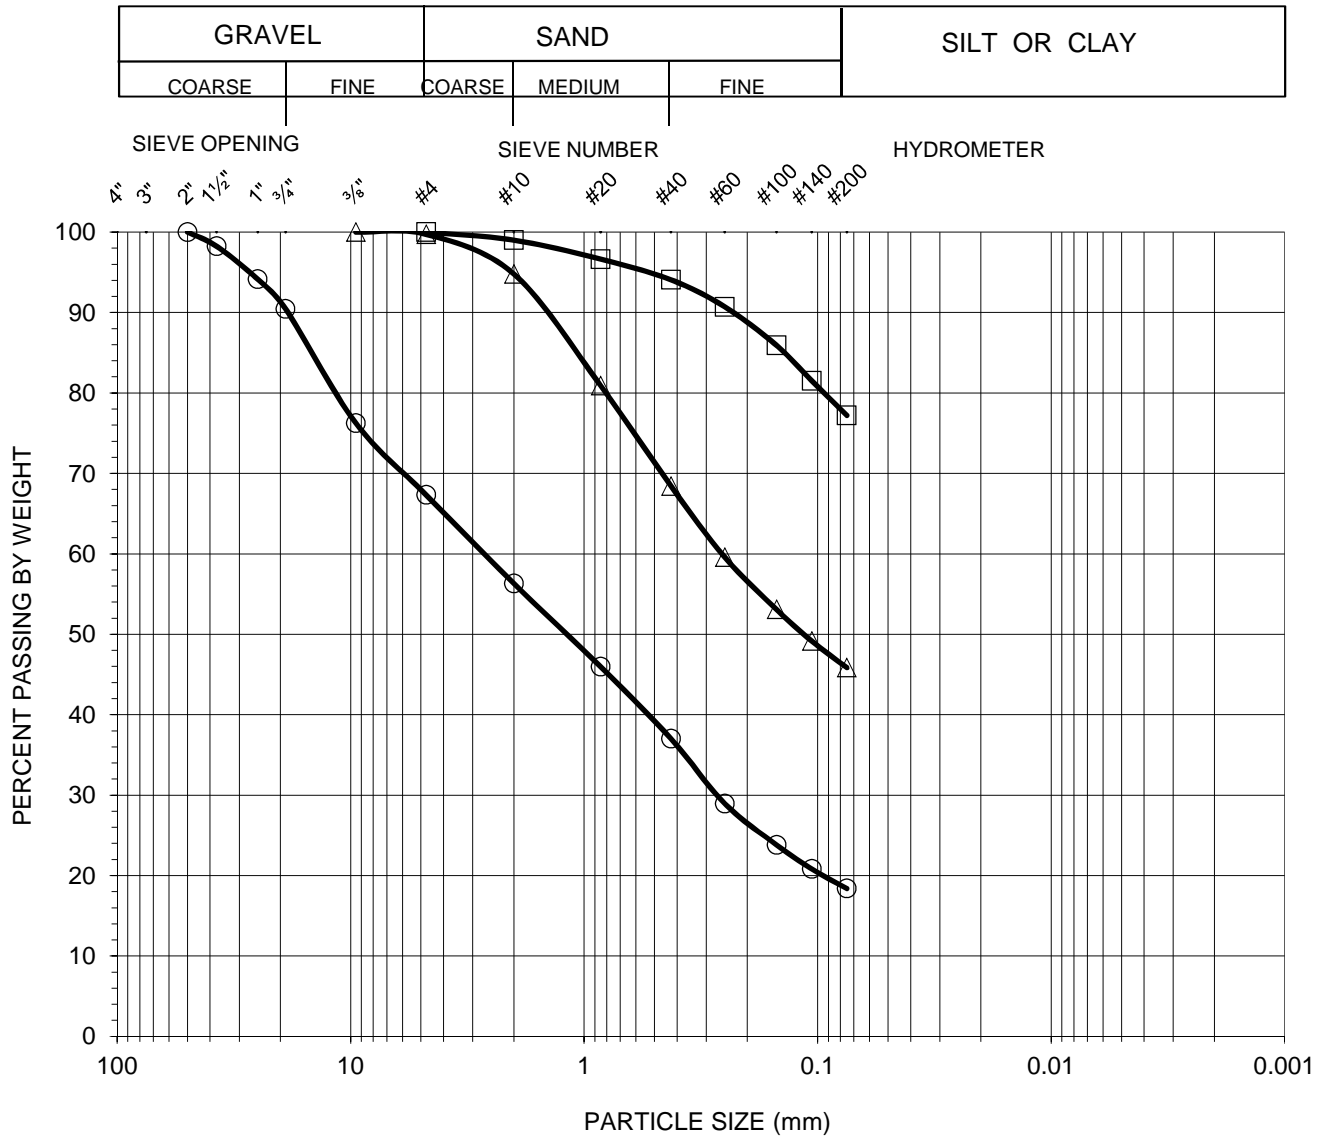
GRAIN SIZE DISTRIBUTION CURVE ASTM D 6913

Client Name: HDR Tested by: SM Date: 04/23/21
 Project Name: LOSSAN - CCLF Computed by: NR Date: 04/26/21
 Project No.: 10171532 Checked by: AP Date: 04/28/21

*Note: Based on visual classification of sample

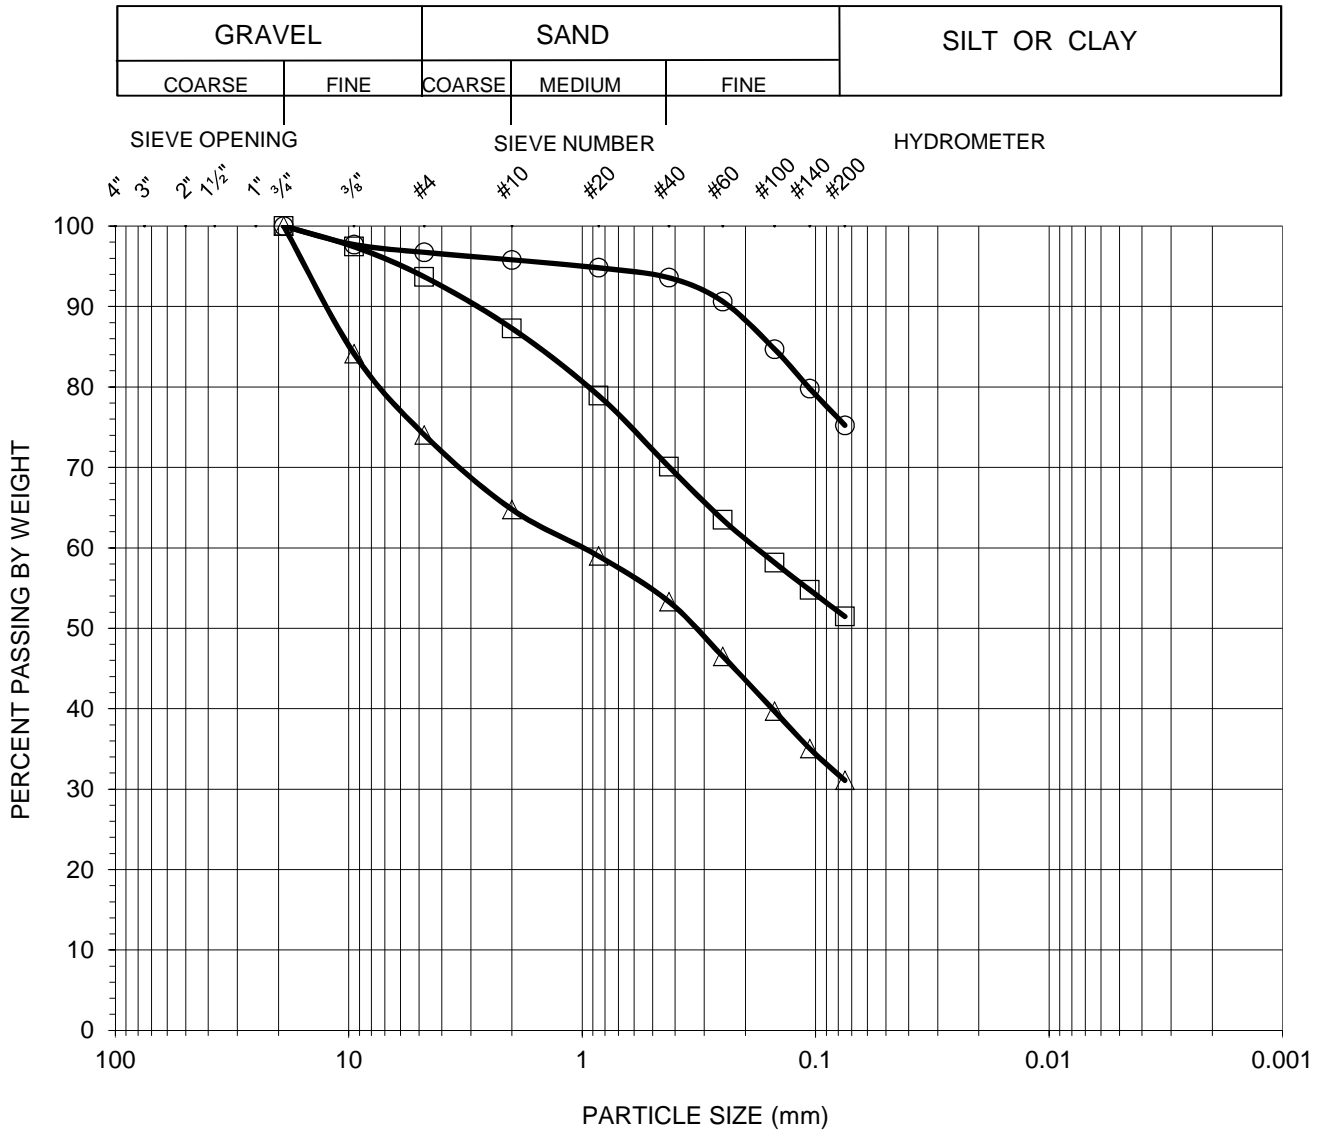
GRAIN SIZE DISTRIBUTION CURVE ASTM D 6913

Symbol	Boring No.	Sample No.	Sample Depth (feet)	Percent			Atterberg Limits LL:PL:PI	Soil Type U.S.C.S
				Gravel	Sand	Silt & Clay		
○	A-21-002	2	7.5	3	22	75	49:13:36	CL
□	A-21-002	4	15	6	43	51	N/A	CL*
△	A-21-002	6	25	26	43	31	N/A	SC*

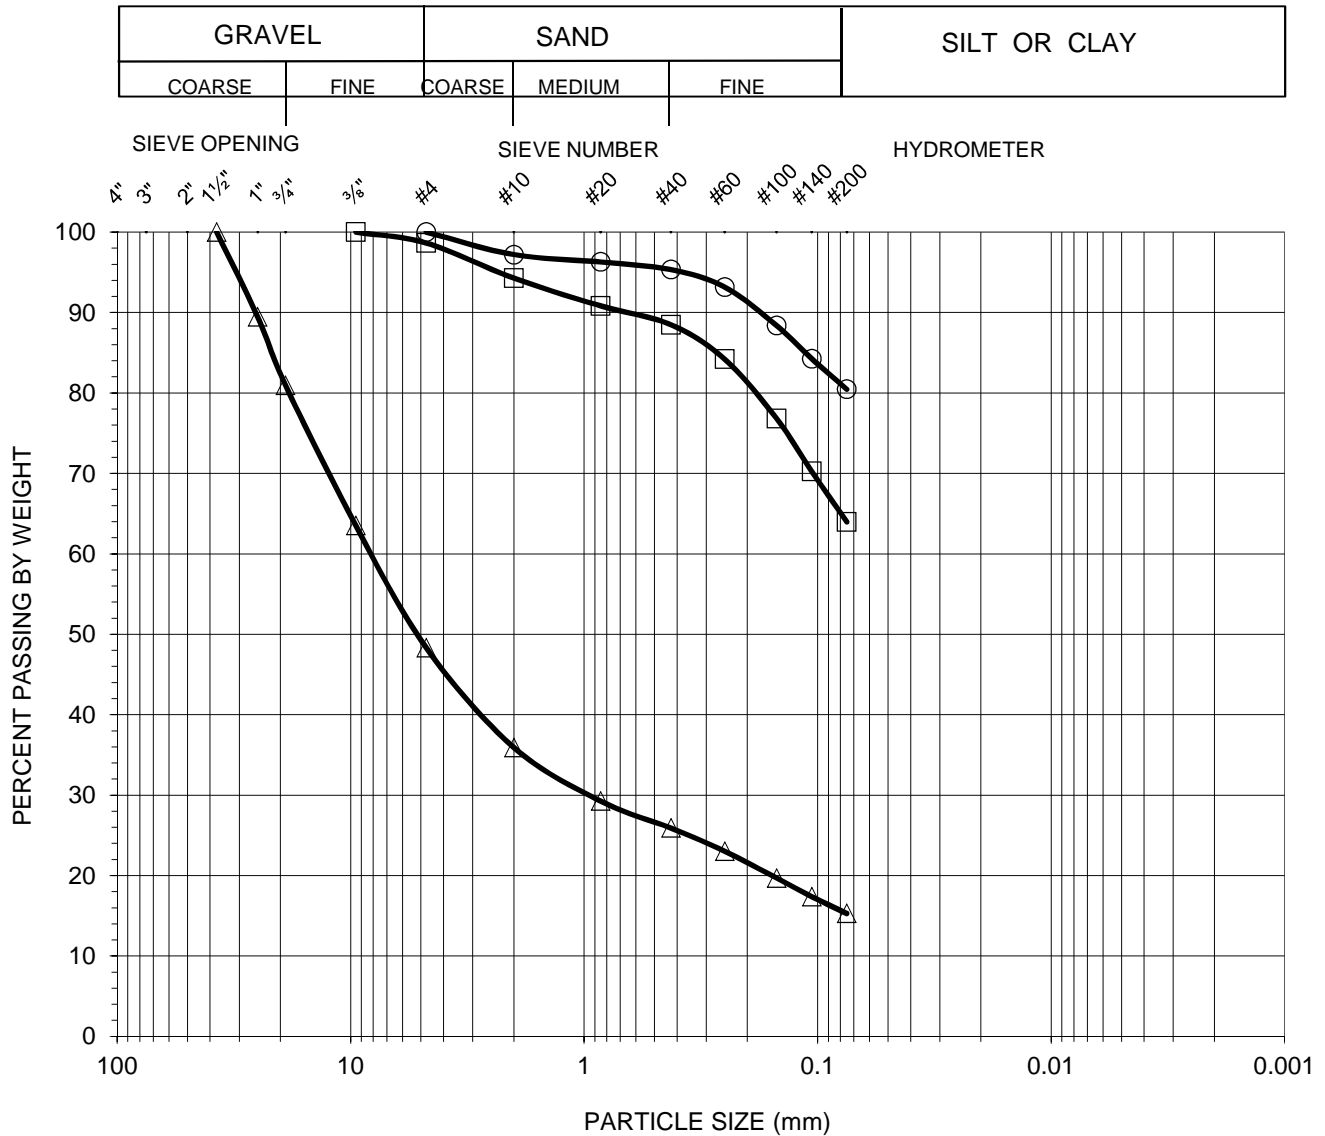
GRAIN SIZE DISTRIBUTION CURVE ASTM D 6913

Symbol	Boring No.	Sample No.	Sample Depth (feet)	Percent			Atterberg Limits LL:PL:PI	Soil Type U.S.C.S
				Gravel	Sand	Silt & Clay		
○	A-21-003	1	5	0	20	80	58:15:43	CH
□	A-21-003	5	20	1	35	64	30:13:17	CL
△	A-21-003	11	50	52	33	15	N/A	GC*

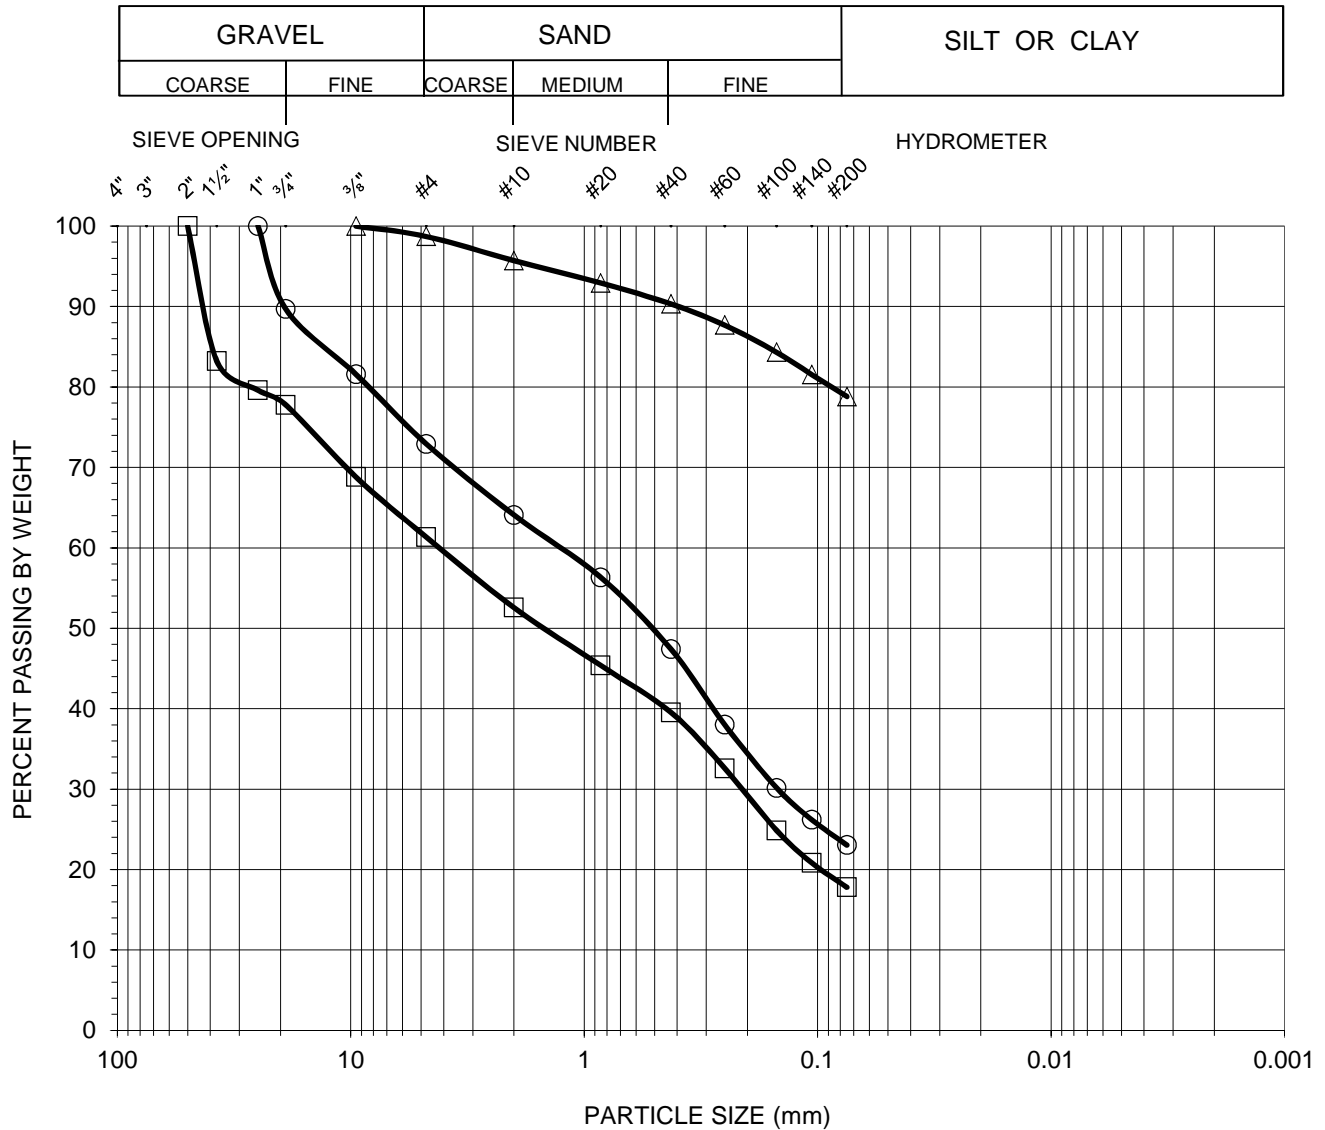
GRAIN SIZE DISTRIBUTION CURVE ASTM D 6913

Symbol	Boring No.	Sample No.	Sample Depth (feet)	Percent			Atterberg Limits LL:PL:PI	Soil Type U.S.C.S
				Gravel	Sand	Silt & Clay		
○	A-21-004	B	0-5	27	50	23	29:16:13	SC
□	A-21-004	1	5	39	43	18	N/A	SC*
△	A-21-004	2	8.5	1	20	79	59:16:43	CH

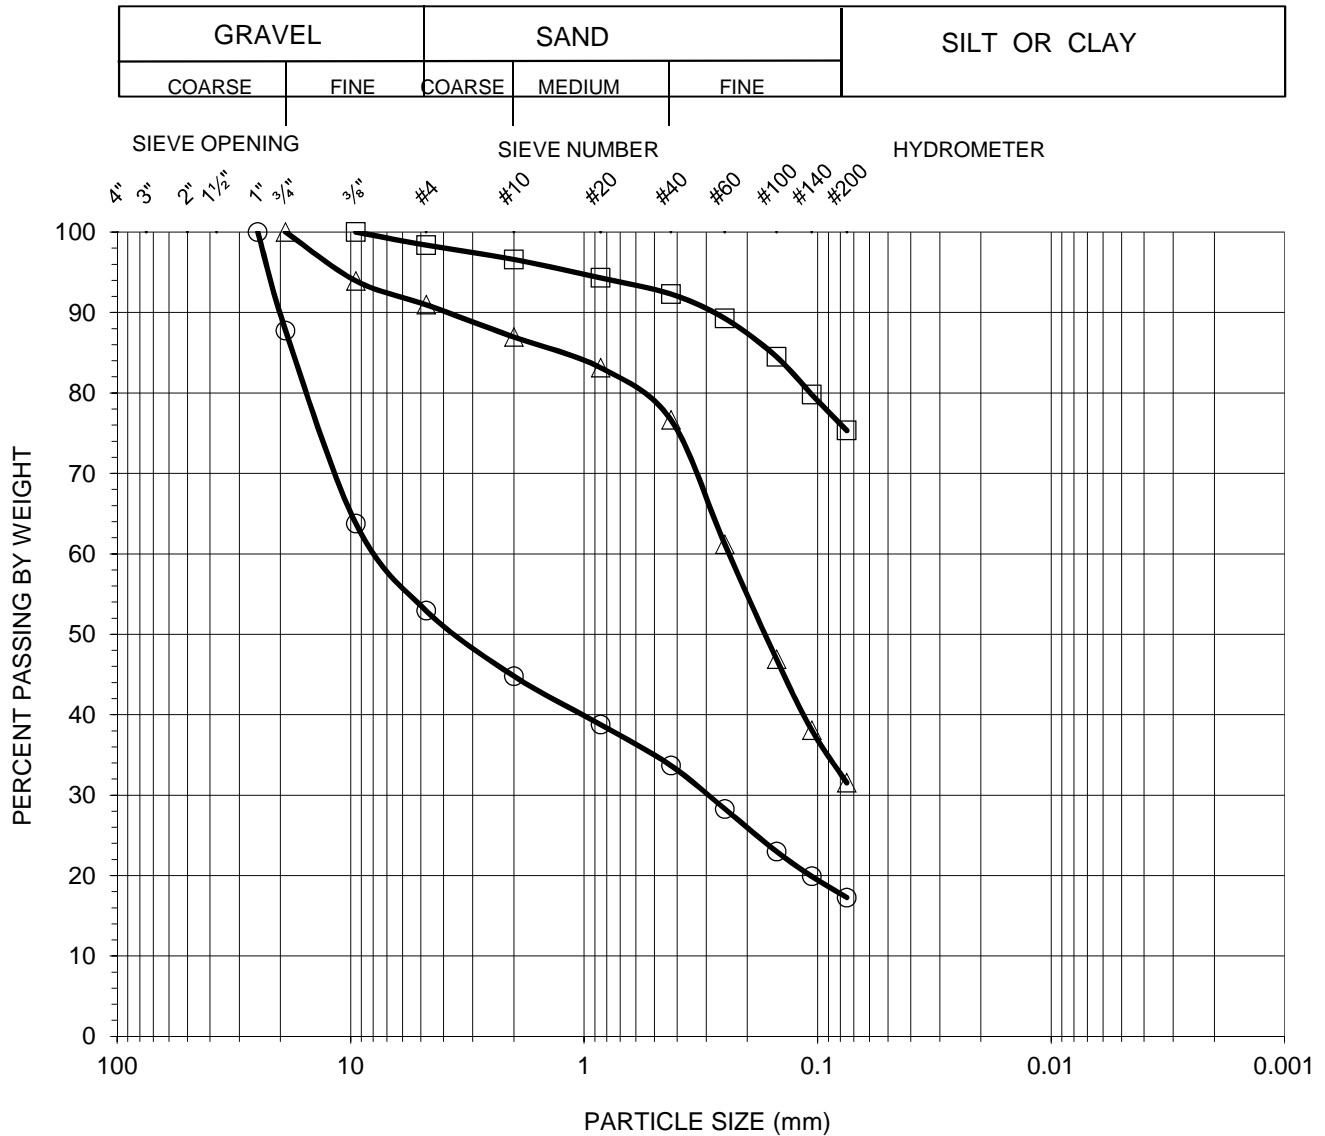
GRAIN SIZE DISTRIBUTION CURVE ASTM D 6913

Client Name: HDR Tested by: SM Date: 04/23/21
 Project Name: LOSSAN - CCLF Computed by: NR Date: 04/26/21
 Project No.: 10171532 Checked by: AP Date: 04/28/21

*Note: Based on visual classification of sample

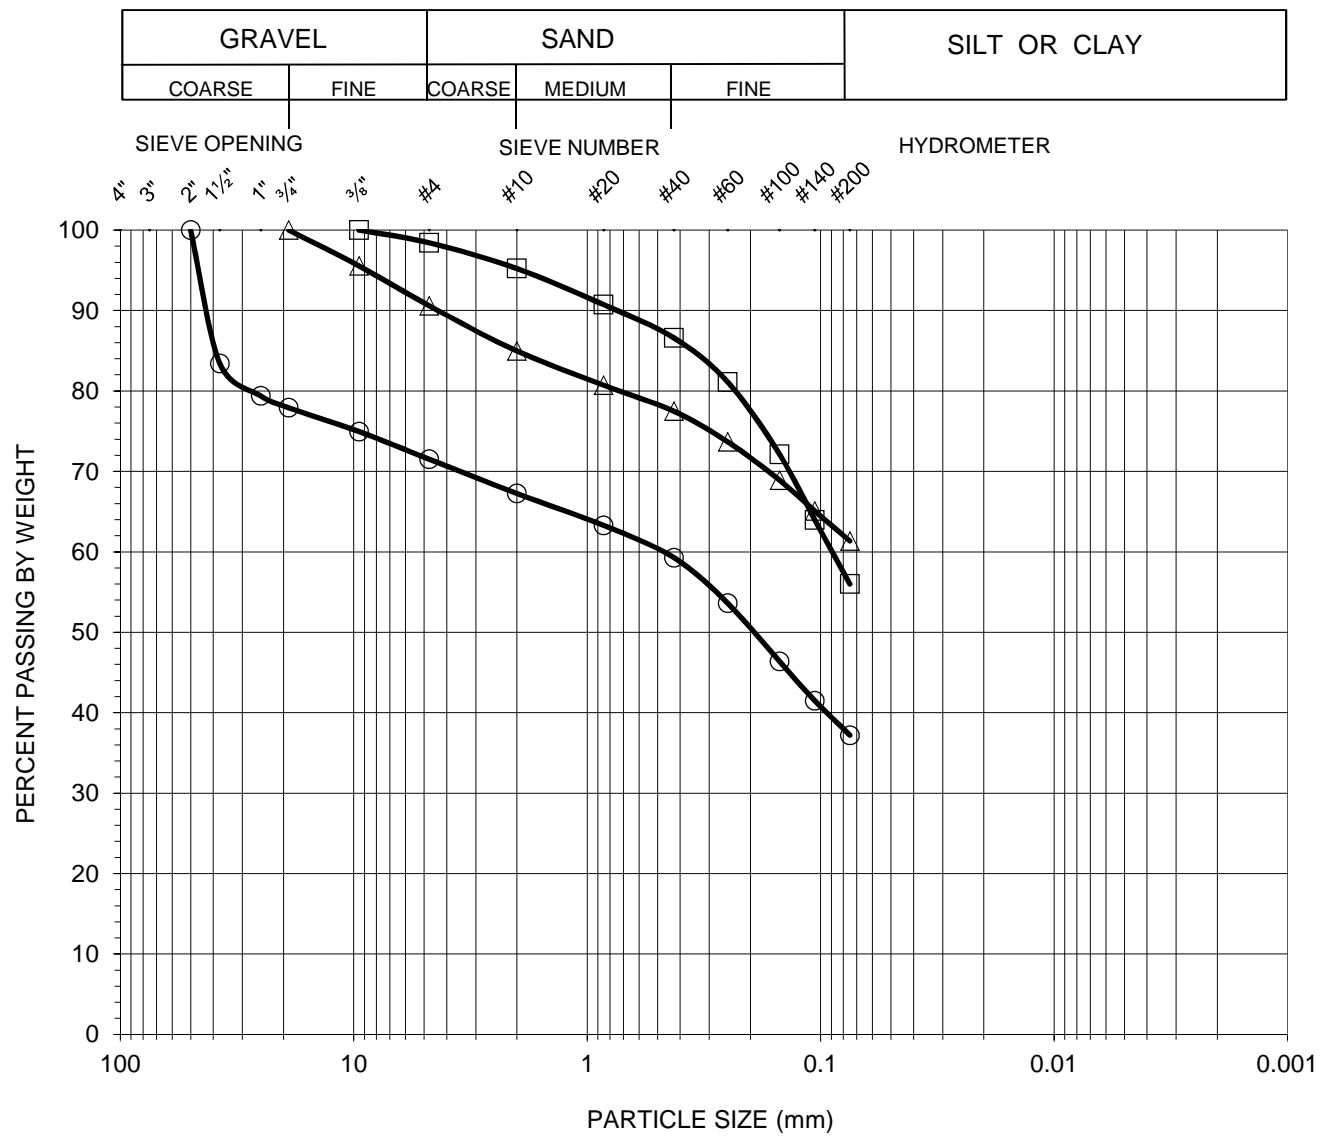
GRAIN SIZE DISTRIBUTION CURVE ASTM D 6913

Symbol	Boring No.	Sample No.	Sample Depth (feet)	Percent			Atterberg Limits LL:PL:PI	Soil Type U.S.C.S
				Gravel	Sand	Silt & Clay		
○	A-21-006	1	5	28	35	37	N/A	SC*
□	A-21-006	4	15	2	42	56	30:14:16	CL
△	A-21-006	6	25	9	30	61	N/A	CL*

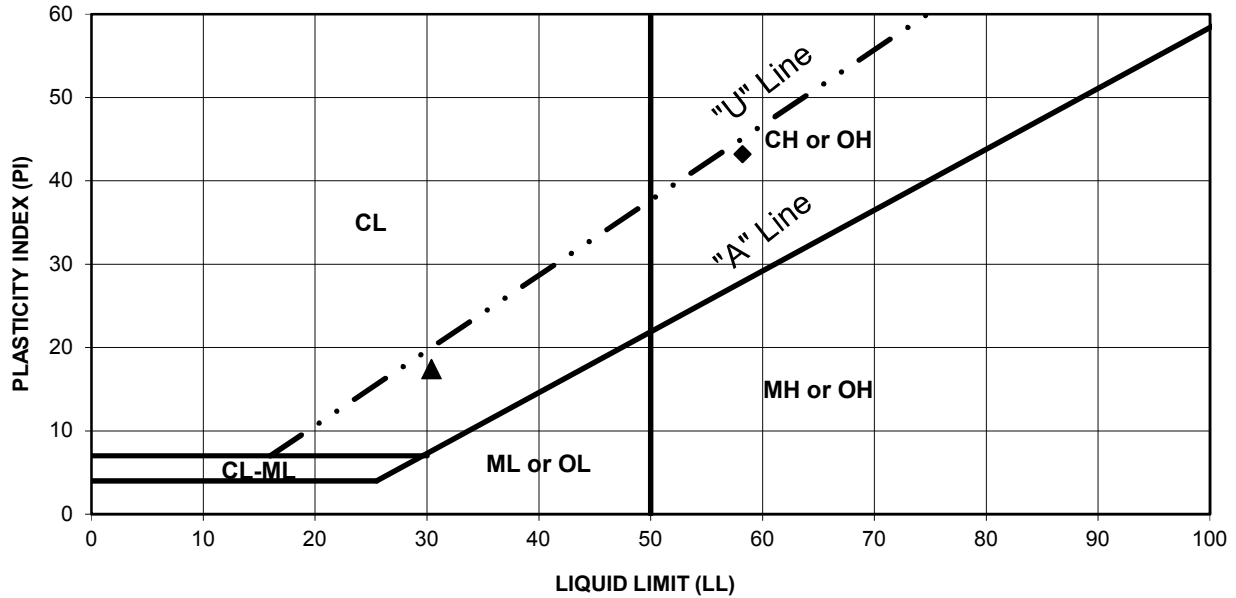
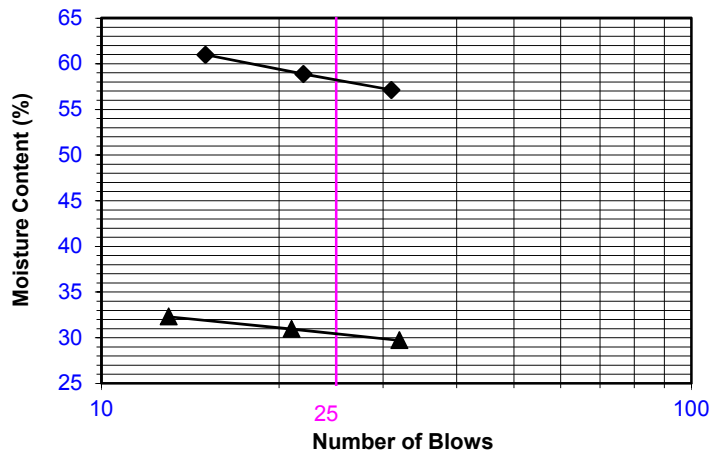
ATTERBERG LIMITS ASTM D 4318

Symbol	Boring Number	Sample Number	Depth (feet)	LL	PL	PI	Plasticity Chart Symbol
◆	A-21-003	1	5	58	15	43	CH
▲	A-21-003	5	20	30	13	17	CL

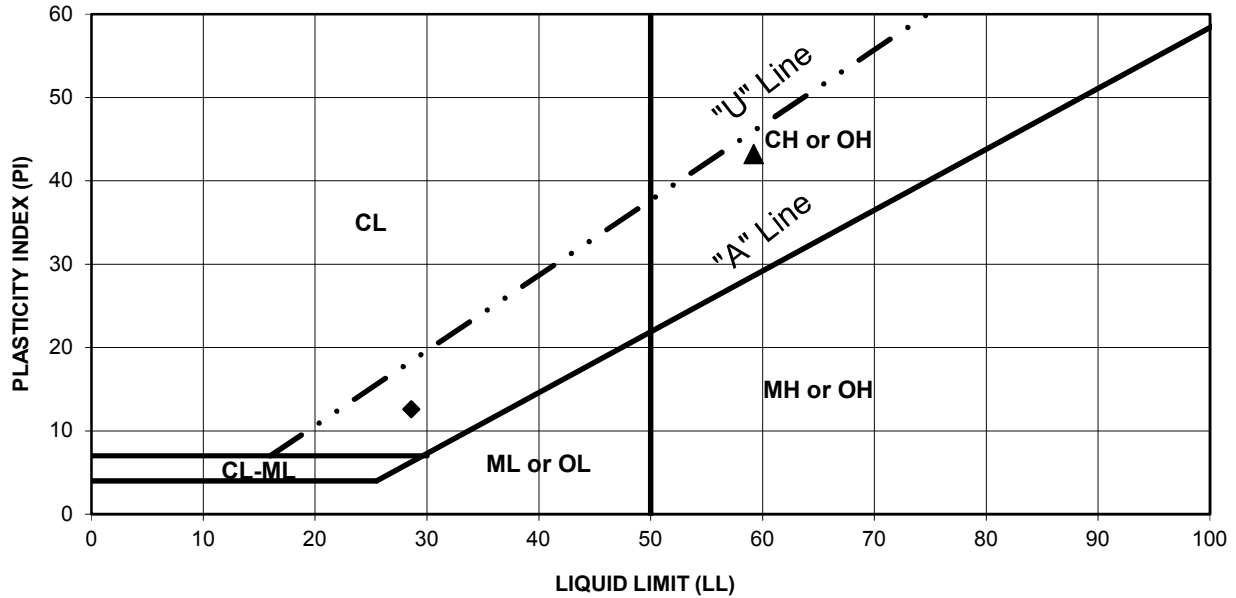
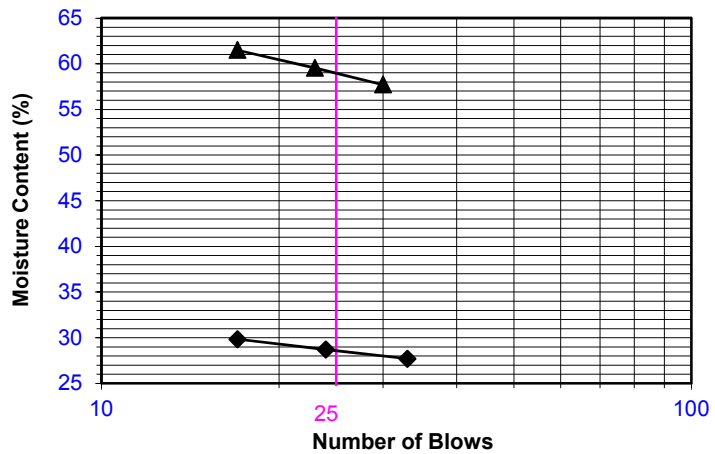
ATTERBERG LIMITS ASTM D 4318

Symbol	Boring Number	Sample Number	Depth (feet)	LL	PL	PI	Plasticity Chart Symbol
◆	A-21-004	B	0-5	29	16	13	CL
▲	A-21-004	2	8.5	59	16	43	CH
