CENTRAL COAST LAYOVER FACILITY
Preliminary Geotechnical Design Report
San Luis Obispo, California

Subject: Preliminary Geotechnical Design Report
LOSSAN Central Coast Layover Facility Project

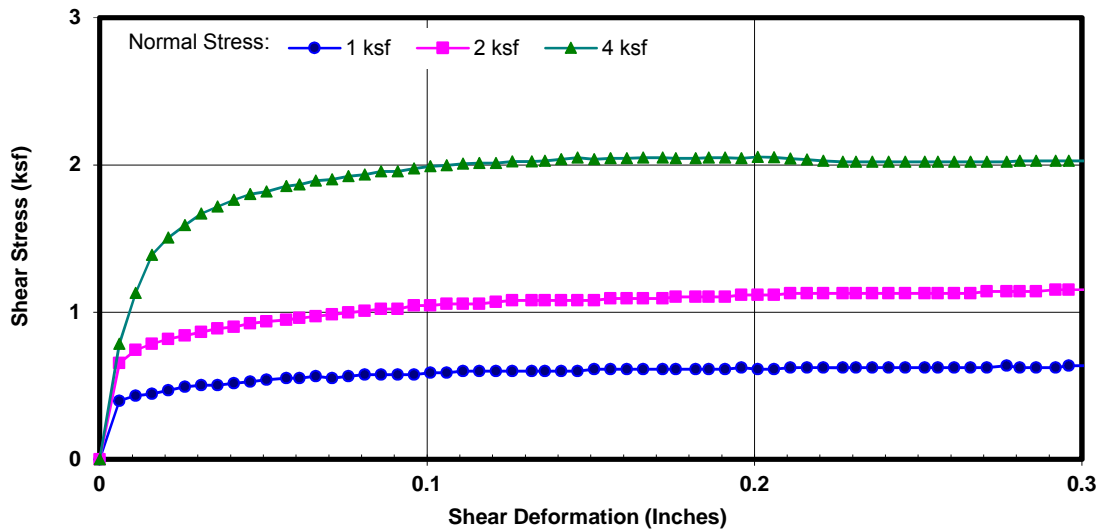
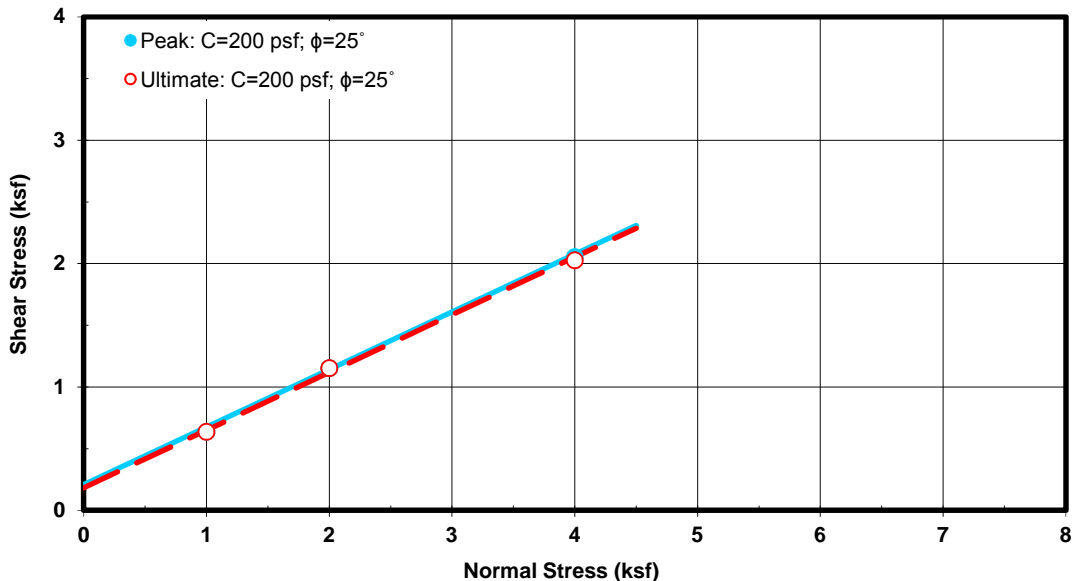
Client: HDR
Project Name: LOSSAN - CCLF
Project No.: 10171532
Boring No.: A-21-002
Sample No.: 1 **Depth (ft):** 5
Sample Type: Mod. Cal.
Soil Description: Clay
Test Condition: Inundated **Shear Type:** Regular

Wet Unit Weight (pcf)	Dry Unit Weight (pcf)	Initial Moisture Content (%)	Final Moisture Content (%)	Initial Degree Saturation (%)	Final Degree Saturation (%)	Normal Stress (ksf)	Peak Shear Stress (ksf)	Ultimate Shear Stress (ksf)
111.4	99.3	12.2	23.5	47	91	1	0.636	0.636
						2	1.152	1.152
						4	2.054	2.028

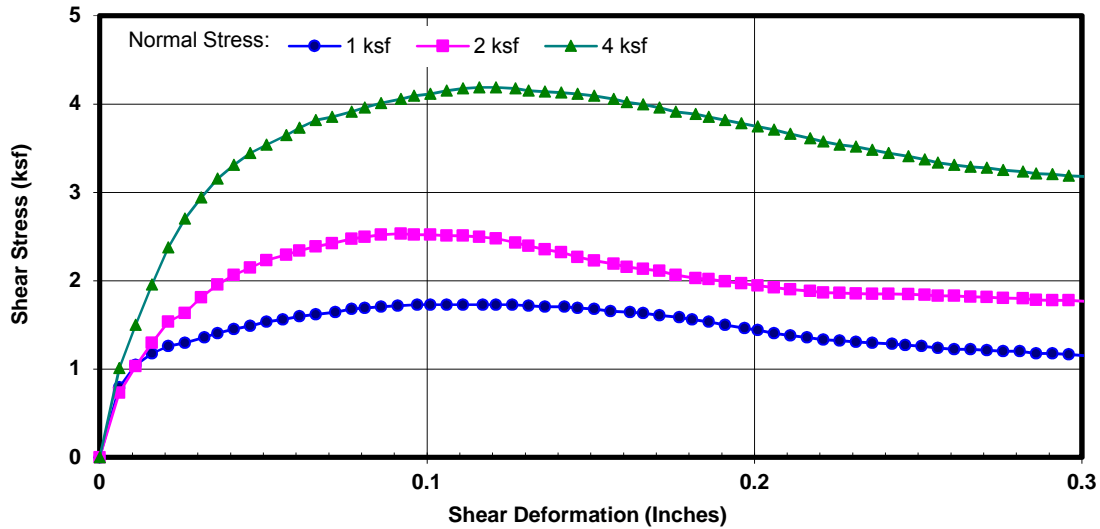
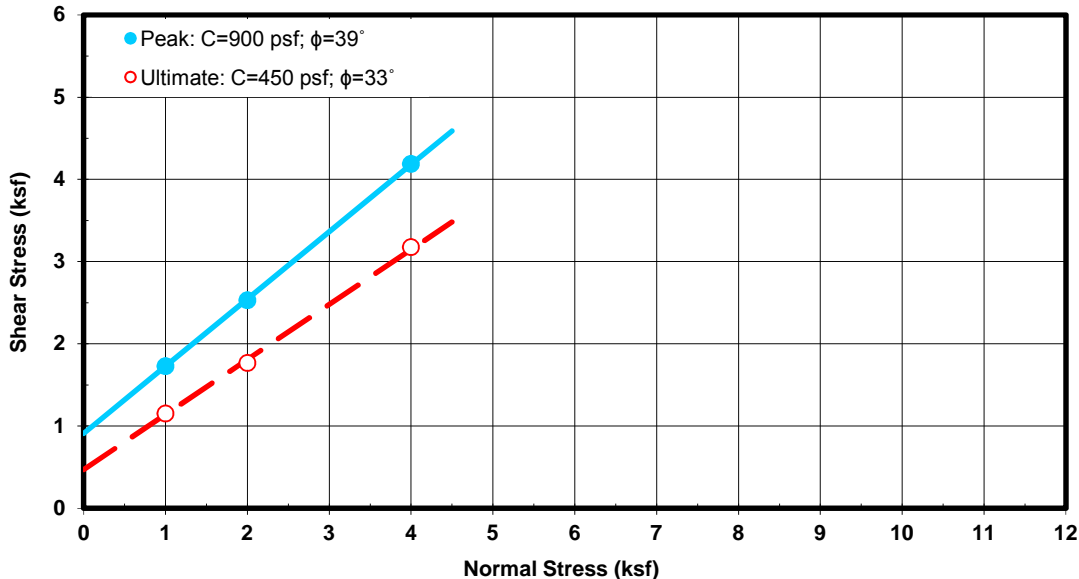
DIRECT SHEAR TEST RESULTS
ASTM D 3080

Client: HDR
Project Name: LOSSAN - CCLF
Project No.: 10171532
Boring No.: A-21-003
Sample No.: 4 **Depth (ft):** 15
Sample Type: Mod. Cal.
Soil Description: Sandy Clay w/gravel
Test Condition: Inundated **Shear Type:** Regular

Wet Unit Weight (pcf)	Dry Unit Weight (pcf)	Initial Moisture Content (%)	Final Moisture Content (%)	Initial Degree Saturation (%)	Final Degree Saturation (%)	Normal Stress (ksf)	Peak Shear Stress (ksf)	Ultimate Shear Stress (ksf)
140.0	130.5	7.3	10.7	67	99	1	1.728	1.152
						2	2.532	1.767
						4	4.188	3.178

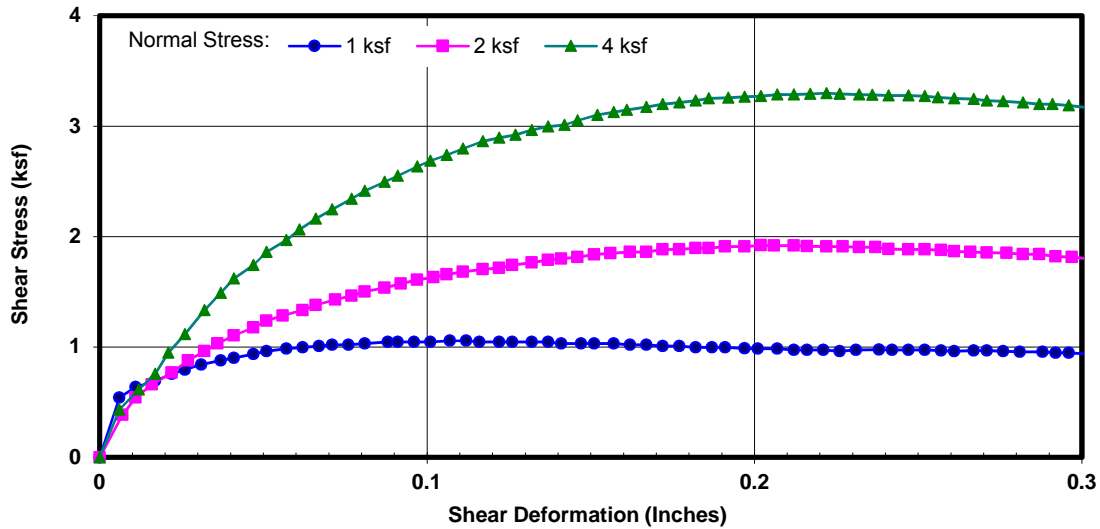
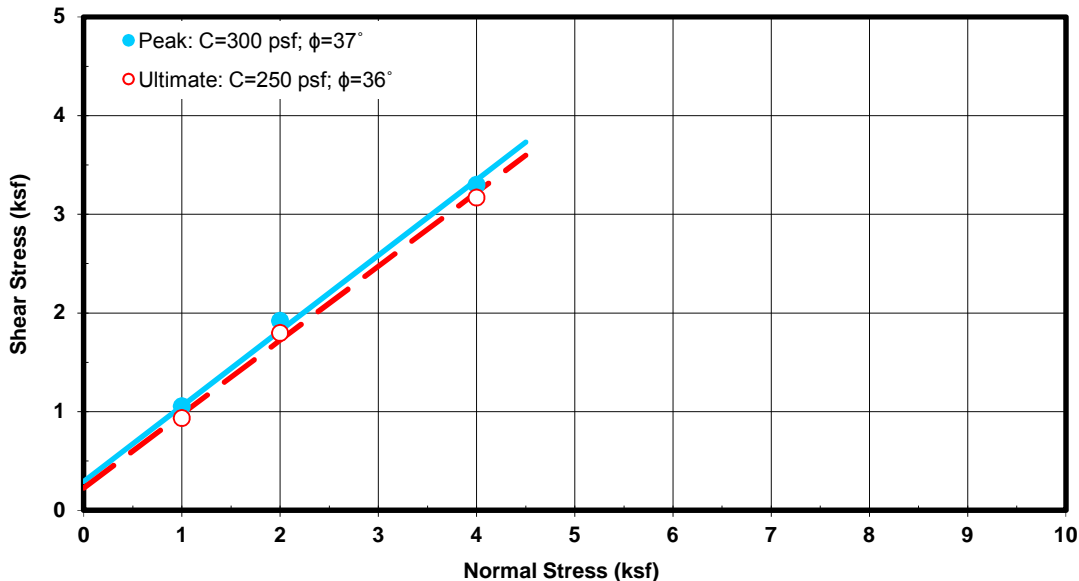
DIRECT SHEAR TEST RESULTS
ASTM D 3080

Wet Unit Weight (pcf)	Dry Unit Weight (pcf)	Initial Moisture Content (%)	Final Moisture Content (%)	Initial Degree Saturation (%)	Final Degree Saturation (%)	Normal Stress (ksf)	Peak Shear Stress (ksf)	Ultimate Shear Stress (ksf)
128.6	118.7	8.4	15.6	54	100	1	1.056	0.936
						2	1.920	1.798
						4	3.298	3.168

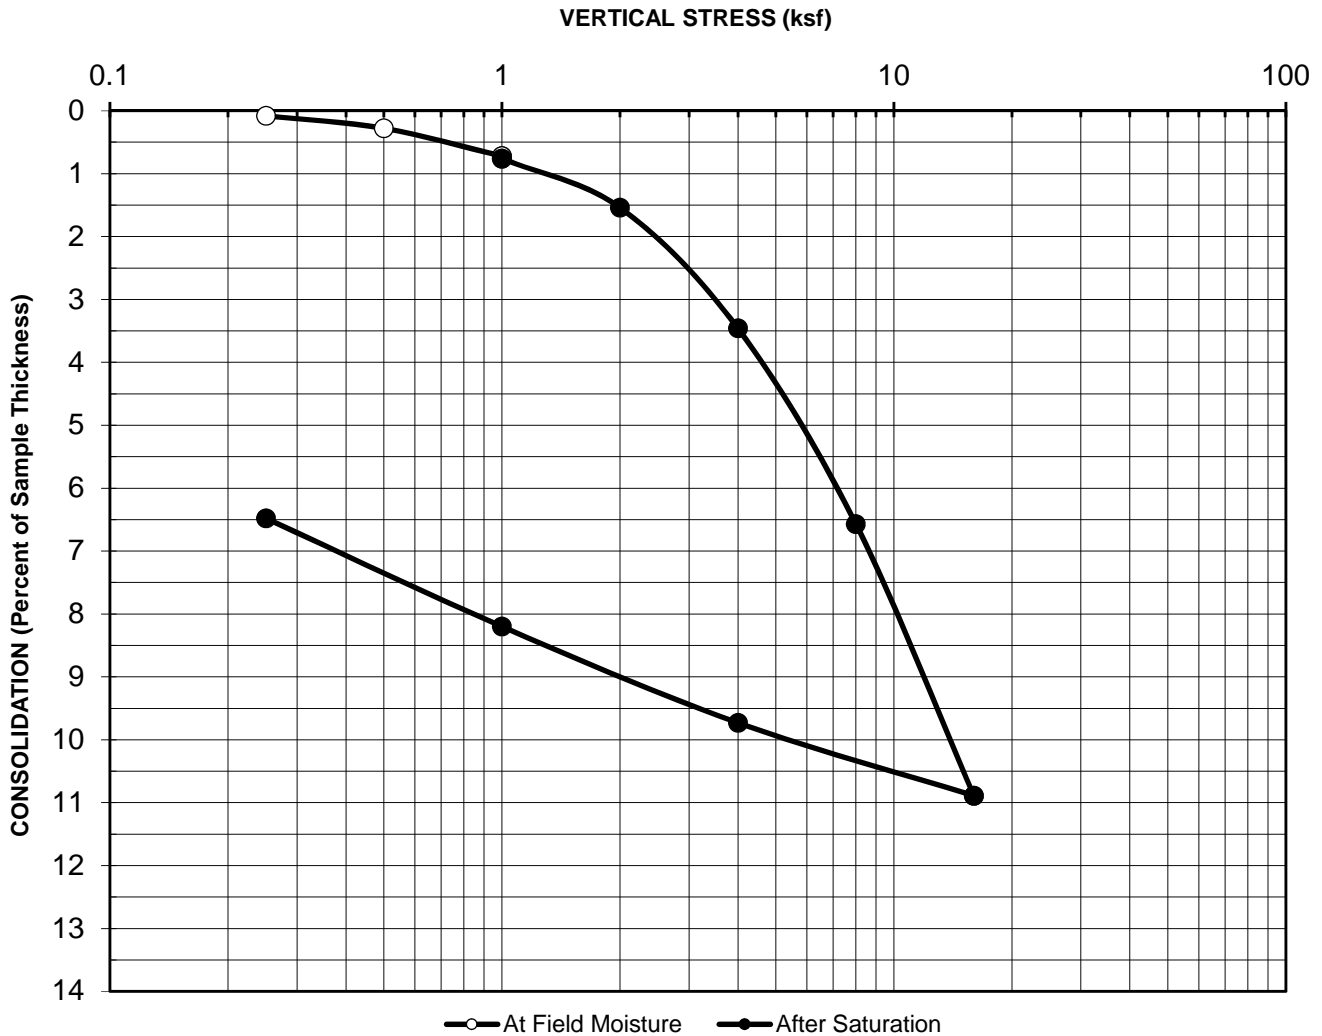
Boring No. : A-21-001

Initial Dry Unit Weight (pcf): 100.4

Initial Moisture Content (%): 22.0

Final Moisture Content (%): 22.9

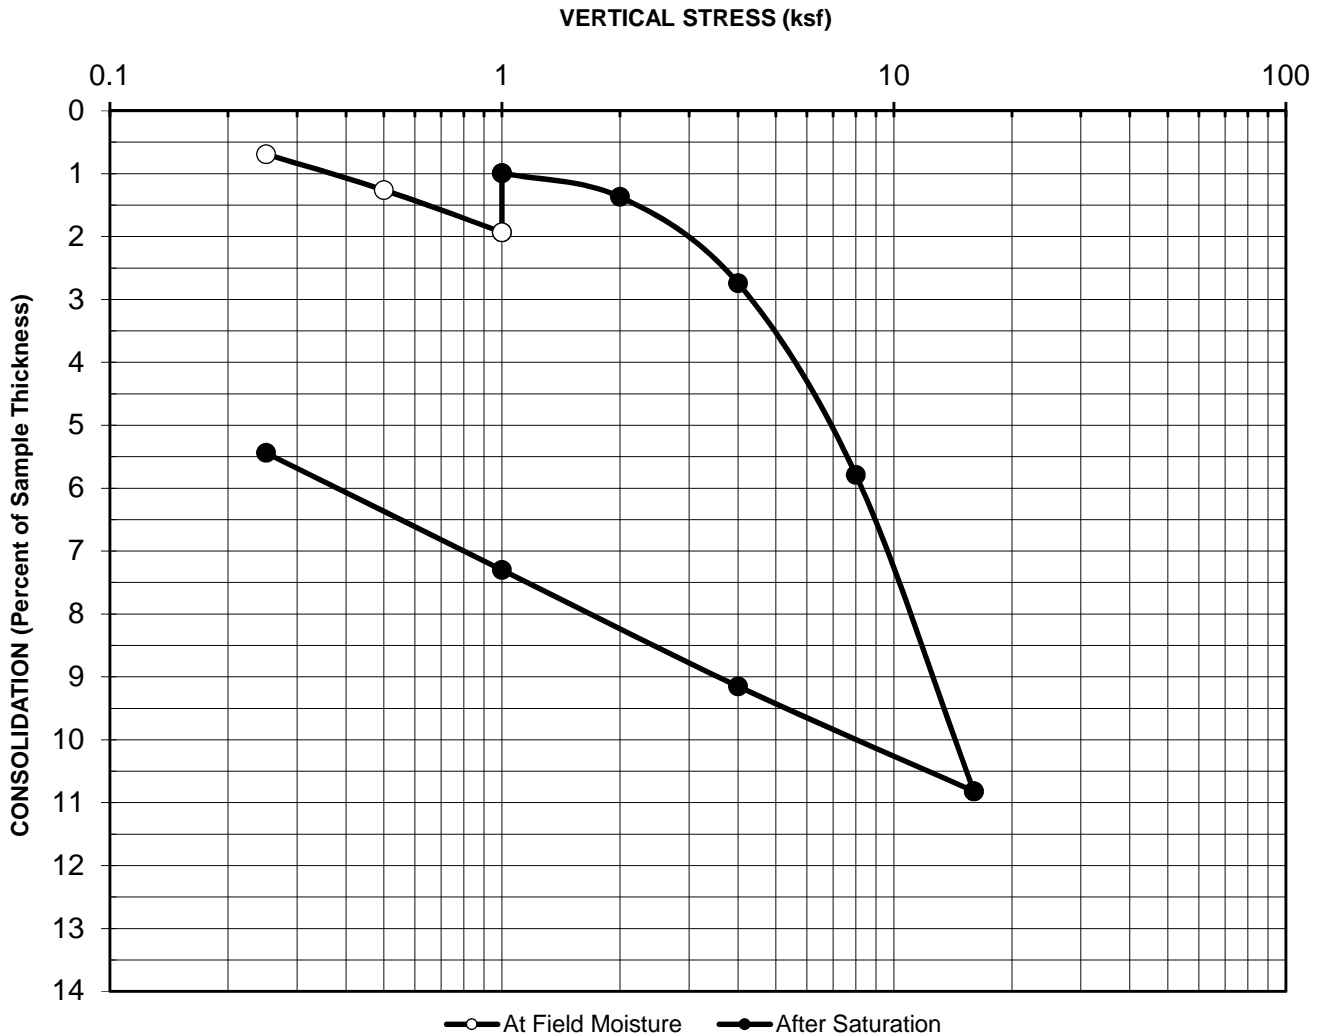
Boring No. : A-21-003

Initial Dry Unit Weight (pcf): 95.4

Initial Moisture Content (%): 27.2

Final Moisture Content (%): 27.3

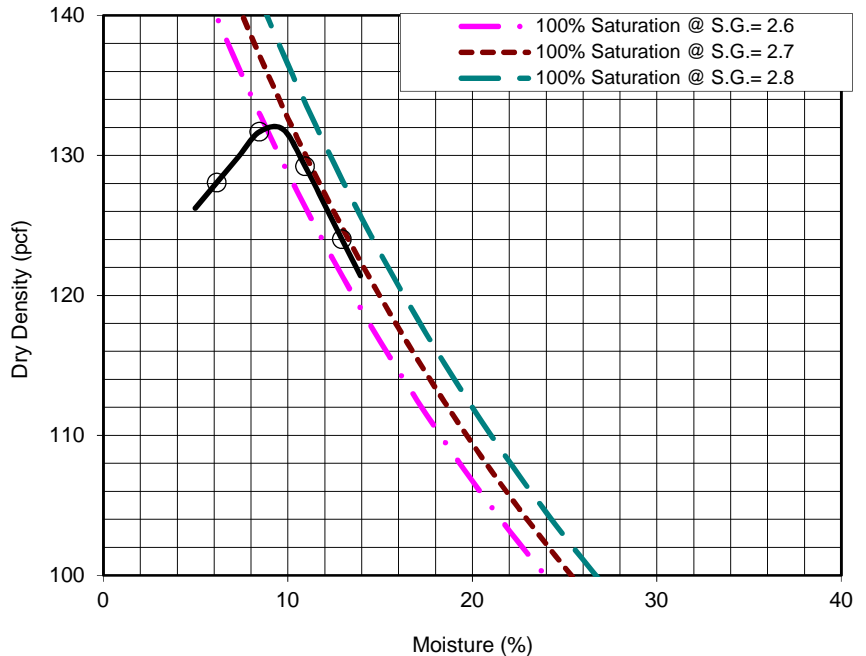
COMPACTION TEST

- METHOD A: Percent of Oversize:** N/A
 Soil Passing No. 4 (4.75 mm) Sieve
 Mold : 4 in. (101.6 mm) diameter
 Layers : 5 (Five)
 Blows per layer : 25 (twenty-five)
- METHOD B: Percent of Oversize:** 23.0%
 Soil Passing 3/8 in. (9.5 mm) Sieve
 Mold : 4 in. (101.6 mm) diameter
 Layers : 5 (Five)
 Blows per layer : 25 (twenty-five)
- METHOD C: Percent of Oversize:** N/A
 Soil Passing 3/4 in. (19.0 mm) Sieve
 Mold : 6 in. (152.4 mm) diameter
 Layers : 5 (Five)
 Blows per layer : 56 (fifty-six)

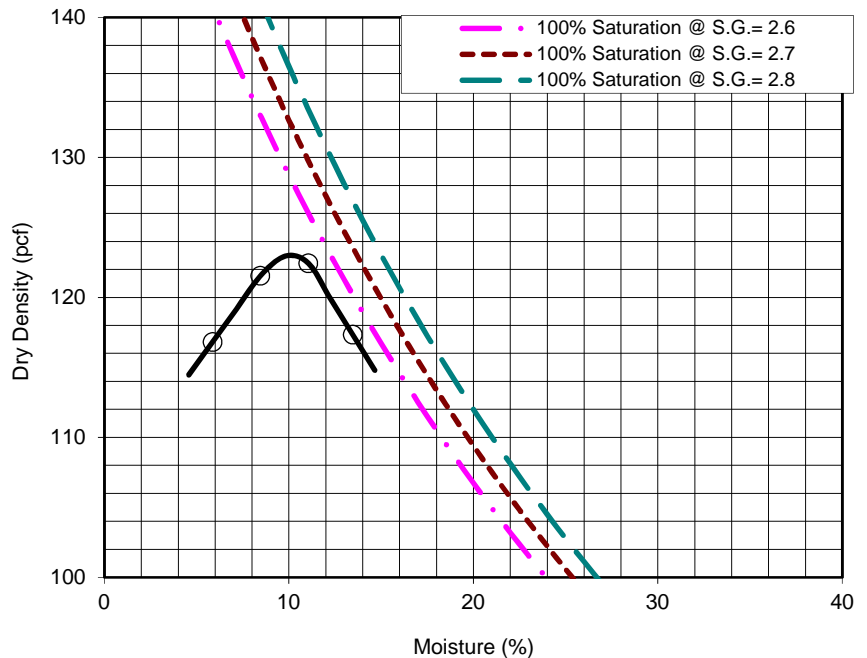
COMPACTION TEST

- METHOD A: Percent of Oversize:** 14.0%
 Soil Passing No. 4 (4.75 mm) Sieve
 Mold : 4 in. (101.6 mm) diameter
 Layers : 5 (Five)
 Blows per layer : 25 (twenty-five)
- METHOD B: Percent of Oversize:** N/A
 Soil Passing 3/8 in. (9.5 mm) Sieve
 Mold : 4 in. (101.6 mm) diameter
 Layers : 5 (Five)
 Blows per layer : 25 (twenty-five)
- METHOD C: Percent of Oversize:** N/A
 Soil Passing 3/4 in. (19.0 mm) Sieve
 Mold : 6 in. (152.4 mm) diameter
 Layers : 5 (Five)
 Blows per layer : 56 (fifty-six)

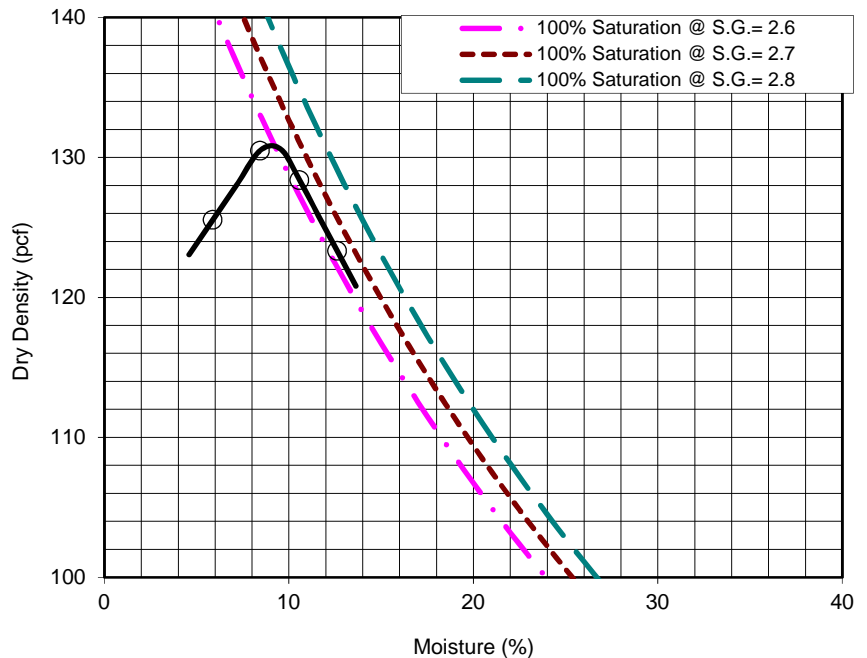
- METHOD A: Percent of Oversize:** 13.6%
 Soil Passing No. 4 (4.75 mm) Sieve
 Mold : 4 in. (101.6 mm) diameter
 Layers : 5 (Five)
 Blows per layer : 25 (twenty-five)
- METHOD B: Percent of Oversize:** N/A
 Soil Passing 3/8 in. (9.5 mm) Sieve
 Mold : 4 in. (101.6 mm) diameter
 Layers : 5 (Five)
 Blows per layer : 25 (twenty-five)
- METHOD C: Percent of Oversize:** N/A
 Soil Passing 3/4 in. (19.0 mm) Sieve
 Mold : 6 in. (152.4 mm) diameter
 Layers : 5 (Five)
 Blows per layer : 56 (fifty-six)

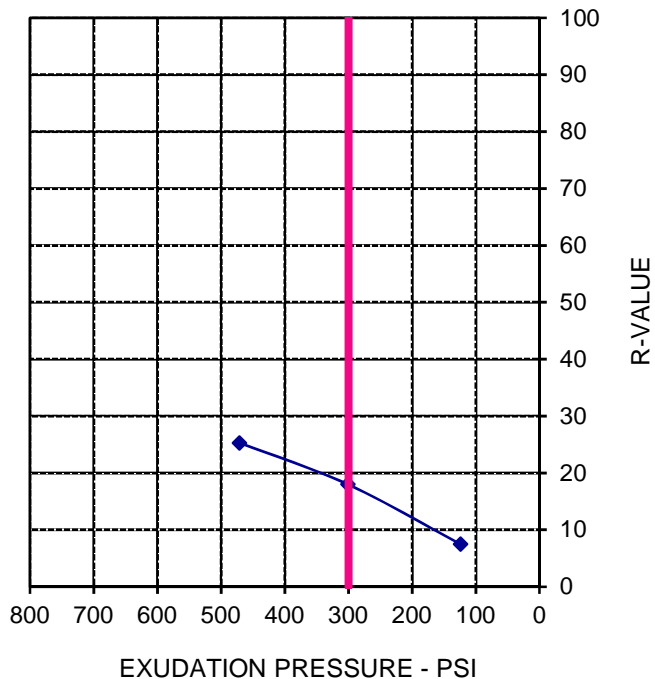
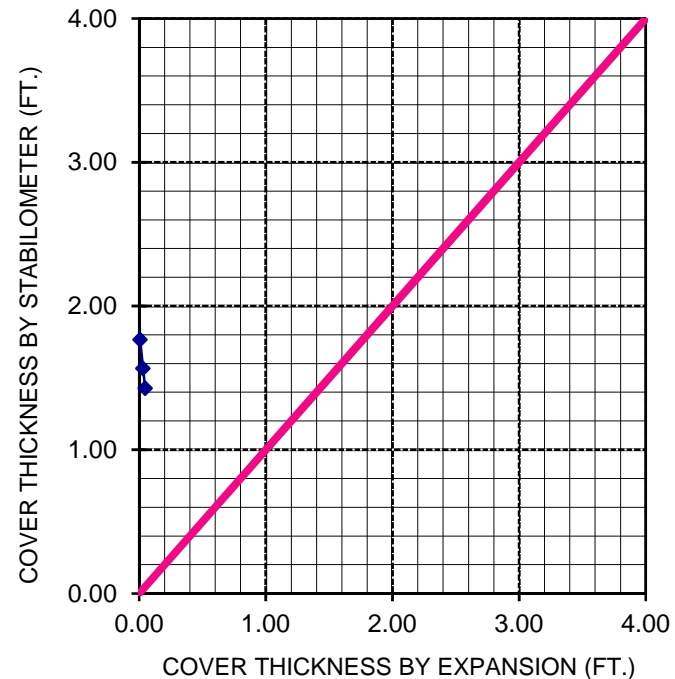
R-VALUE TEST DATA
 ASTM D2844

Mold Number	R7	R9	R8	
Water Added, g	0	15	31	
Compact Moisture(%)	15.4	17.0	18.8	
Compaction Gage Pressure, psi	150	75	50	
Exudation Pressure, psi	471	301	124	
Sample Height, Inches	2.4	2.4	2.4	
Gross Weight Mold, g	3043	3046	3077	
Tare Weight Mold, g	2011	2012	2016	
Net Sample Weight, g	1031	1034	1061	
Expansion, inchesx10 ⁻⁴	14	9	2	
Stability 2,000 (160 psi)	40/100	46/114	60/138	
Turns Displacement	4.02	4.32	4.60	
R-Value Uncorrected	27	19	8	
R-Value Corrected	25	18	8	
Dry Density, pcf	112.9	111.5	112.8	
Traffic Index	8.0	8.0	8.0	
G.E. by Stability	1.43	1.57	1.77	
G.E. by Expansion	0.05	0.03	0.01

R-VALUE	By Exudation:	18
	By Expansion:	*N/A
	At Equilibrium: (by Exudation)	18
Remarks	Gf = 1.34, and 11.2 % Retained on the 3/4" *Not Applicable

Two bulk samples were tested for R-value. The samples taken at A-21-004 and A-21-006 indicated R-values of 18 and 76, respectively. It should be noted that material encountered at A-21-006 had lower plasticity and higher gravel content compared to the rest of the borings. The test result at A-21-004 may be more representative of the site conditions.

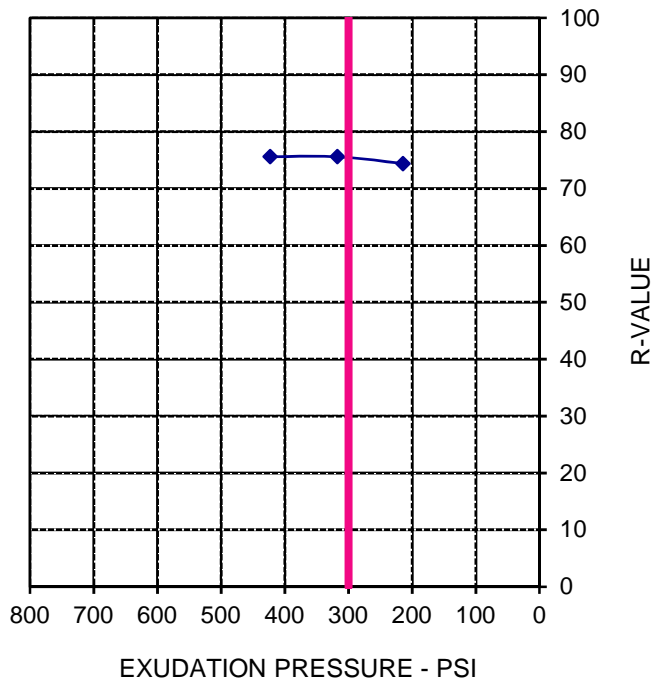
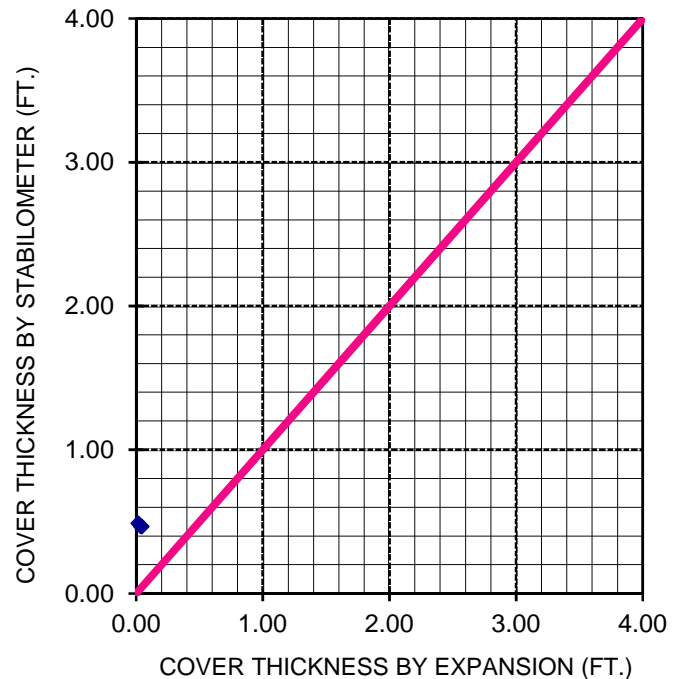
R-VALUE TEST DATA
 ASTM D2844

Mold Number	R4	R6	R5	
Water Added, g	30	23	16	
Compact Moisture(%)	8.1	7.4	6.6	
Compaction Gage Pressure, psi	250	250	250	
Exudation Pressure, psi	214	318	423	
Sample Height, Inches	2.3	2.3	2.3	
Gross Weight Mold, g	3093	3078	3069	
Tare Weight Mold, g	2017	2012	2012	
Net Sample Weight, g	1076	1066	1058	
Expansion, inches $\times 10^{-4}$	5	11	13	
Stability 2,000 (160 psi)	11/19	10/18	10/18	
Turns Displacement	5.55	5.58	5.62	
R-Value Uncorrected	77	78	78	
R-Value Corrected	74	76	76	
Dry Density, pcf	131.2	130.7	130.7	
Traffic Index	8.0	8.0	8.0	
G.E. by Stability	0.49	0.47	0.47	
G.E. by Expansion	0.02	0.04	0.04

R-VALUE	By Exudation:	76
	By Expansion:	*N/A
	At Equilibrium: (by Exudation)	76
Remarks	Gf = 1.34, and 10.1 % Retained on the 3/4" *Not Applicable
