WATER USE/ WATER AVAILABILITY STUDY

**19658 East Road
Lower Lake, CA, 95457
APN 012-049-190**

PROJECT NO. 5076.01

RE: Water Use / Water Availability Study
19658 East Road
Lower Lake, CA
APN 012-049-190
Hurvitz Environmental Project No. 5076.01

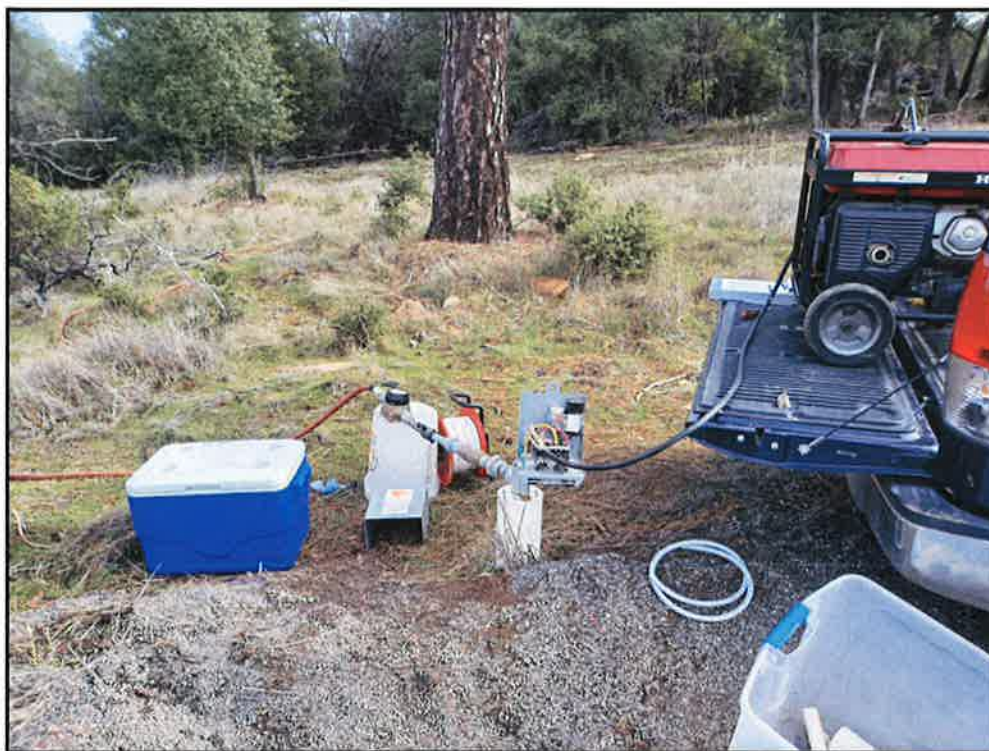
Photo 1: View of site well during well yield test.

On January 23, 2020, HES conducted a 4.5-hour well yield test at the on-site domestic well. The initial static water level was measured at 92.1 feet below the top-of-casing and we used an existing 1.5hp submersible pump set in the well to perform the test. A 5,000-watt generator was also required to provide for power to the well pump. The yield test began at 9:35am and ended at 2:05pm the same day. The sustained yield was 19.4 GPM and the total drawdown was 1.85 feet with a total of 5,155-gallons being pumped from the well. The specific capacity was calculated to be 10.49 gpm/foot of drawdown (i.e., 19.4gpm/1.85ft). The well yield test data and calculations are attached in **APPENDIX C**.

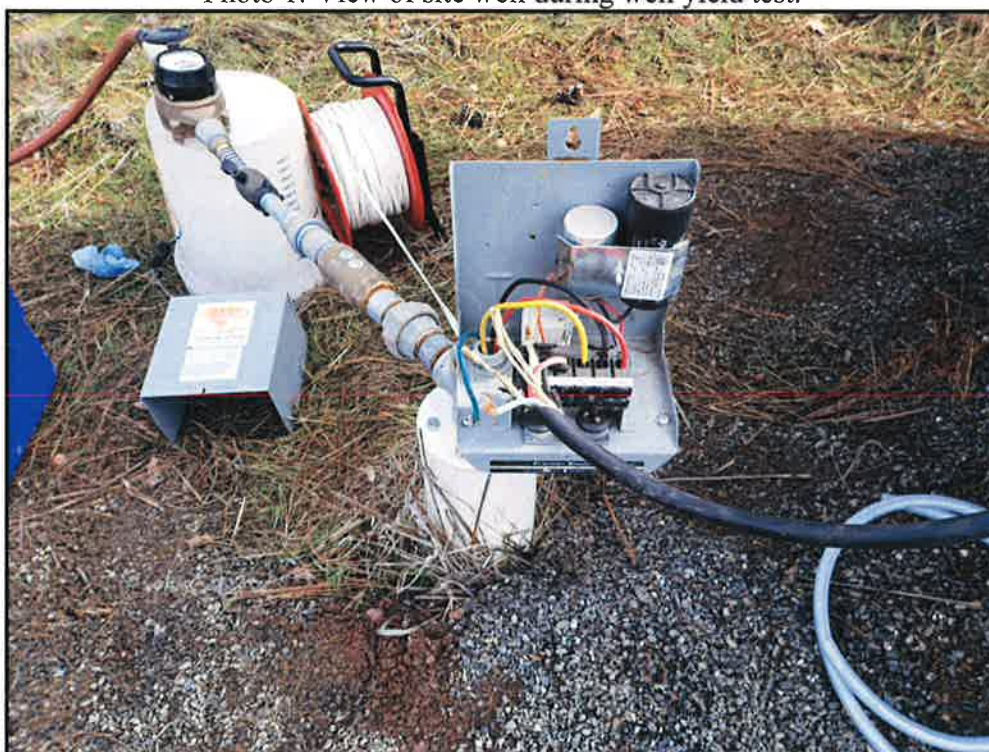
Photo 2: Close-up view of site well during well yield test.
