Feasibility Level Geotechnical Evaluation

East Whisman
441 Logue Avenue
Mountain View, California

July 14, 2020 | Project No. 403253010

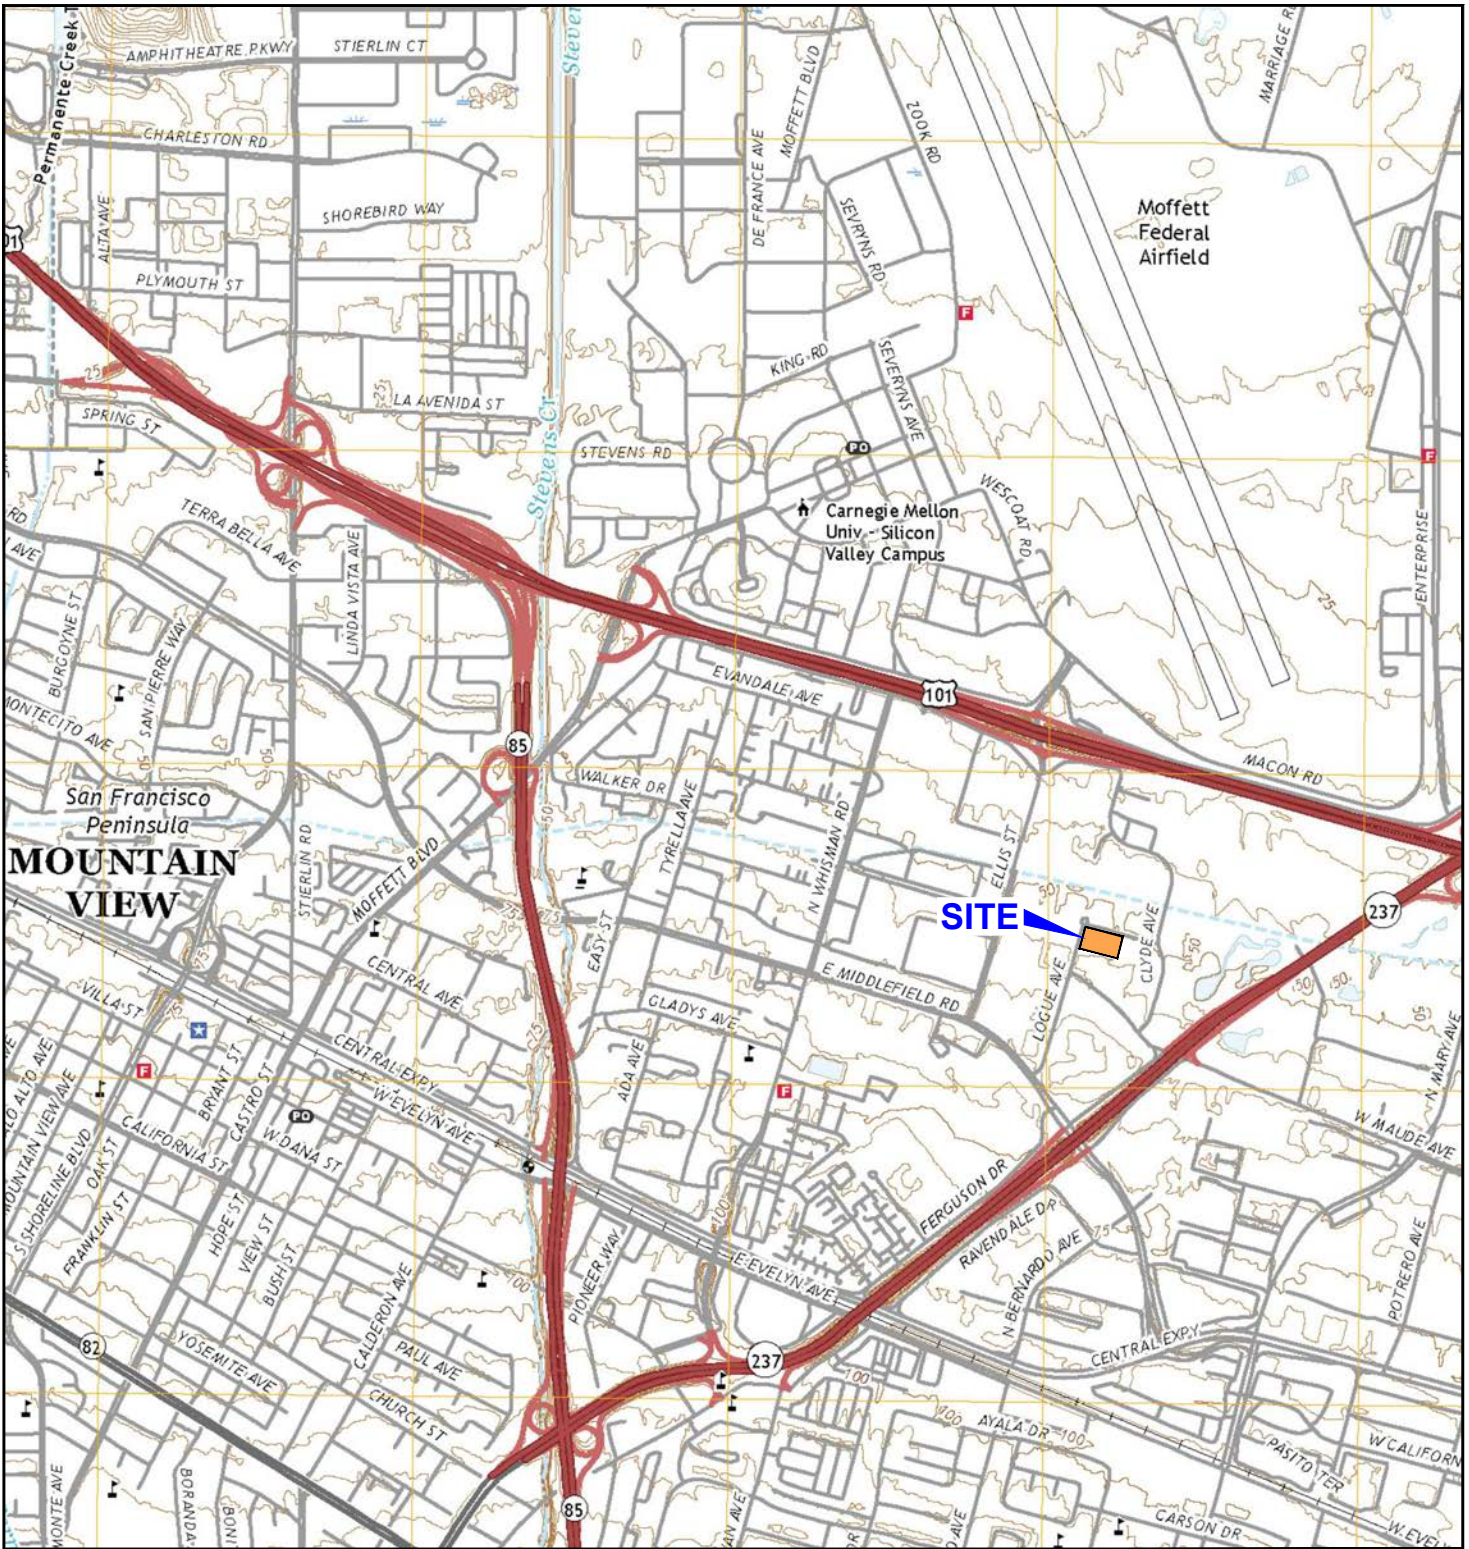
FIGURE 1

In accordance with your request, we have performed a feasibility level geotechnical evaluation for the 441 Logue Avenue property in Mountain View, California (Figure 1) as part of the East Whisman project. The purpose of our geotechnical evaluation was to assess the subsurface conditions and geologic hazards at the site, and to provide preliminary conclusions and recommendations for planning purposes for the sites described in Section 4 of this report.

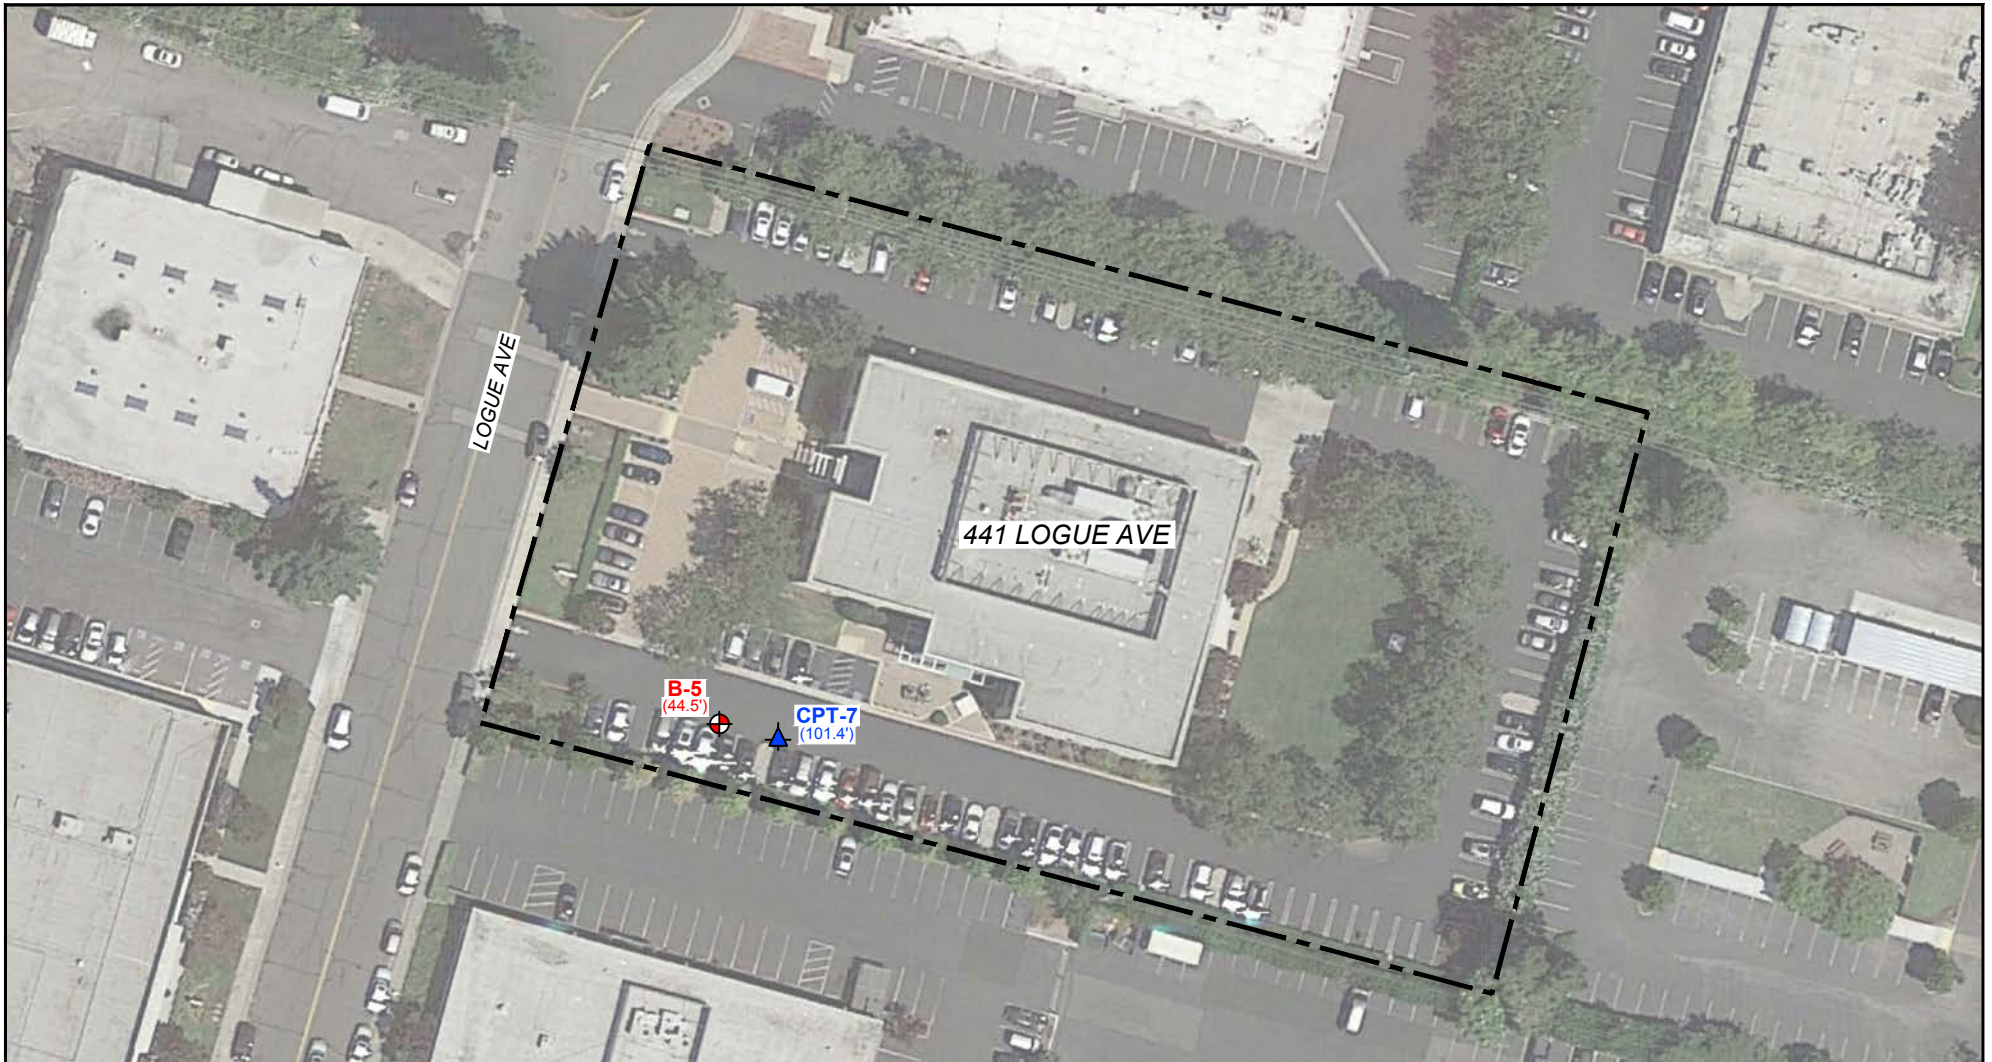
EXPLORATION LOCATIONS

- B-5** (44.5') BORING LOCATION TOTAL DEPTH, IN FEET
- CPT-7** (101.4') CPT LOCATION TOTAL DEPTH, IN FEET
- SITE BOUNDARY

- Obtained a boring permit from the Santa Clara Valley Water District.
- Provided the utility checklist for review and approval by Google.
- Performed one (1) Cone Penetration Test (CPT) sounding to a depth of approximately 101½ feet below the existing grade to evaluate the subsurface conditions and liquefaction susceptibility. The sounding was backfilled with Portland cement grout in compliance with the Santa Clara Valley Water District drilling permit, and pavement was patched.

- Drilled one (1) boring to a depth of approximately 44½ feet below grade, to evaluate the subsurface conditions. The boring was drilled using a truck-mounted drill rig. A representative of Ninyo & Moore logged the subsurface conditions exposed in the boring, and collected bulk and relatively undisturbed samples for laboratory testing. The boring was backfilled with Portland cement grout.

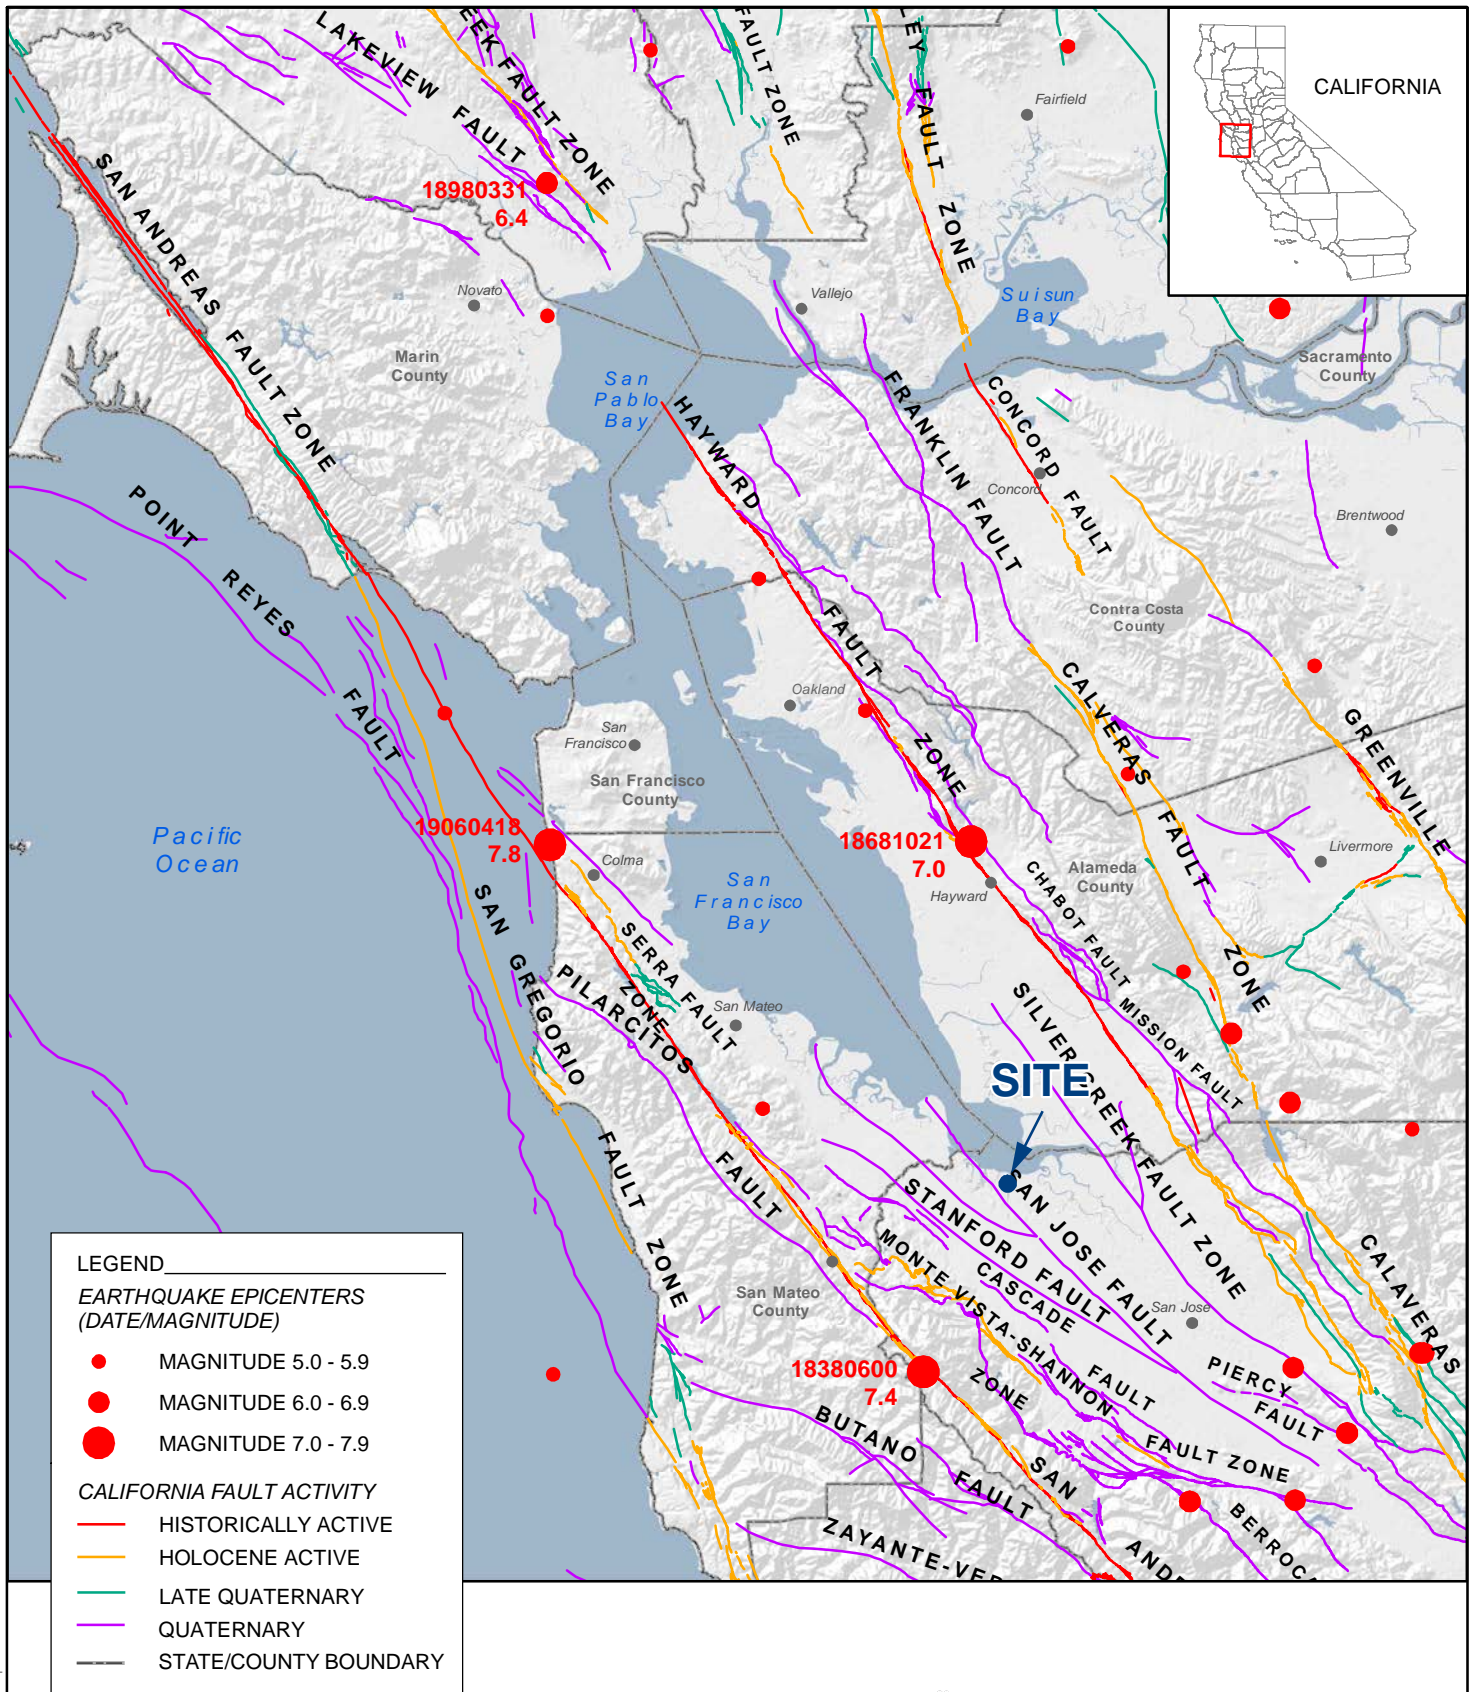
FAULT LOCATIONS AND EARTHQUAKE EPICENTERS

The site is located in a seismically active region. Figure 3 presents the location of the site relative to the epicenters of historic earthquakes with magnitudes of 5.5 or more from 1800 to 2000. Records of historic ground effects related to seismic activity (e.g. liquefaction, sand boils, lateral spreading, ground cracking) compiled by Knudsen et al. (2000), indicate that no ground effects related to historic seismic activity have been reported for the site.

The site is not located within an Alquist-Priolo Earthquake Fault Zone established by the State Geologist (CGS, 2018) to delineate regions of potential ground surface rupture adjacent to active faults. The closest known active fault is the southern segment of the Hayward fault located approximately 9 miles northeast of the site (Santa Clara County [SCC],

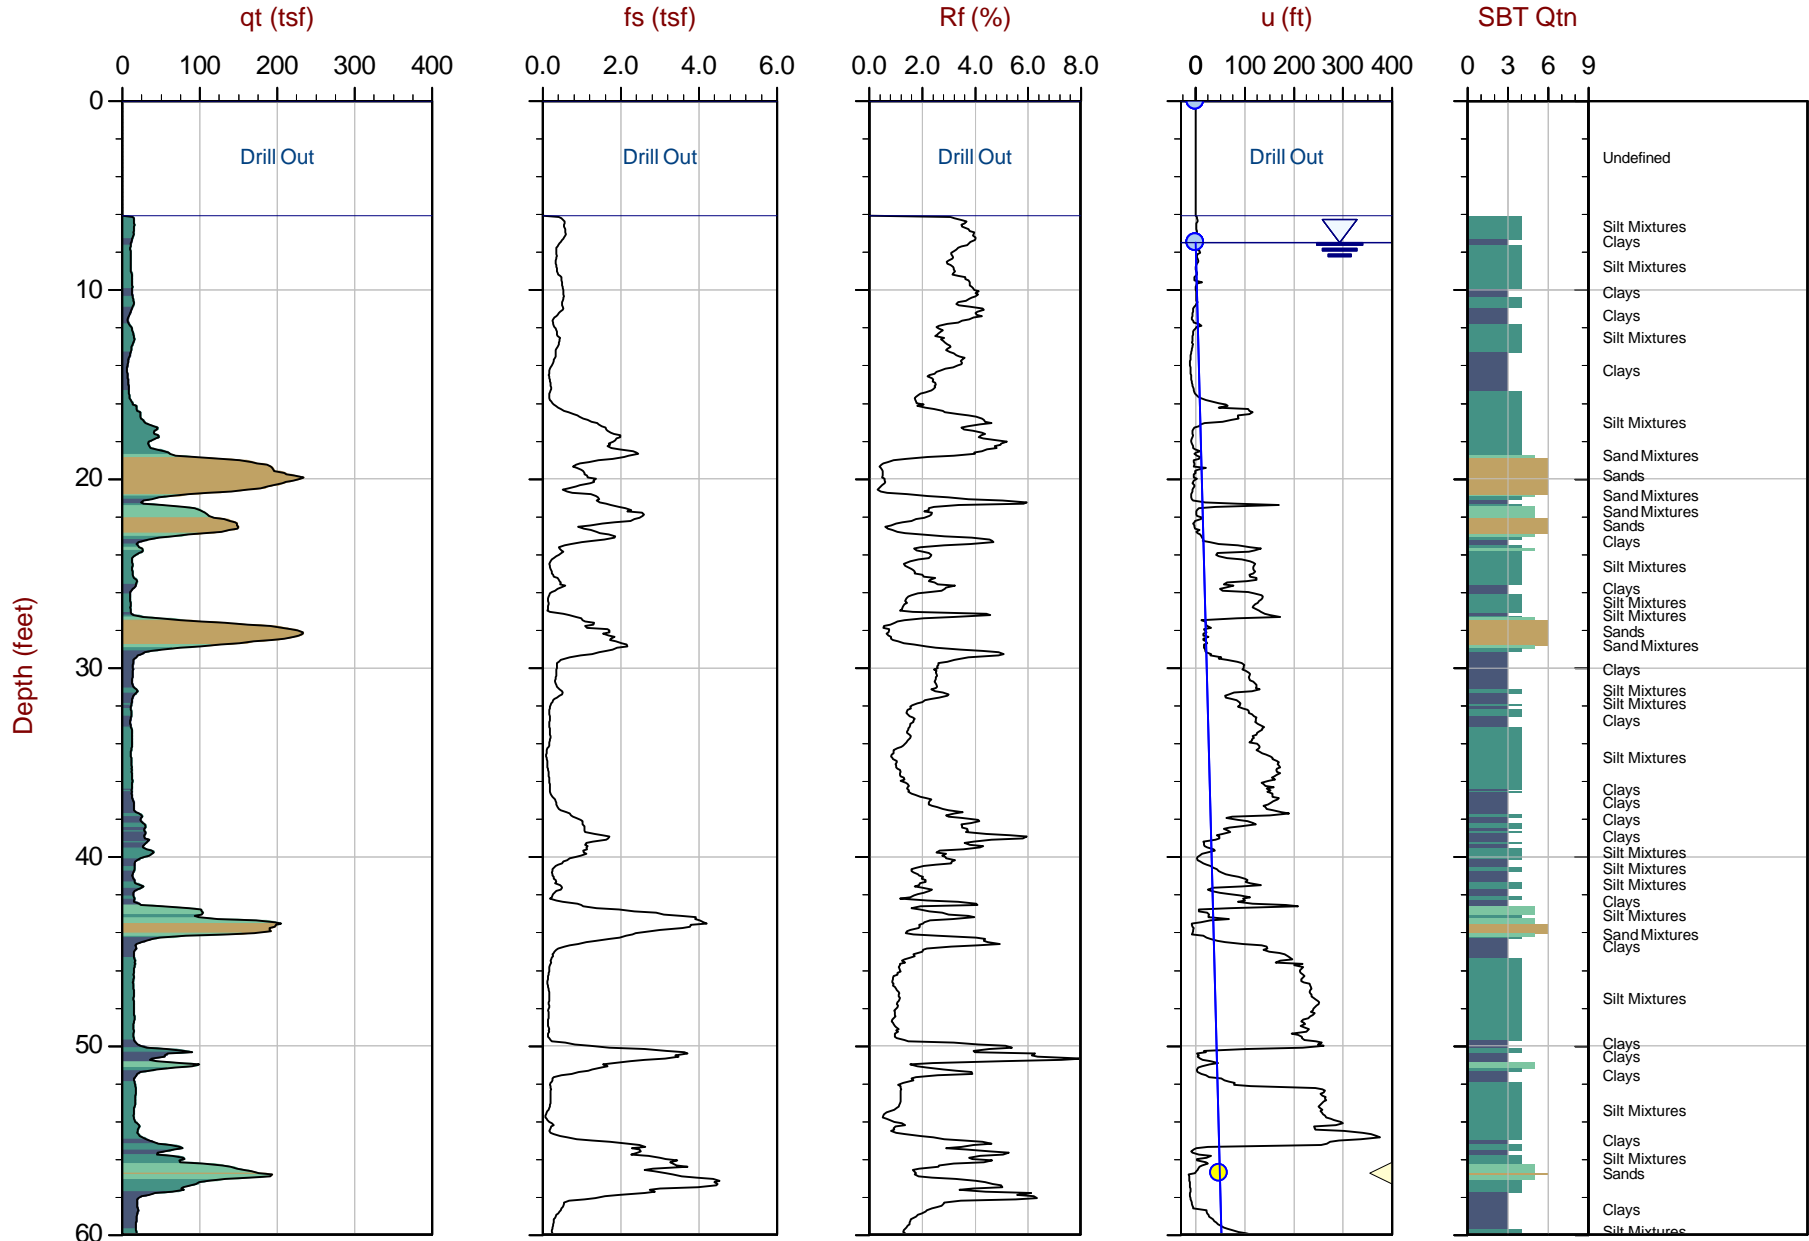
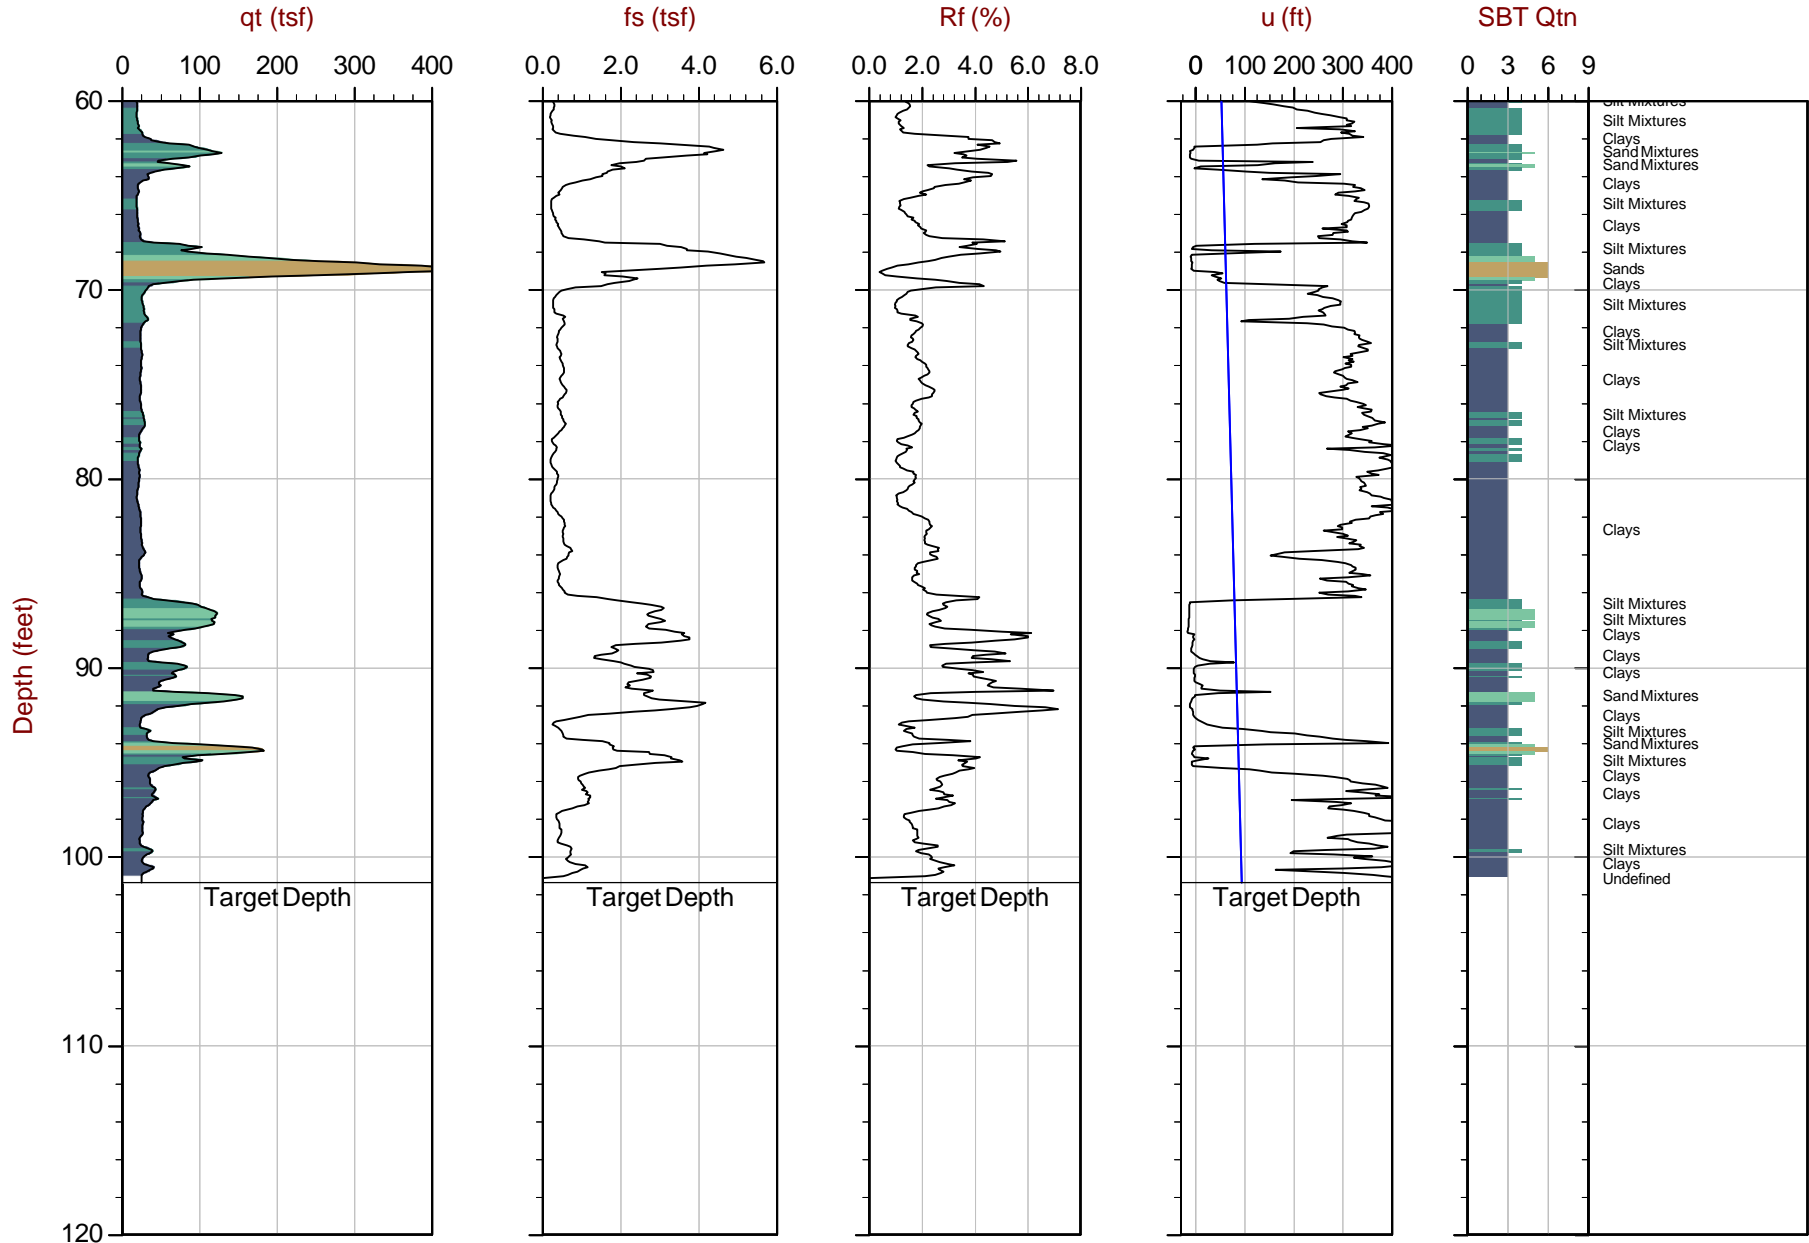
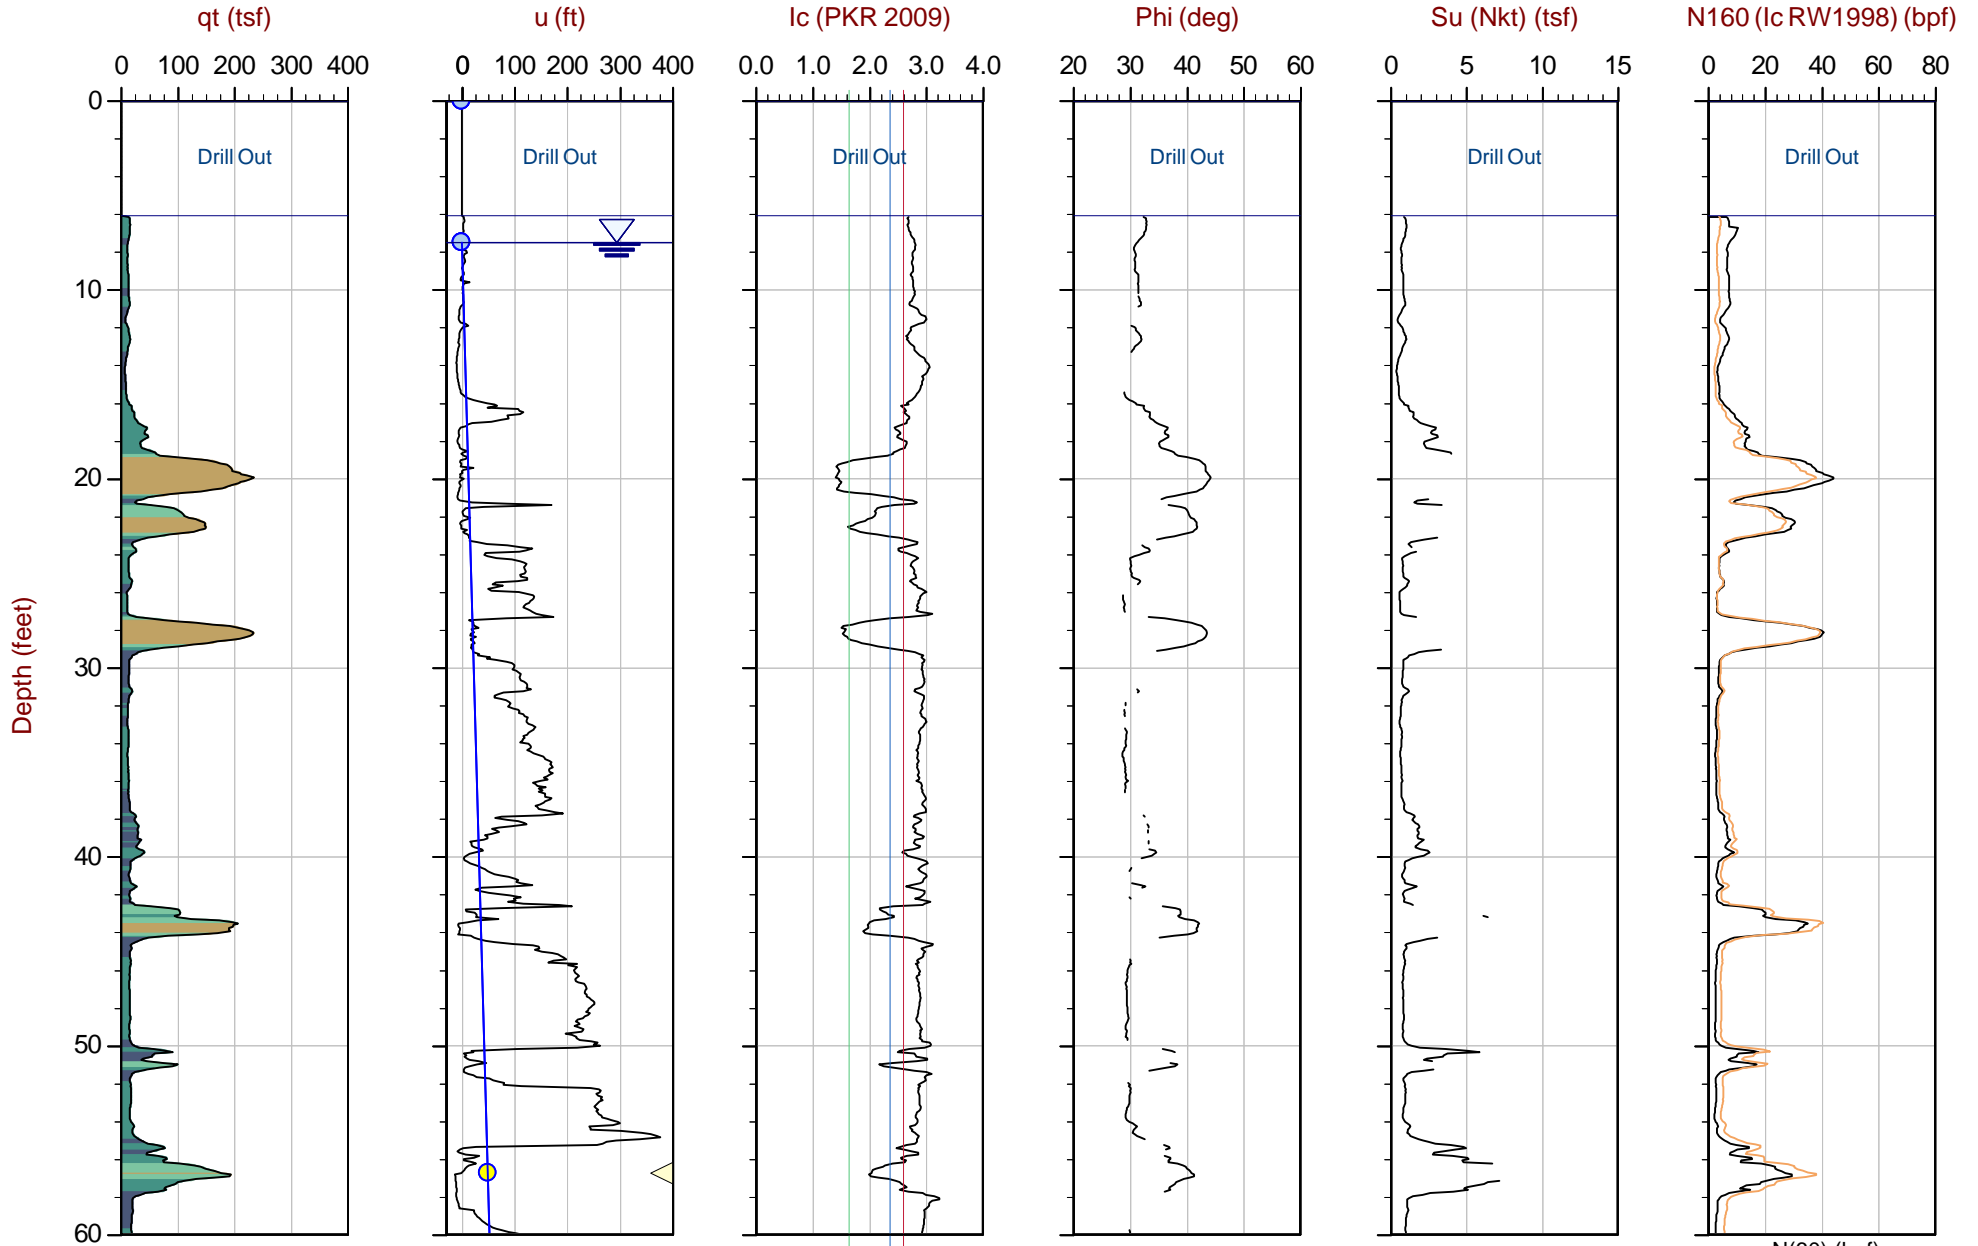
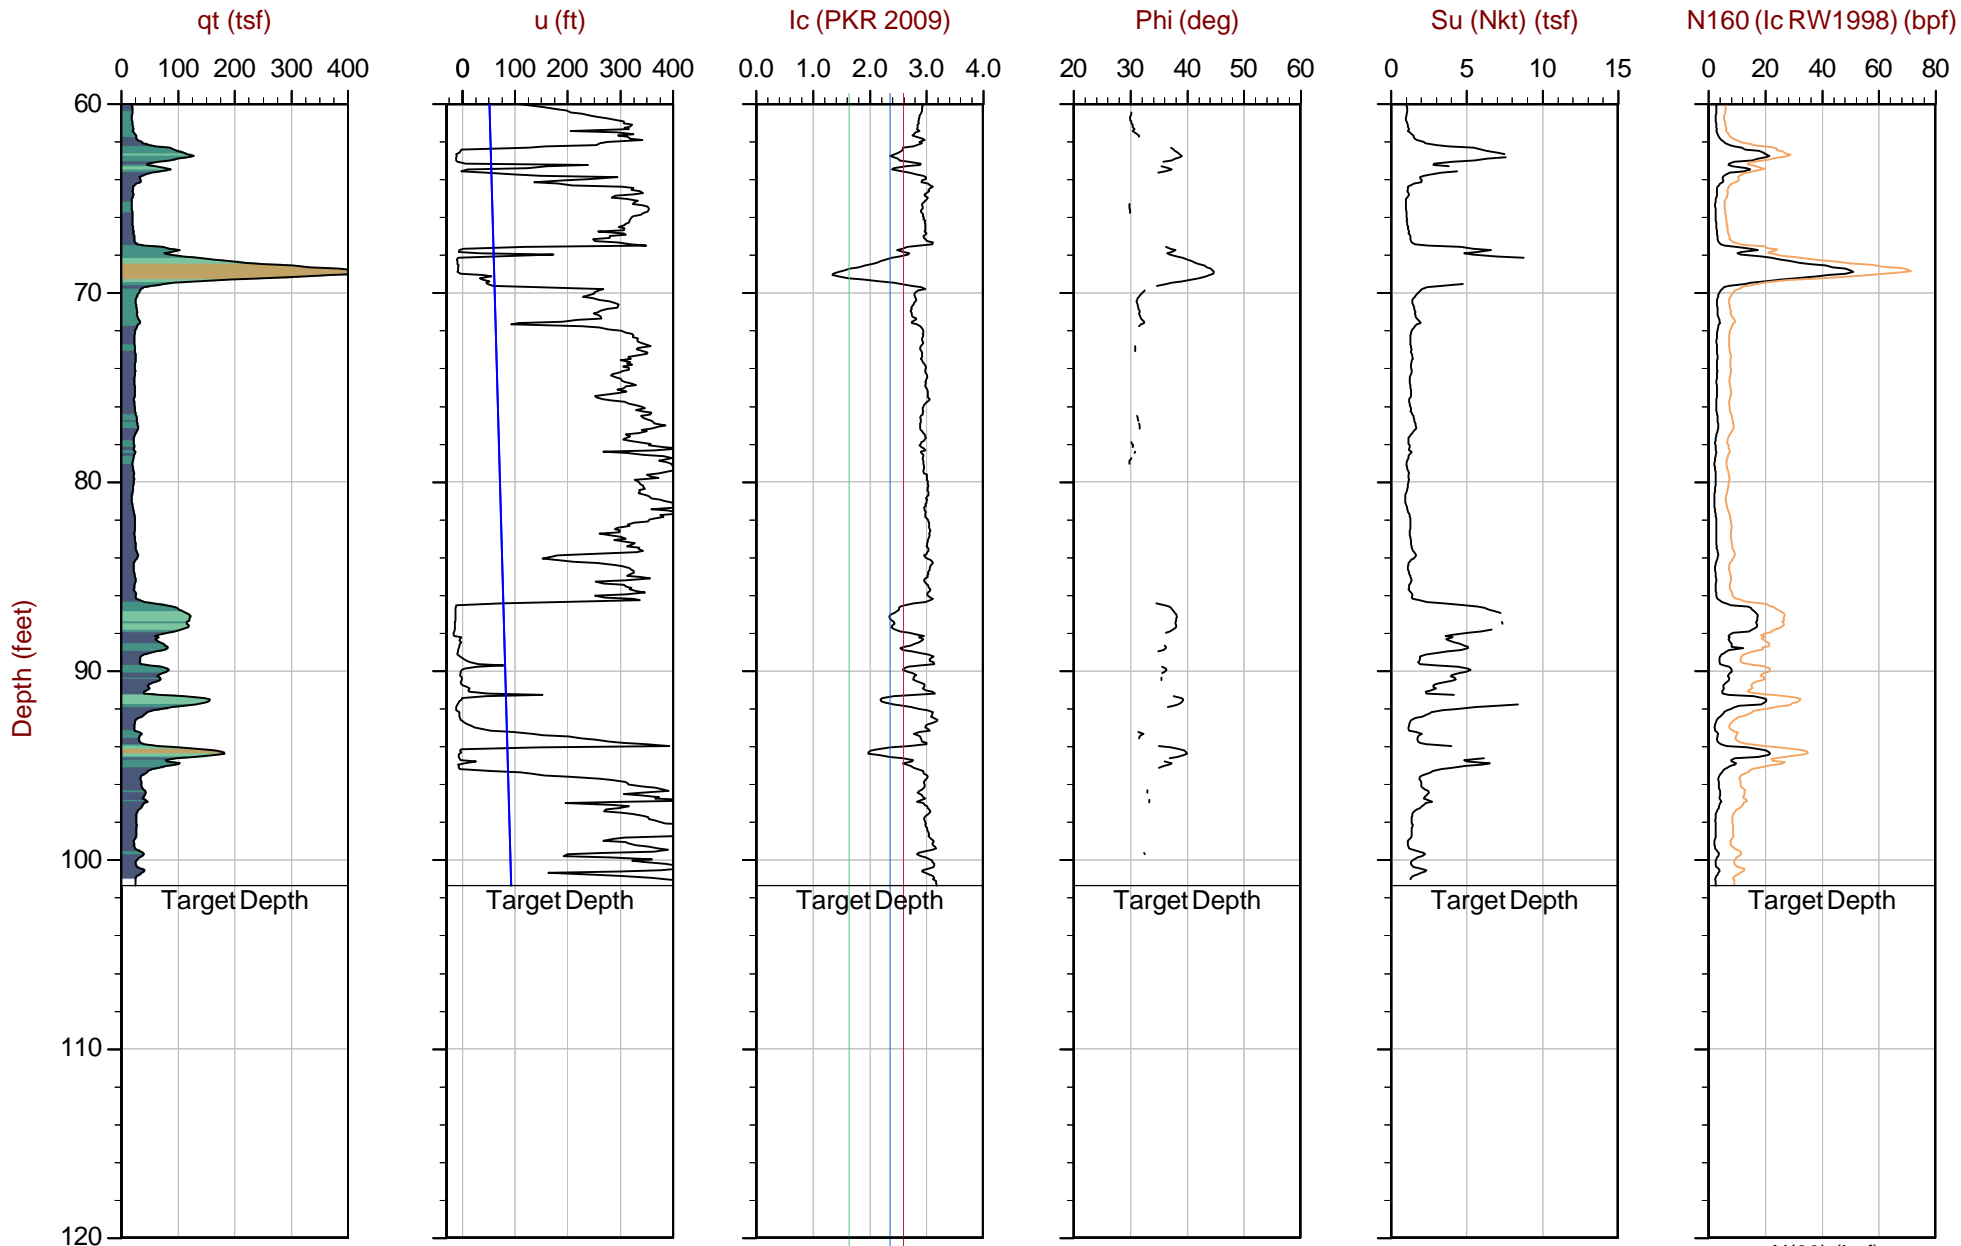
Sounding: CPT-07
Cone: 446:T1500F15U500

A penetrometer with a conical tip having an apex angle of 60 degrees and a cone base area of 15 square centimeters was hydraulically pushed through the soil using the reaction mass of a 30-ton rig at a constant rate of about 20 millimeters per second in accordance with ASTM D 5778. The penetrometer was instrumented to measure, by electronic methods, the water pressure acting on a transducer near the cone tip, the force on the conical point required to penetrate the soil, and the force on a friction sleeve behind the cone tip as the penetrometer was advanced. Penetration and pore water pressure data (P_w) was collected and recorded electronically at intervals of approximately 1 inch. Cone resistance (Q_t) was calculated by dividing the measured force of penetration by the cone base area. Friction sleeve resistance (F_s) was calculated by dividing the measured force on the friction sleeve by the surface area of the sleeve. The friction ratio (R_f) was calculated as the ratio of the tip resistance to the sleeve friction (Q_t/F_s). A graph of the computed values of cone resistance (Q_t), friction ratio (F_s/Q_t), and pore water pressure (U) are presented on the logs in the following pages. The tip resistance and friction ratio were used to classify the soil type encountered using the method by Robertson and Campanella (1986). Equivalent SPT blowcounts at a 60 percent energy ratio with overburden correction ($N_{1(60)}$ values) were calculated from the tip resistance and friction ratio. A graph of the equivalent $N_{1(60)}$ values and the encountered soil types are also presented on the logs in the following pages.

Alluvium was encountered in the boring and CPT sounding from below the fill to the depths explored. The alluvium generally consisted of moist to wet, firm to hard fat clay, lean clay, and sandy lean clay, and wet, medium dense to very dense clayey sand. More detailed descriptions are presented on the boring log in Appendix B. Soil Behavior Type classifications interpreted from CPT data are presented in Appendix A.

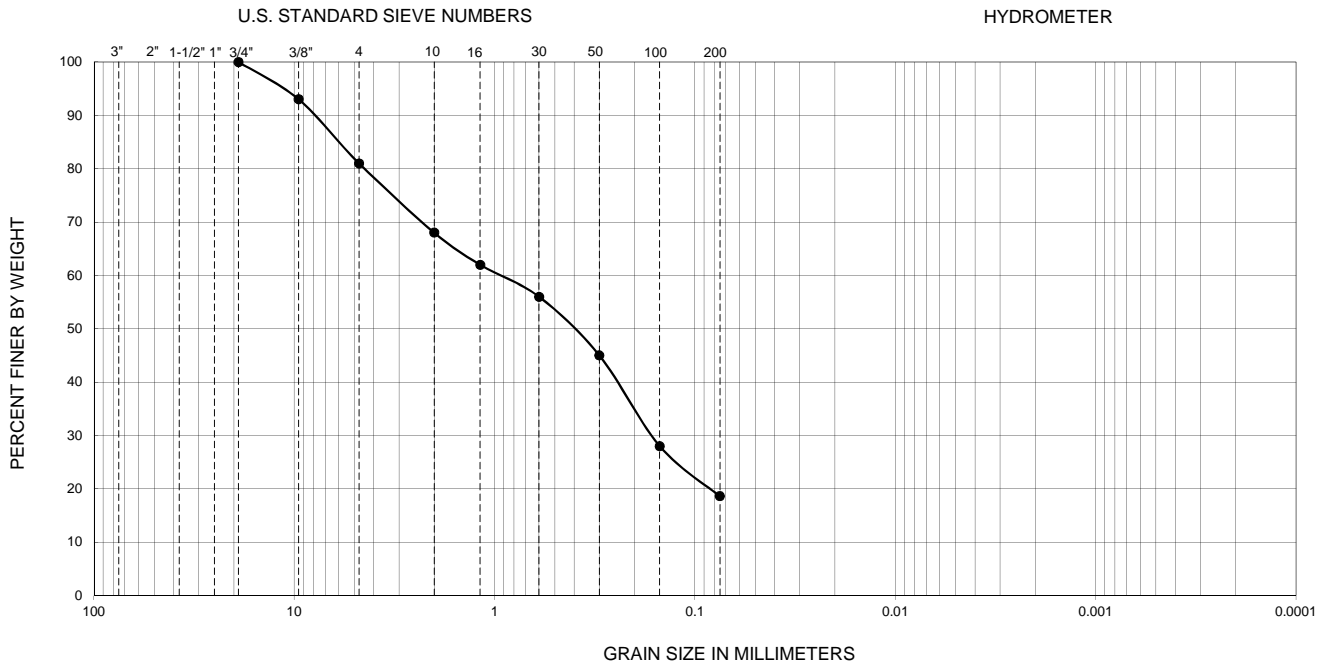
GRADATION TEST RESULTS

Symbol	Sample Location	Depth (ft)	Liquid Limit	Plastic Limit	Plasticity Index	D ₁₀	D ₃₀	D ₆₀	C _u	C _c	Passing No. 200 (percent)	USCS
●	B-5	20.0-21.5	--	--	--	--	--	--	--	--	19	SC

PERFORMED IN ACCORDANCE WITH ASTM D 422 / D6913

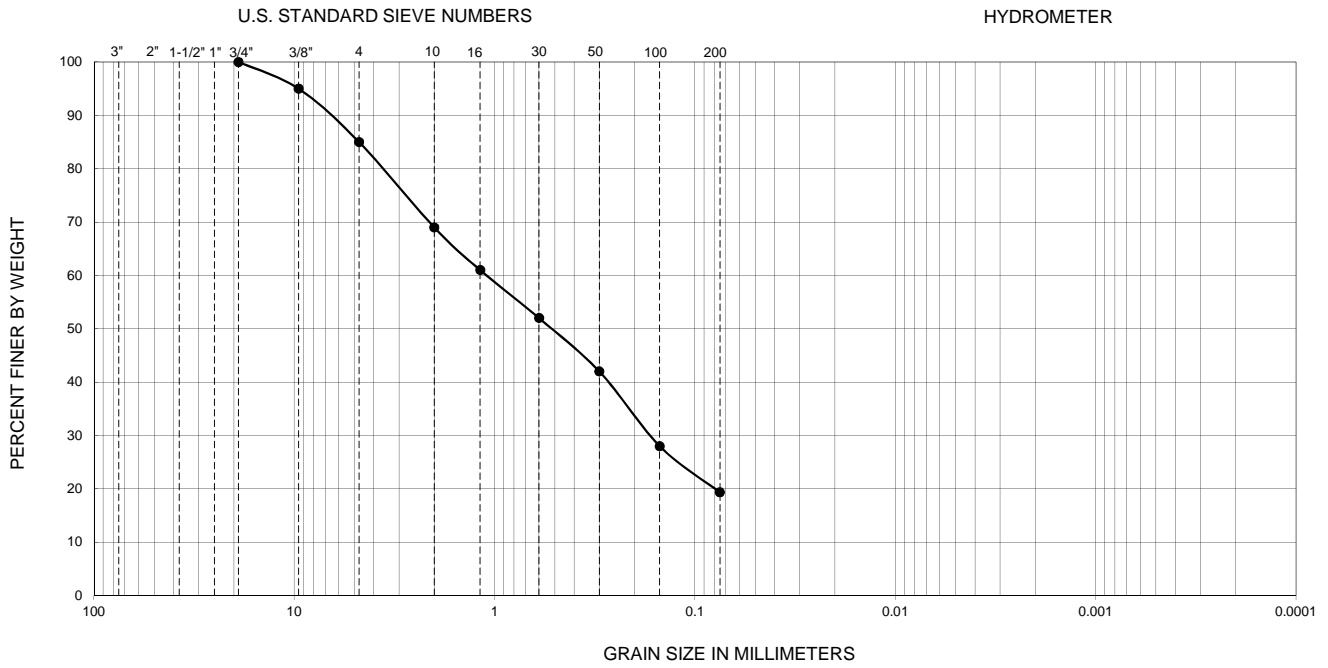
GRADATION TEST RESULTS

Symbol	Sample Location	Depth (ft)	Liquid Limit	Plastic Limit	Plasticity Index	D ₁₀	D ₃₀	D ₆₀	C _u	C _c	Passing No. 200 (percent)	USCS
●	B-5	28.5-30.0	--	--	--	--	--	--	--	--	19	SC

PERFORMED IN ACCORDANCE WITH ASTM D 422 / D6913

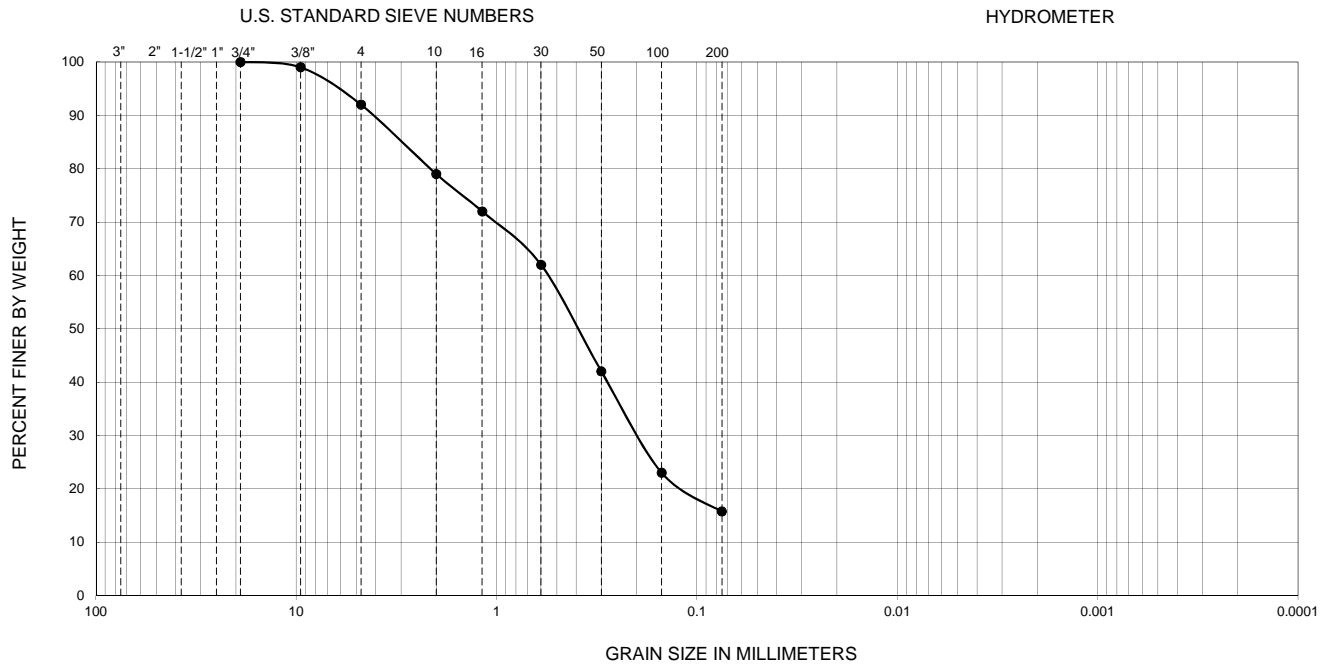
GRADATION TEST RESULTS

Symbol	Sample Location	Depth (ft)	Liquid Limit	Plastic Limit	Plasticity Index	D ₁₀	D ₃₀	D ₆₀	C _u	C _c	Passing No. 200 (percent)	USCS
●	B-5	41.0-41.5	--	--	--	--	--	--	--	--	16	SC

PERFORMED IN ACCORDANCE WITH ASTM D 422 / D6913

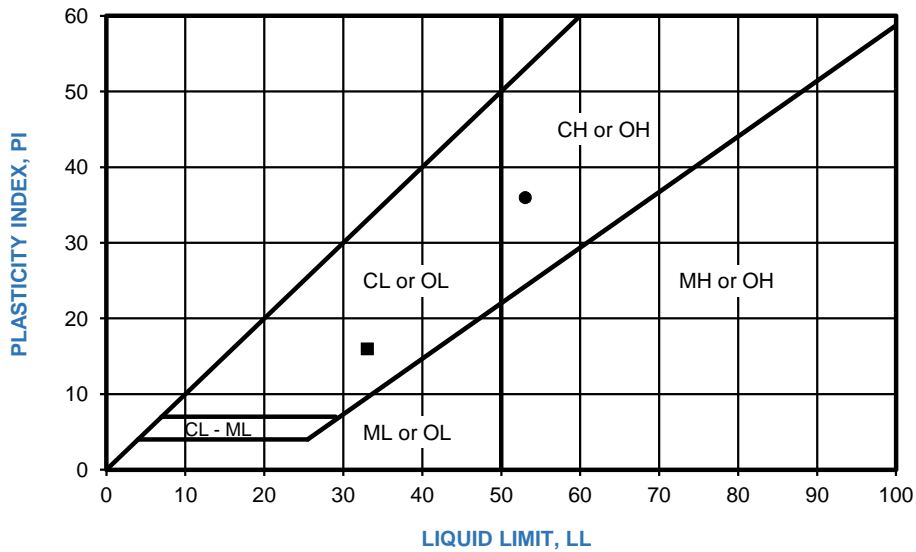
FIGURE C-4

SYMBOL	LOCATION	DEPTH (ft)	LIQUID LIMIT	PLASTIC LIMIT	PLASTICITY INDEX	USCS CLASSIFICATION (Fraction Finer Than No. 40 Sieve)	USCS
●	B-5	10.5-11.0	53	17	36	CH	CH
■	B-5	35.5-36.0	33	17	16	CL	CL

ATTERBERG LIMITS TEST RESULTS

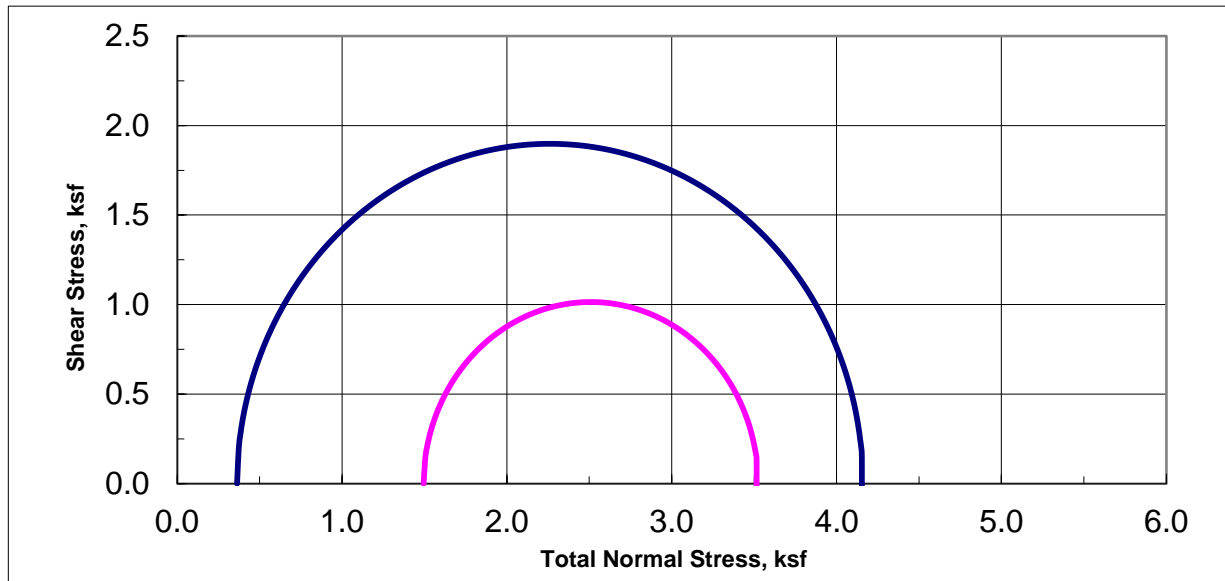
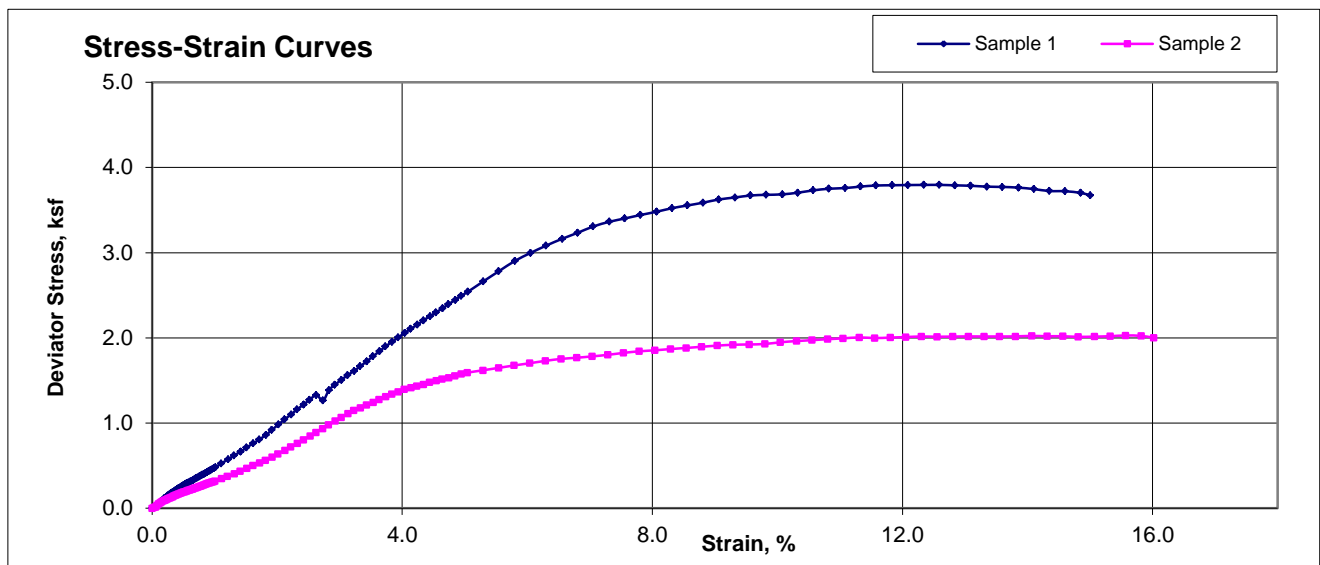
SYMBOL	DESCRIPTION	SOIL TYPE	SAMPLE LOCATION	SAMPLE DEPTH (ft.)	MOISTURE CONTENT w , (%)	DRY DENSITY γ_d , (pcf)	CELL PRESSURE (ksf)	UNDRAINED SHEAR STRENGTH (ksf)
◆	Brown Lean CLAY	CL	B-5	6.0-8.0	25.1	94.1	0.36	1.90
●	Gray Lean CLAY	CL	B-5	15.0-17.5	24.6	100.1	1.49	1.01

PERFORMED IN ACCORDANCE WITH ASTM D 2850
 STRAIN RATE: 1.0%/MIN

Triaxial compression tests were performed on selected relatively undisturbed samples in accordance with ASTM D 2850. The test results are shown on Figure C-8.
