Feasibility Level Geotechnical Evaluation

East Whisman
441 Logue Avenue
Mountain View, California

July 14, 2020 | Project No. 403253010

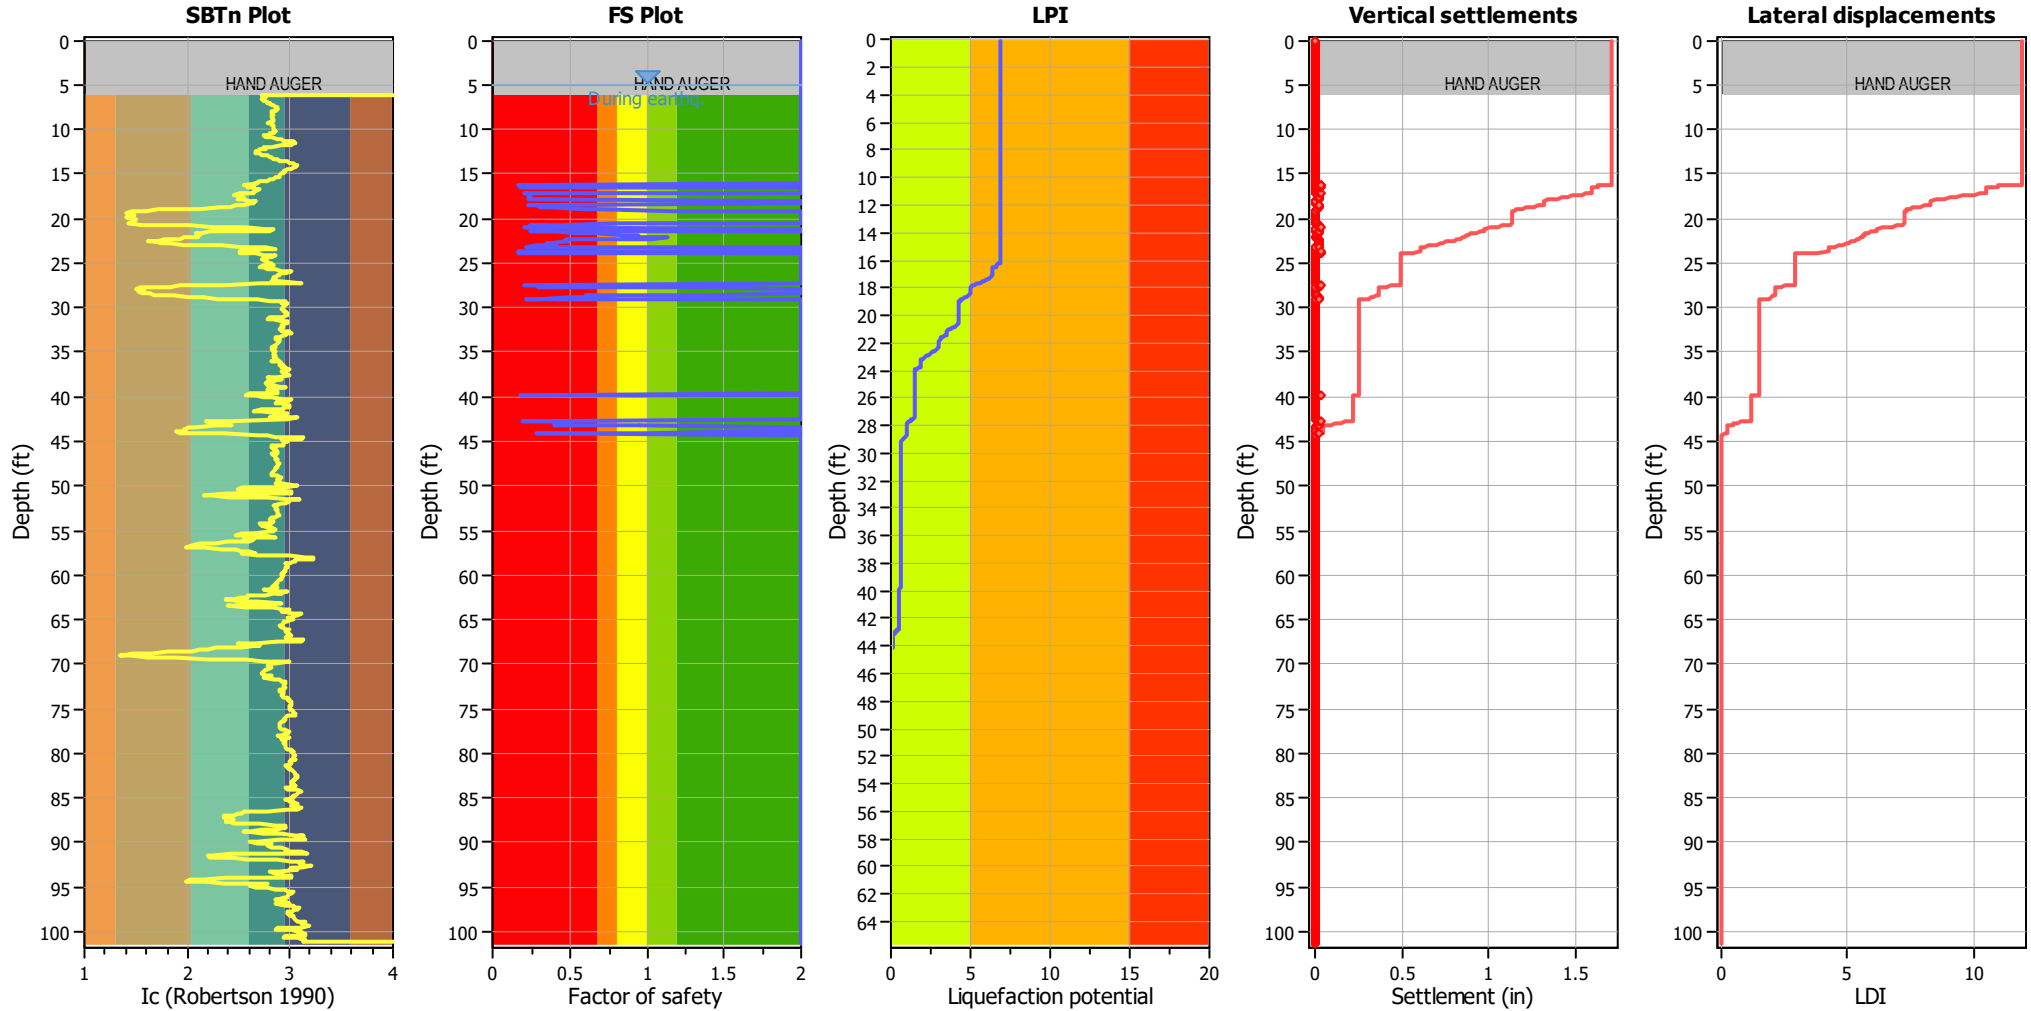
Estimated Liquefaction-Induced Vertical and Lateral Soil Displacements
Based on CPT Data

Analysis method:	B&I (2014)	G.W.T. (in-situ):	7.50 ft	Use fill:	No	Clay like behavior	
Fines correction method:	B&I (2014)	G.W.T. (earthq.):	5.00 ft	Fill height:	N/A	applied:	.
Points to test:	Based on Ic value	Average results interval:	1	Fill weight:	N/A	Limit depth applied:	Yes
Earthquake magnitude M_w :	7.30	Ic cut-off value:	2.60	Trans. detect. applied:	No	Limit depth:	50.00 ft
Peak ground acceleration:	0.72	Unit weight calculation:	Based on SBT	K_σ applied:	Yes	MSF method:	Method based

We evaluated the potential for dynamic settlement due to liquefaction of saturated soil using the computer program CLiq (GeoLogismiki, 2018) to evaluate the CPT data collected during our field investigation with the methodology of Boulanger and Idriss (2014). Our analysis considered a Magnitude 7.3 earthquake producing a PGA of 0.723g and a design groundwater elevation of 5 feet below the ground surface. The results of our analysis, presented in Appendix D, indicate that the free-field total dynamic settlement following the considered seismic event will be approximately $1\frac{3}{4}$ inches with negligible dry sand settlement. Differential dynamic settlement is estimated to be about 1 inch over a horizontal distance of approximately 30 feet.

- The results of our dynamic settlement analysis, presented in Appendix D, indicate that the total dynamic settlement following the considered seismic event will be approximately 1¾ inches with a differential dynamic settlement of about 1 inch over a horizontal distance of approximately 30 feet. Deep foundations or ground improvement can mitigate dynamic settlement concerns for structures. The results are based on a limited number of exploration points and the results may vary in a design level study.
