Initial Site Assessment for  
13<sup>th</sup> Street Bridge Project  
13<sup>th</sup> and Walnut Streets, Ramona,  
Unincorporated County of  
San Diego, California

Prepared for:  
County of San Diego Department of Public Works

Project Number: 60562978

May 2020

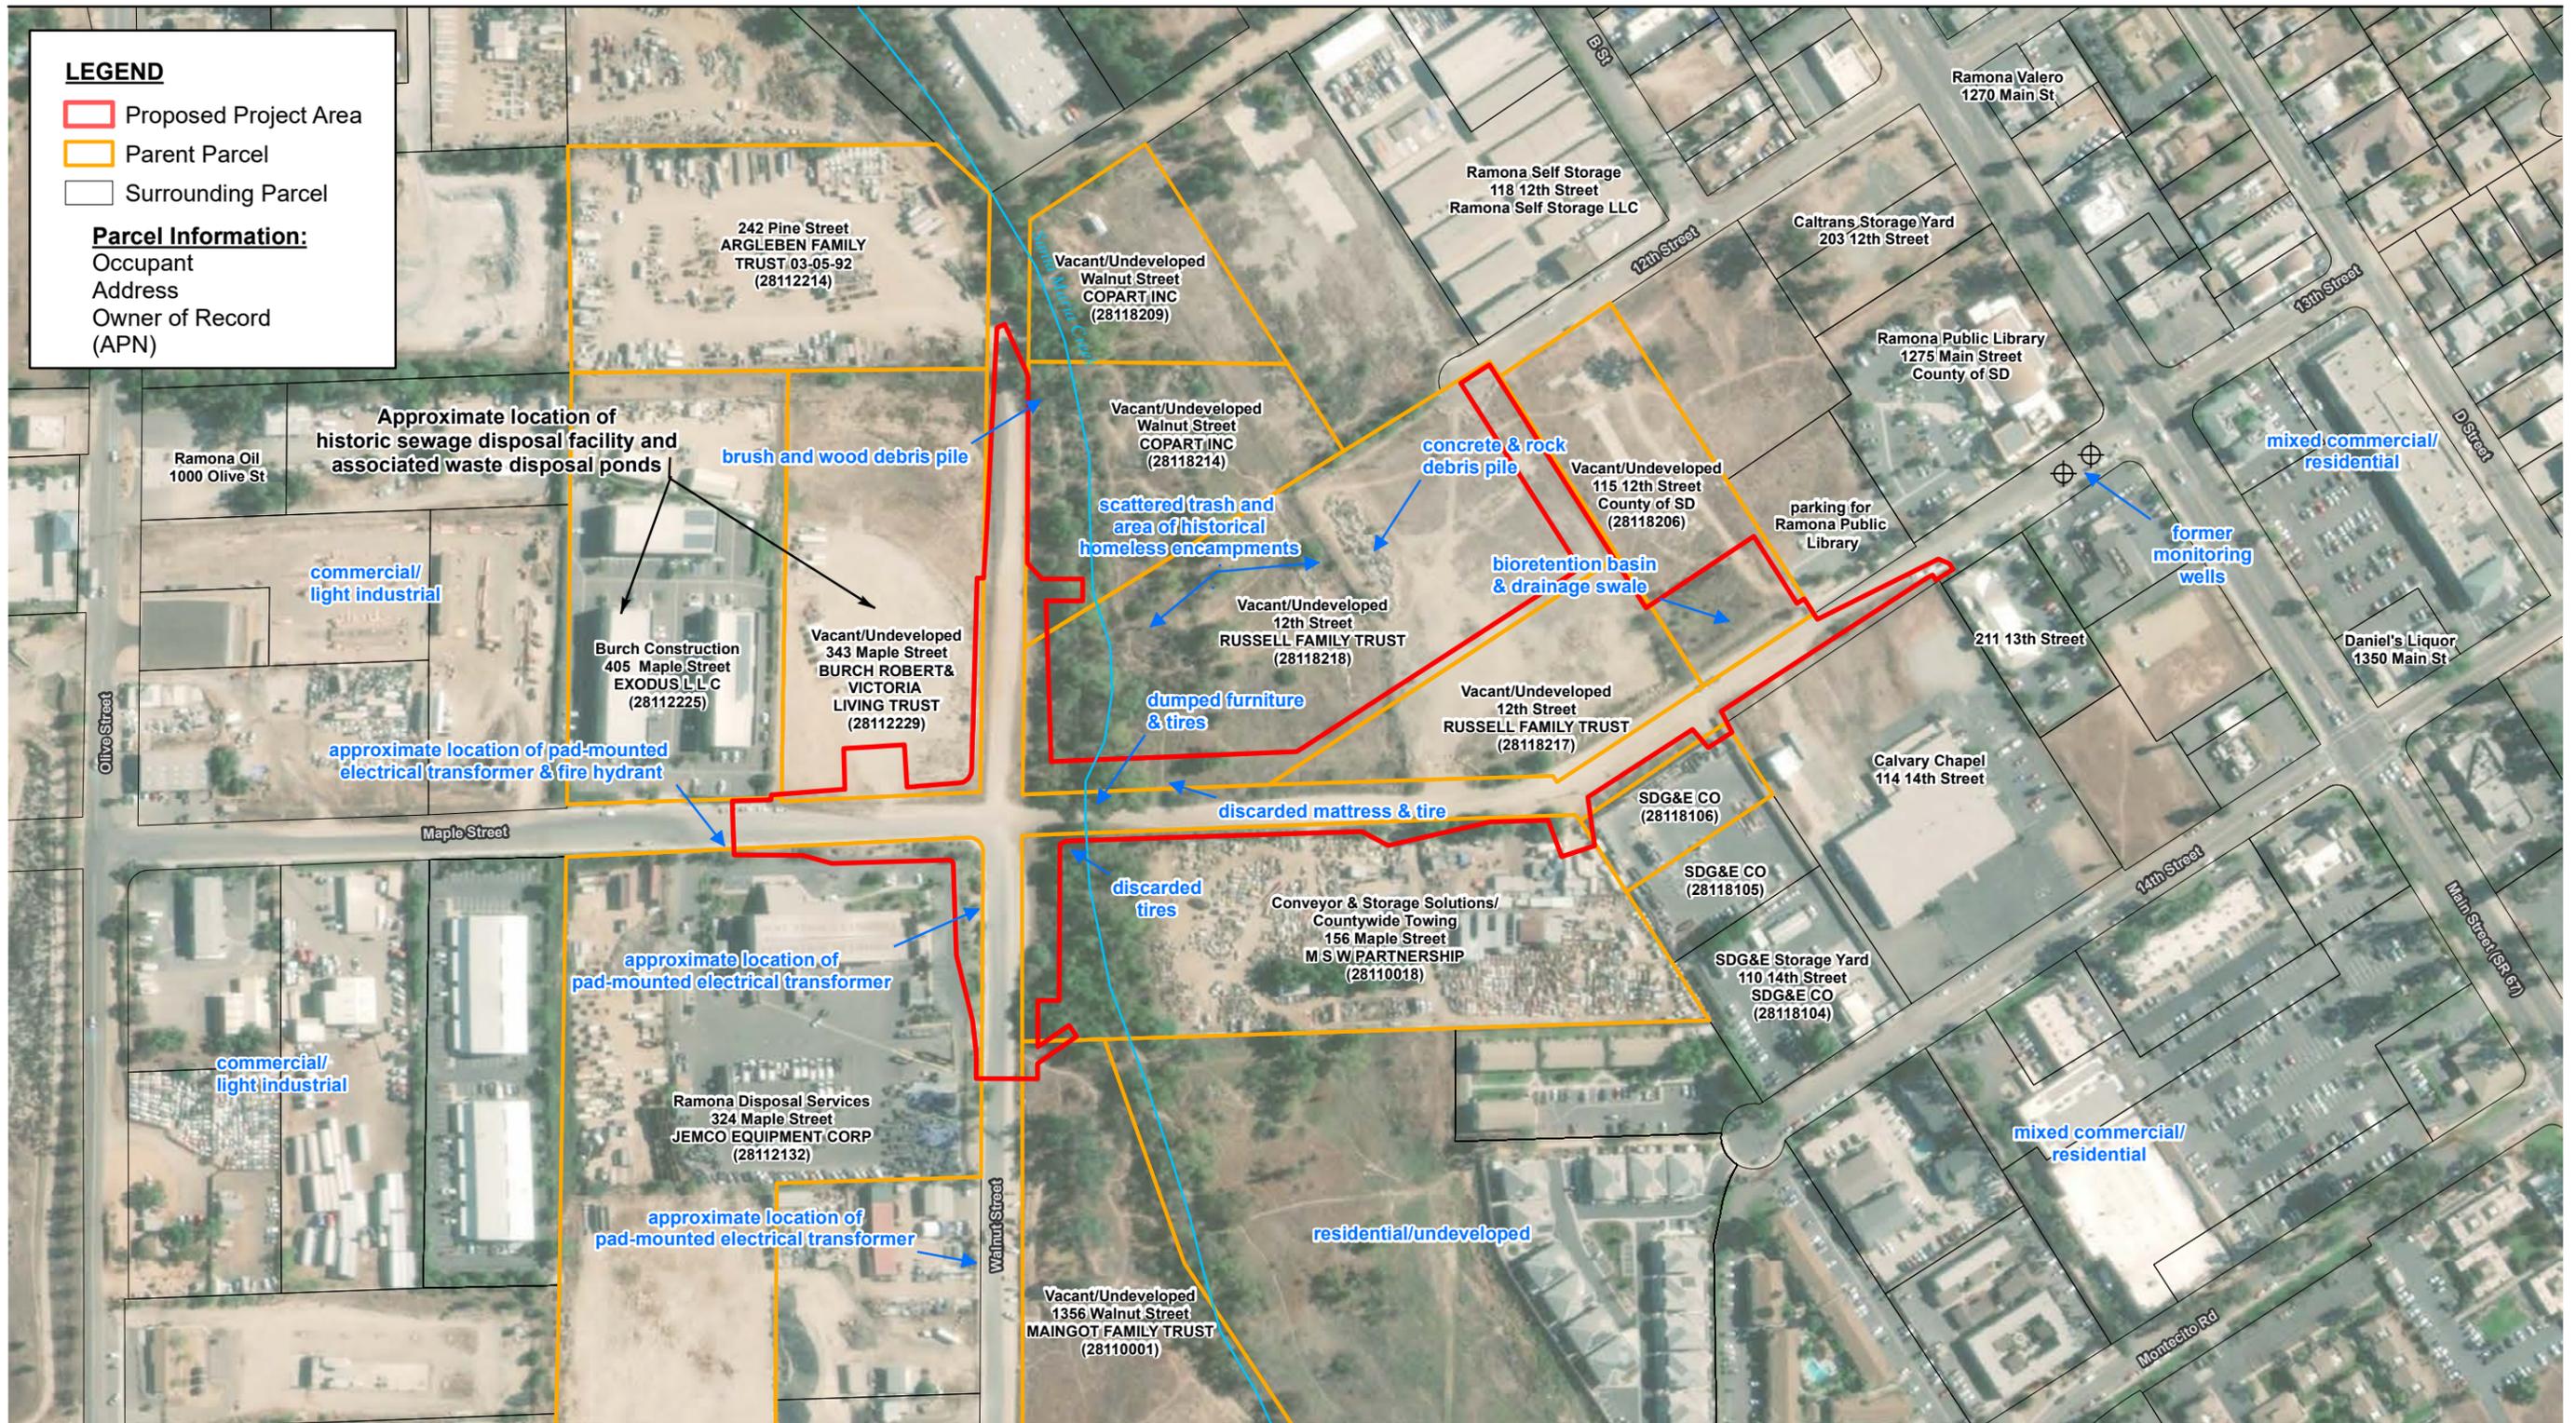
There is no physical address for the portions of the proposed project area within the existing roadways. According to the County, these sections of 13<sup>th</sup>, Maple, and Walnut Streets are County maintained and there are no Assessor's Parcel Numbers (APNs) specifically listed for the roadways. The portion of Walnut Street east of 13<sup>th</sup>/Maple Streets is unpaved and is not shown as a County-maintained roadway in County mapping records. Portions of the proposed project area extend onto the adjacent parent parcels on both sides of these sections of the roadway, and specific ownership of these parent parcels is provided in **Table 1** in Section 2.4. The project footprint is shown on the site plan provided as **Figure 2** and includes the associated APNs and ownership information for the parent parcels.

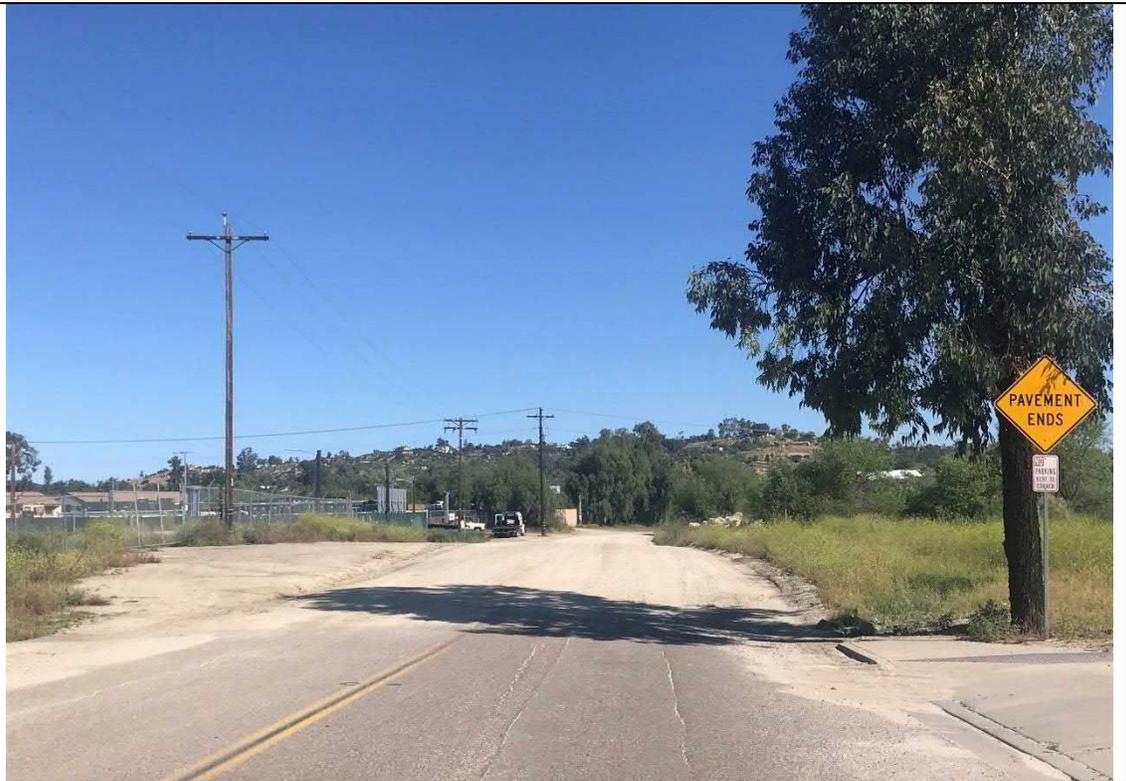
<b>Photo No.</b> <b>1</b>	<b>Date:</b> 05/08/20
<b>Direction Photo Taken:</b>  North	
<b>Description:</b>  View north from paved portion of 13 <sup>th</sup> Street at the south end of the proposed project area.

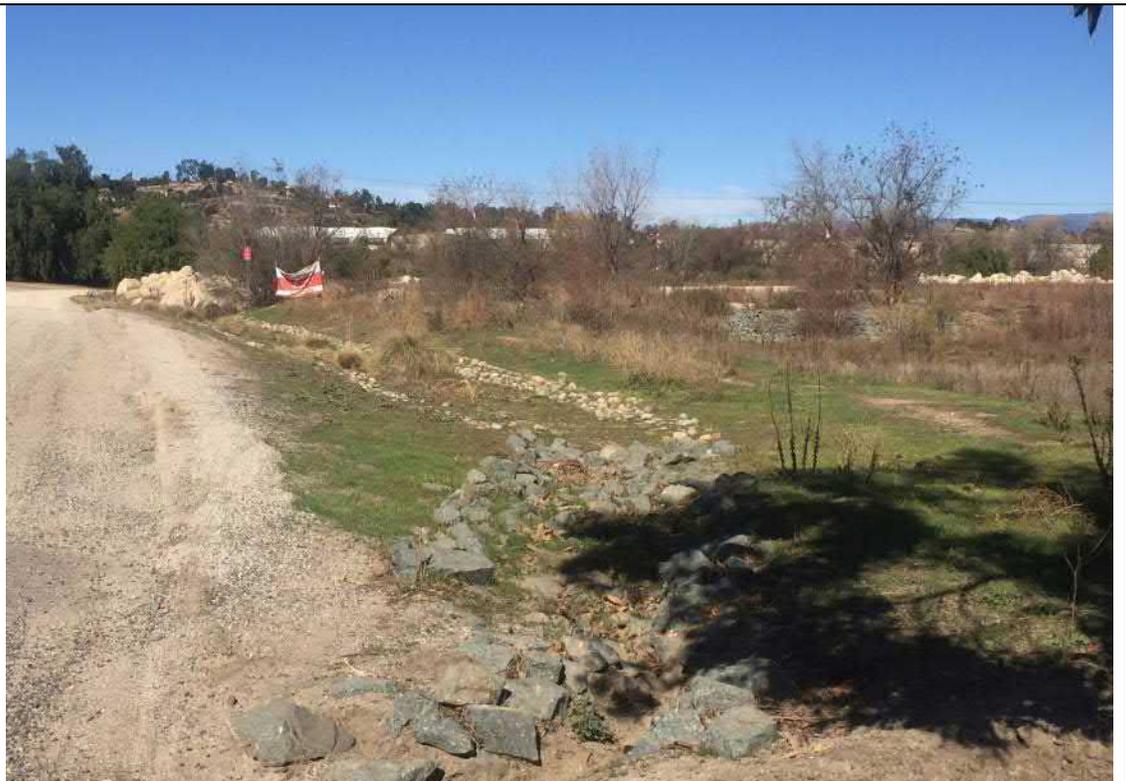
<b>Photo No.</b> <b>2</b>	<b>Date:</b> 05/08/20
<b>Direction Photo Taken:</b>  Northeast	
<b>Description:</b>  View northeast from the southern end of the proposed project area near the end of the pavement. Drainage swale adjacent to (east of) 13 <sup>th</sup> Street in center of photograph. Bioretention basin on the County-owned property at 115 12 <sup>th</sup> Street can be seen in upper right quadrant of photograph.

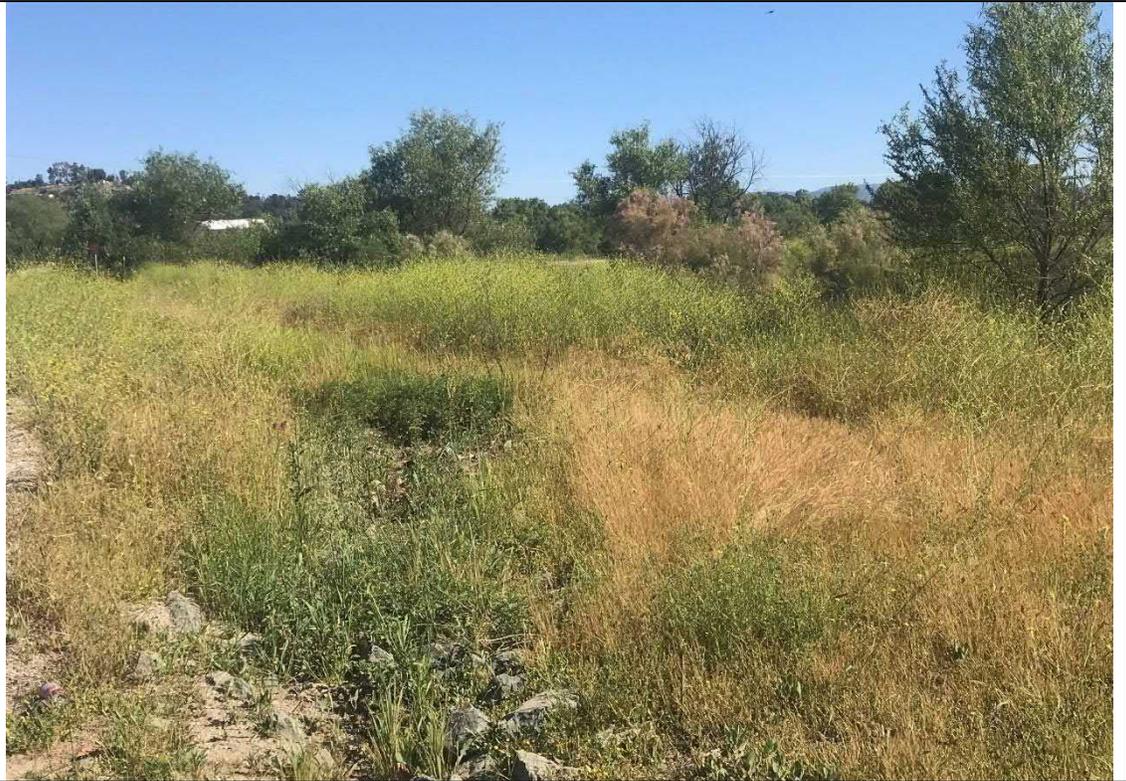
<b>Photo No.</b> <b>3</b>	<b>Date:</b> 05/08/20
<b>Direction Photo Taken:</b>  Northeast	
<b>Description:</b>  View northeast of the retention basin from the County-owned property at 115 12 <sup>th</sup> Street, in the southeastern corner of the proposed project area.

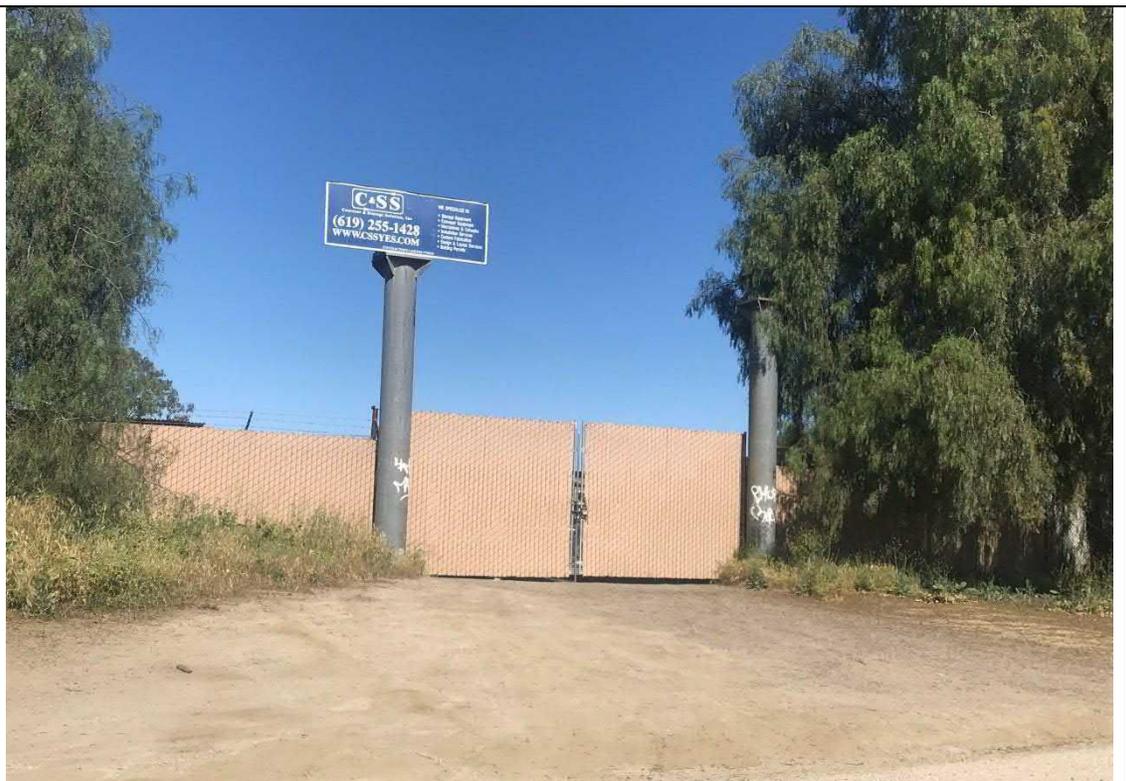
<b>Photo No.</b> <b>6</b>	<b>Date:</b> 05/08/20
<b>Direction Photo Taken:</b>  West	
<b>Description:</b>  View west of the entrance to County Wide Towing, located at 156 Maple Street, on the west side of 13 <sup>th</sup> /Maple Streets.

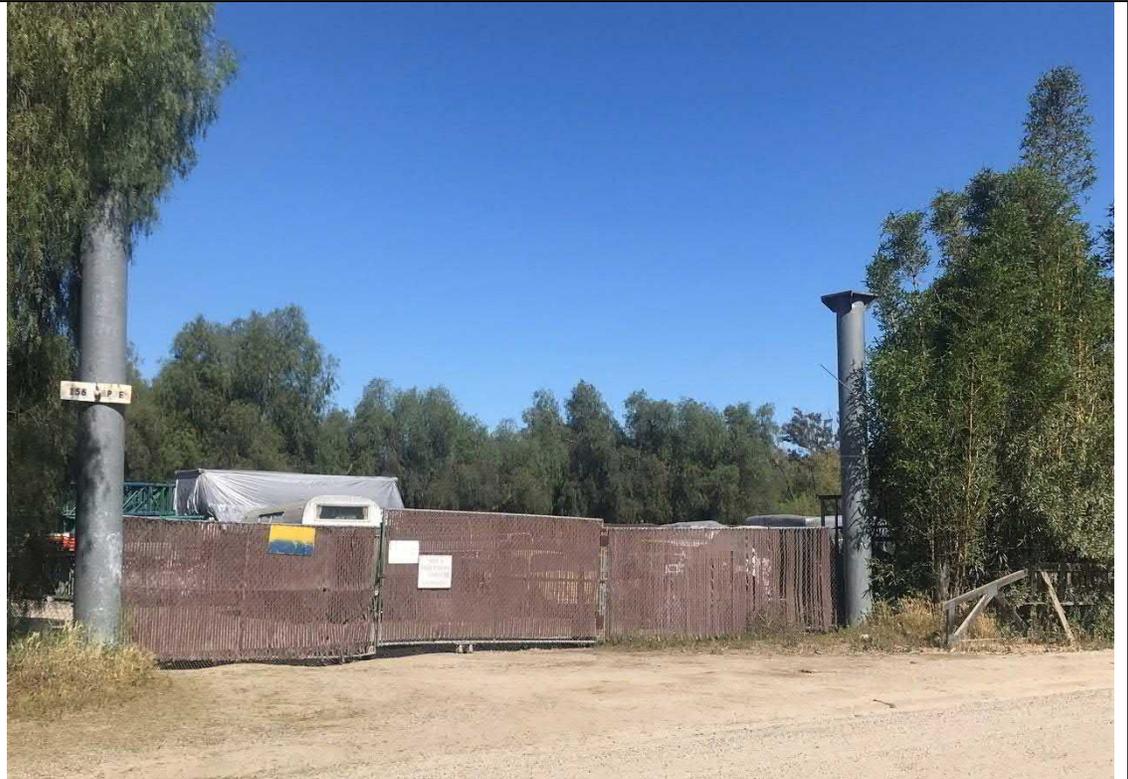
<b>Photo No.</b> <b>7</b>	<b>Date:</b> 05/08/20
<b>Direction Photo Taken:</b>  Northwest	
<b>Description:</b>  View northwest of the auto storage yard at 156 Maple Street, on the west side of 13 <sup>th</sup> /Maple Streets. This facility shares the same address and APN as the towing company to the south.

- Based on the presence of the sewage disposal facility for approximately 30 years near the northern area of the project and the presence of the auto salvage yard for more than 20 years at 156 Maple Street, AECOM recommends conducting a Phase II investigation to characterize soil and groundwater conditions in the vicinity of these properties.

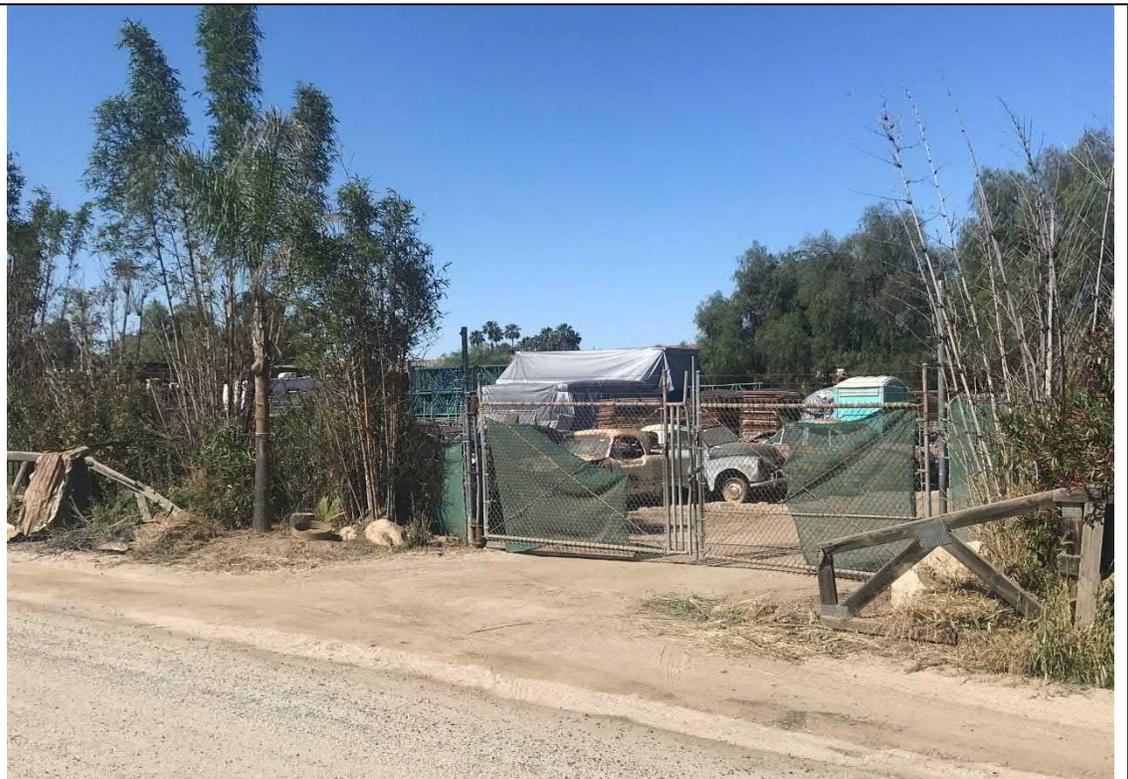
<b>Photo No.</b> <b>9</b>	<b>Date:</b> 05/08/20
<b>Direction Photo Taken:</b>  Northwest	
<b>Description:</b>  View northwest of the interior area of the auto storage yard. This area is along the fence on the eastern boundary of this property, just west of the proposed project area limits.

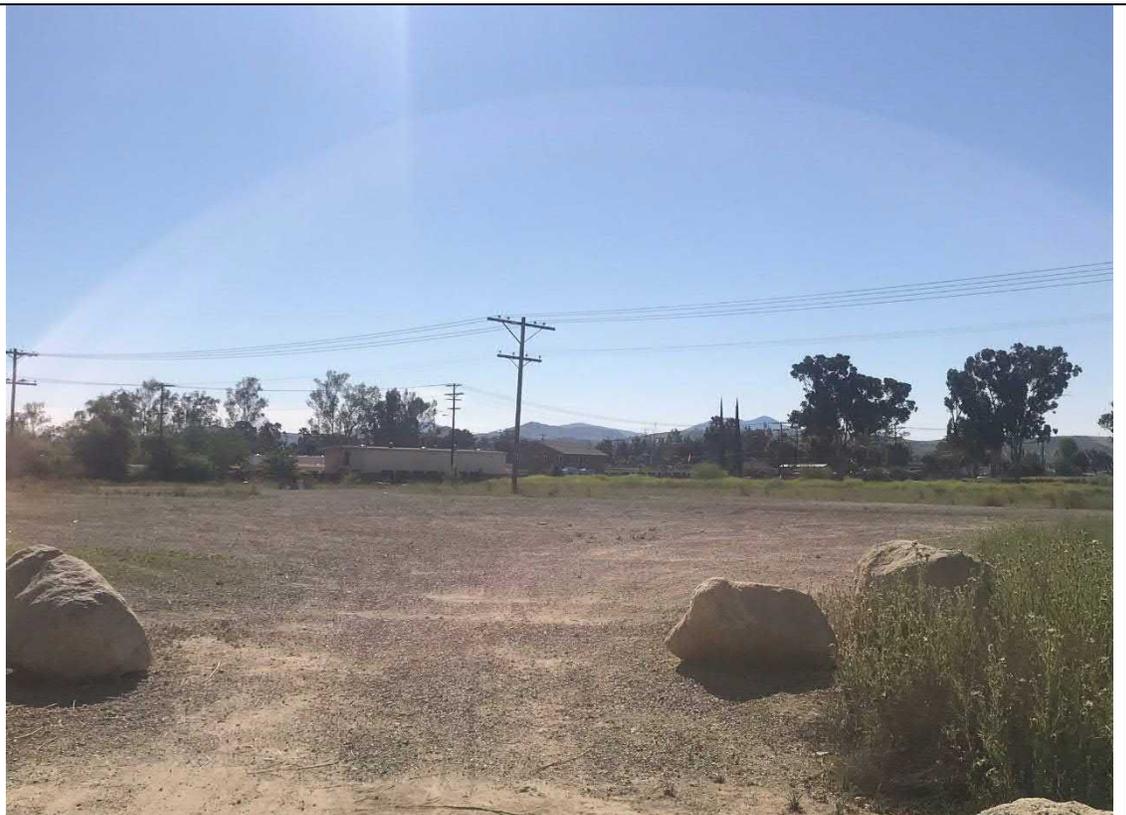
<b>Photo No.</b> <b>11</b>	<b>Date:</b> 05/08/20	
<b>Direction Photo Taken:</b>  Northeast		
<b>Description:</b>  View northeast of the vacant parcel APN 281-182-17. Concrete and rock debris pile on right side of photograph is in the central portion of the adjacent vacant lot (APN 281-182-18).

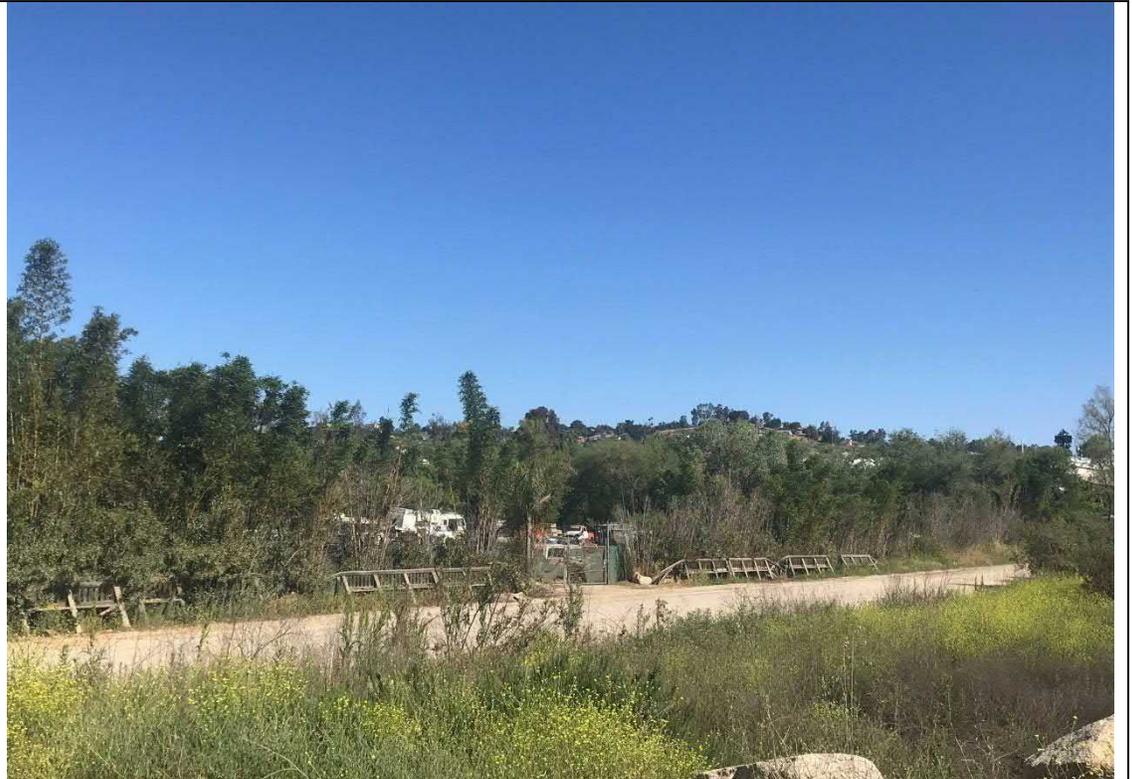
<b>Photo No.</b> <b>14</b>	<b>Date:</b> 05/08/20
<b>Direction Photo Taken:</b>  South	
<b>Description:</b>  View south of 13 <sup>th</sup> /Maple Street from near the Santa Maria Creek crossing.

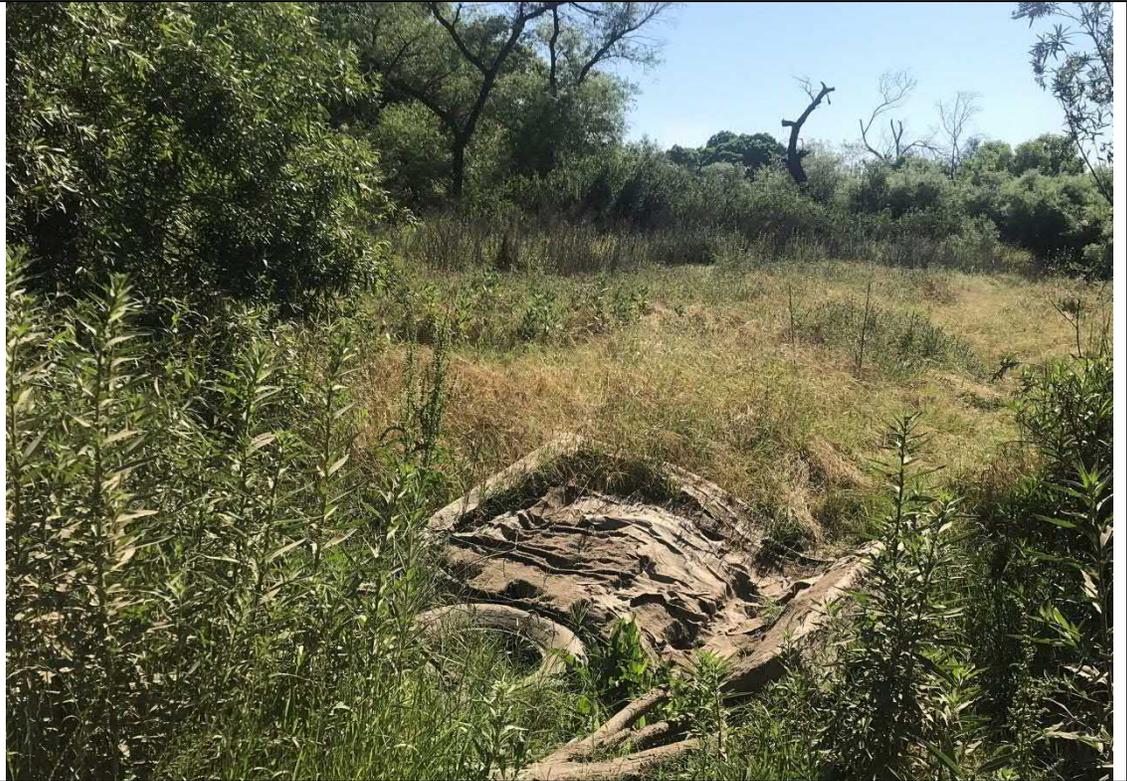
- Evidence of illegal dumping and disposal of trash was observed in various portions of the proposed project area (i.e., tires, furniture, etc.). No staining or other concerns (i.e., hazardous materials or wastes) were observed associated with these items, and the presence of such items does not represent a material threat to the environment. Therefore, AECOM considers this a DMC.

<b>Photo No.</b> <b>15</b>	<b>Date:</b> 05/08/20
<b>Direction Photo Taken:</b>  East	
<b>Description:</b>  Discarded mattress and tire on the eastern side of 13 <sup>th</sup> /Maple Streets, just south of Santa Maria Creek.

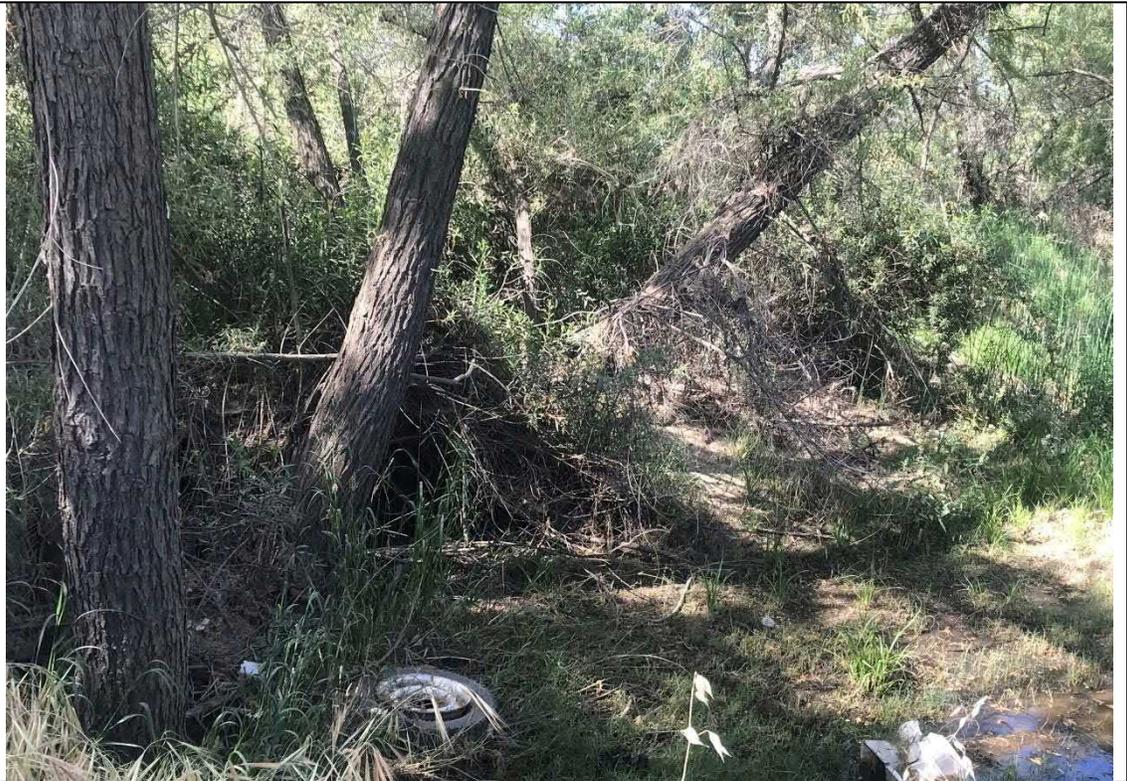
<b>Photo No.</b> <b>16</b>	<b>Date:</b> 05/08/20
<b>Direction Photo Taken:</b>  West	
<b>Description:</b>  Tires and trash adjacent to the south side of the creek on the west side of Maple Street.

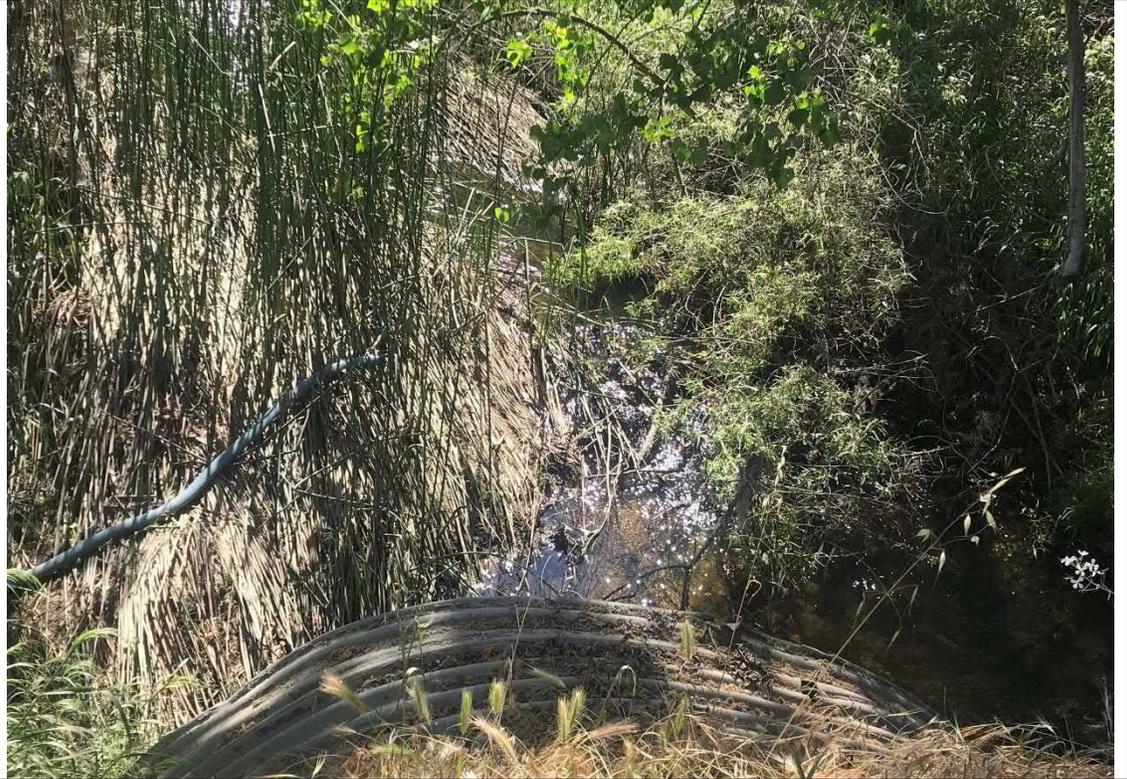
Flowing water through the existing culvert in Santa Maria Creek.

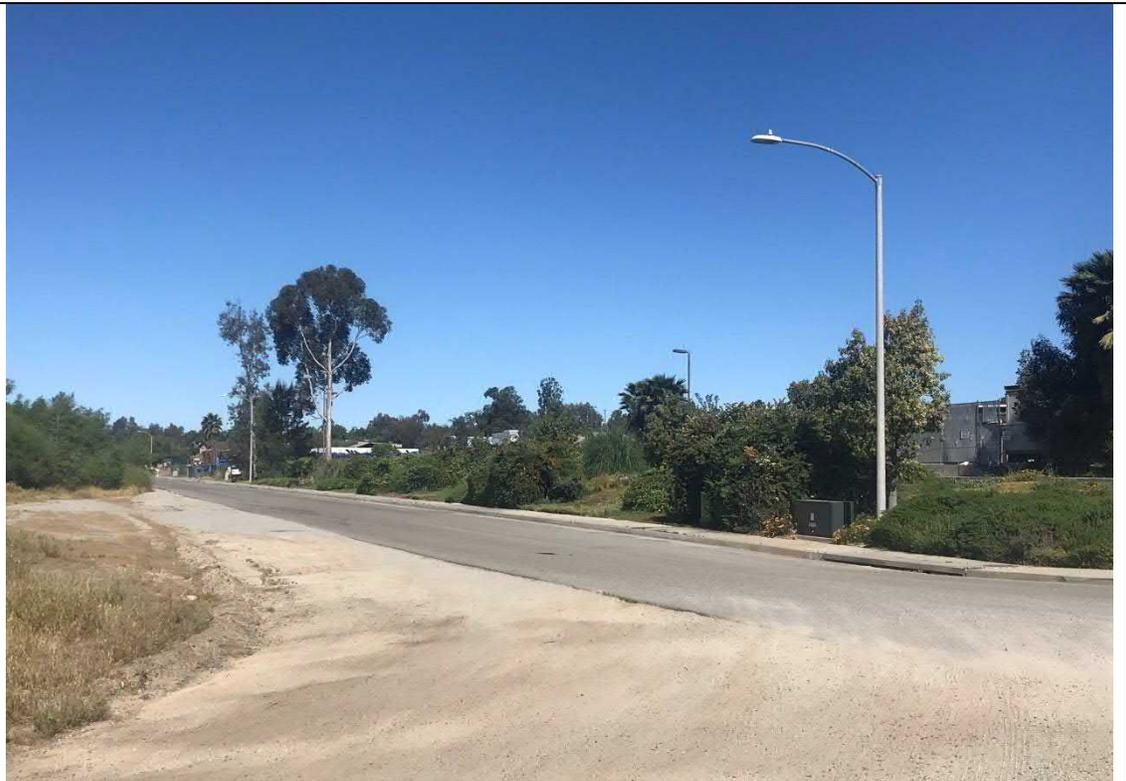
<b>Photo No.</b> <b>20</b>	<b>Date:</b> 05/08/20
<b>Direction Photo Taken:</b>  West	
<b>Description:</b>  View west from the far eastern end of Walnut Street.

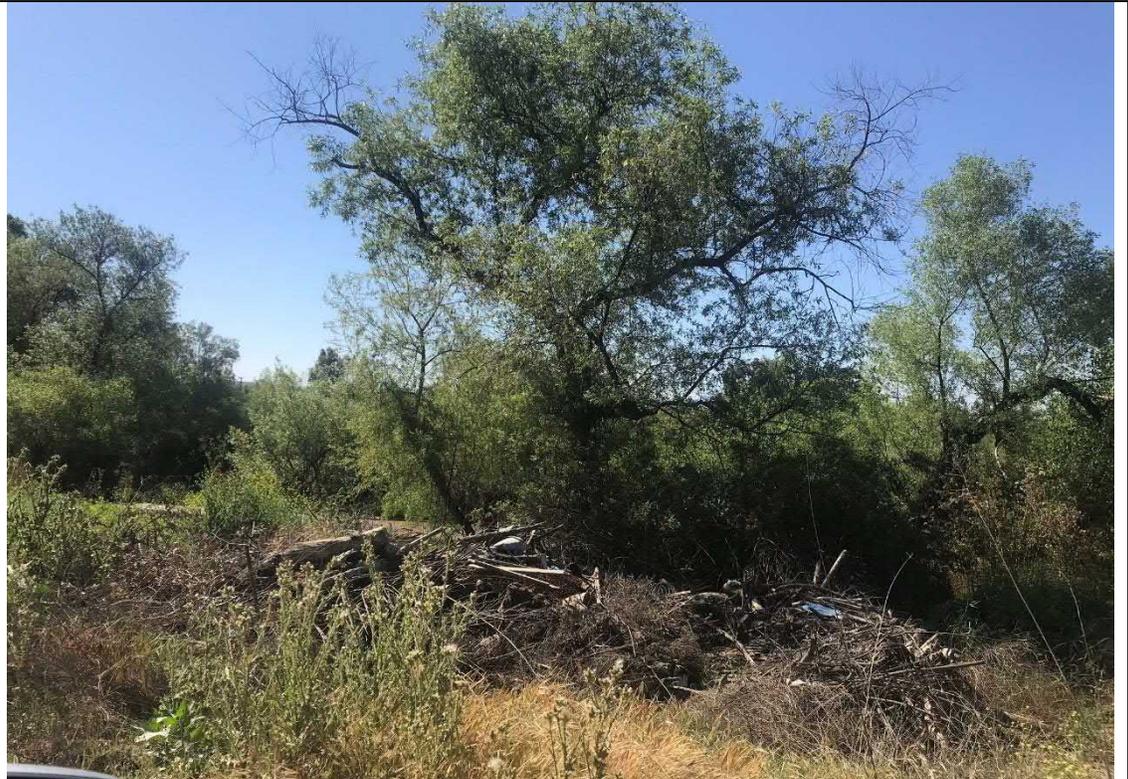
Brush and wood debris pile on the southeastern side of Walnut Street.

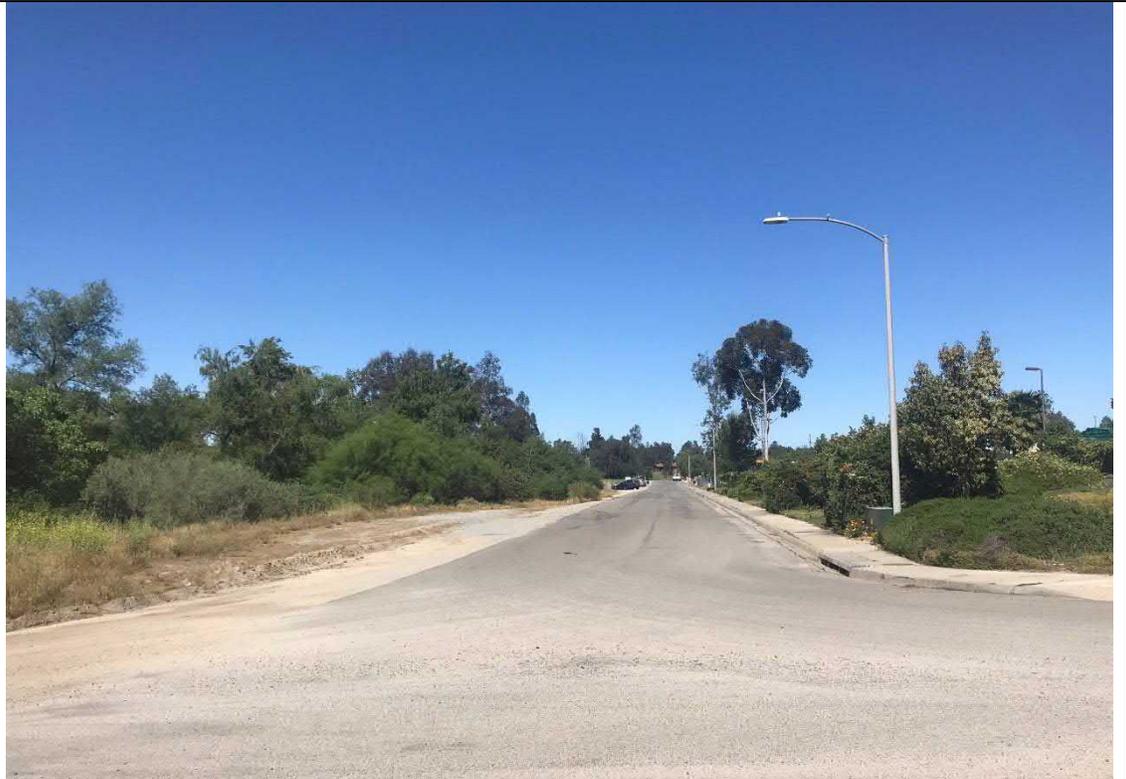
<b>Photo No.</b> <b>26</b>	<b>Date:</b> 05/08/20
<b>Direction Photo Taken:</b>  Northeast	
<b>Description:</b>  View northeast of the western end of Walnut Street. The recycling facility is visible on the left side of the photograph.

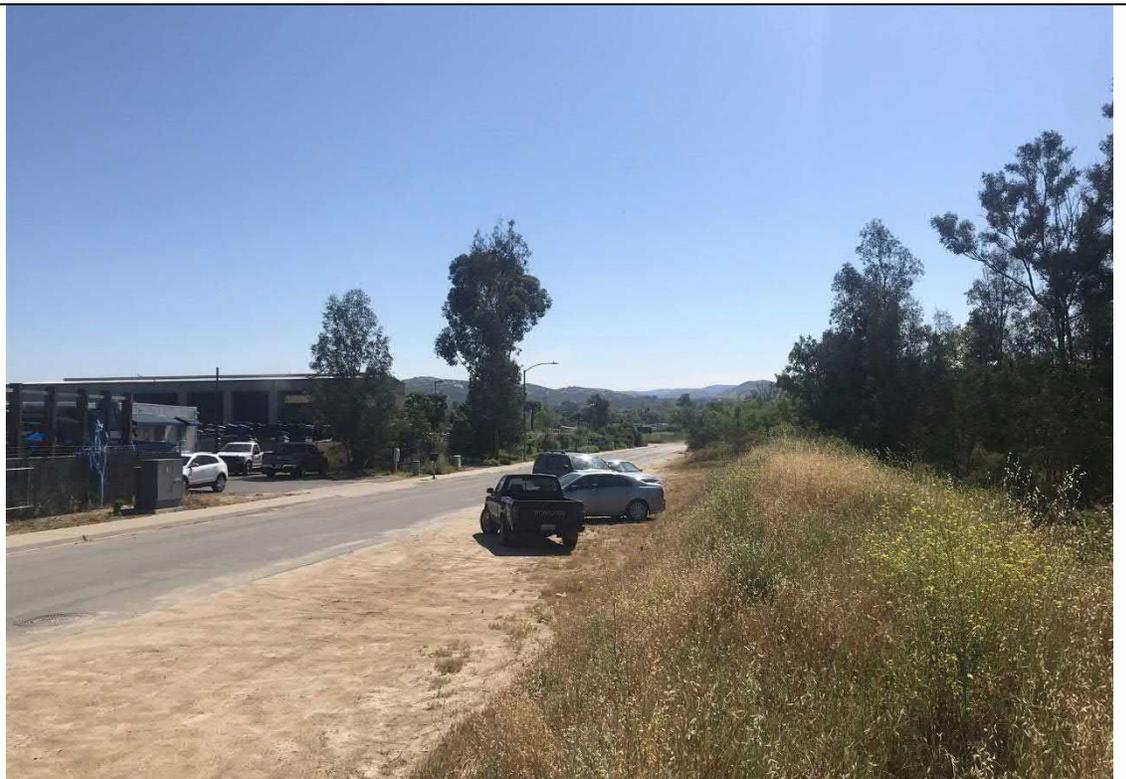
<b>Photo No.</b> <b>27</b>	<b>Date:</b> 05/08/20
<b>Direction Photo Taken:</b>  West	
<b>Description:</b>  View west of the western side of Walnut Street, near the intersection with Maple Street. Existing stormwater culvert visible on left side of photograph.

An existing corrugated steel culvert directs stormwater flow beneath 13<sup>th</sup> Street; however, this drainage system does not have the sufficient capacity to convey the volume of water that collects in this area during storm events. Flooding at this crossing makes the roadway impassable for motor vehicles and pedestrians during portions of the rainy season. As discussed in Section 2.3, the County plans to replace the existing culvert crossing with a bridge, channel improvements, and roadway improvements, and plans to add multiple storm drain systems that will ultimately discharge into Santa Maria Creek. Additionally, the bioretention basin on the eastern side of the County-owned property in the southeastern corner of the proposed project area will be redesigned and regraded as part of the roadway and drainage improvements planned in this area.

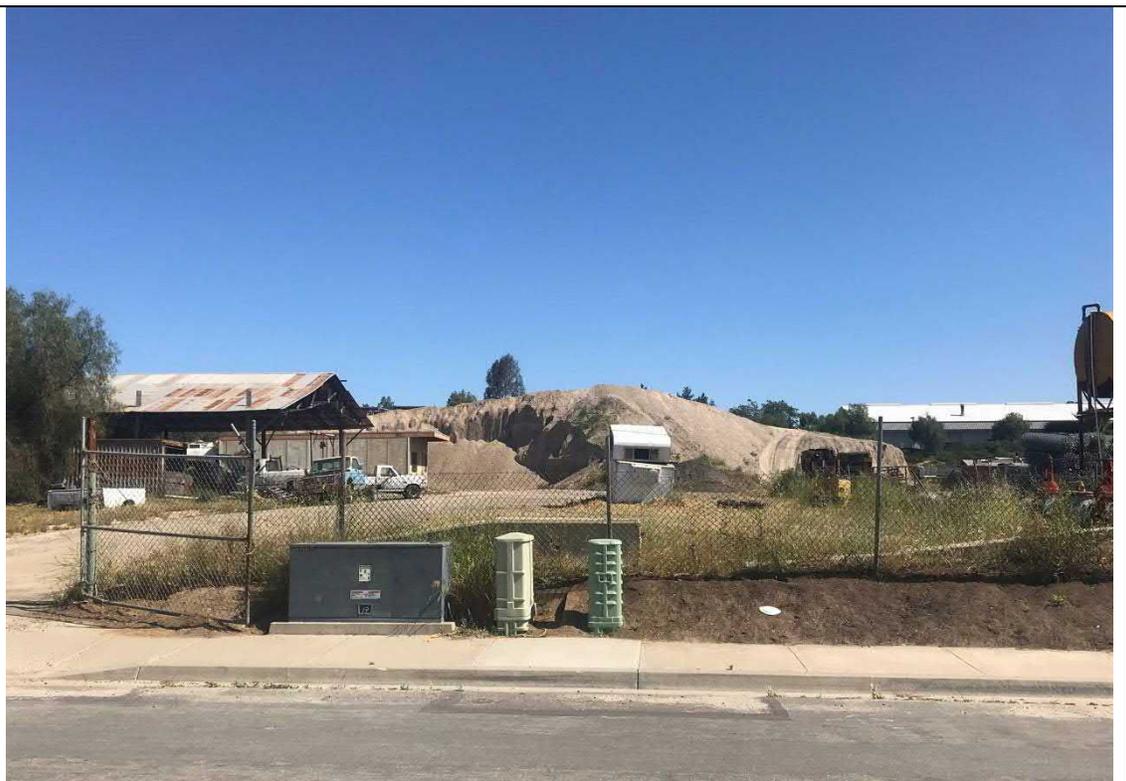
<b>Photo No.</b> <b>28</b>	<b>Date:</b> 05/08/20
<b>Direction Photo Taken:</b>  North	
<b>Description:</b>  View north of the western end of the recycling facility on Walnut Street. Transformer visible at entrance to facility at this end.

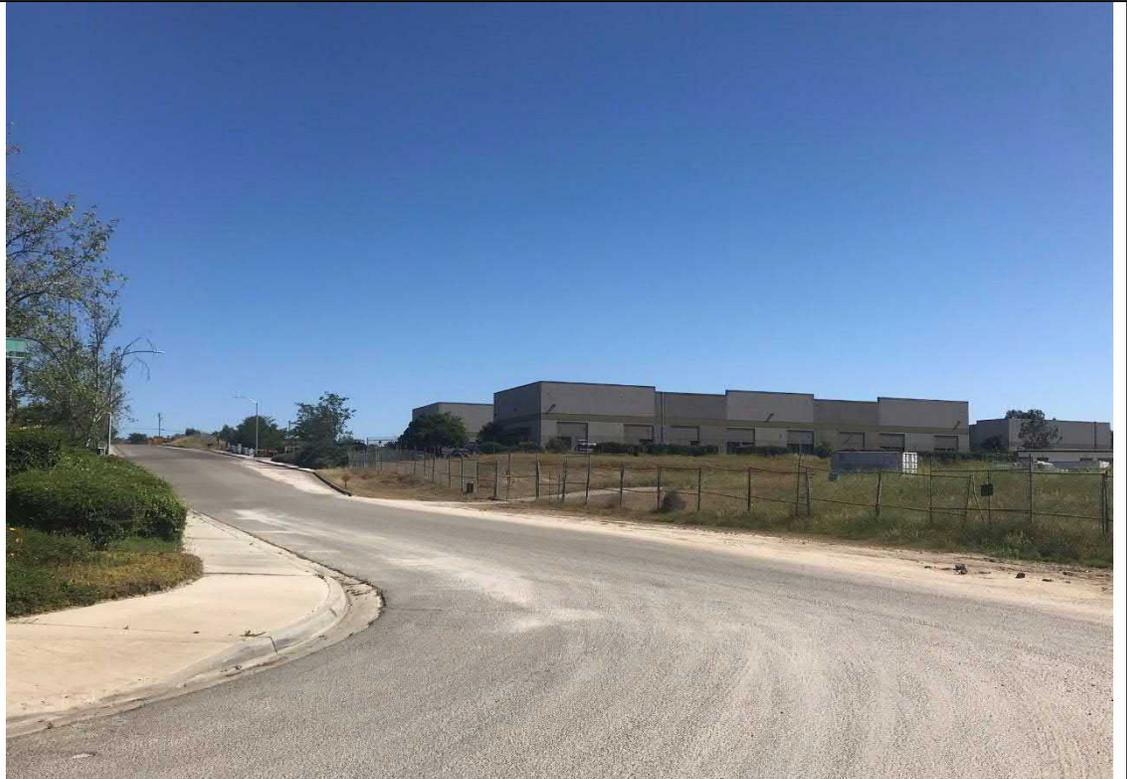
<b>Photo No.</b> <b>30</b>	<b>Date:</b> 05/08/20
<b>Direction Photo Taken:</b>  North	
<b>Description:</b>  View north of the northern end of Maple Street, just north of the intersection with Walnut Street.

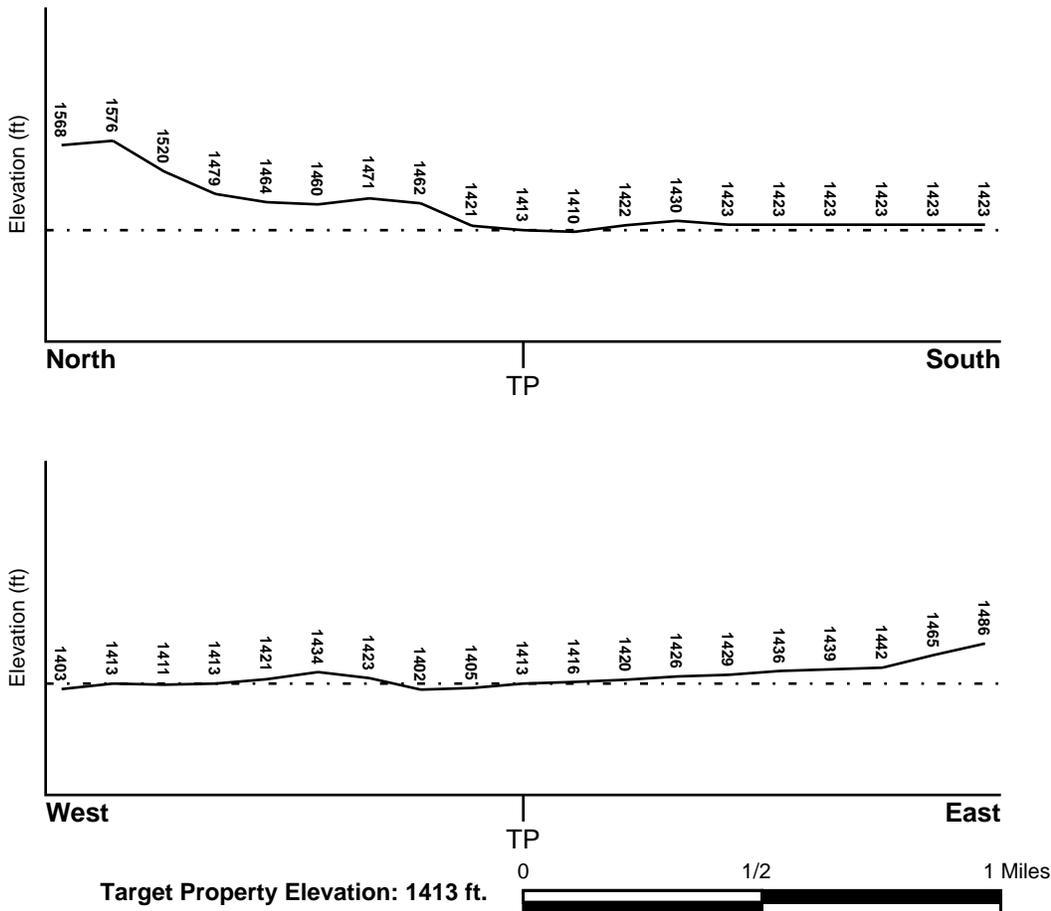
Source: Topography has been determined from the USGS 7.5' Digital Elevation Model and should be evaluated on a relative (not an absolute) basis. Relative elevation information between sites of close proximity should be field verified.

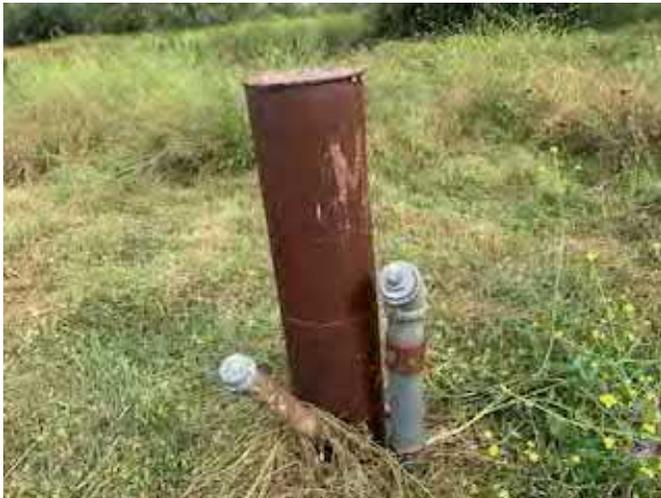
7. Possible former wellhead at the central eastern area of the Site.

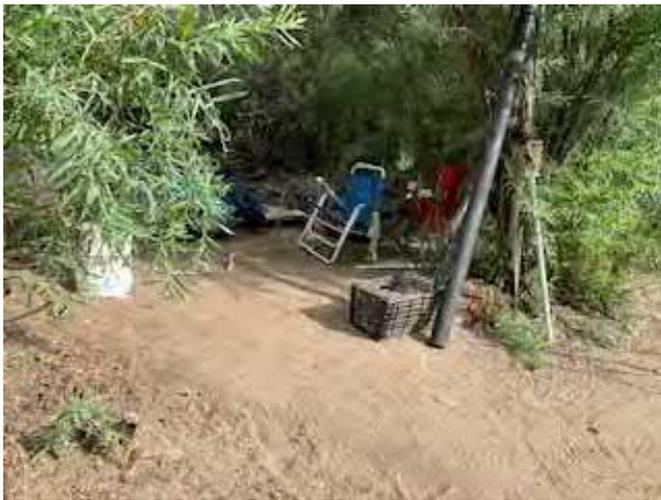
9. Household debris in the northern portion of the Site.

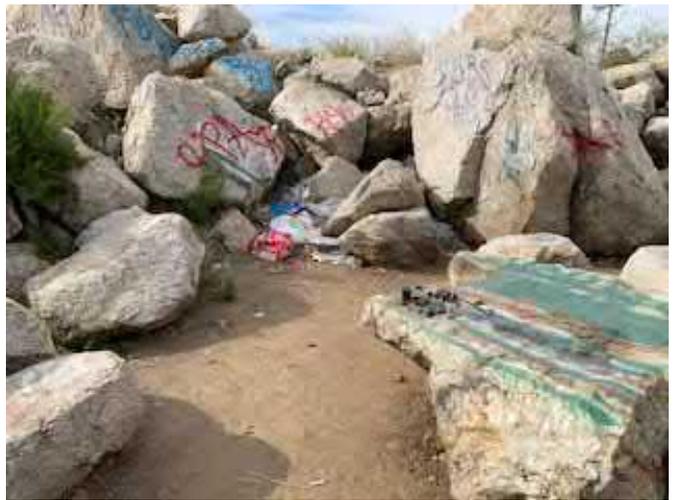
10. Household debris in the northern portion of the Site.

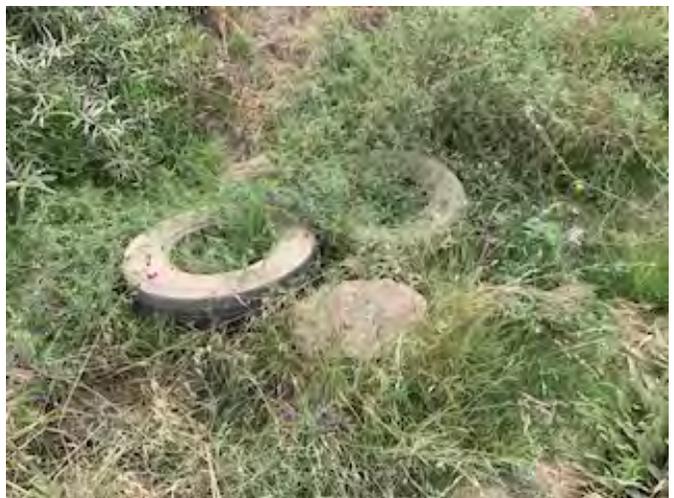
12. Debris on Site.

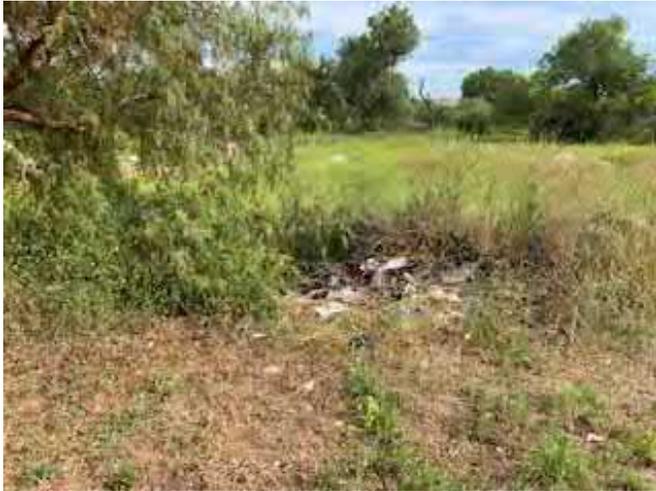
13. Debris on Site.
