Initial Site Assessment for  
13<sup>th</sup> Street Bridge Project  
13<sup>th</sup> and Walnut Streets, Ramona,  
Unincorporated County of  
San Diego, California

Prepared for:  
County of San Diego Department of Public Works

Project Number: 60562978

May 2020

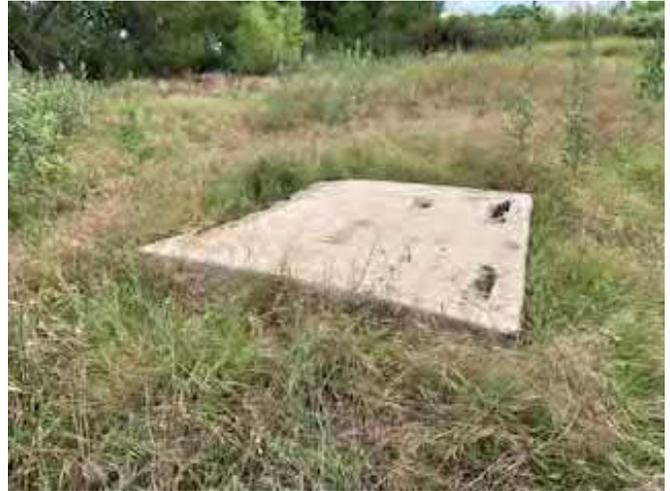
14. Debris on Site.

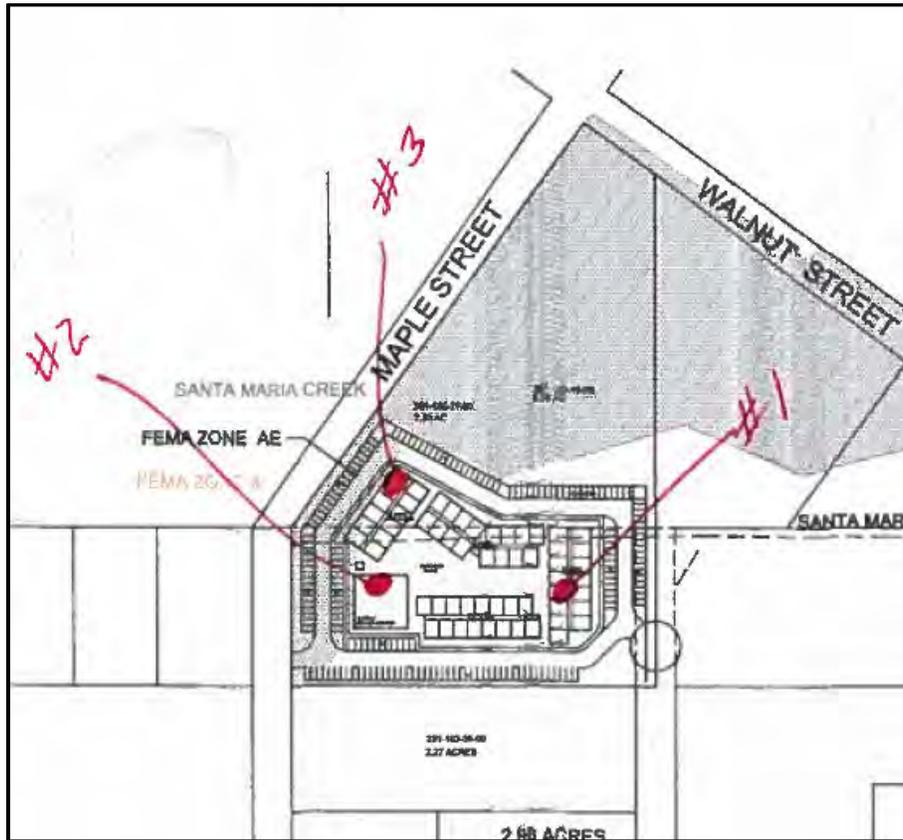
**Figure 2-2. Preliminary Site Layout**

(Source: Hedencamp Architecture & Planning, 2019, Ramona Senior Center with Low Income Senior Housing dated March 28, 2019)

The preliminary site layout provided to NOVA by Chelsea, indicates that portions of both parcels are proposed to be developed, with the majority of structures and improvements constructed on the southern half of the site, which is where NOVA focused the subsurface investigation. The preliminary site layout is shown in Figure 2.2.

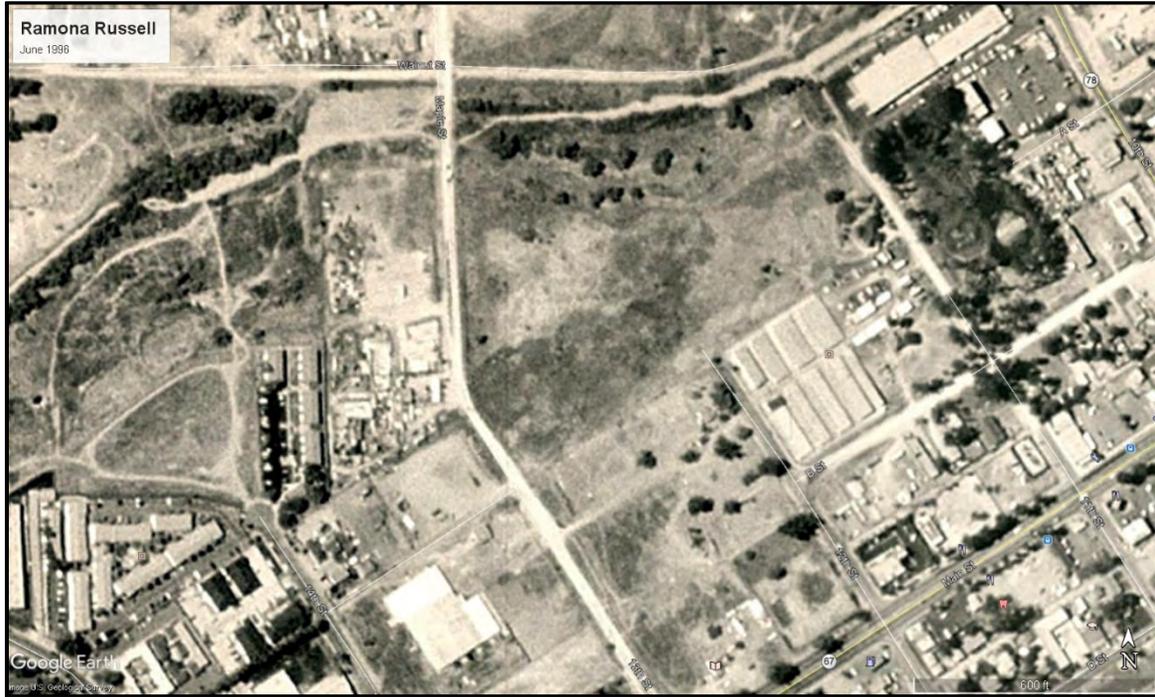
**Figure 2-3. 1996 Historical Photo of the Site**  
(Source: Historicaerials.com)

Some grading was done on the parcels starting between 1996 and 2002. Graded pads are visible in the southern portion of the property. In 2003, it appears the site was used for oversized rock storage. Piles of rock appear along the southwestern boundary, as well as an area in the center of the site. Aerial photographs dated March 2008 show the site was regraded and used for rock crushing operations at that time (Google Earth).

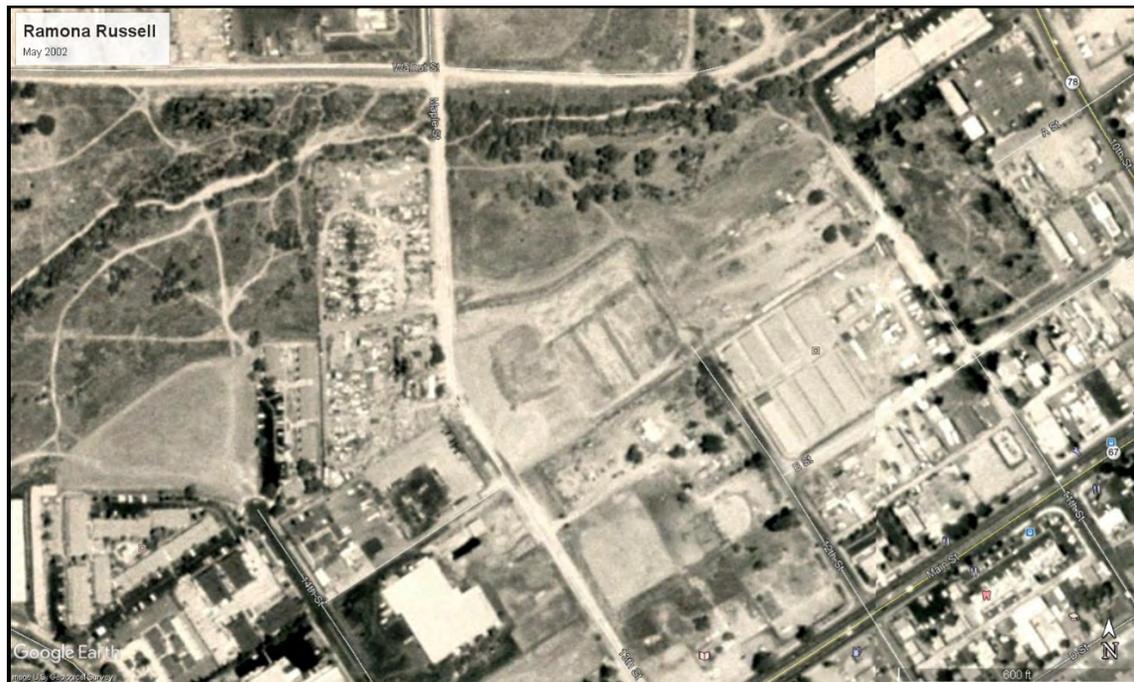
**Figure 2-4. 2002 Historical Photo of the Site**  
(Source: Historicaerials.com)

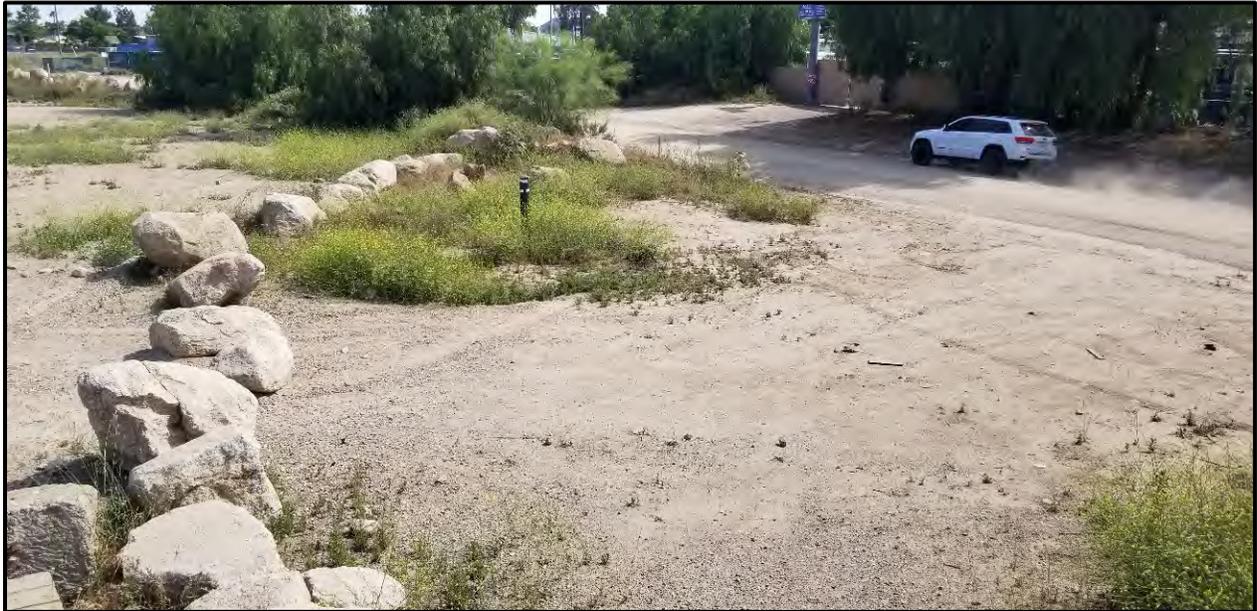
**Figure 2-6. Oversized Material Along Western Boundary Along 13<sup>th</sup> Street (Looking South).**

Oversized rock from 2003 is still present. It appears to have been pushed along the western edge of the property, and is still present in the central eastern portion as well. This oversized rock appears to be derived of the local tonalite and granodiorite formations, composing the majority of the bedrock in the Ramona area.

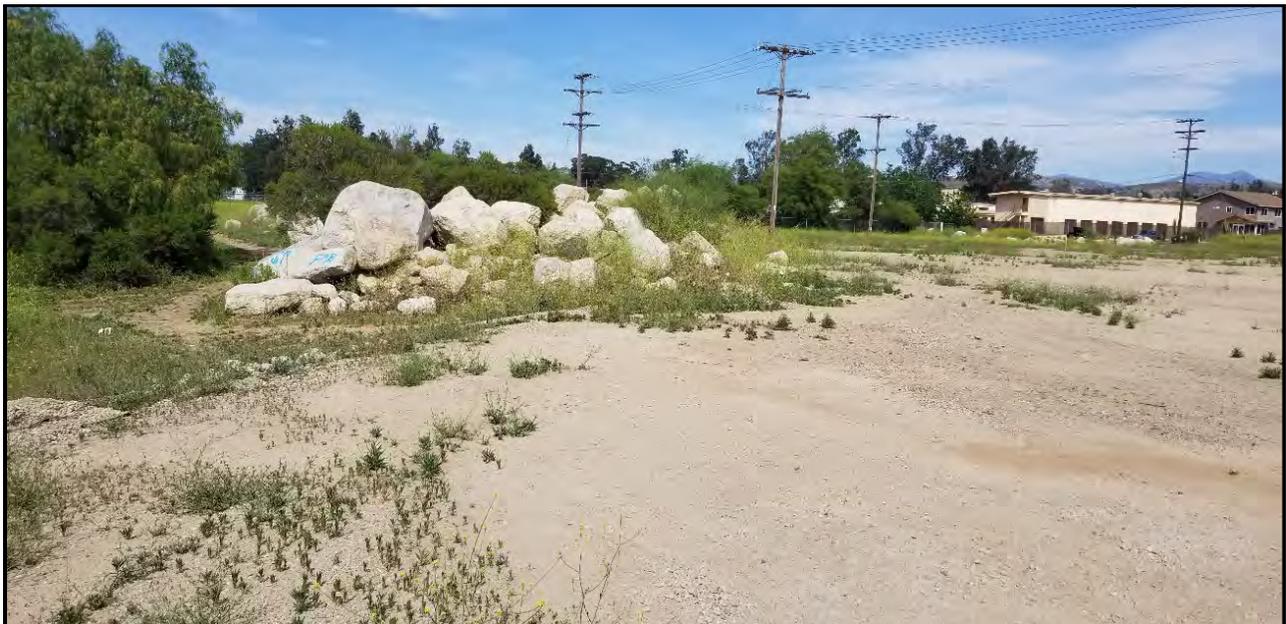
**Figure 2-7. Looking Northeast from Center of Site at Oversized Material Along Central Eastern Portion of Site.**

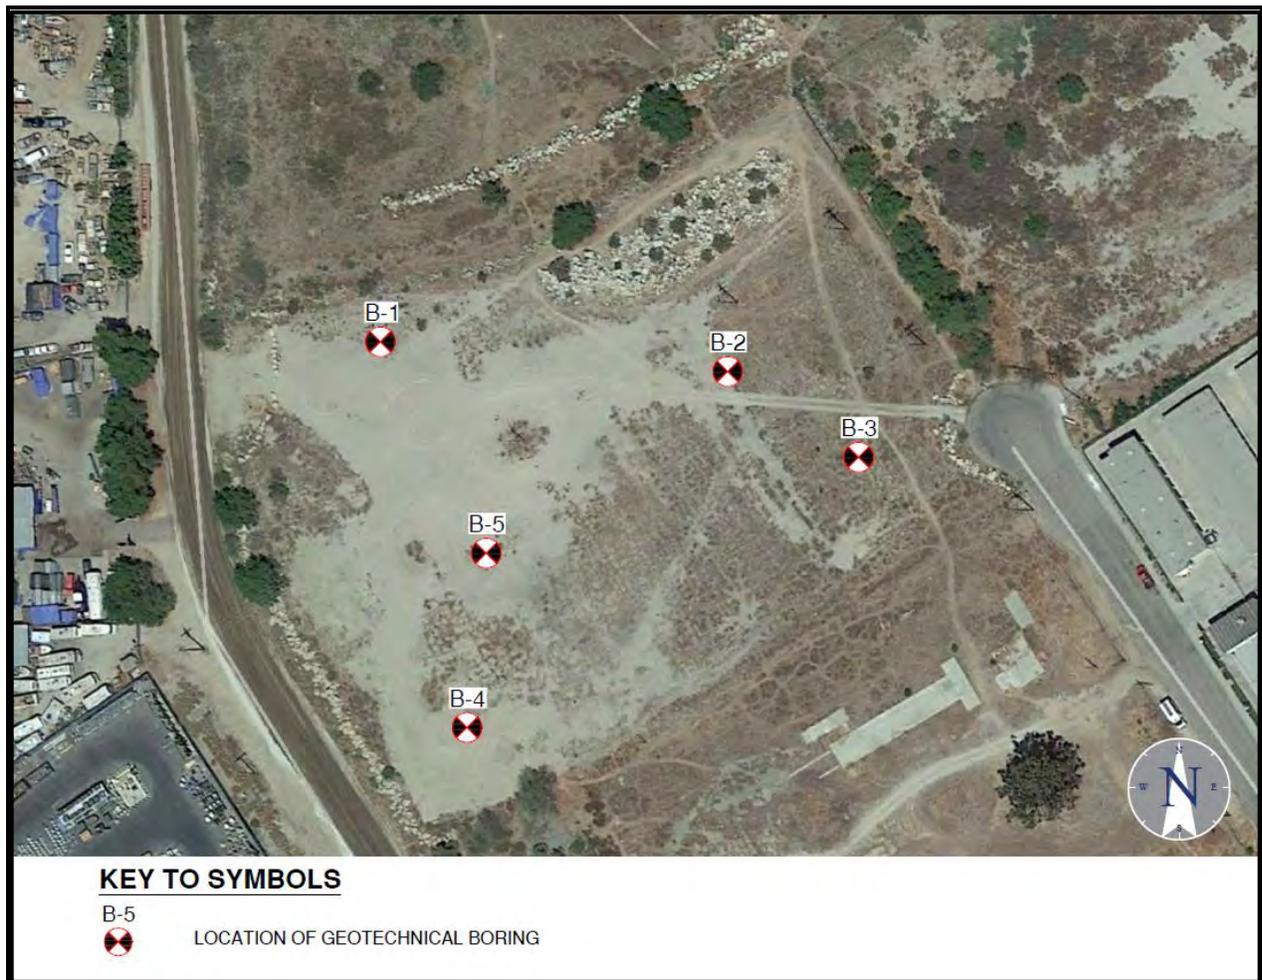
**Figure 3-1. Locations of Geotechnical Borings B-1 through B-5**

A subsurface exploration was completed by NOVA on June 6, 2019. The subsurface exploration included five (5) geotechnical borings (referenced as ‘B-1’ to ‘B-5’). Figure 3-1 indicate the location of the geotechnical borings. The geotechnical borings were completed by a specialty subcontractor retained by NOVA. All work was completed under the continuous supervision of a NOVA geologist.

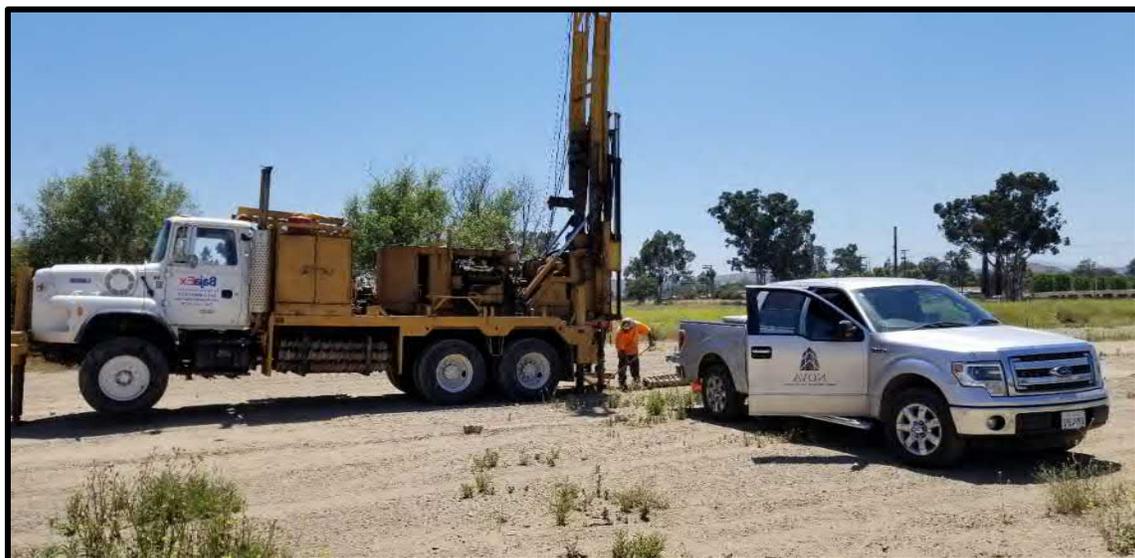
**Figure 3-2. Drilling Operations, June 6, 2019**

Upon completion of drilling and logging, borings were backfilled with cuttings. Logs of the borings are provided in Appendix B.

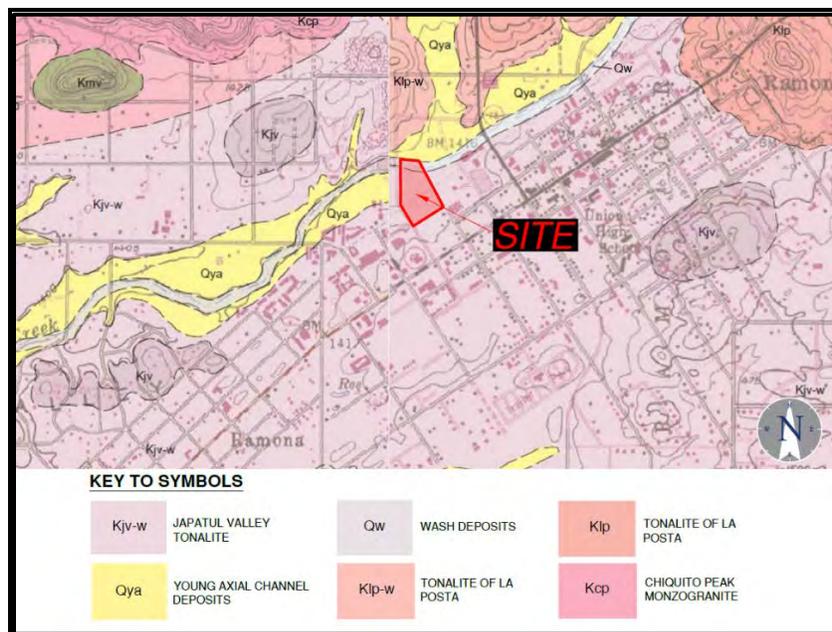
## Figure 4-1. Regional Geologic Map

The geologic units encountered during the site investigation include undocumented artificial fill (map symbol Afu), Quaternary alluvium (Qal), and Japatul Valley Tonalite bedrock (Kjv-w). Figure 4-1 presents the geologic map of the near-surface the geology of the site area (Hernandez et al, 2007 and Todd et al, 2006).

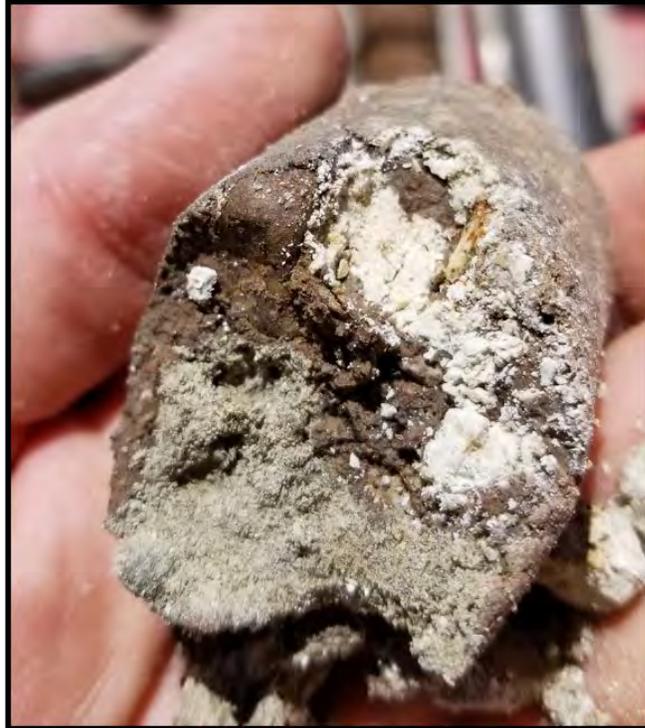
**Figure 4-2. Undocumented Artificial Fill- Silty to Clayey Sand.**

For the purposes of this report, the subsurface may be generalized to occur as the sequence of soil and rock described below. Figures 4-2 through 4-4 (following page) depicts these units.

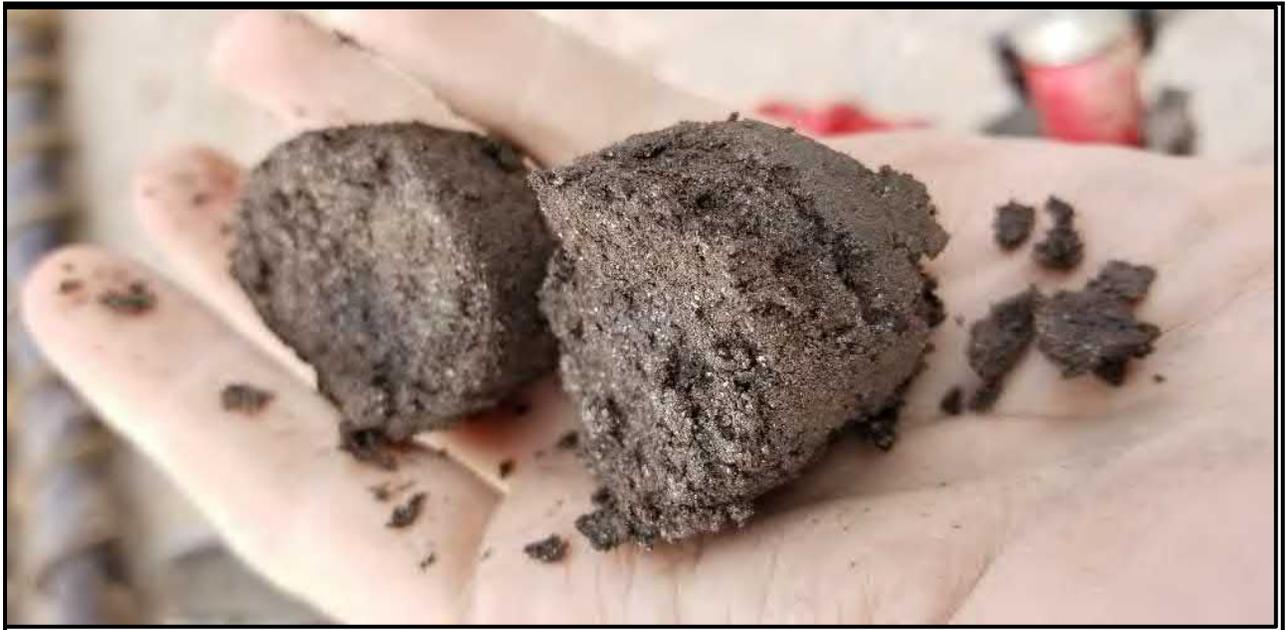
**Figure 4-3. Quaternary Alluvium- Silty Sand.**

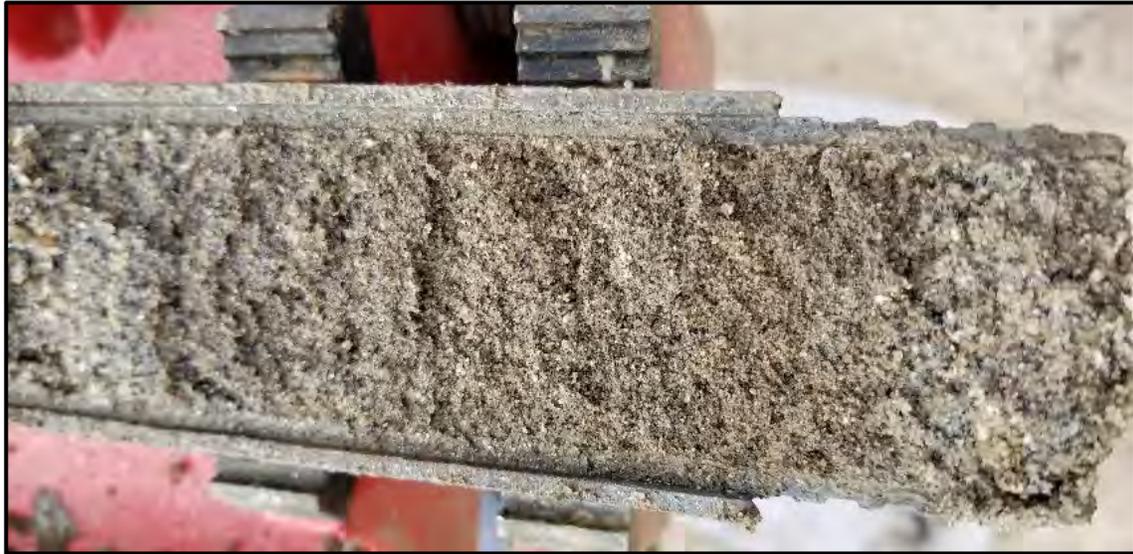
**Figure 4-4. Tonalite Bedrock Increasing in Depth and Decreasing in Weathering (from Left to Right).**

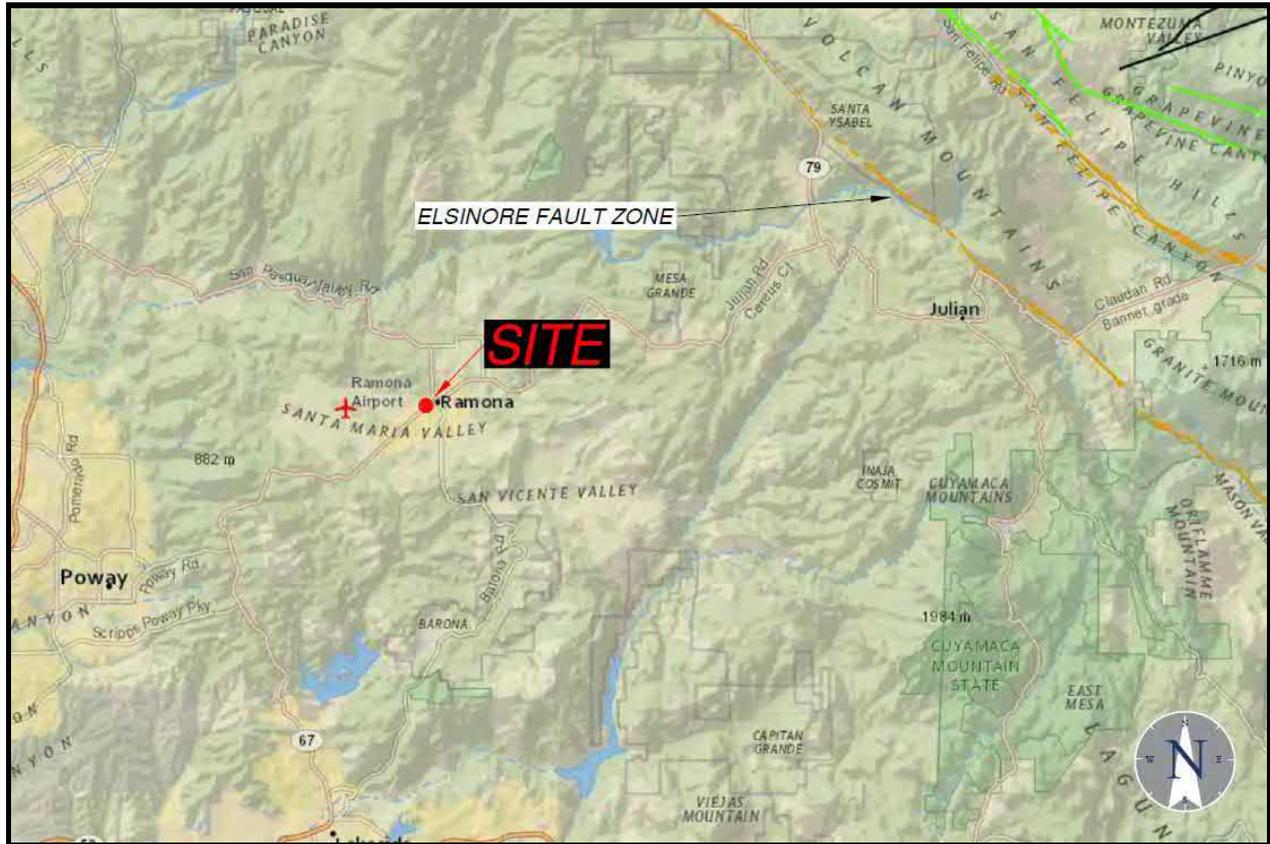
**Figure 5-1. Regional Fault Location Map**

Figure 5-1 (following page) maps faulting in the site area.

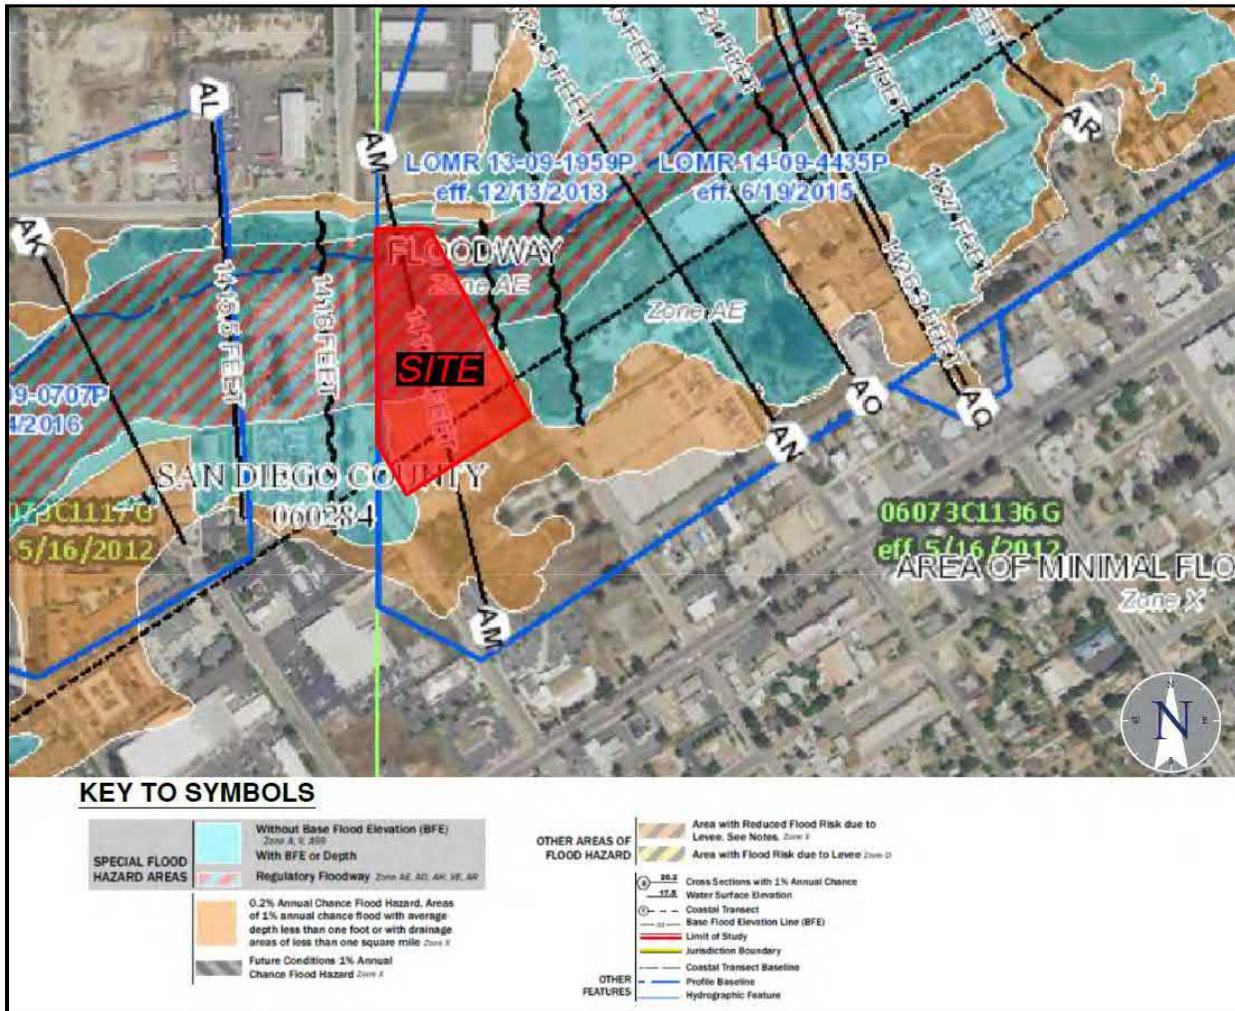
**Figure 5-2. Flood Hazard Mapping of the Site Area**  
 (source: adapted from FIRM Panel 06073C1136G, effective 5/16/2012)

Figure 5-2 reproduces flood mapping by FEMA of the site area.

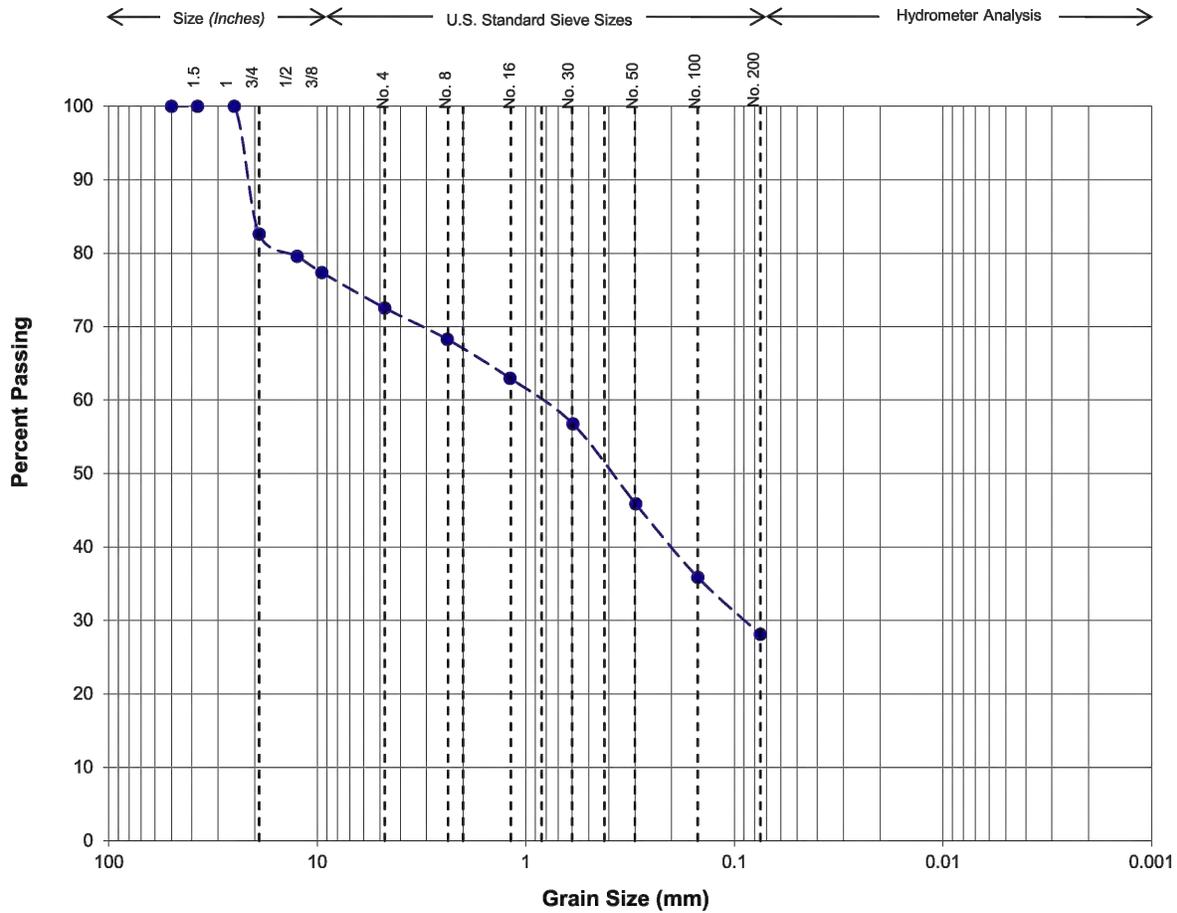
APPENDIX: C.1

Gravel		Sand			Silt or Clay
Coarse	Fine	Coarse	Medium	Fine

Sample Location: B-1  
 Depth (ft): 1.5'  
 USCS Soil Type: SC  
 Passing No. 200 (%): 28

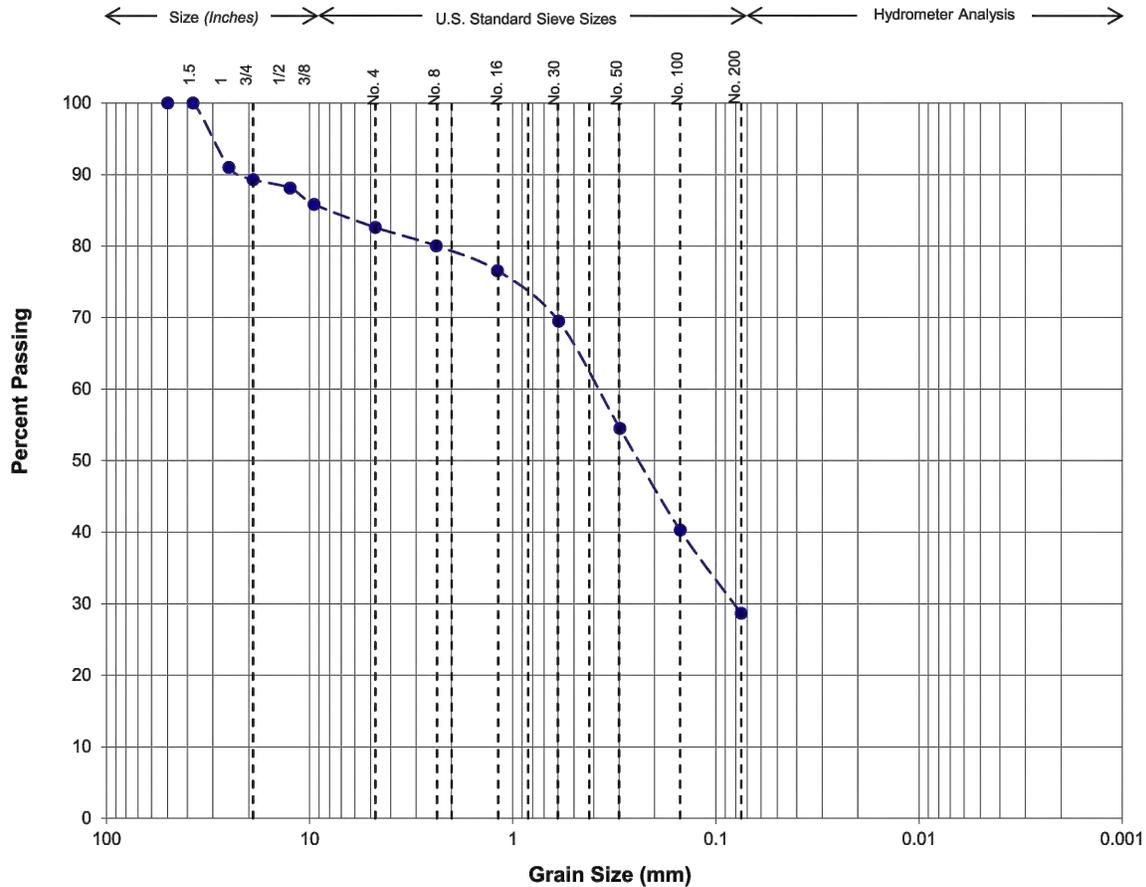
APPENDIX: C.3

Gravel		Sand			Silt or Clay
Coarse	Fine	Coarse	Medium	Fine

Sample Location: B-1  
 Depth (ft): 5.0'  
 USCS Soil Type: SM  
 Passing No. 200 (%): 29

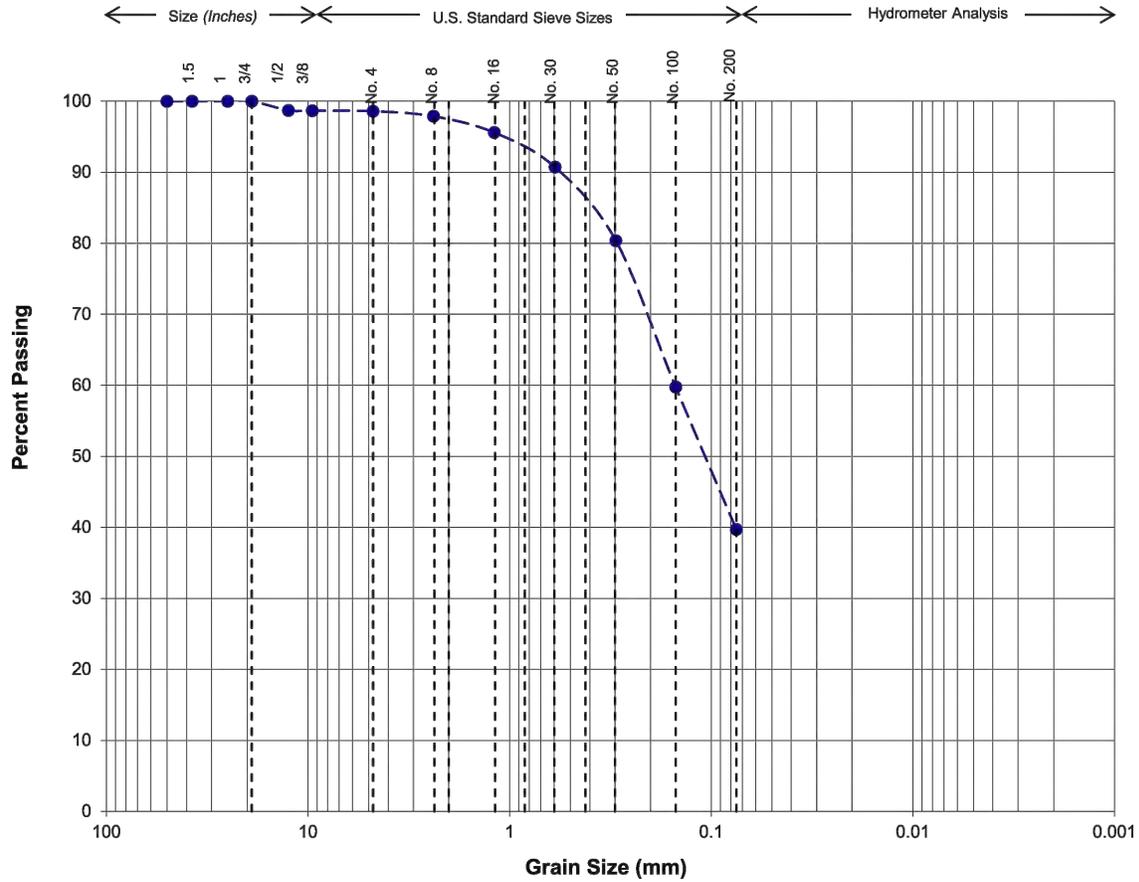
APPENDIX: C.4

Gravel		Sand			Silt or Clay
Coarse	Fine	Coarse	Medium	Fine

Sample Location: B-1  
 Depth (ft): 10.0'  
 USCS Soil Type: SM  
 Passing No. 200 (%): 40

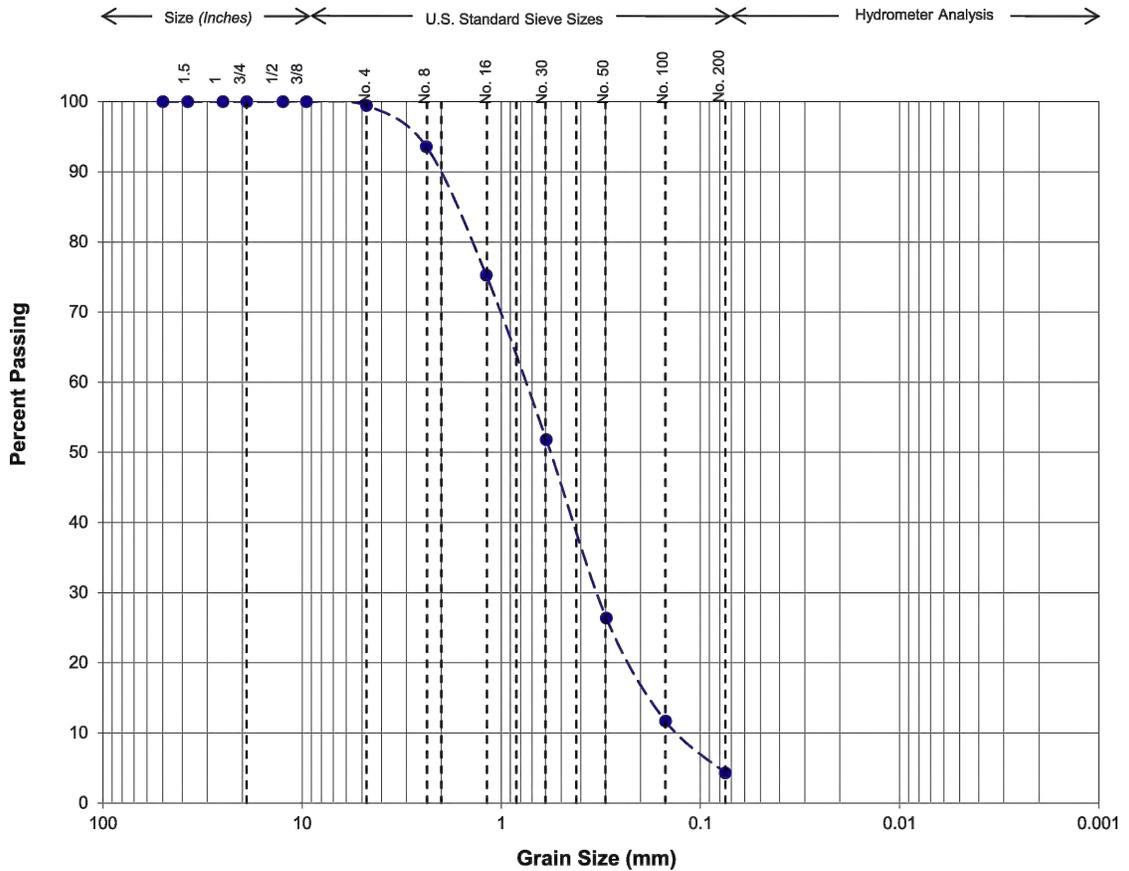
APPENDIX: C.5

Gravel		Sand			Silt or Clay
Coarse	Fine	Coarse	Medium	Fine

Sample Location: B-1  
 Depth (ft): 20.0'  
 USCS Soil Type: SP  
 Passing No. 200 (%): 4

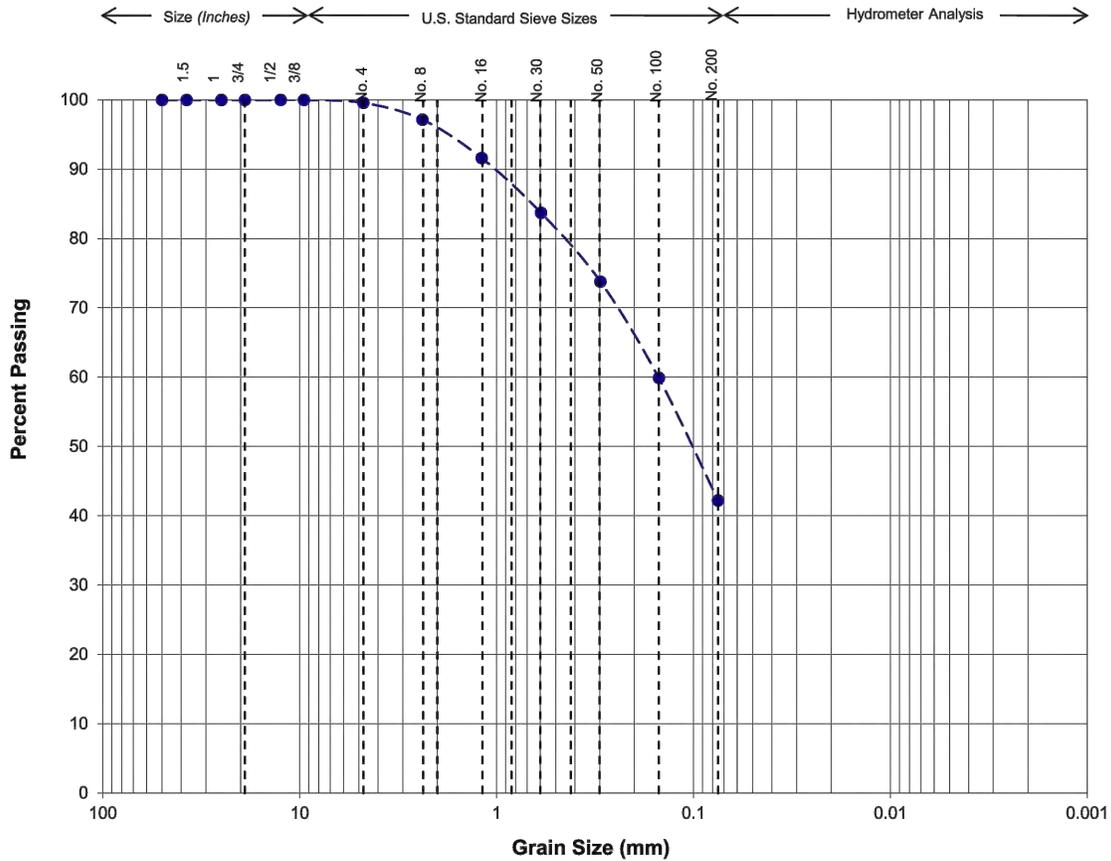
BY: HP	DATE: JUNE 2019	PROJECT: 2019130	APPENDIX: C.6
--------	-----------------	------------------	---------------

Gravel		Sand			Silt or Clay
Coarse	Fine	Coarse	Medium	Fine

Sample Location: B-2  
 Depth (ft): 15.0'  
 USCS Soil Type: SC  
 Passing No. 200 (%): 42

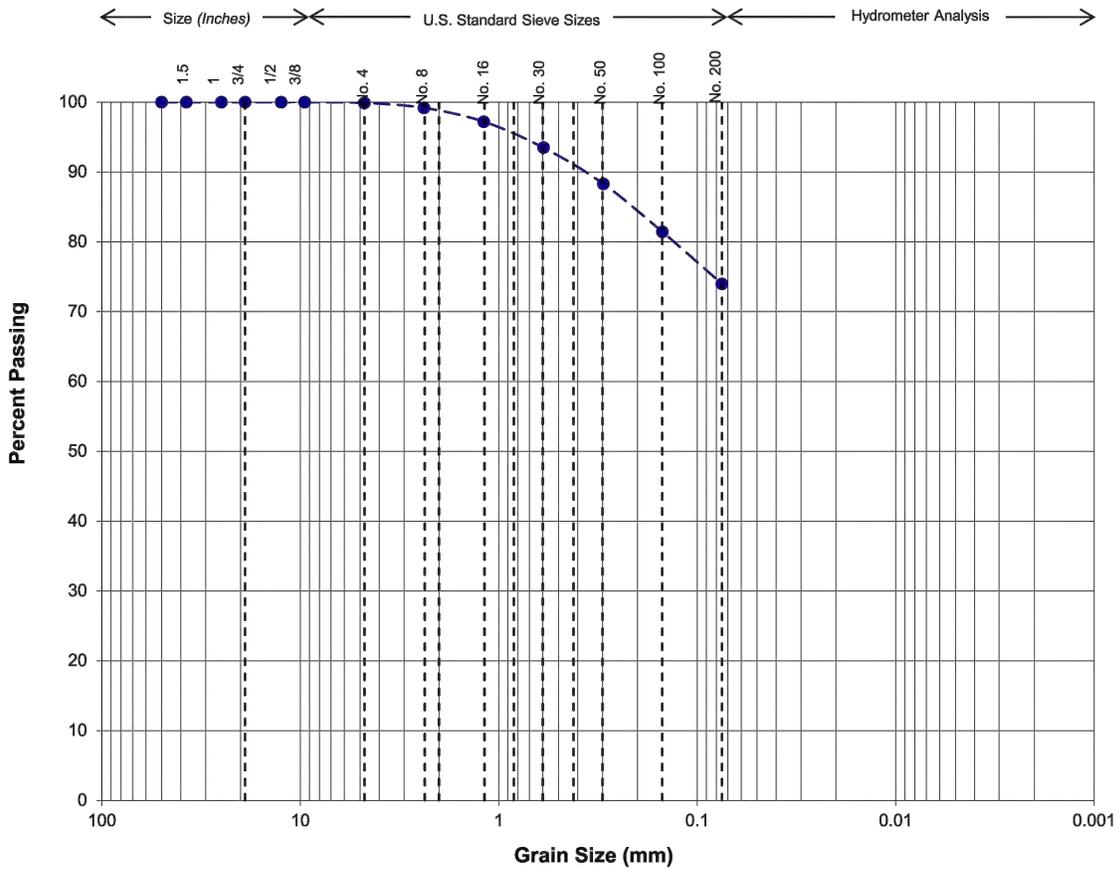
APPENDIX: C.7

Gravel		Sand			Silt or Clay
Coarse	Fine	Coarse	Medium	Fine

Sample Location: B-4  
 Depth (ft): 7.5'  
 USCS Soil Type: CL  
 Passing No. 200 (%): 74

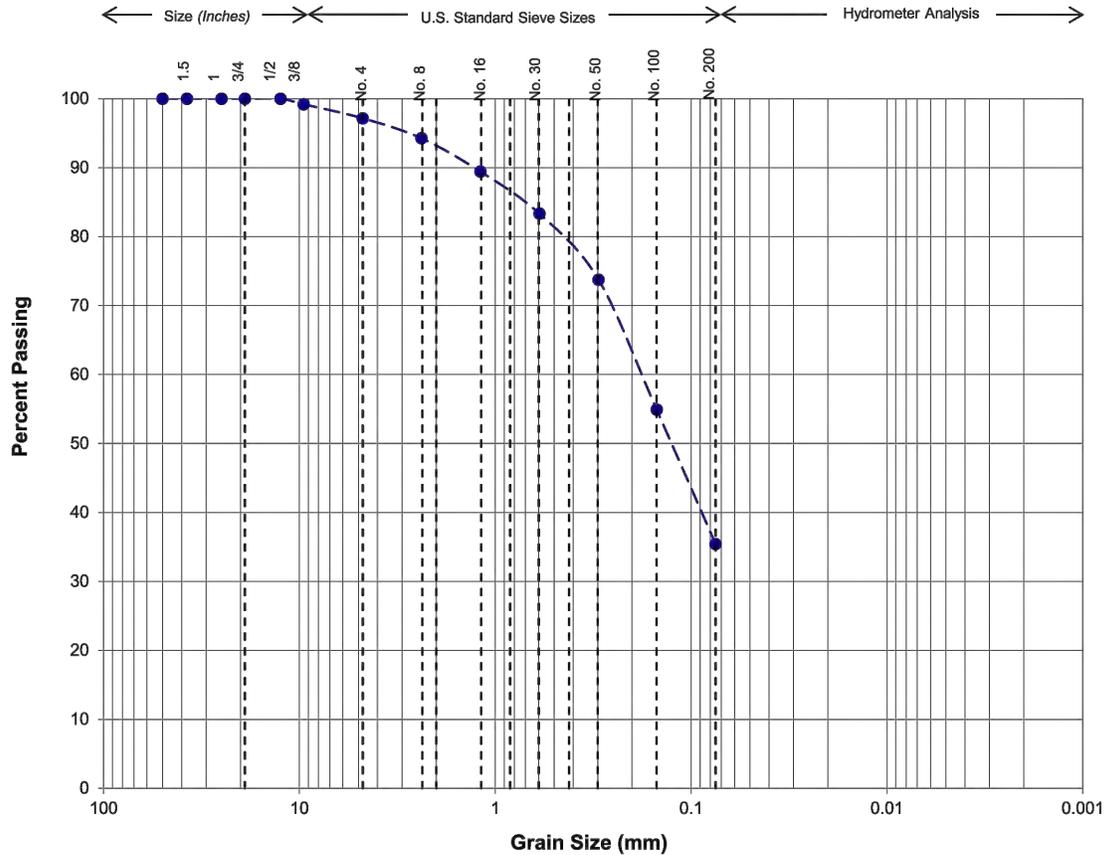
APPENDIX: C.8

Gravel		Sand			Silt or Clay
Coarse	Fine	Coarse	Medium	Fine

Sample Location: B-4  
 Depth (ft): 10.0'  
 USCS Soil Type: SC  
 Passing No. 200 (%): 35

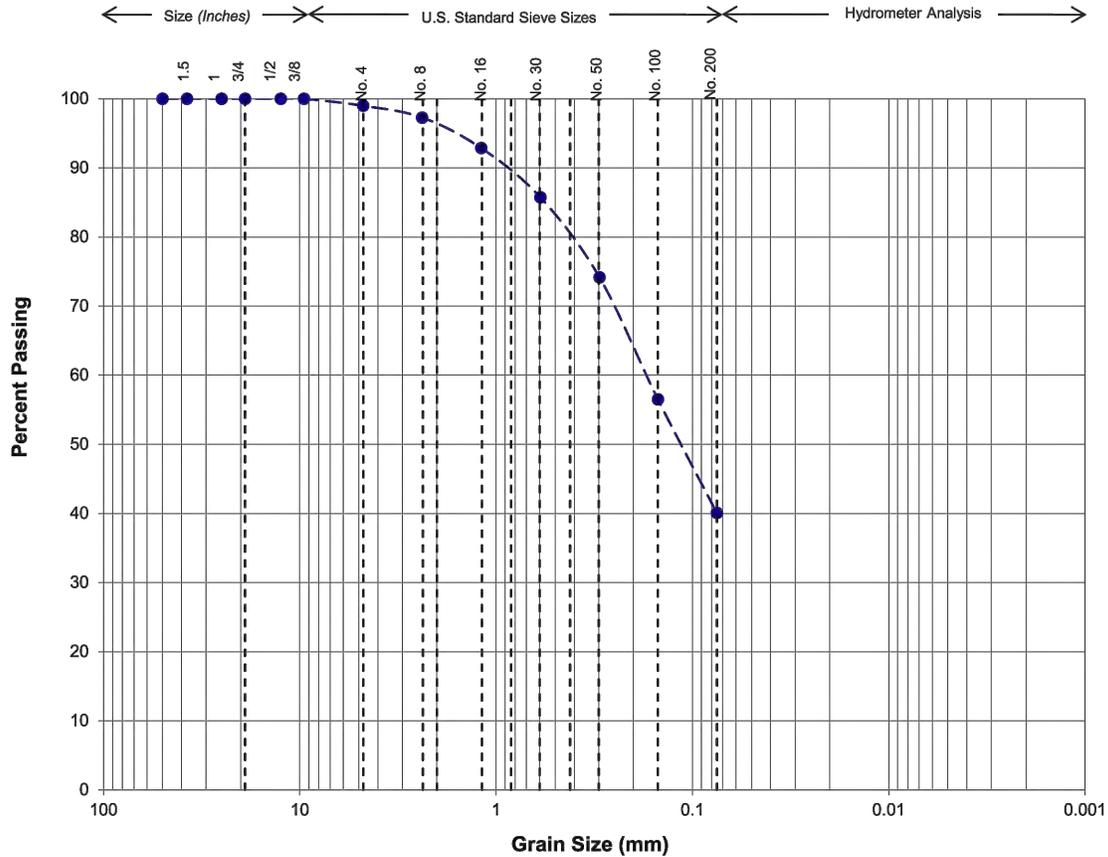
APPENDIX: C.9

Gravel		Sand			Silt or Clay
Coarse	Fine	Coarse	Medium	Fine

Sample Location: B-5  
 Depth (ft): 15.0'  
 USCS Soil Type: SC  
 Passing No. 200 (%): 40
