**GEOTECHNICAL INVESTIGATION REPORT
PROPOSED PACIFIC GAS & ELECTRIC COMPANY
DFM 0630-01 (R-1385) PIPELINE REPLACEMENT
SACRAMENTO RIVER CROSSING
MERIDIAN, CALIFORNIA**

December 1, 2020

December 1, 2020
Project No. 20201644.013A

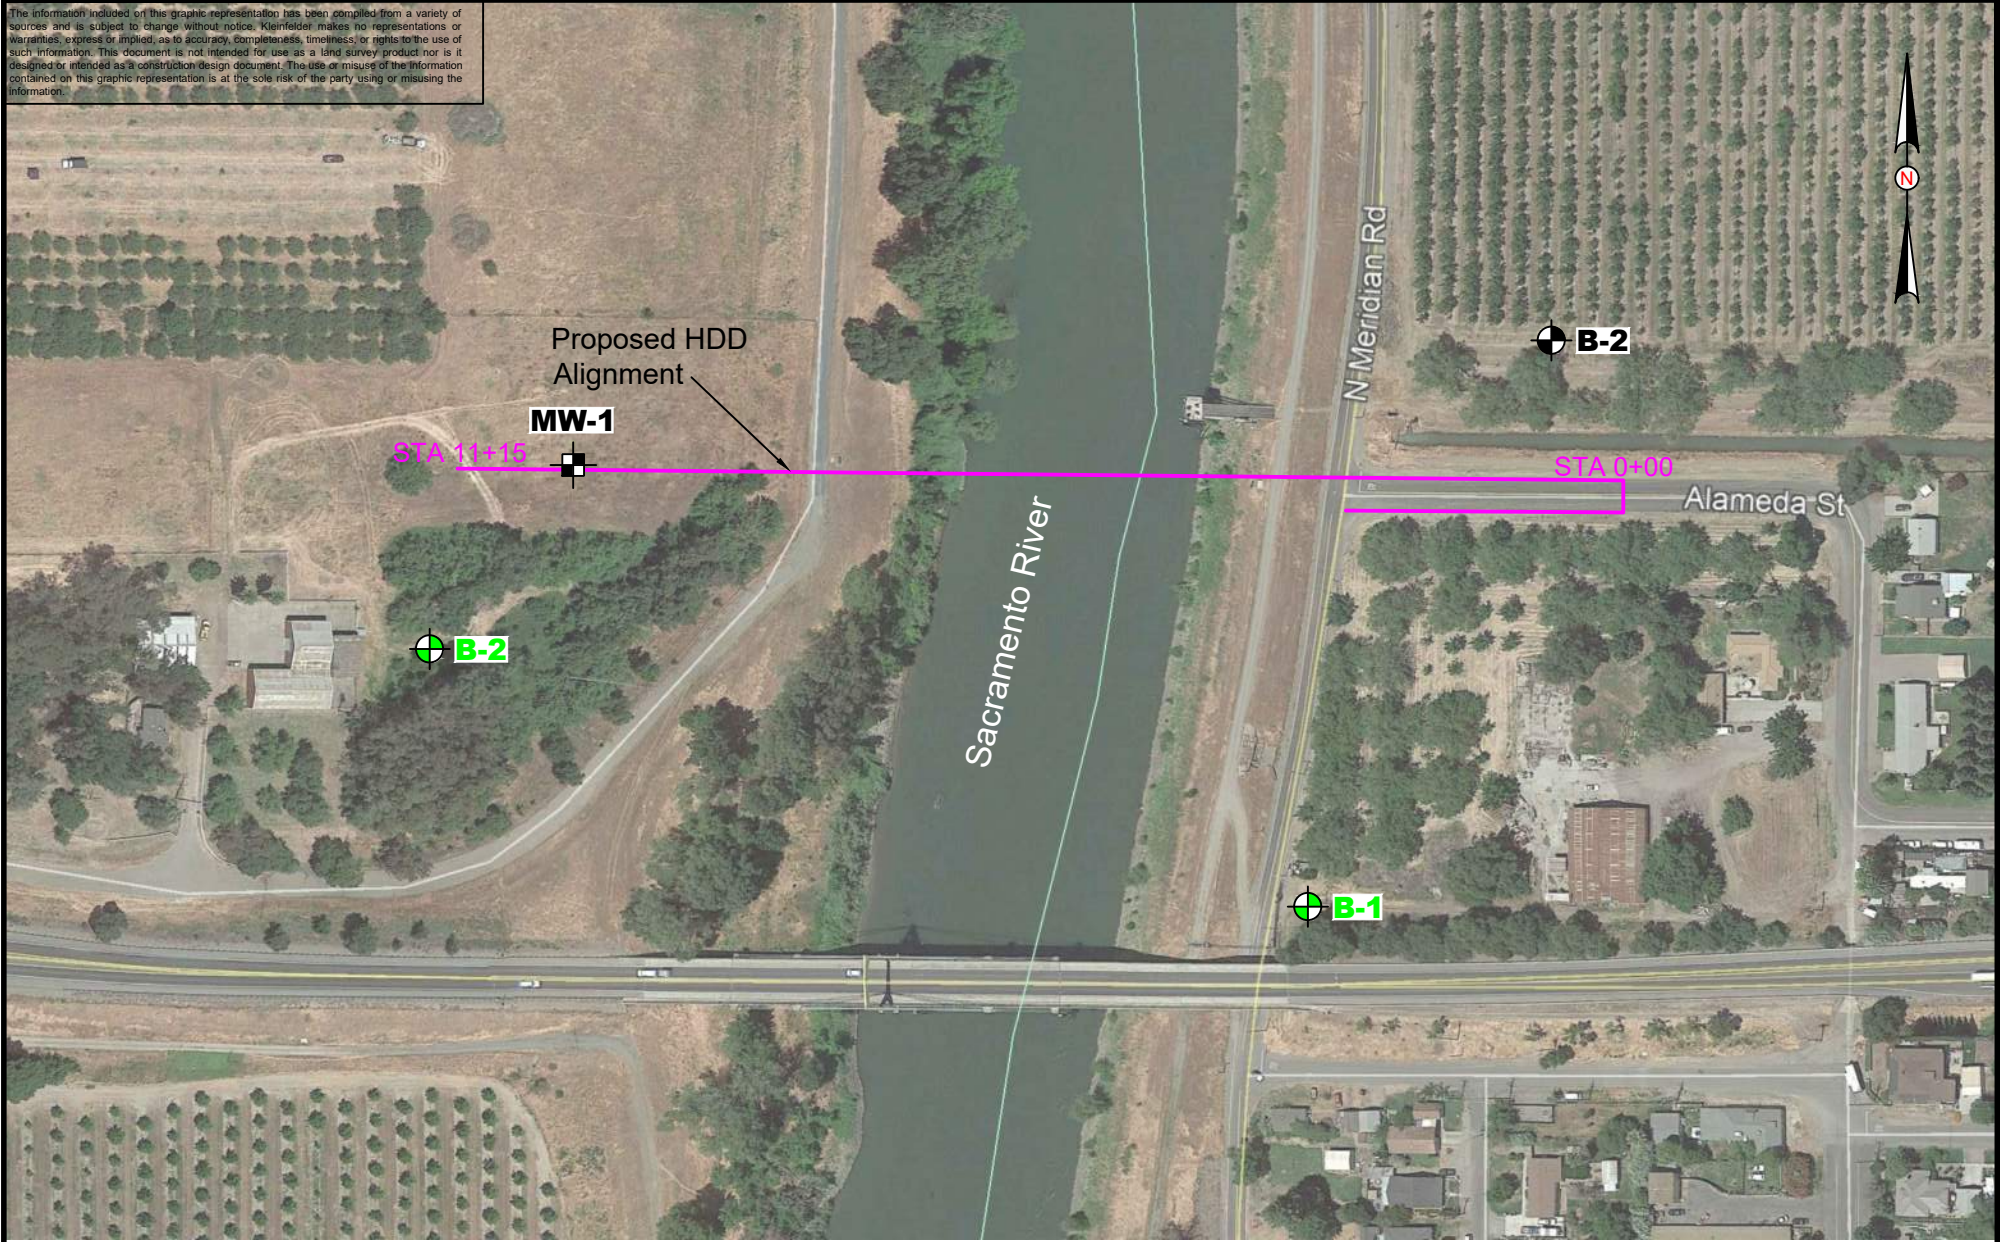
2

Conclusions and recommendations presented in this report are based on the subsurface conditions encountered in two exploratory borings (MW-1 and B-2) drilled for this investigation, past borings drilled for a nearby transmission line (B-1 and B-2), and our review of published geologic data referenced in this report. Recommendations presented herein should not be extrapolated to other areas or used for other projects without our prior review. The approximate locations of our exploratory borings are shown on Figure 2, Exploration Location Map.

⊗ Denotes Number & Approximate Location of Boring Drilled For This Investigation

⊠ Denotes Number & Approximate Location of Monitoring Well For This Investigation

The subsurface conditions at the site were explored between October 7th through October 9, 2020 by drilling two (2) borings to depths of approximately 80 and 81½ feet below the ground surface. The boring located on the west side of the Sacramento River was converted into a monitoring well (MW-1). The well casing was set to a depth of approximately 50 feet below the ground surface.

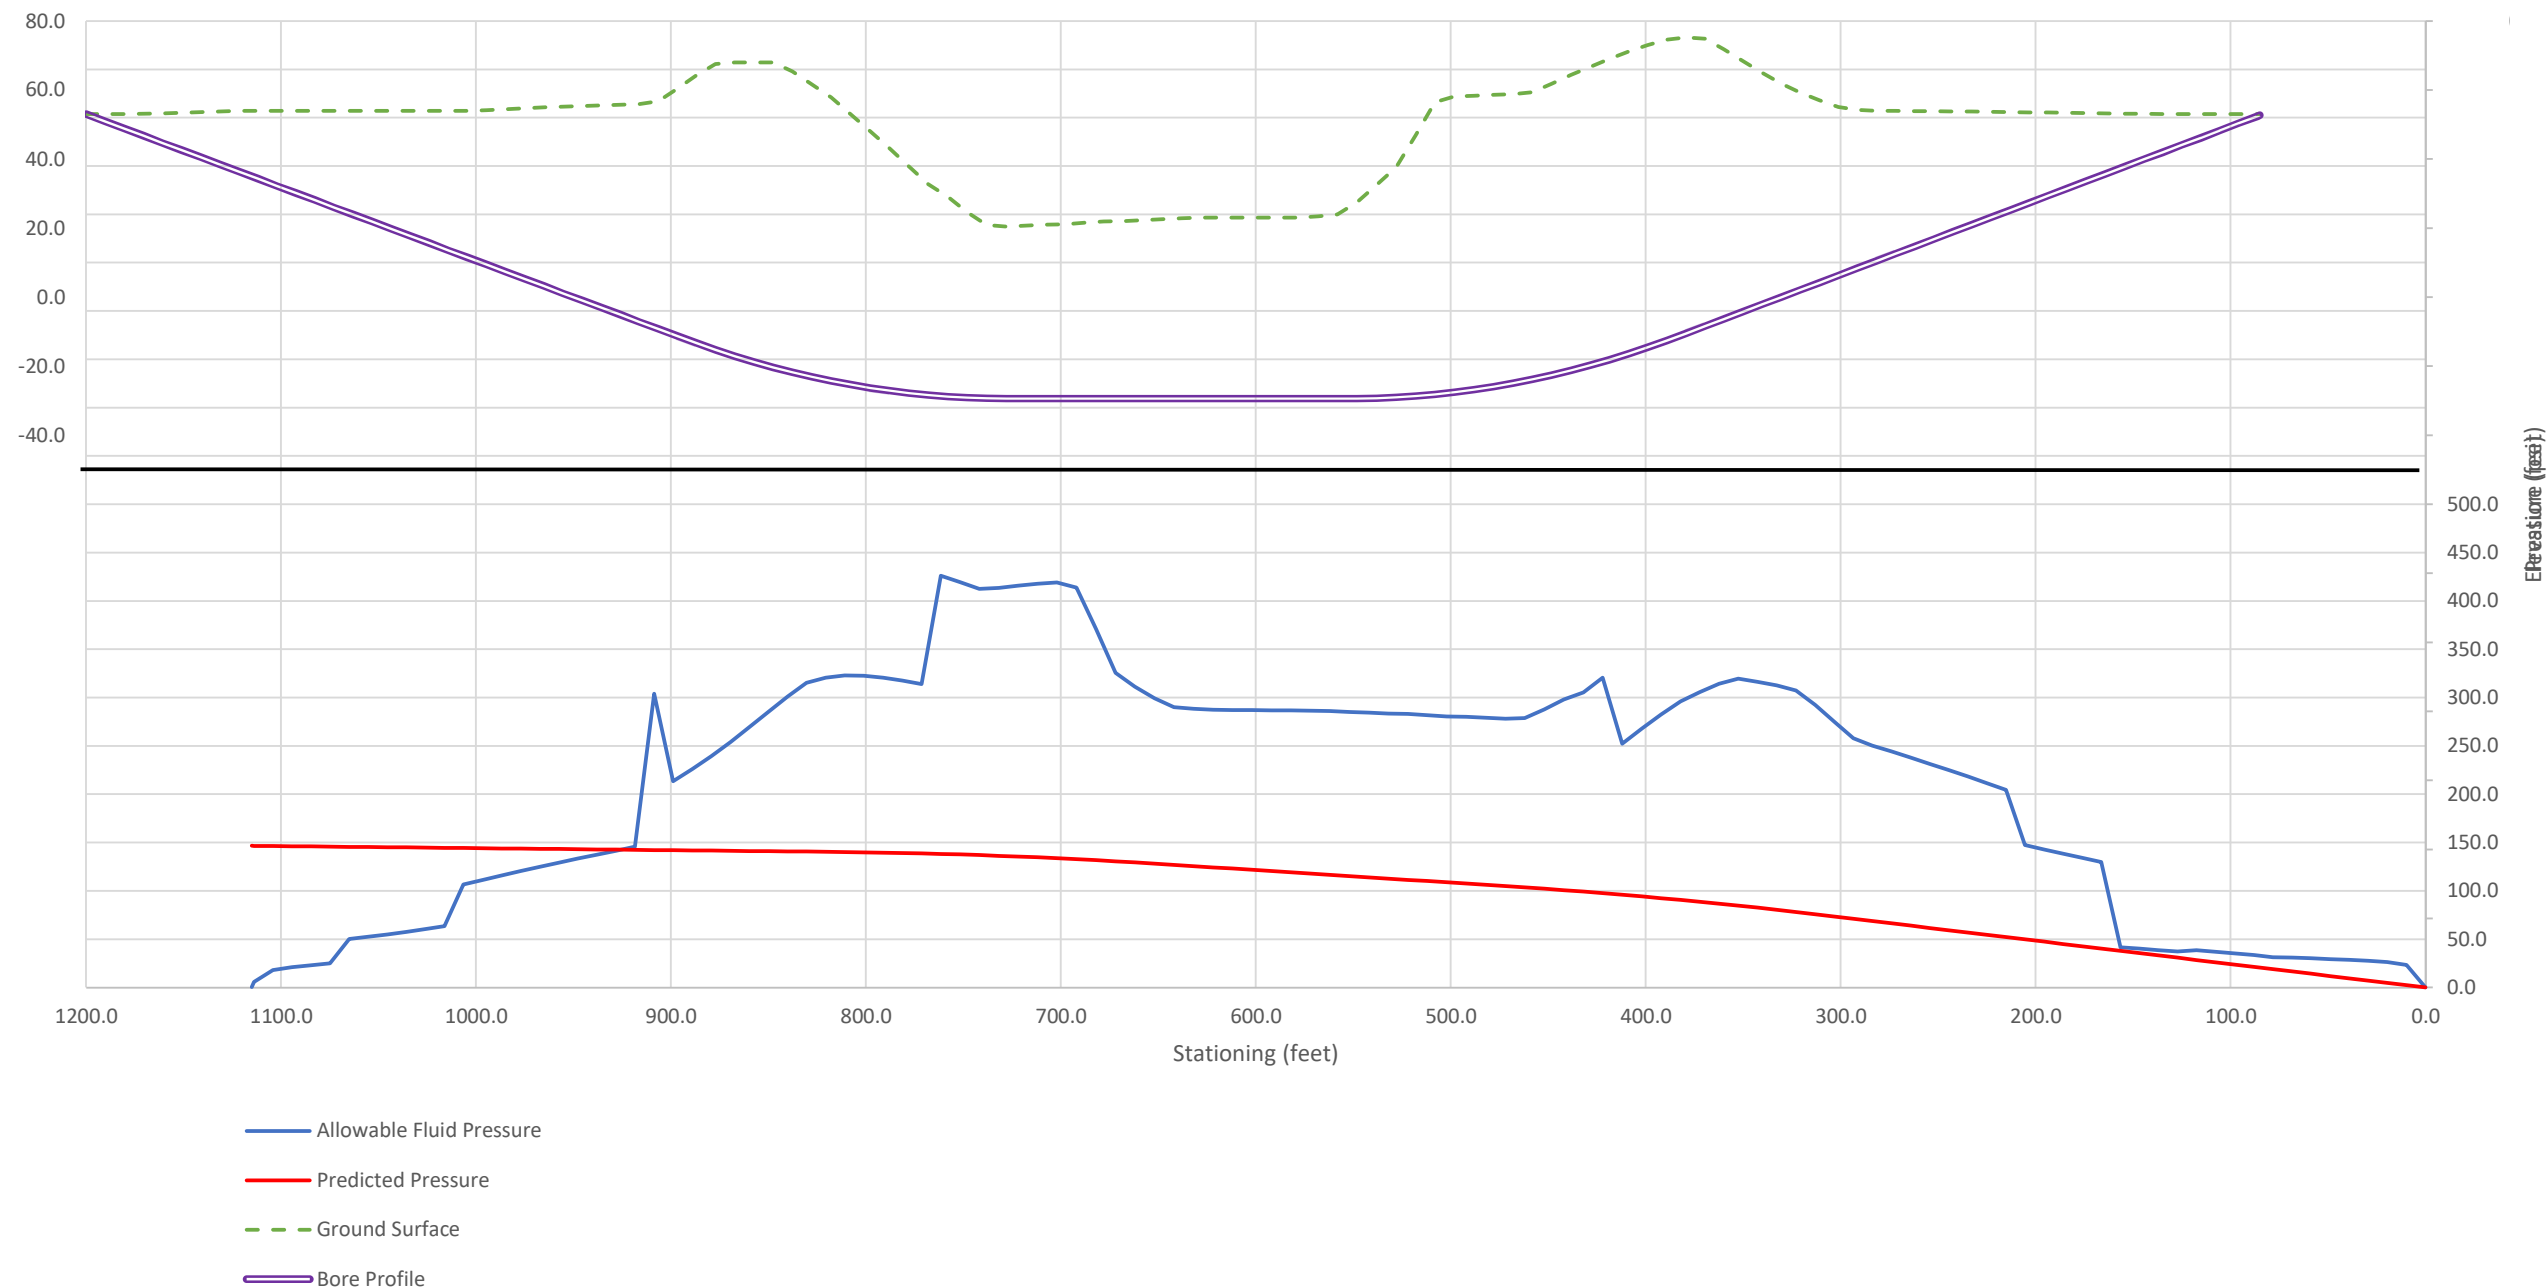
| Figure 4a | Conceptual HDD Profile With Hydrofracture Analysis, Entry at Station 0+00 |

Hydrofracture Risk Analysis for the Pilot Bore of the DFM 0630-01 (R-1385) HDD CROSSING

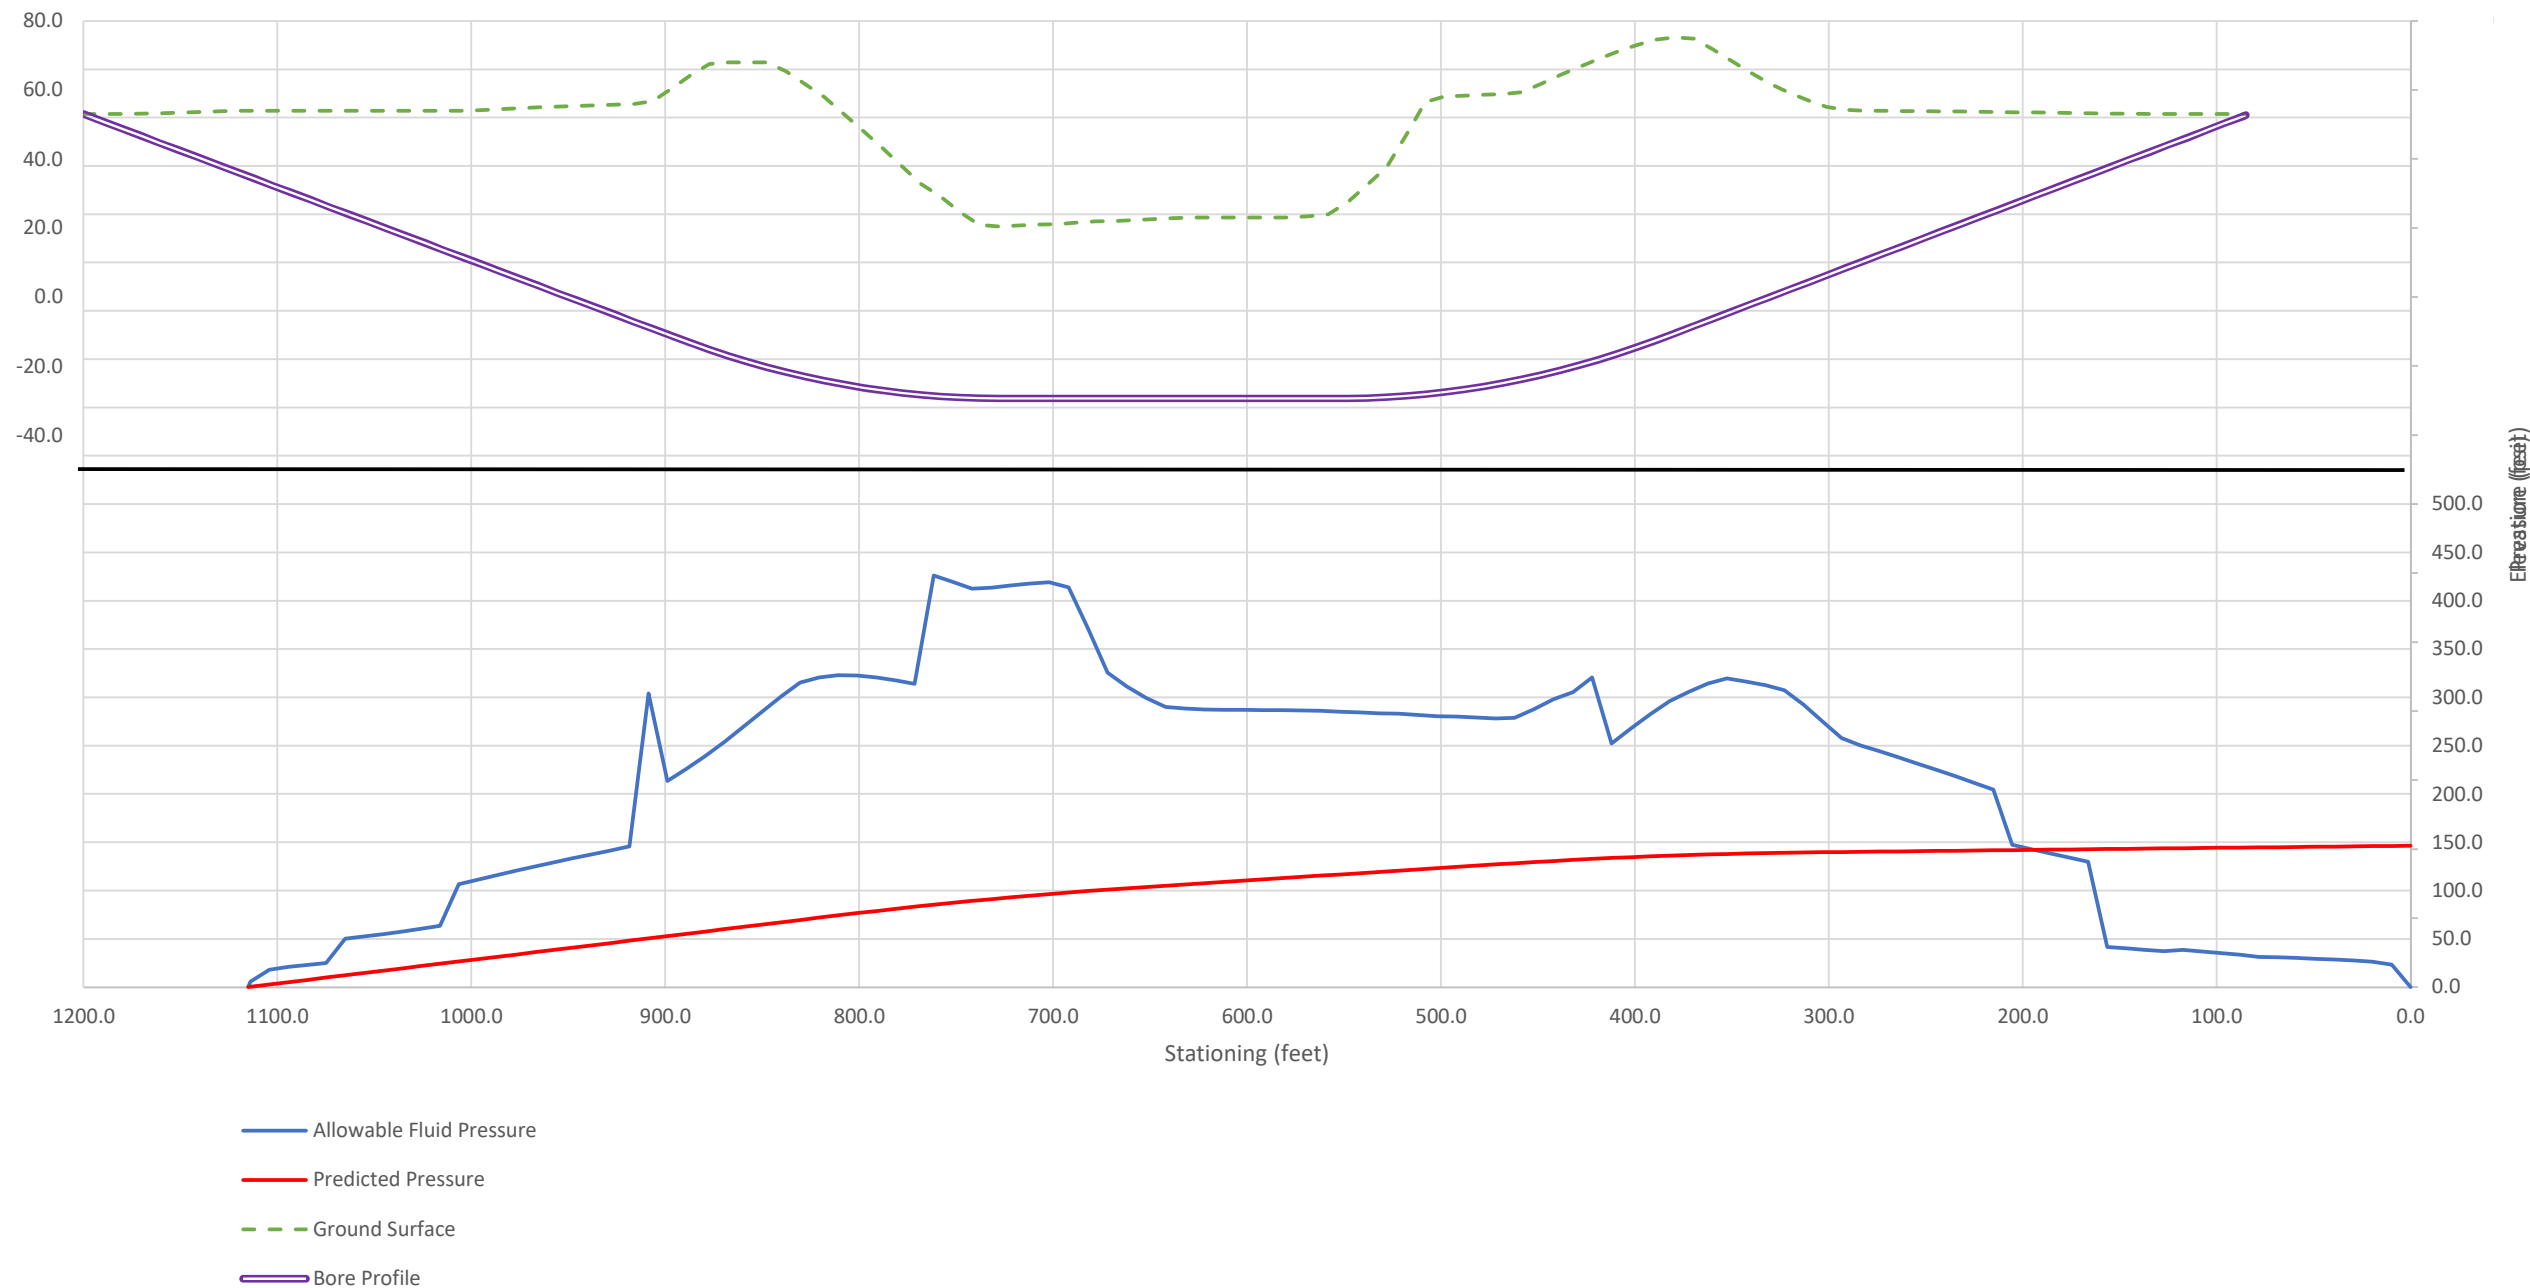
| Figure 4b | Conceptual HDD Profile With Hydrofracture Analysis, Entry at Station 11+15 |

Hydrofracture Risk Analysis for the Pilot Bore of the DFM 0630-01 (R-1385) HDD CROSSING

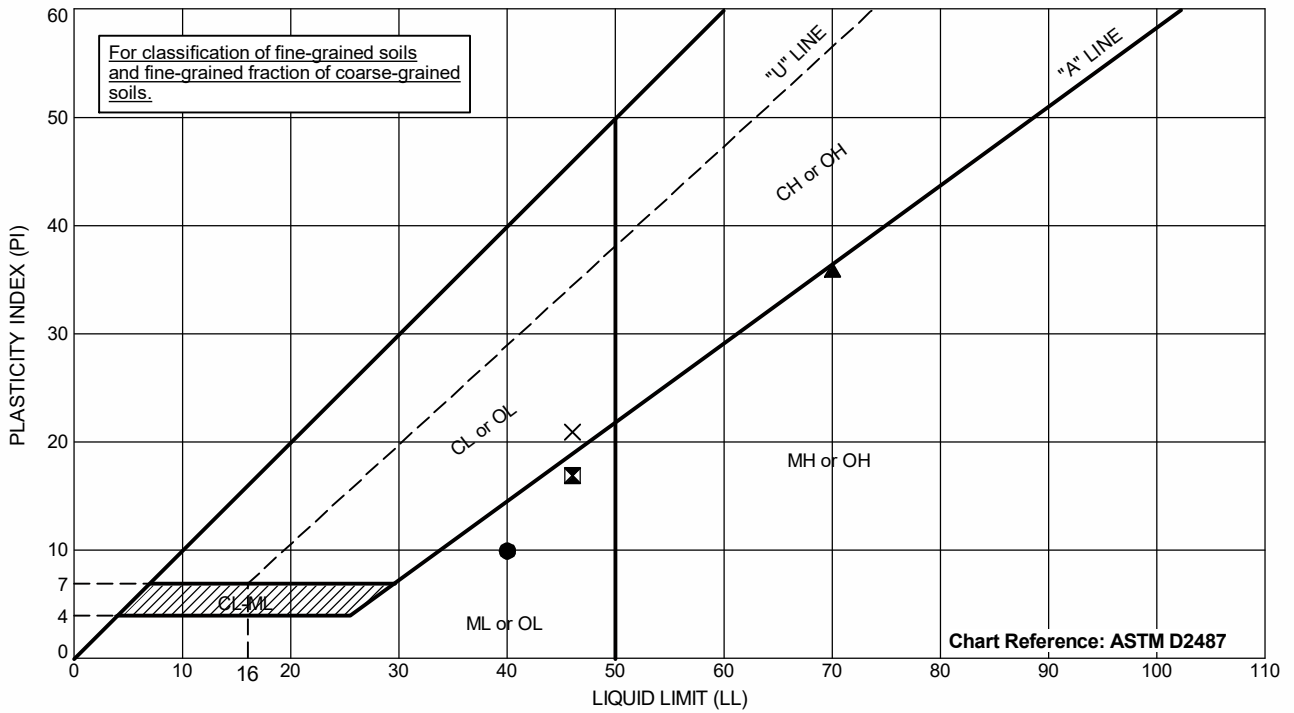
| Exploration ID | Depth (ft.) | Sample Description | Passing #200 | LL | PL | PI |
| ● B-2 | 20 - 21.5 | CLAYEY SILT (ML) | 100 | 40 | 30 | 10 |
| × B-2 | 70 - 71.5 | LEAN CLAY (CL) | NM | 46 | 25 | 21 |

Testing performed in general accordance with ASTM D4318.
 NP = Nonplastic
 NM = Not Measured

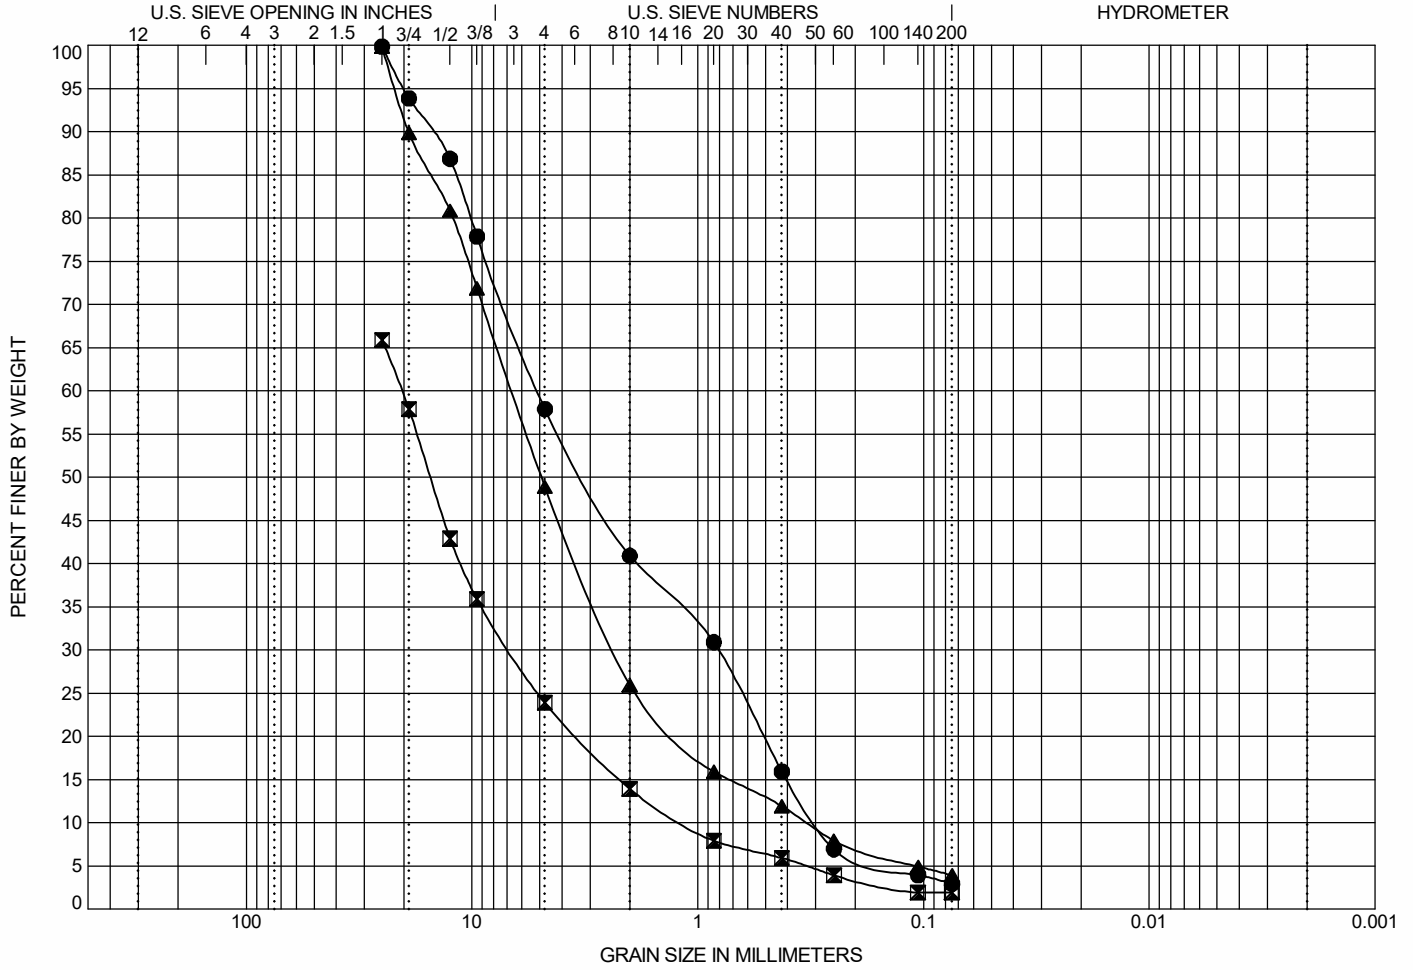
| Exploration ID | Depth (ft.) | Sample Description | LL | PL | PI |
| ● MW-1 | 35.5 - 36 | POORLY GRADED SAND | NM | NM | NM |

*These numbers represent silt-sized and clay-sized content but may not indicate the percentage of the material with the engineering properties of silt or clay. Sieve Analysis and Hydrometer Analysis testing performed in general accordance with ASTM D6913(Sieve Analysis) and ASTM D7928 (Hydrometer Analysis).
 NP = Nonplastic
 NM = Not Measured

Coefficients of Uniformity - $C_u = D_{60} / D_{10}$
 Coefficients of Curvature - $C_c = (D_{30})^2 / D_{60} D_{10}$
 D₆₀ = Grain diameter at 60% passing
 D₃₀ = Grain diameter at 30% passing
 D₁₀ = Grain diameter at 10% passing

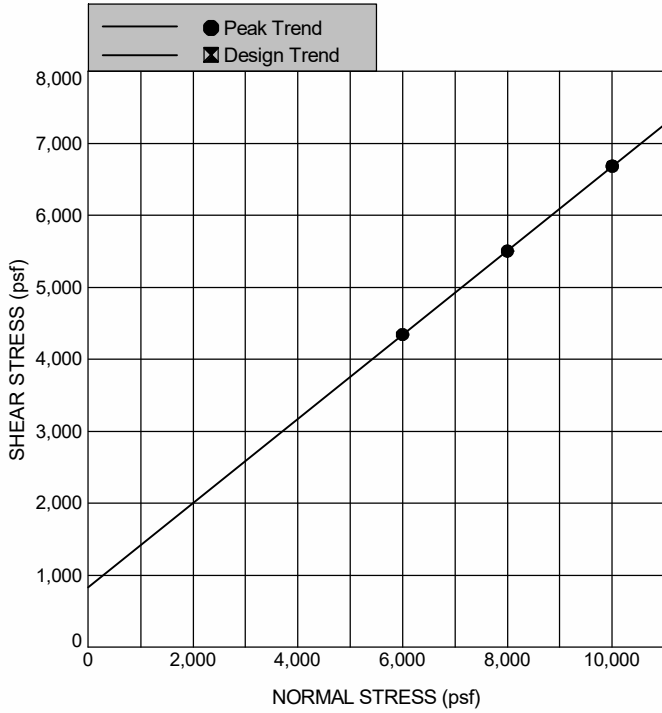
| Exploration ID | Depth (ft.) | Sample Description |
| B-2 | 66 - 66.5 | CLAYEY SAND (SC) |

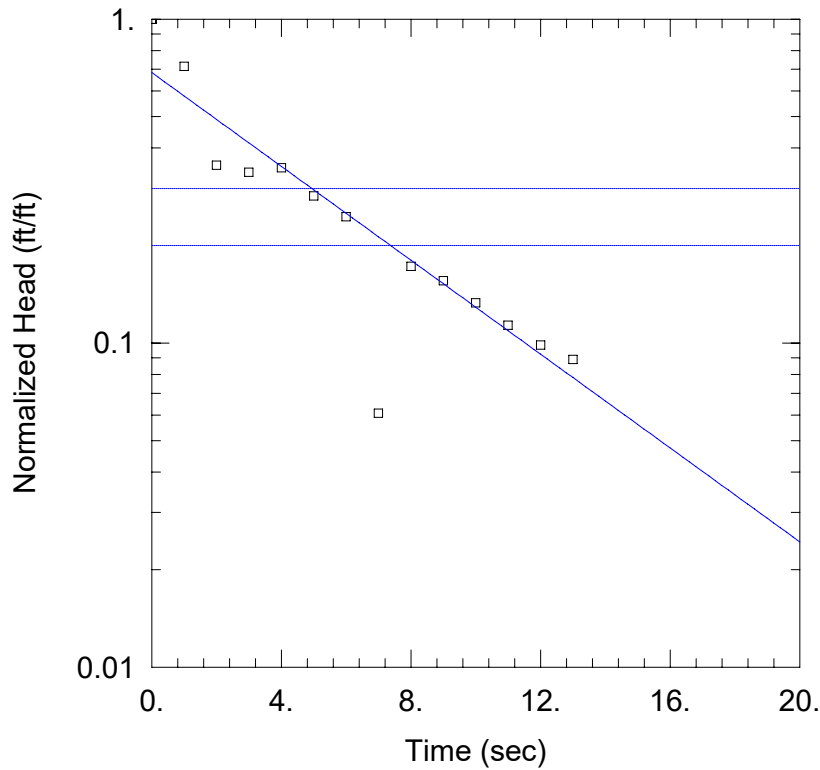
PG&E R-1385 IN-1

$K = 0.01745$ ft/min

$y_0 = 0.7769$ ft

For our slug testing, the solid slug was alternately lowered into the wells (falling head test) and removed (rising head test) from the wells to create a condition of groundwater disequilibrium. The groundwater level was monitored with a pressure transducer over time as water level returned to equilibrium. A minimum of three slug-in and three slug-out tests were performed in each well. Depth to water was measured at 18½ feet below ground surface at the time of slug testing.

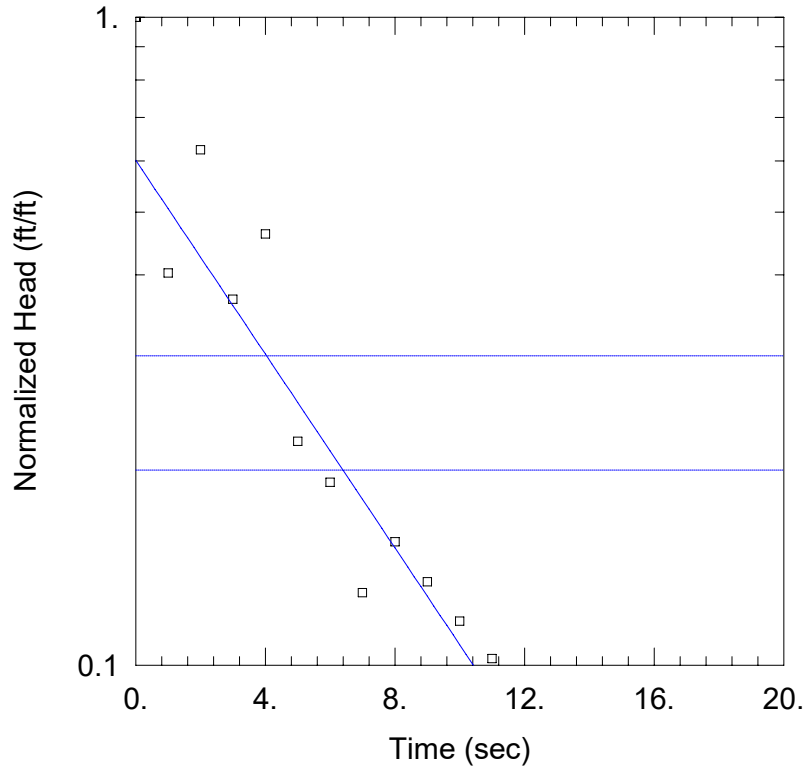
PG&E R-1385 IN-2

$K = 0.01802$ ft/min

$y_0 = 0.8227$ ft

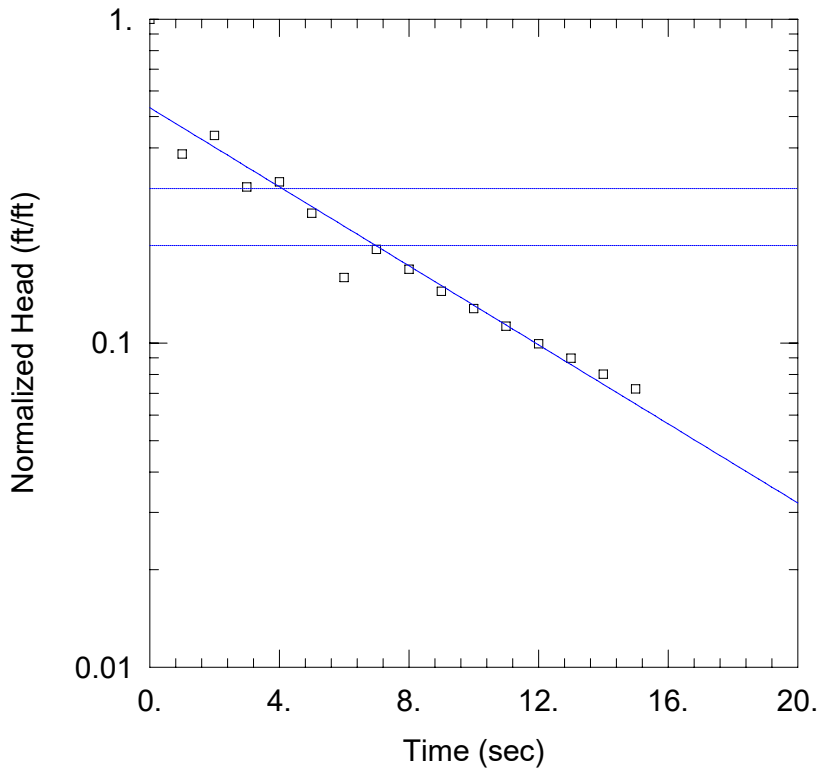
PG&E R-1385 IN-3

K = 0.01469 ft/min

y0 = 0.6048 ft

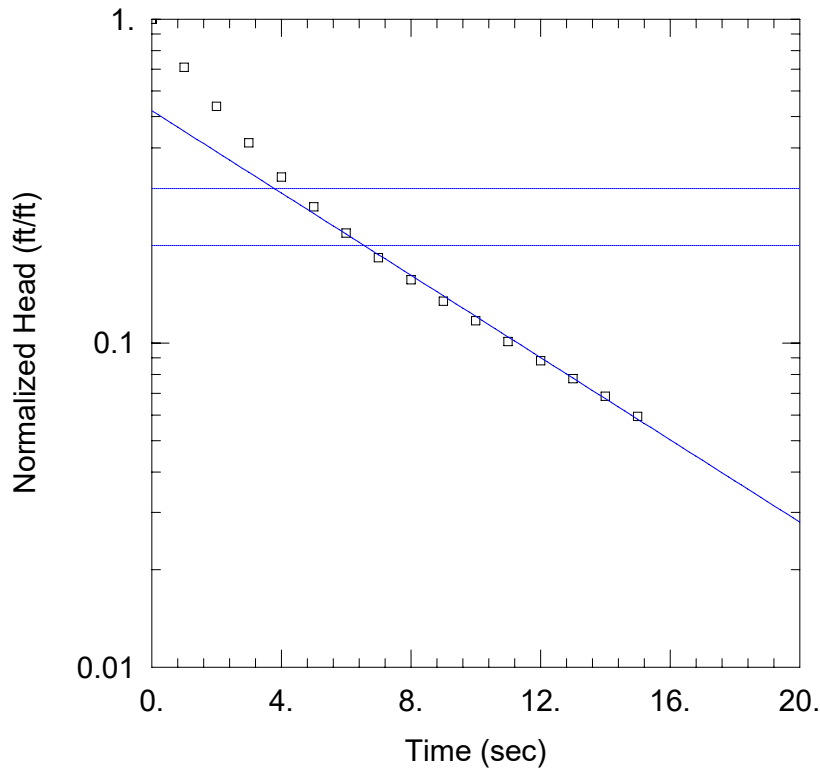
PG&E R-1385 OUT-1

K = 0.0153 ft/min

y0 = 0.6855 ft

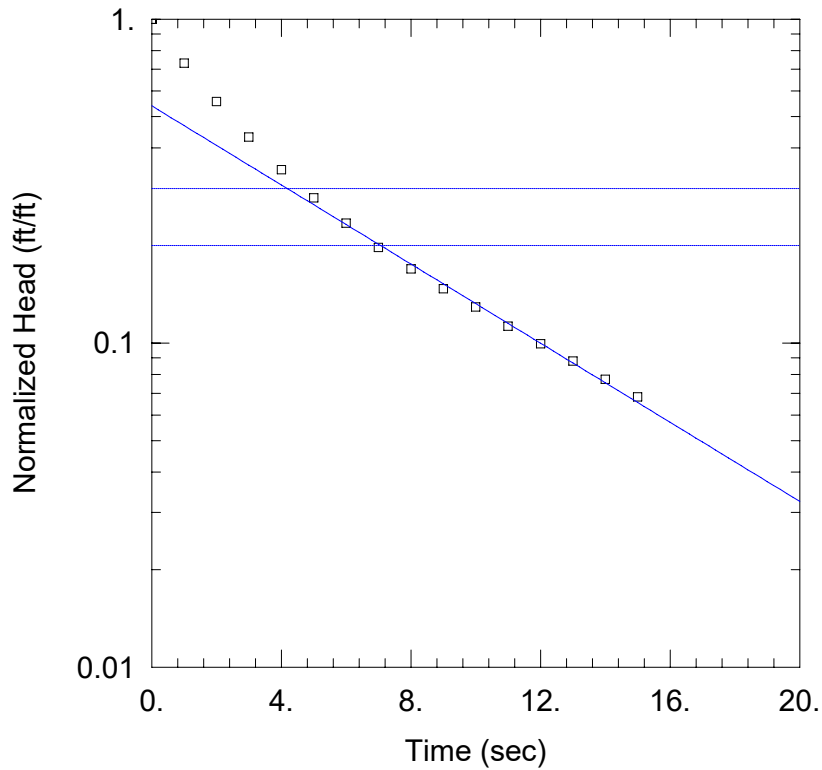
PG&E R-1385 OUT-2

K = 0.01471 ft/min

y0 = 0.6561 ft

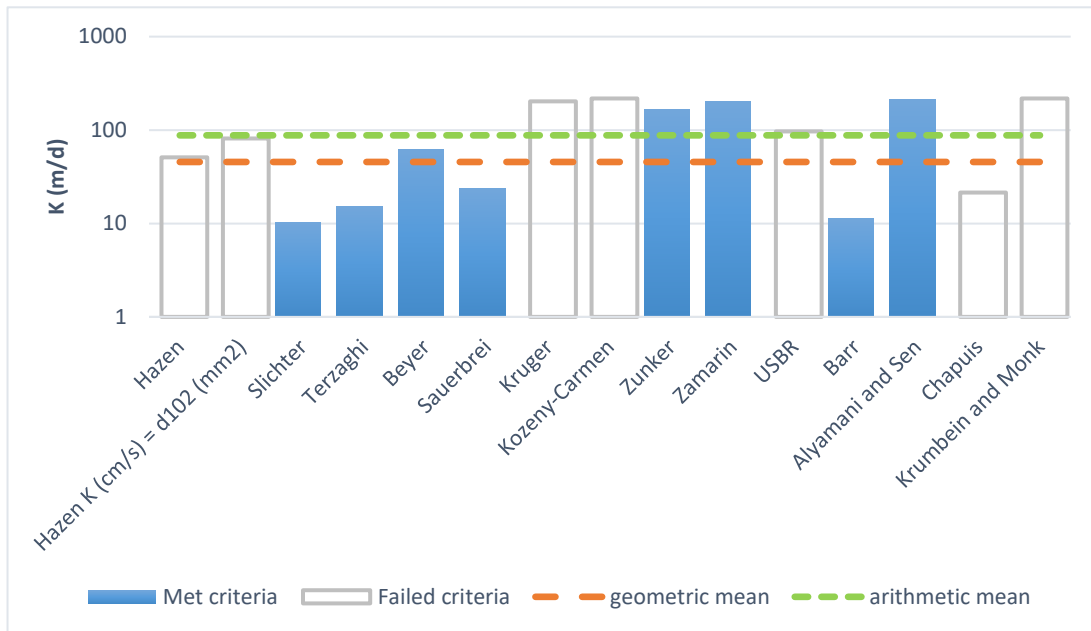
Poorly sorted sandy gravel low in fines

| Estimation of Hydraulic Conductivity | cm/s | m/s | m/d |
| Hazen | .592E-01 | .592E-03 | 51.13 |

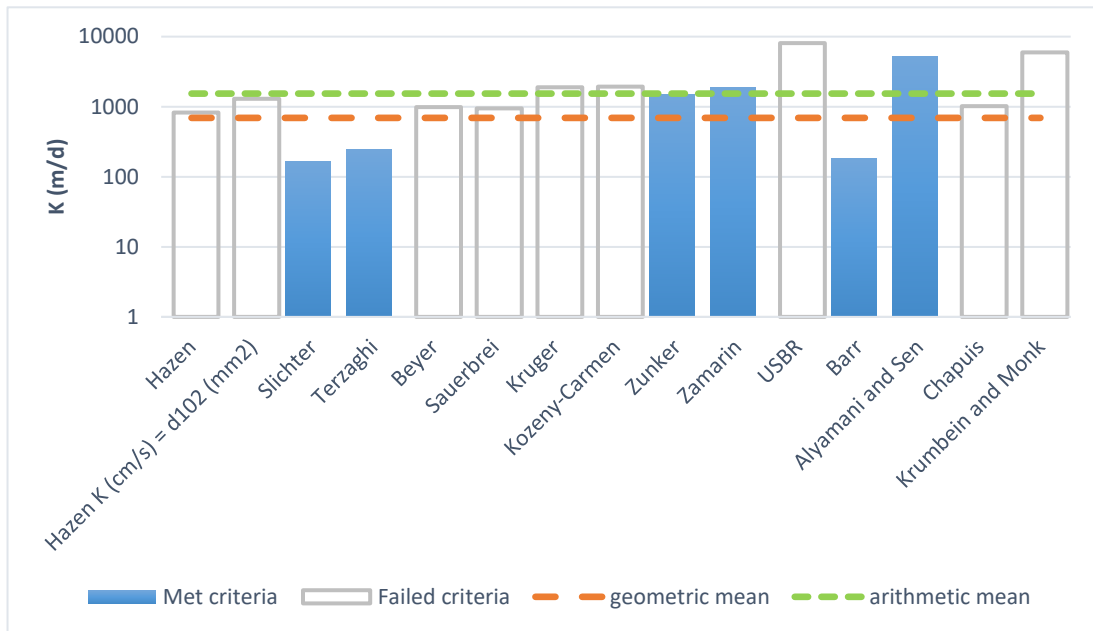
Poorly sorted sandy gravel low in fines

| Estimation of Hydraulic Conductivity | cm/s | m/s | m/d |
| Hazen | .953E+00 | .953E-02 | 823.55 |

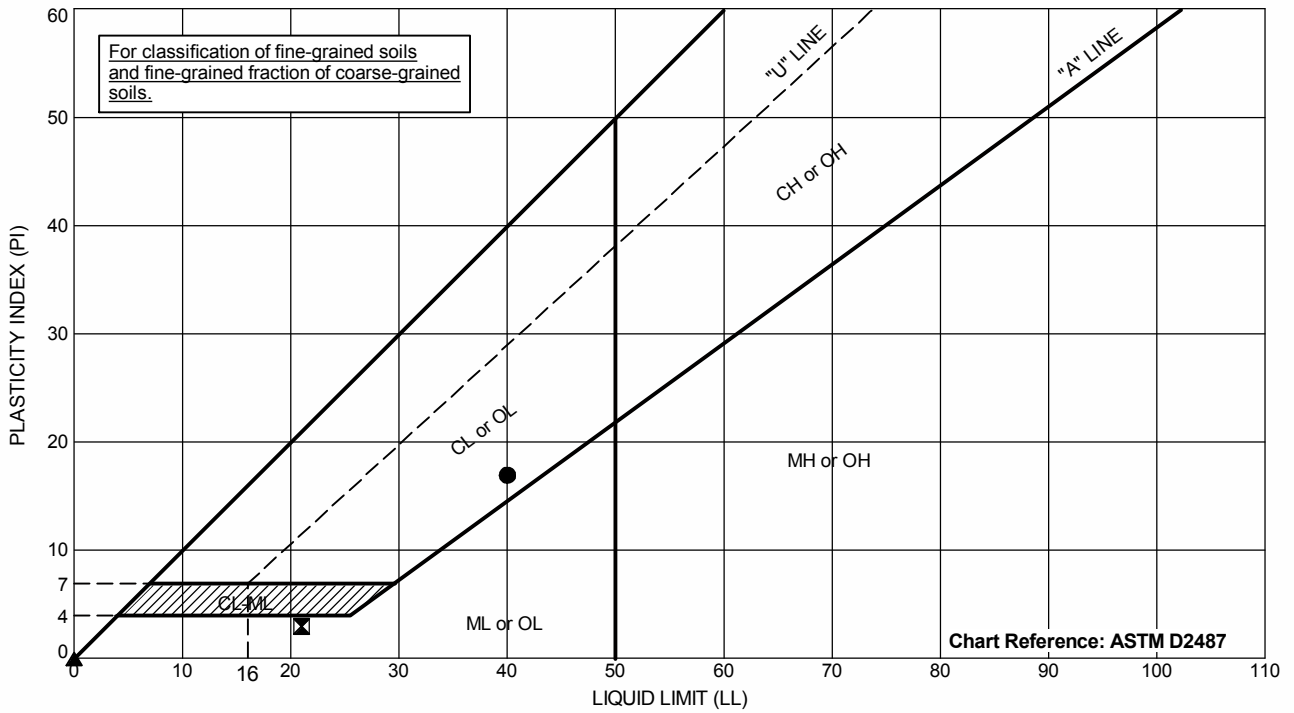
| Exploration ID | Depth (ft.) | Sample Number | Sample Description | Passing #200 | LL | PL | PI |
| ● B-1 | 6 | 1A | LEAN CLAY (CL) | NM | 40 | 23 | 17 |

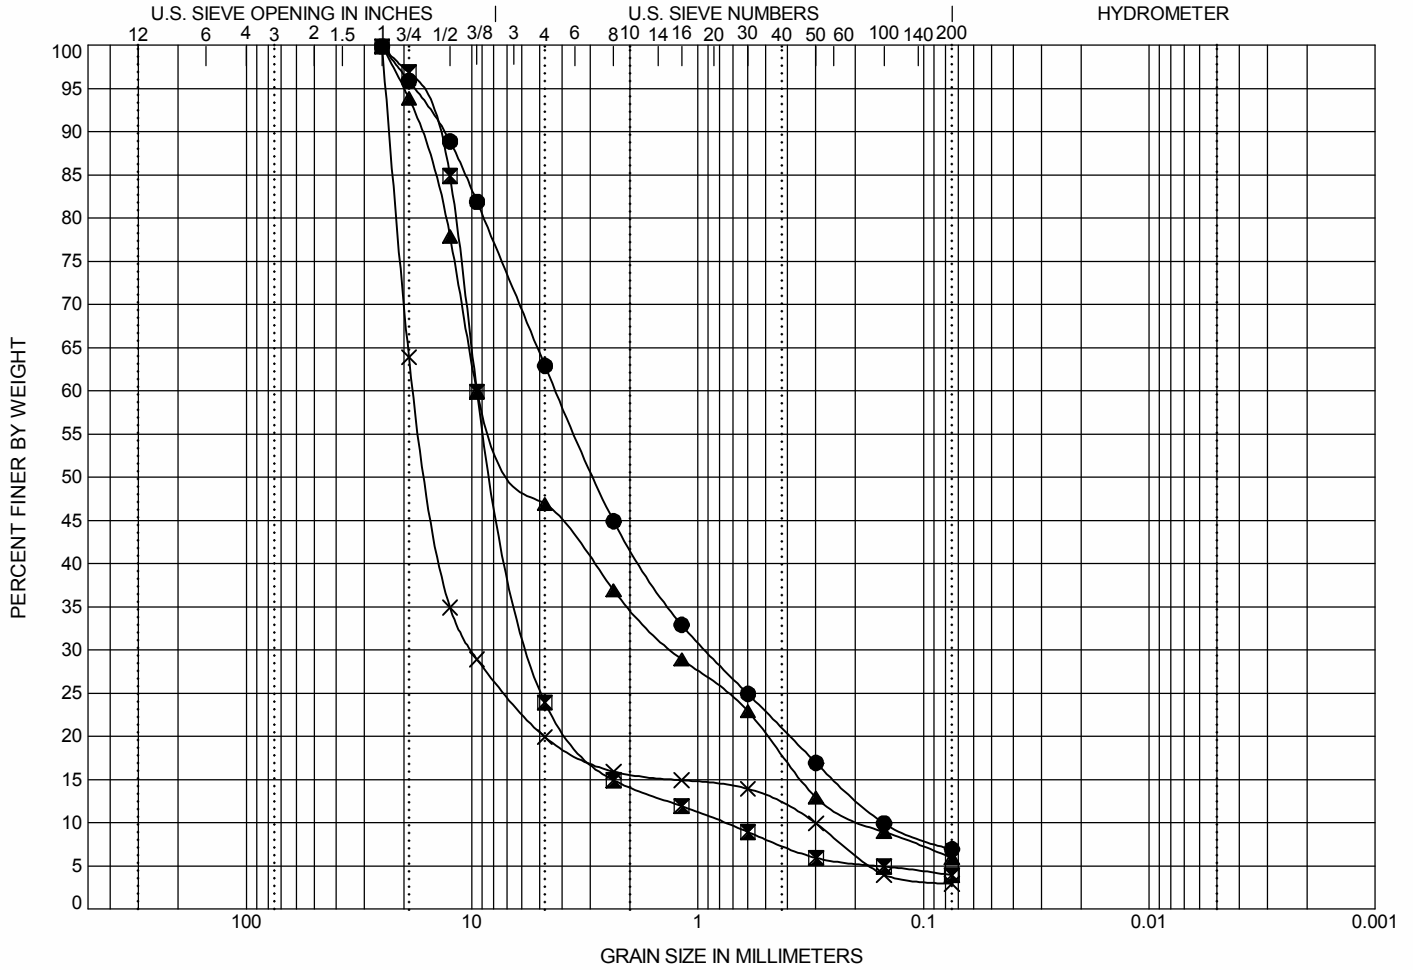
| Exploration ID | Depth (ft.) | Sample Number | Sample Description | LL | PL | PI | |
| ● | B-2 | 36 | NA | WELL-GRADED SAND WITH GRAVEL (SW) | NM | NM | NM |
