**GEOTECHNICAL INVESTIGATION REPORT
PROPOSED PACIFIC GAS & ELECTRIC COMPANY
DFM 0630-01 (R-1385) PIPELINE REPLACEMENT
SACRAMENTO RIVER CROSSING
MERIDIAN, CALIFORNIA**

December 1, 2020

December 1, 2020
Project No. 20201644.013A

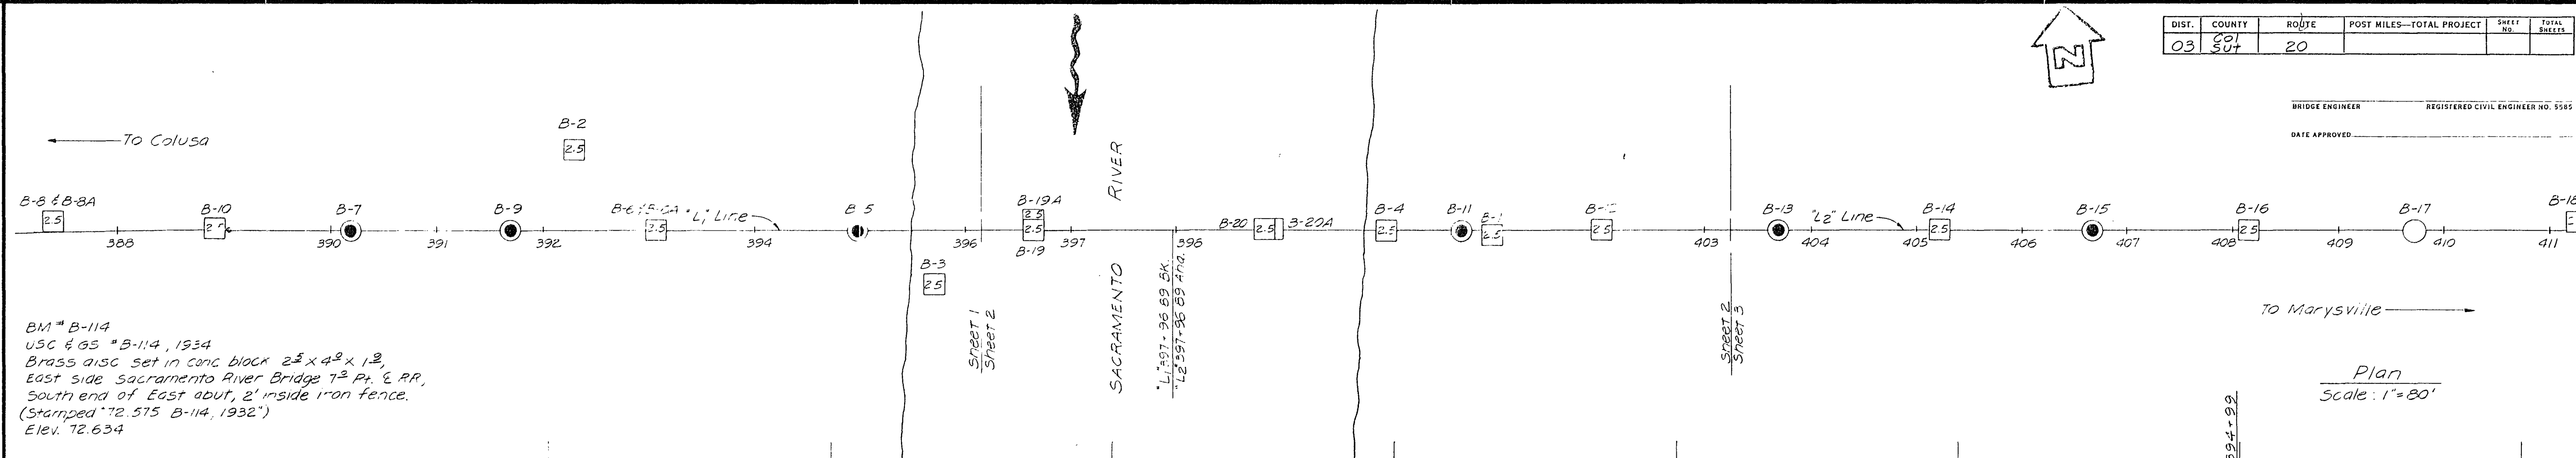
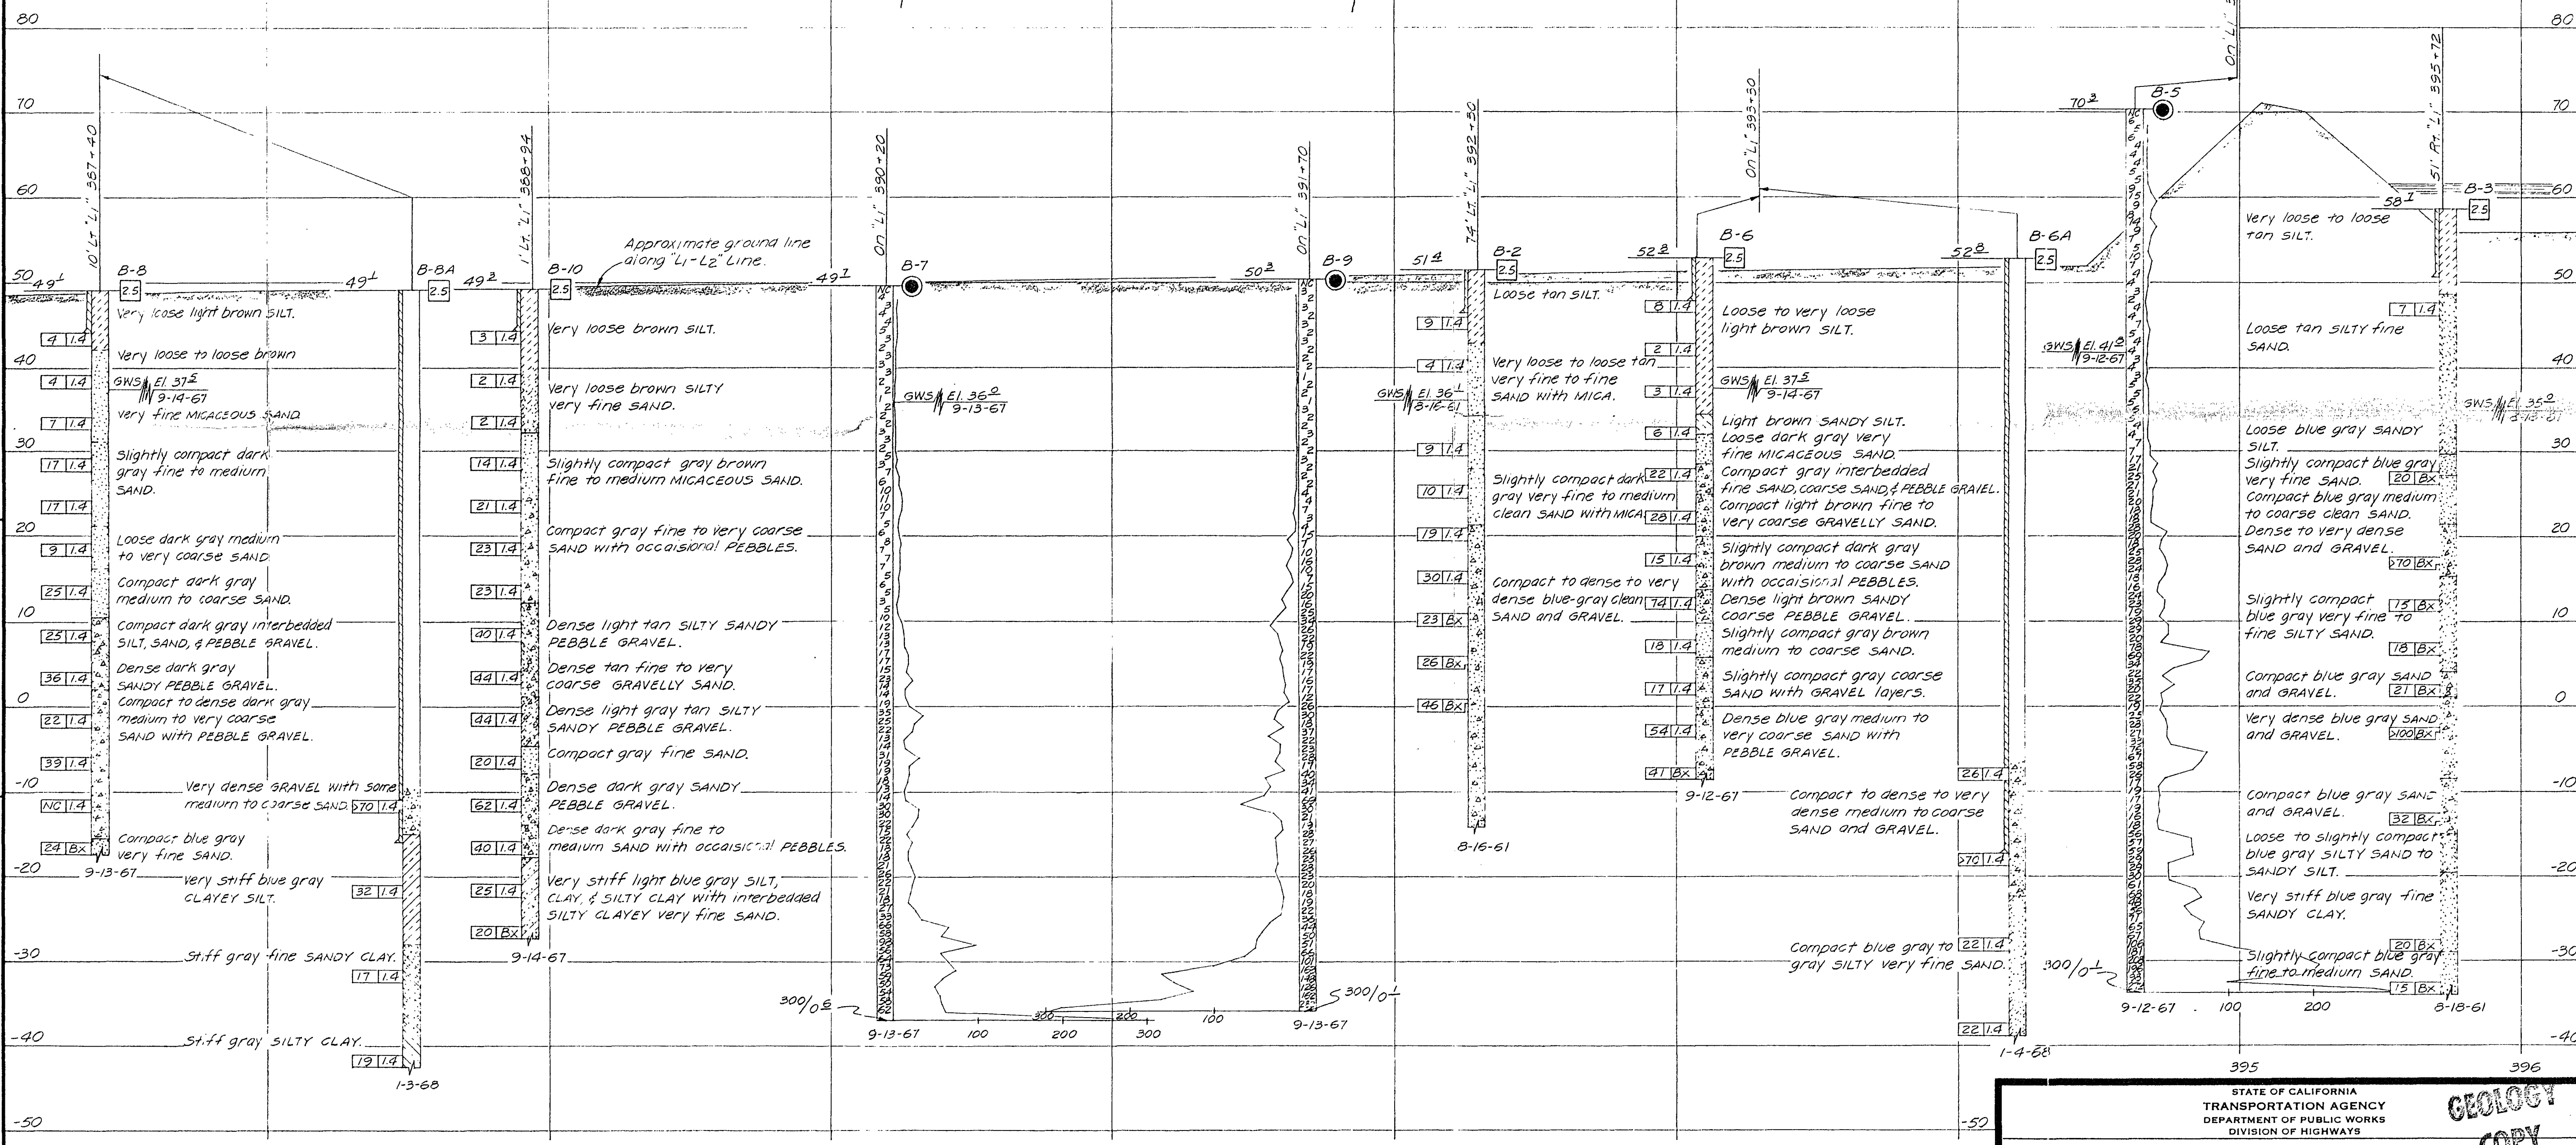
BM = B-114
 USC 6 65 * B-114, 1934
 Brass disc set in conc block 2 1/2 x 4 1/2 x 1 1/2
 East side Sacramento River Bridge 7th Pt. E. RR.
 South end of East abut, 2' inside iron fence.
 (Stamped "72 575 B-114, 1932")
 Elev. 72.634
