PHASE I ENVIRONMENTAL SITE ASSESSMENT

MCCAFFERTY & BARTON PROPERTY

1370 BURBANK AVENUE

EBA Project No. 16-2345-4

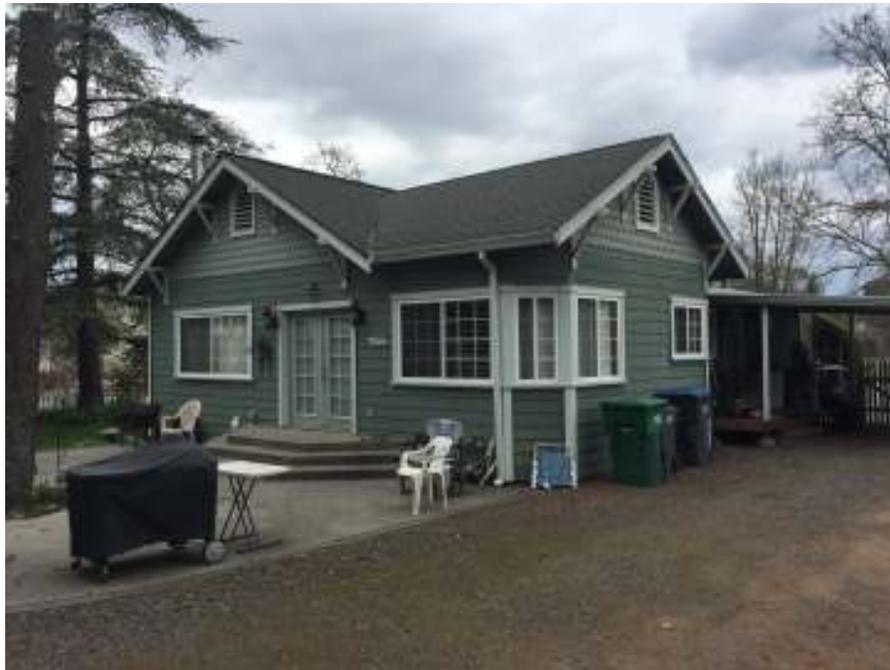
FIGURE
4

The project site contains two single-family dwellings, a mobile home trailer and several associated outbuildings. A single-family dwelling is located on the western side of the project site and is the first structure encountered upon entering the western side of the project site from Burbank Avenue. The dwelling consists of a single-story, wood-framed structure that has a concrete perimeter foundation. At the time of the property inspection the dwelling was reported to be occupied by a tenant. The condition of the dwelling was observed to be fair.

View of western dwelling at project site from looking northwest.

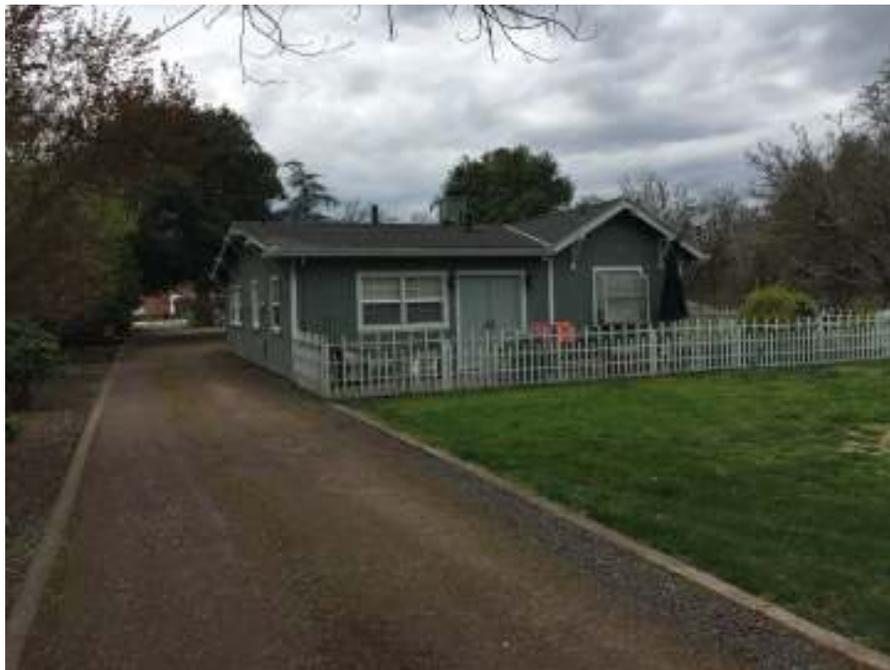
A second dwelling is located to the east of the domestic water supply well. The second dwelling also consists of a single-story, wood-framed structure that has an attached garage and slab on grade foundation. At the time of the property inspection the dwelling was reported to be occupied by a tenant. The condition of the dwelling was observed to be fair.

View of eastern dwelling at project site looking west.

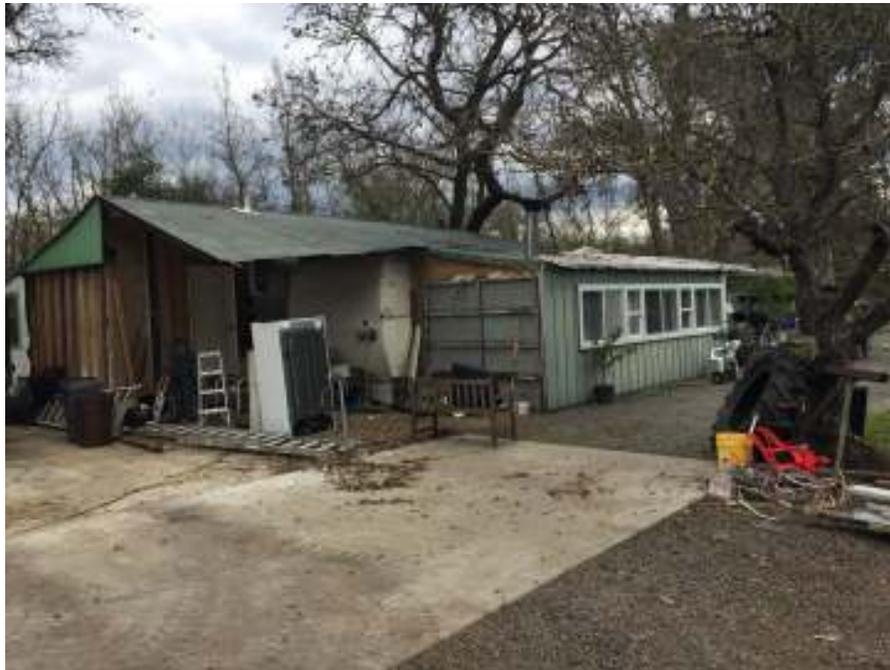
FIGURE
5

removed. The trailer appeared to be occupied by a tenant. The condition of the structure appeared to be poor.

View of mobile home at project site from looking northeast.

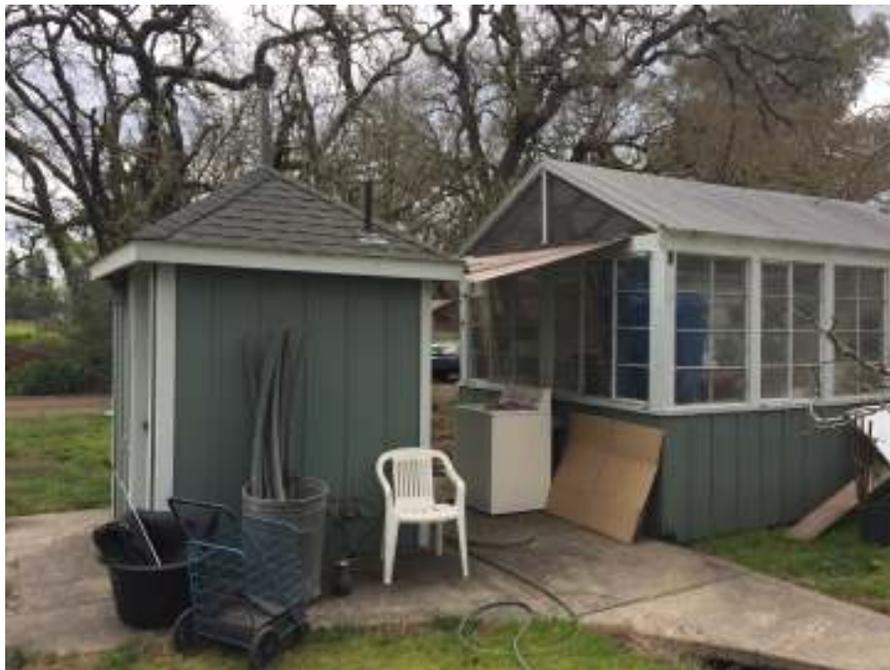
A small greenhouse and bathroom structure are located to the south of the mobile home trailer. The greenhouse appeared to be used for the storage of household items. A septic system appears to be located on the western side of the bathroom structure. The use and condition of the septic system is unknown.

View of greenhouse and bathroom at project site looking southwest.

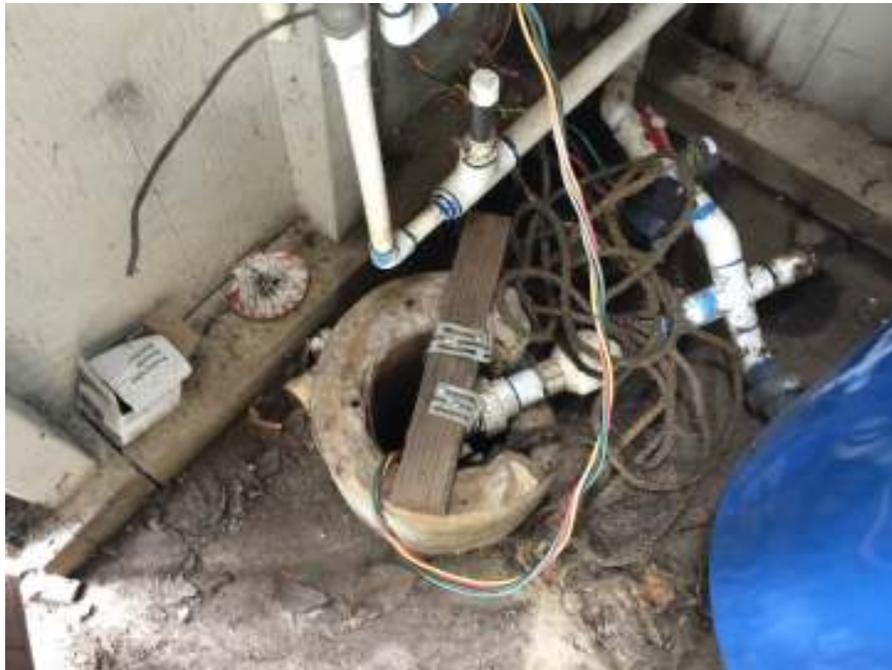
FIGURE
6

At the time of the property inspection the domestic water supply well located on the eastern side of the project site was observed to have an open top with no seal. It appears that the well is in use. The well should be fully sealed if it is to remain in use.

There are two water supply wells present at the project site. The wells are located on the western and central portion of the property parcel and both appear to be in active use. It should be noted the well located in the central portion of the property has an open top with no seal.

View of eastern domestic well.

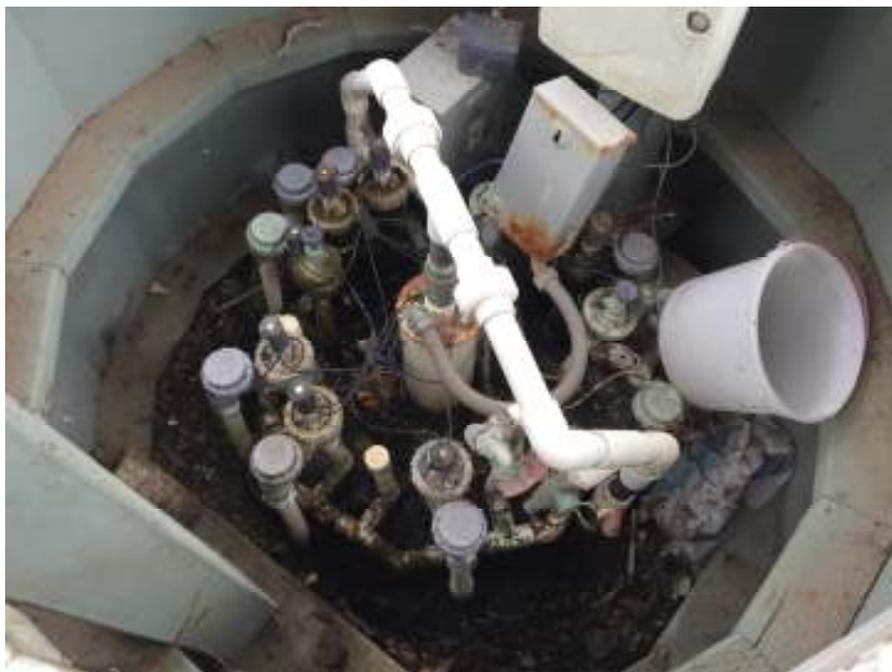
View of western domestic well.

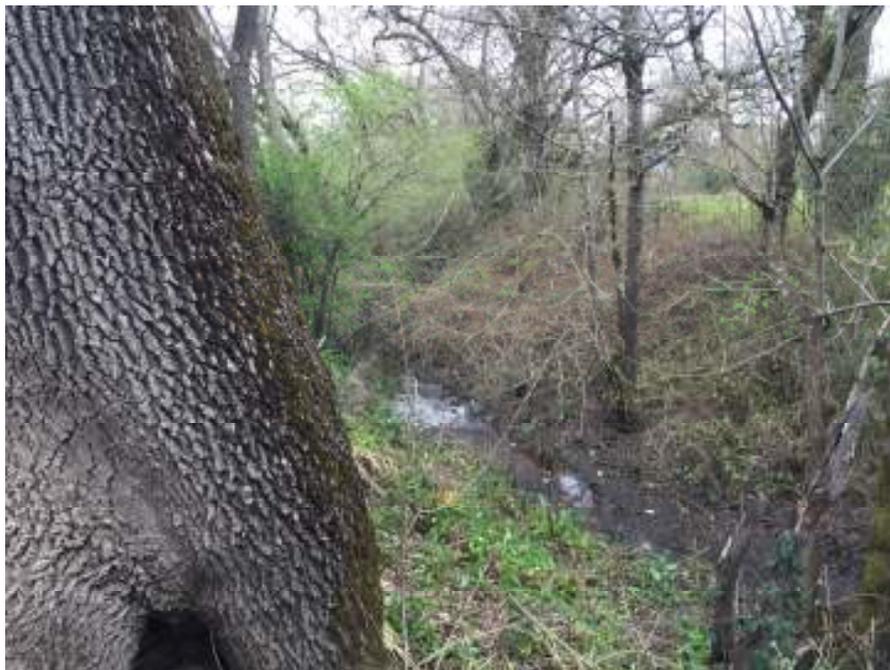
The conditions encountered within Roseland Creek at the school property are likely representative of sediments within the creek both upstream and downstream of the school and including the project site. A general awareness of the potential of contaminated sediments within the creek should be recognized for any future work within Roseland Creek at the project site.

View of Roseland Creek.
