Geology and Soils

GeoLabs Report Sept 14, 2018

SUBJECT: Update Geotechnical Report,
Tentative Tract Map 5658-A, North Canyon Ranch,
City of Simi Valley, California

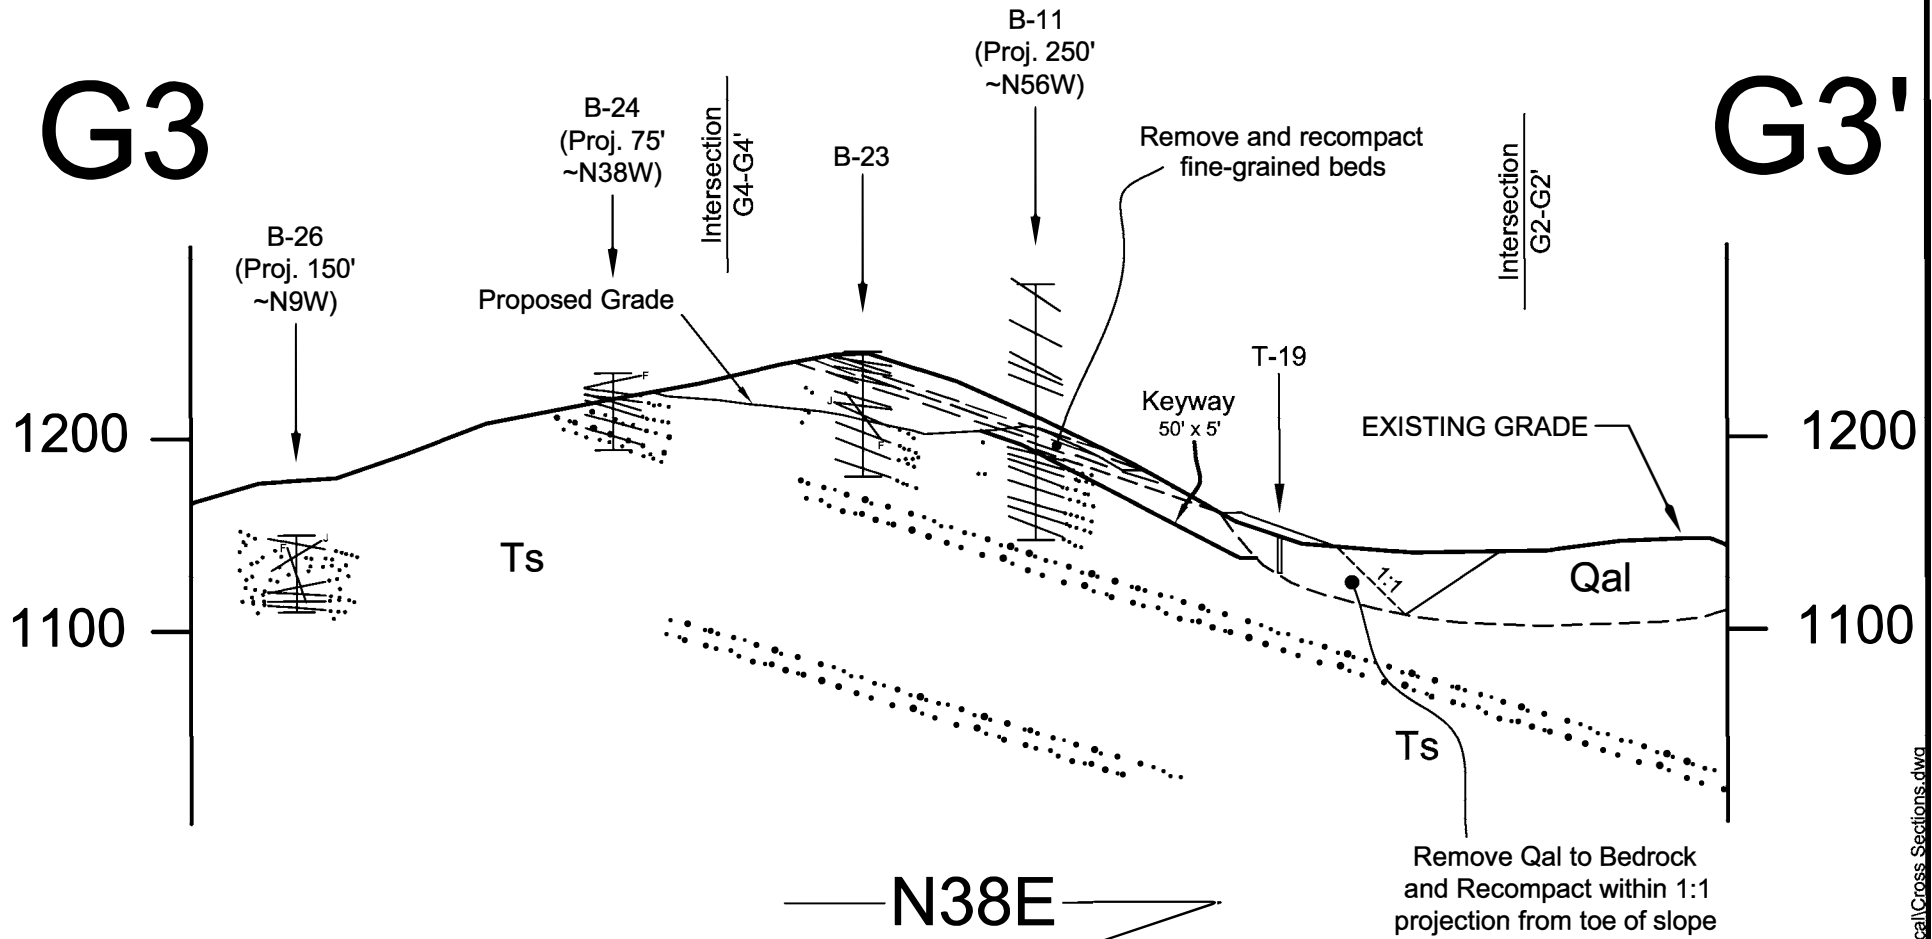
Geolabs - Westlake Village	
	GEOLOGY AND SOIL ENGINEERING	
	DATE 9/14/2018	BY RMP
SCALE 1"=100'	W.O. 8980	
PLATE 2.3

Perimeter slopes about the lots in the central canyon were revised. These are the slopes that rebuild the areas affected by removals of landslides Q1s1 and Q1s2, and the fine-grained bed removal illustrated in cross sections G3, G4, and G19. The revisions generally lower the proposed grade.

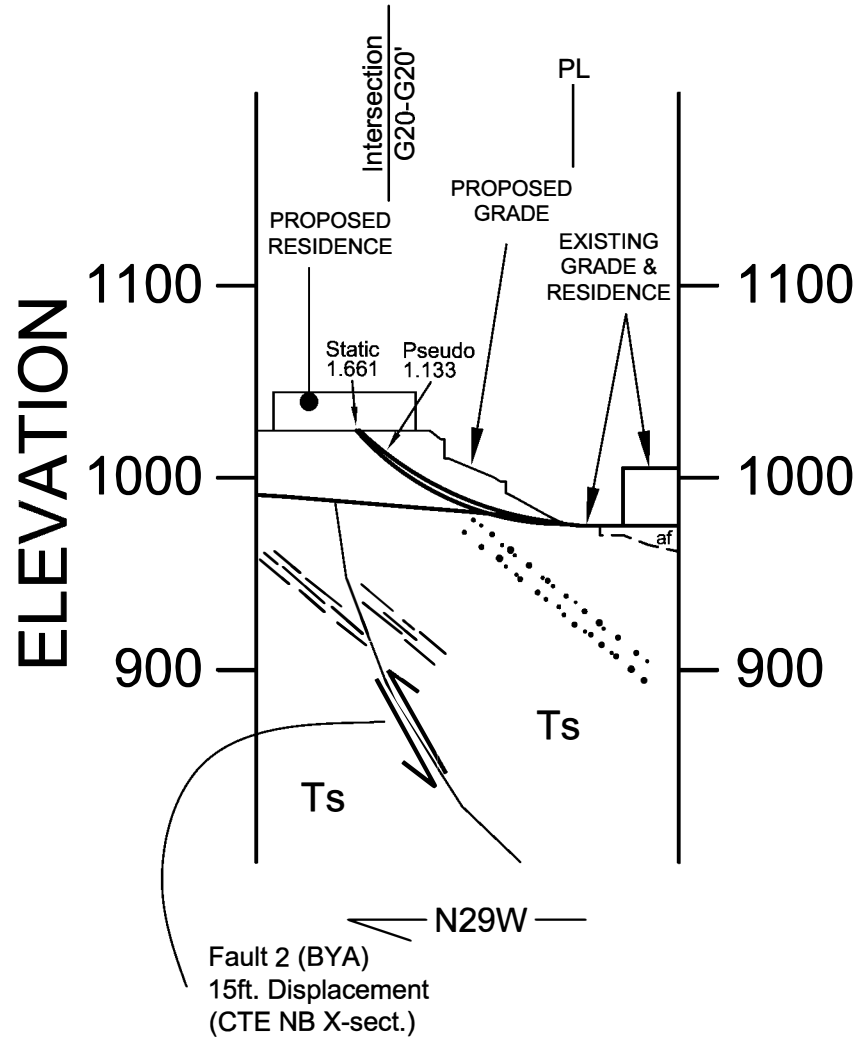
G20.1 G20.1'

The most critical wall configuration is located near the east side of the townhome site and consists of a 2:1 fill slope broken by two retaining walls, the upper wall attains a maximum height of 10 feet, and the lower a maximum height of 6 feet. The slope and walls are illustrated in cross section G20.1-G20.1' (see Plate 2.20.1). The walls will support compacted fill.

backfill (GWV, 2007). The surcharge from the proposed residential structures was simulated as a 500 pound per square foot (psf) distributed load setback seven feet from the top of slope. Preliminary analyses indicated relatively deep failure surfaces that go below both walls and exit near the toe of the slope had inadequate factors of safety.

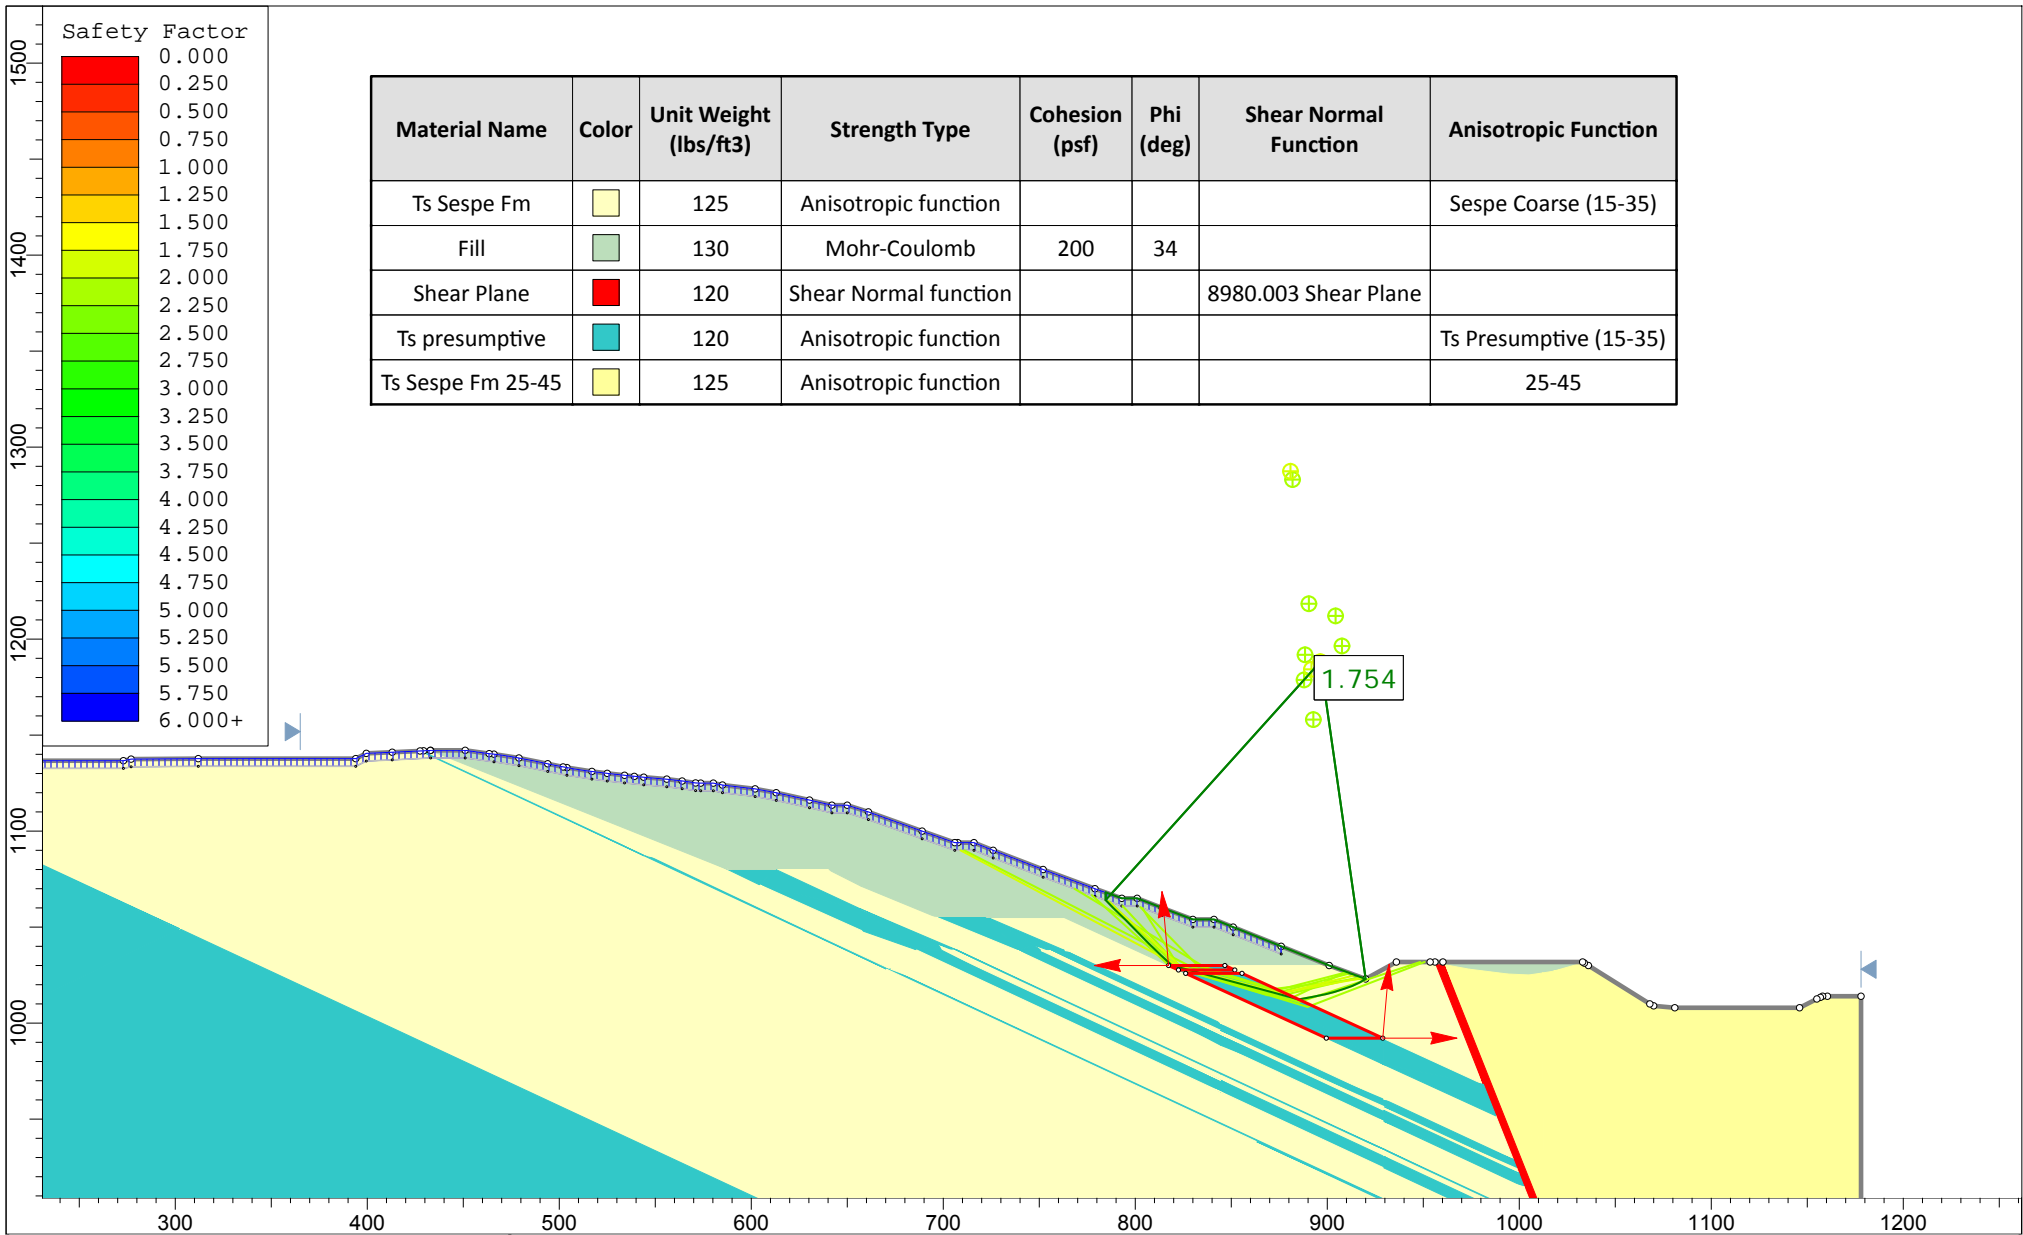
Project			North Canyon Ranch		
	Analysis Description			G1-G1' static upper fine-grained layer		
	Drawn By	RMP	Scale	1:1200	Company	GWV
	Date		File Name	2018 Update - G1 B-105at21.slim

Slope stability analyses considering proposed grades with along-bedding failures through these layers obtained inadequate factors of safety for both static and pseudostatic conditions. A buttress was designed to partially remove these layers such that adequate factors of safety may be obtained. The upper layer should be removed to an elevation of 1030 feet, the middle layer to an elevation of 1055 feet, and the lower layer to an elevation of 1080 feet. The removal is illustrated on the cross section (see Plate 2.1) and in the output from the slope stability analyses (see Appendix A). This buttress provides the slope adequate static and pseudostatic factors of safety considering along-bedding failures through each of the fine-grained layers as indicated in the table below.

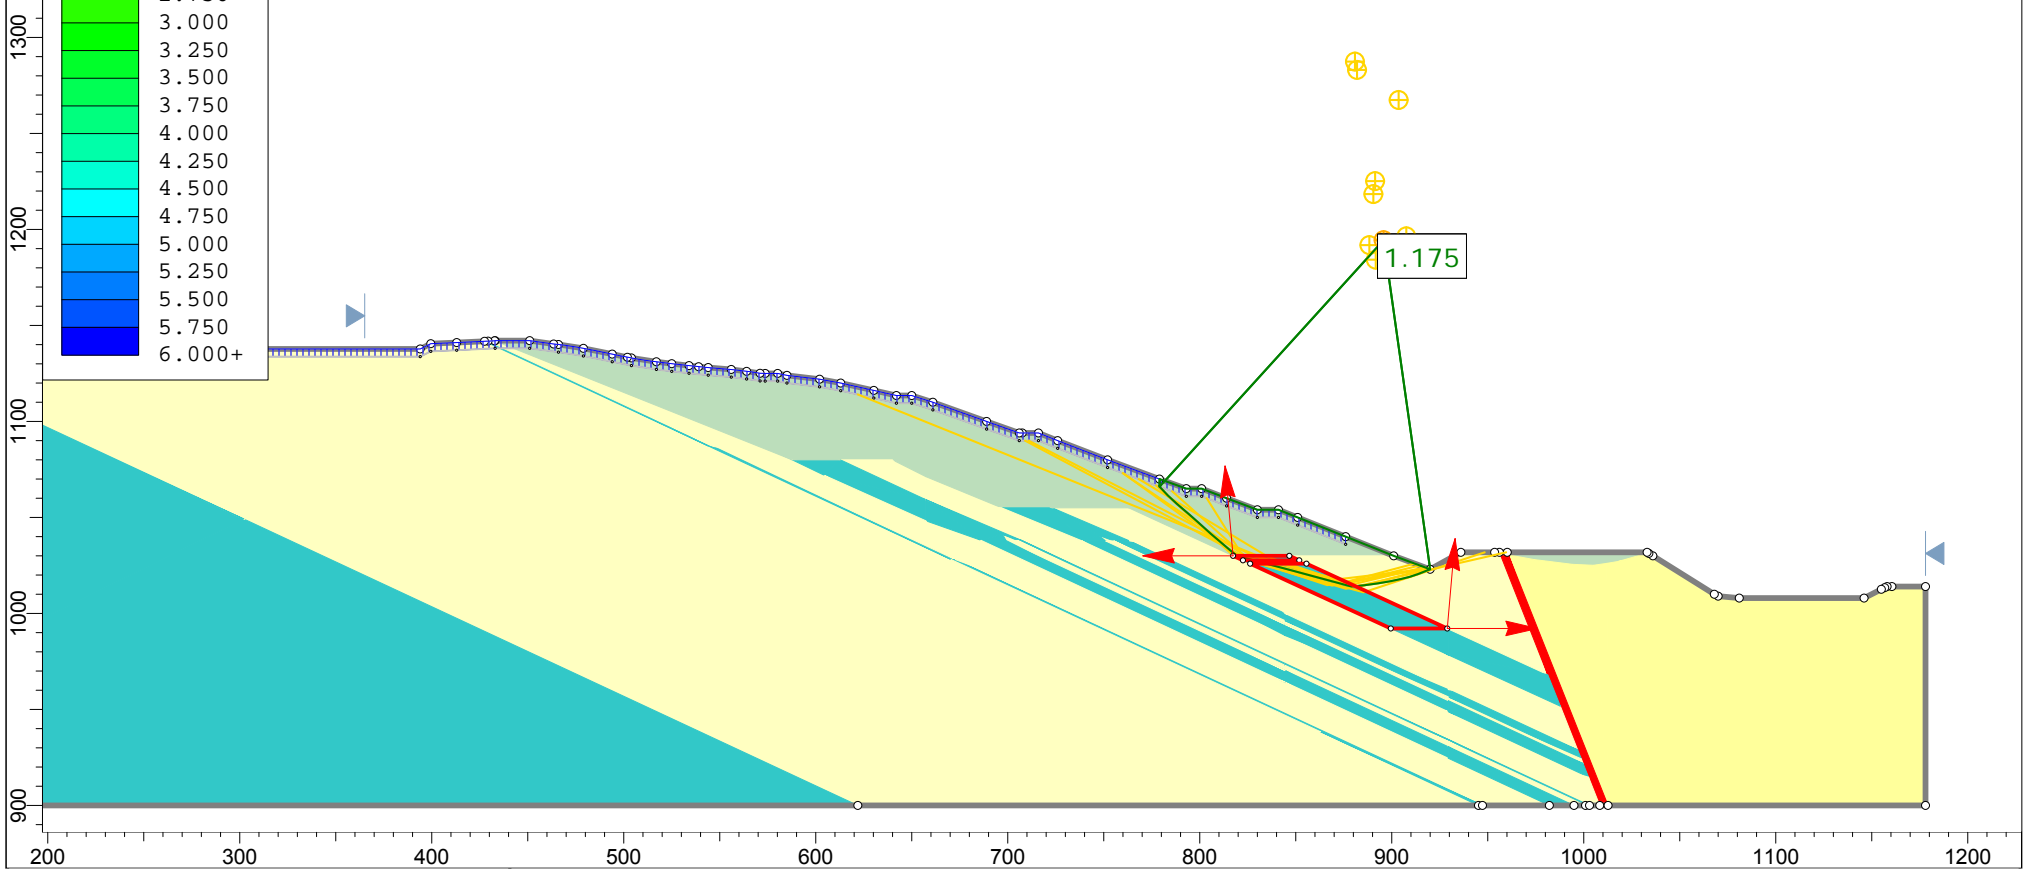
Project			North Canyon Ranch		
	Analysis Description			G1-G1' pseudostatic upper fine-grained layer		
	Drawn By	RMP	Scale	1:1200	Company	GWV
	Date		File Name	2018 Update - G1p B-105at21.slim

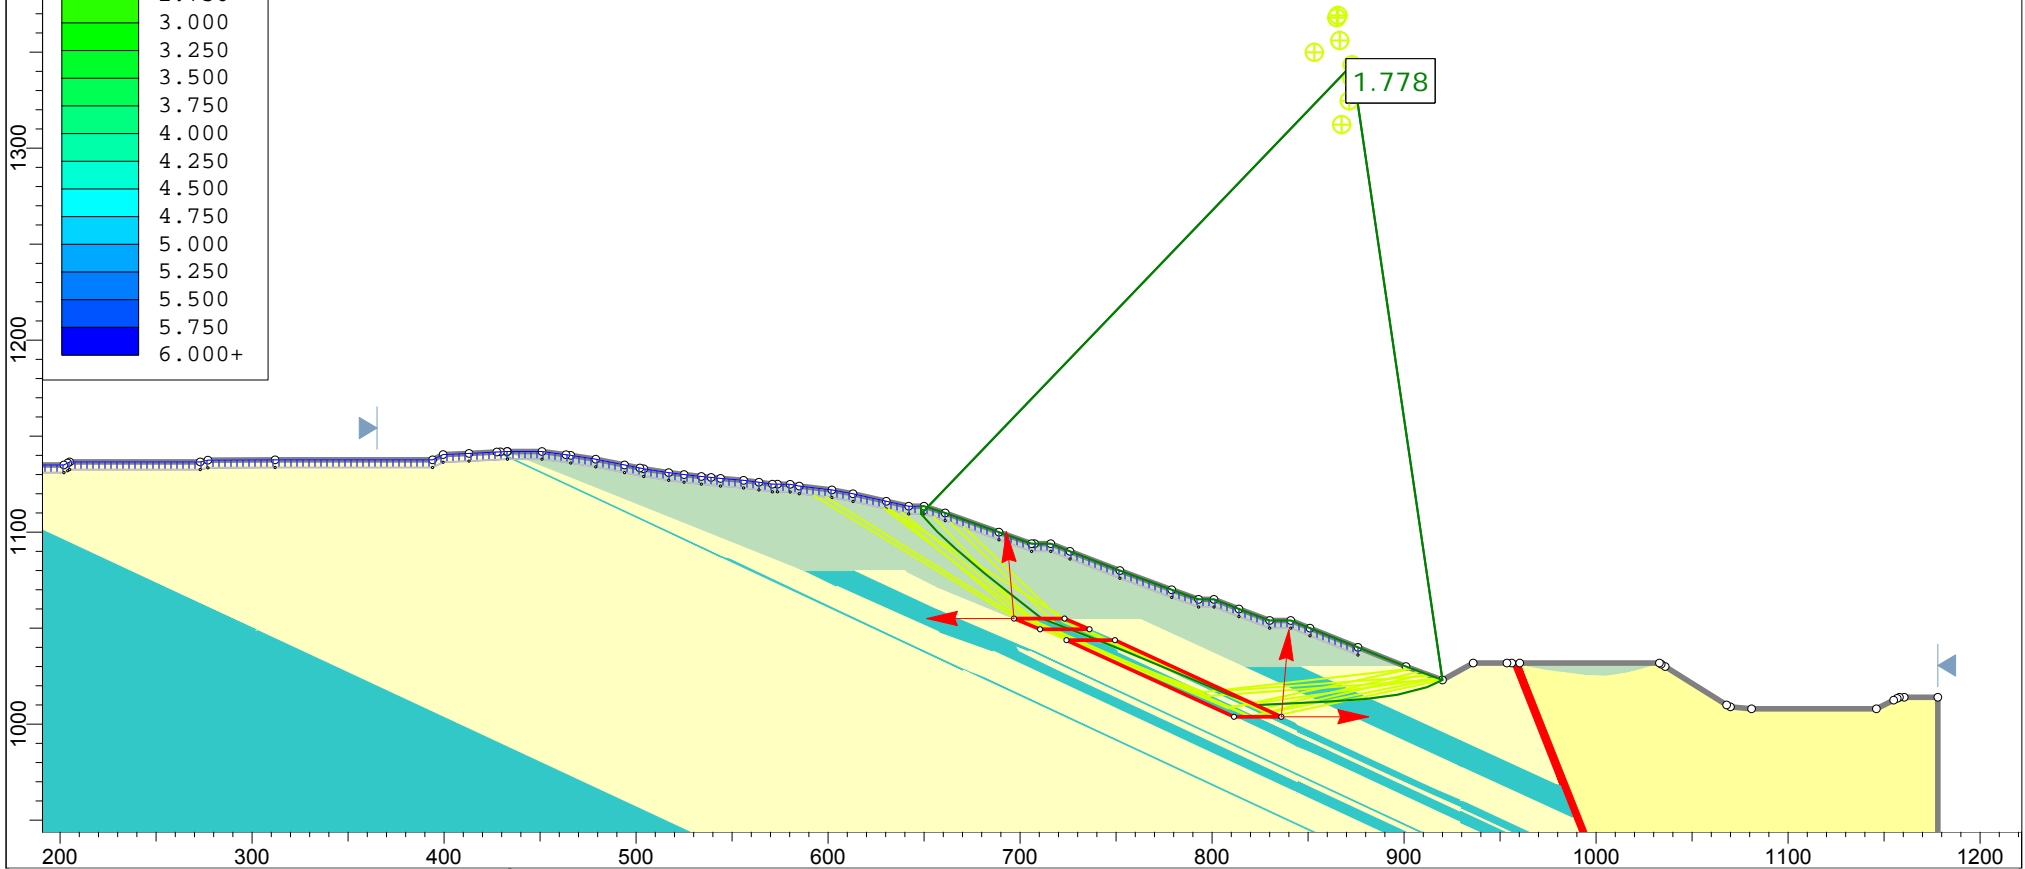
Project			North Canyon Ranch		
	Analysis Description			G1-G1' static middle fine-grained layer		
	Drawn By	RMP	Scale	1:1200	Company	GWV
	Date		File Name	2018 Update - G1 B14at21.slim

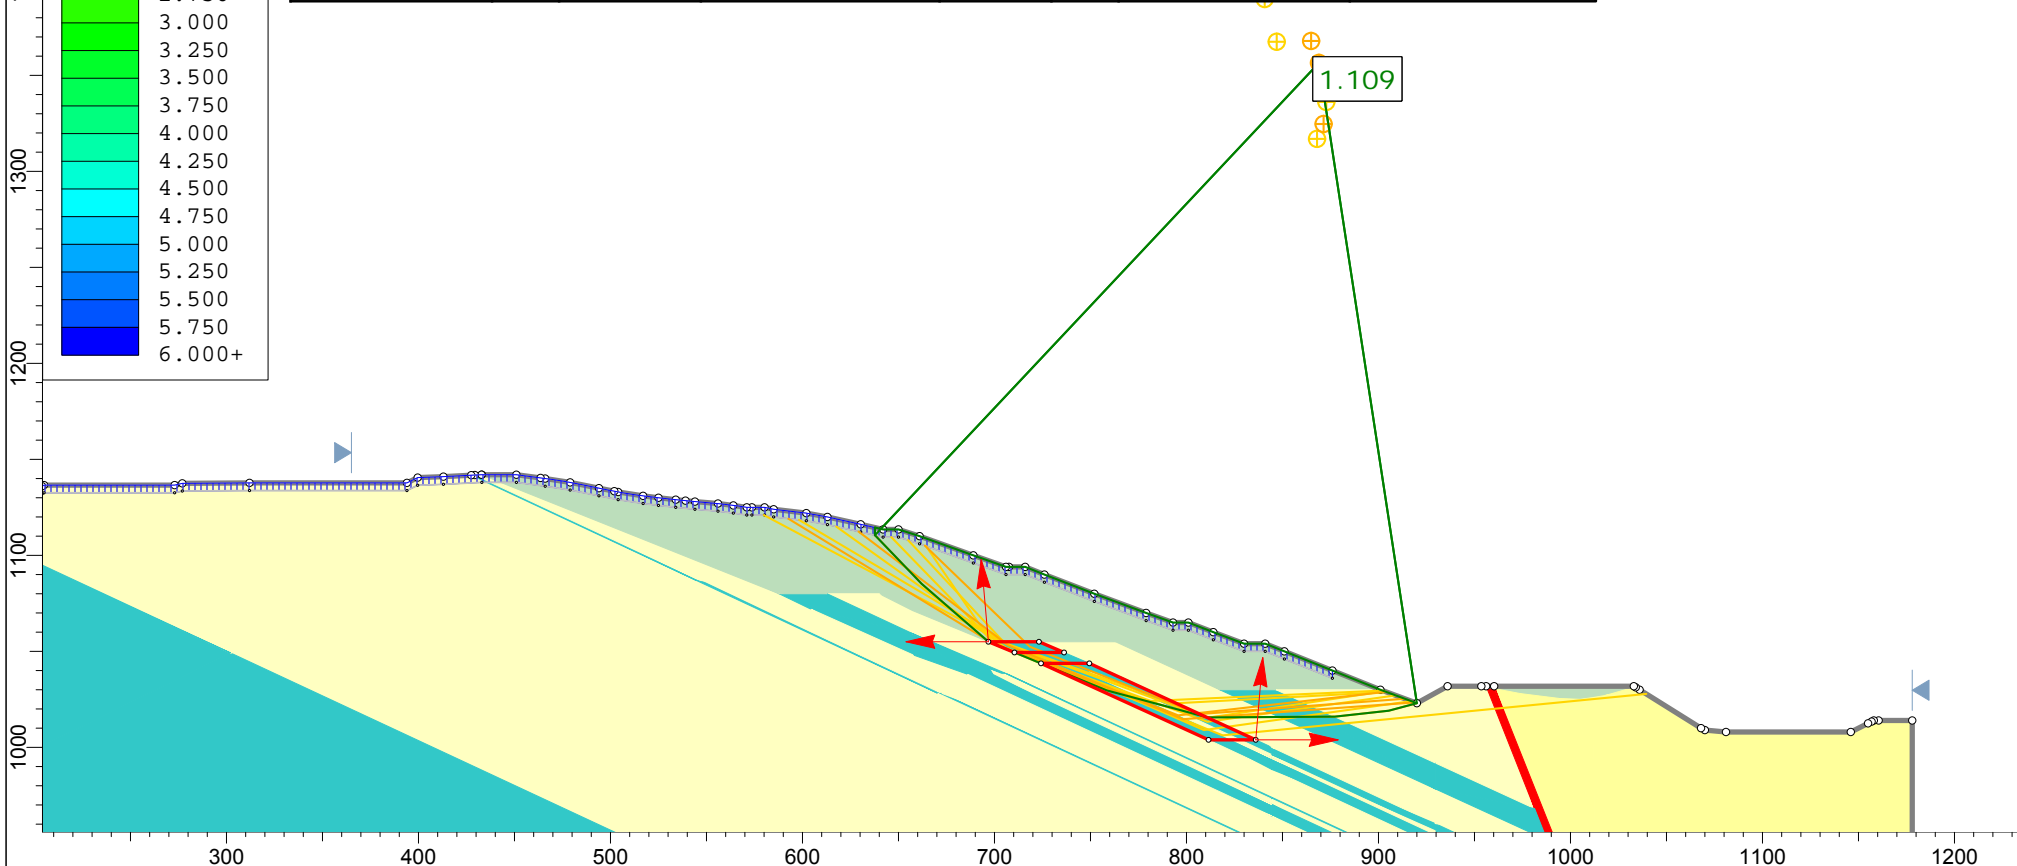
Project			North Canyon Ranch		
	Analysis Description			G1-G1' pseudostatic middle fine-grained layer		
	Drawn By	RMP	Scale	1:1200	Company	GWV
	Date		File Name	2018 Update - G1p B14at21.slim

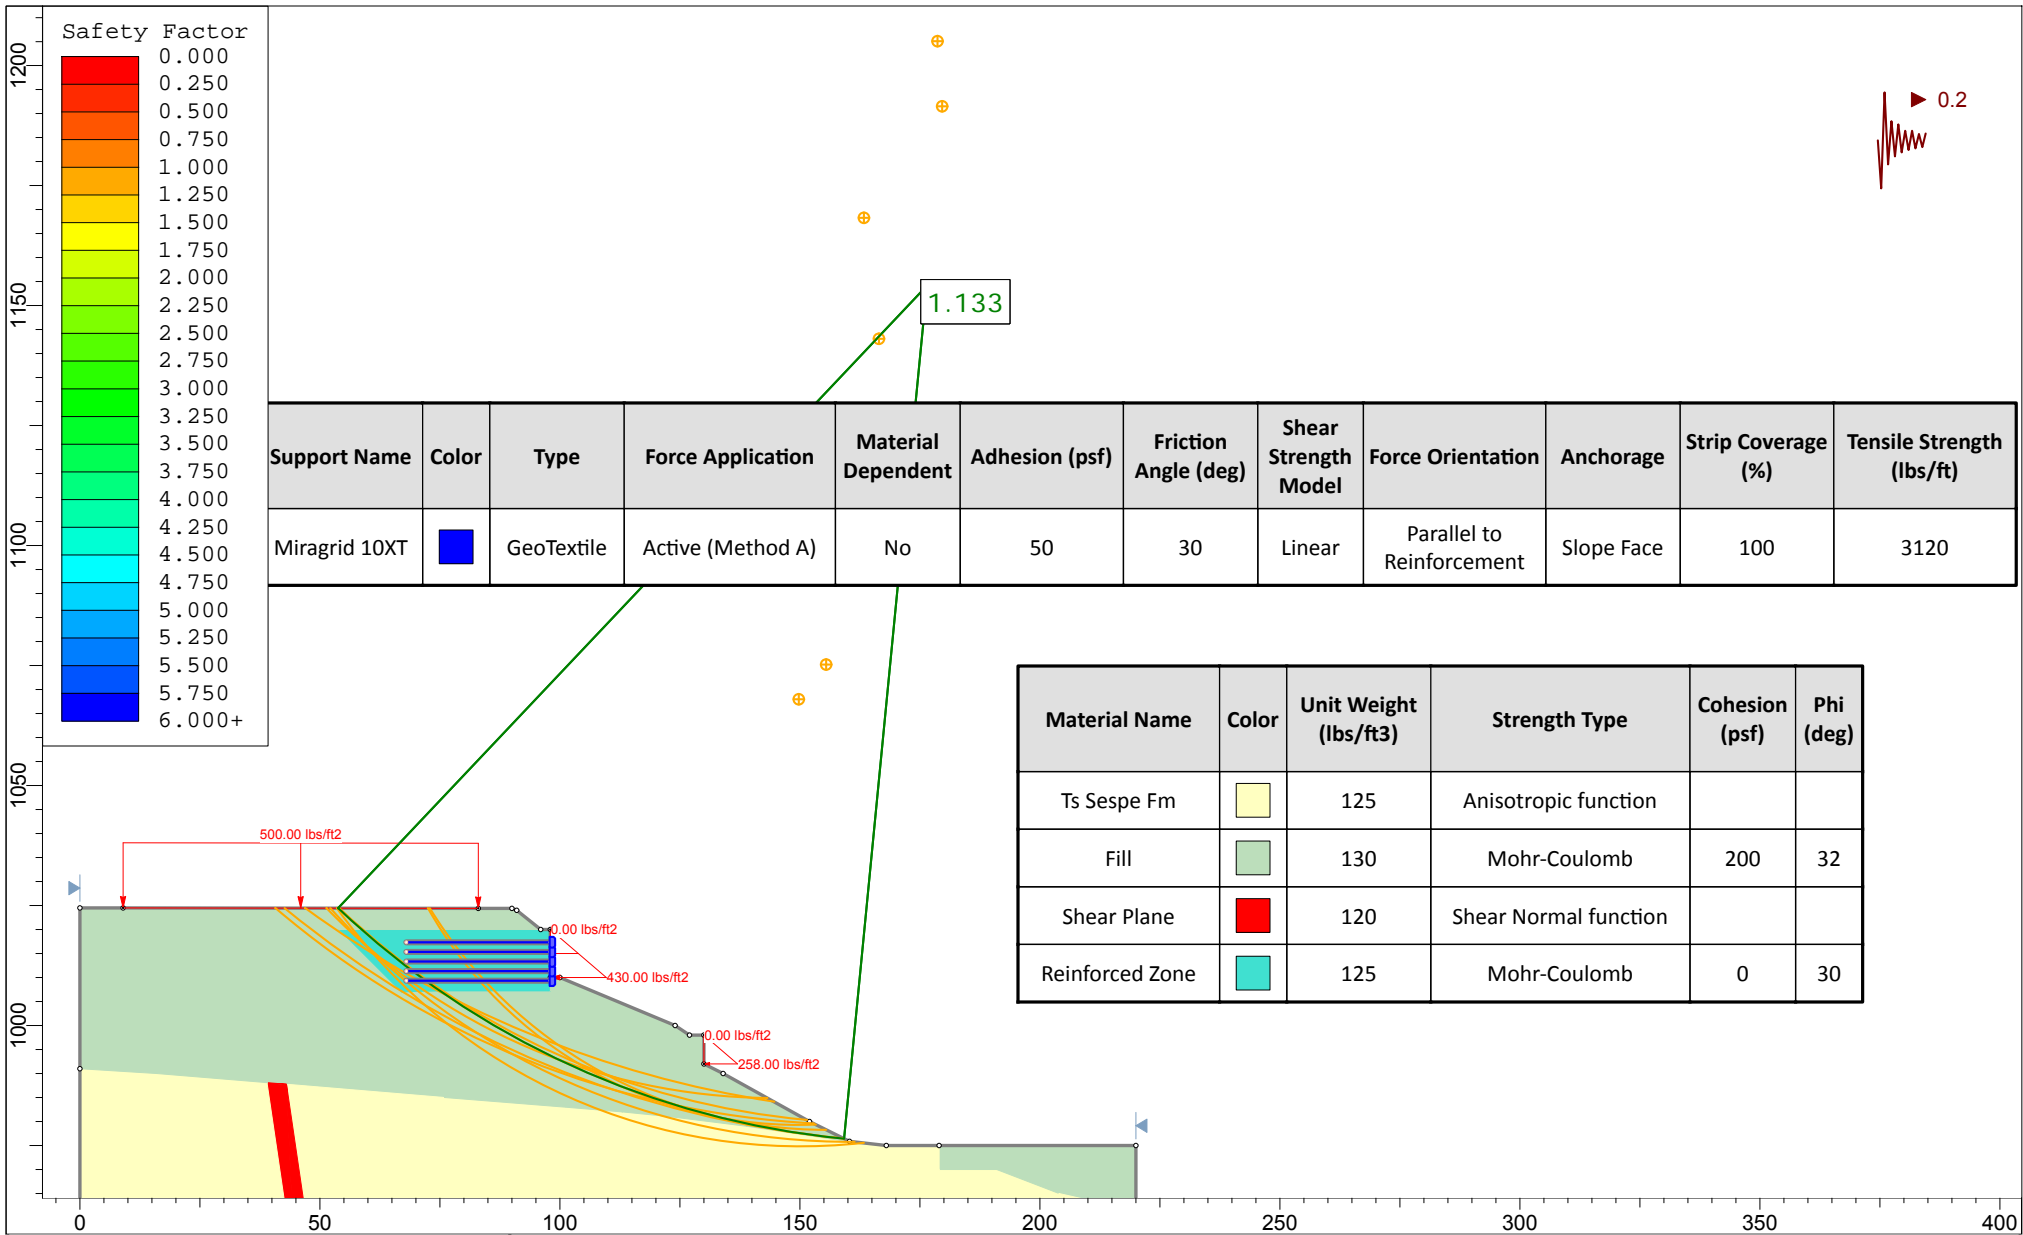
Project		North Canyon Ranch	
	Analysis Description		G20.1-G20.1' pseudostatic	
	Drawn By	RMP	Scale	1:480
	Date		Company	GWV
			File Name	G20.1Rp_EFP and grids.slim

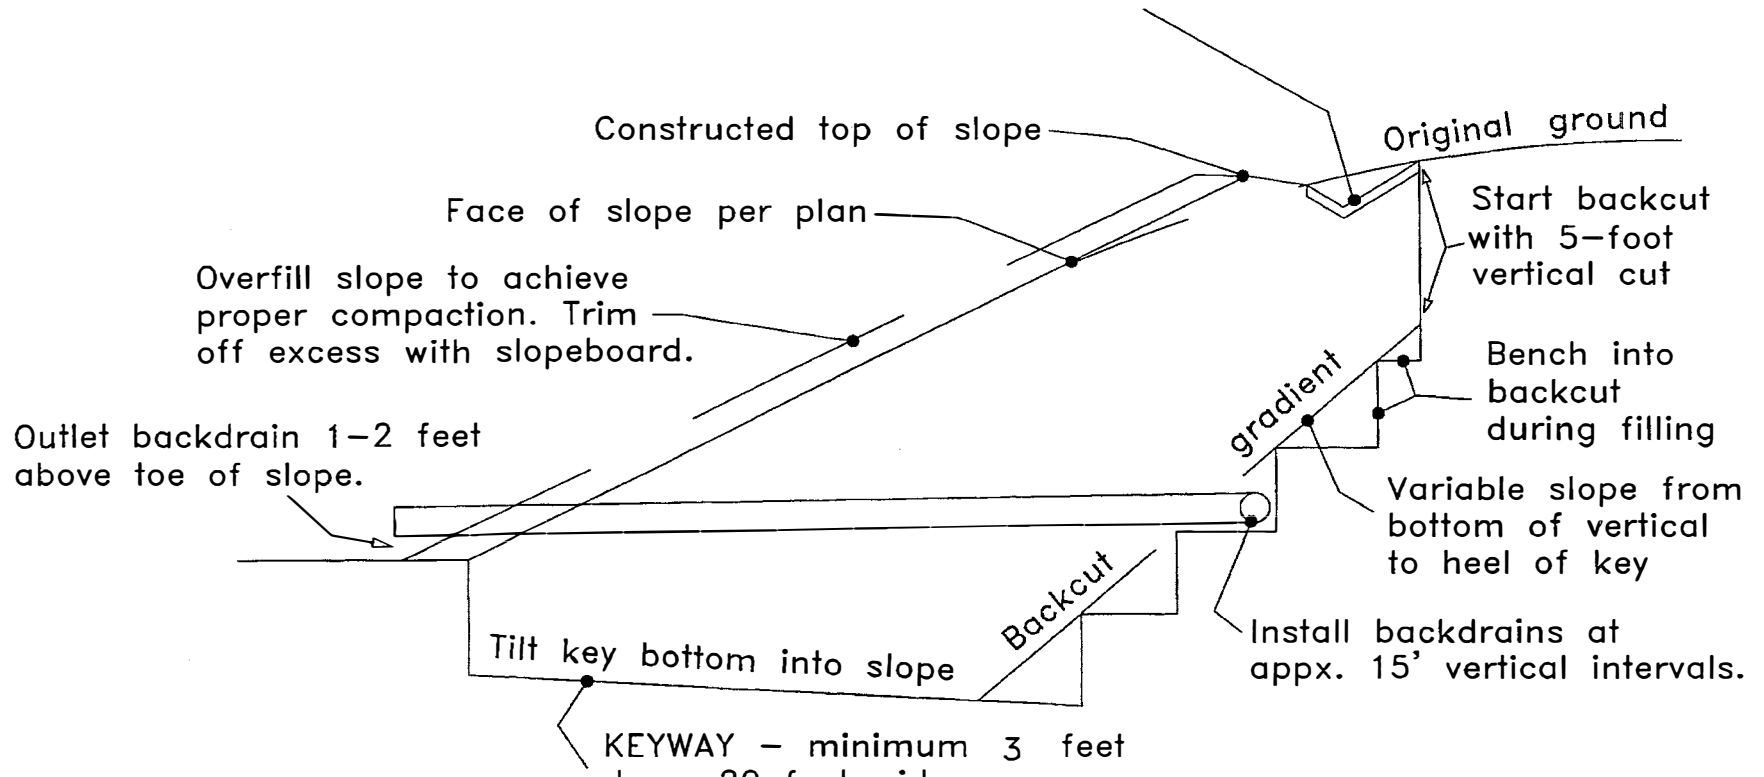
TYPICAL STABILITY/BUTTRESS FILL BELOW PAD OR OTHER FLAT GRADED AREA

Construct interceptor drain in compacted fill. Engineer should verify that top of fill (top of backcut) has adequate fall for interceptor drain.

Install lowermost backdrain at heel of key if gravity flow outlet can be maintained.

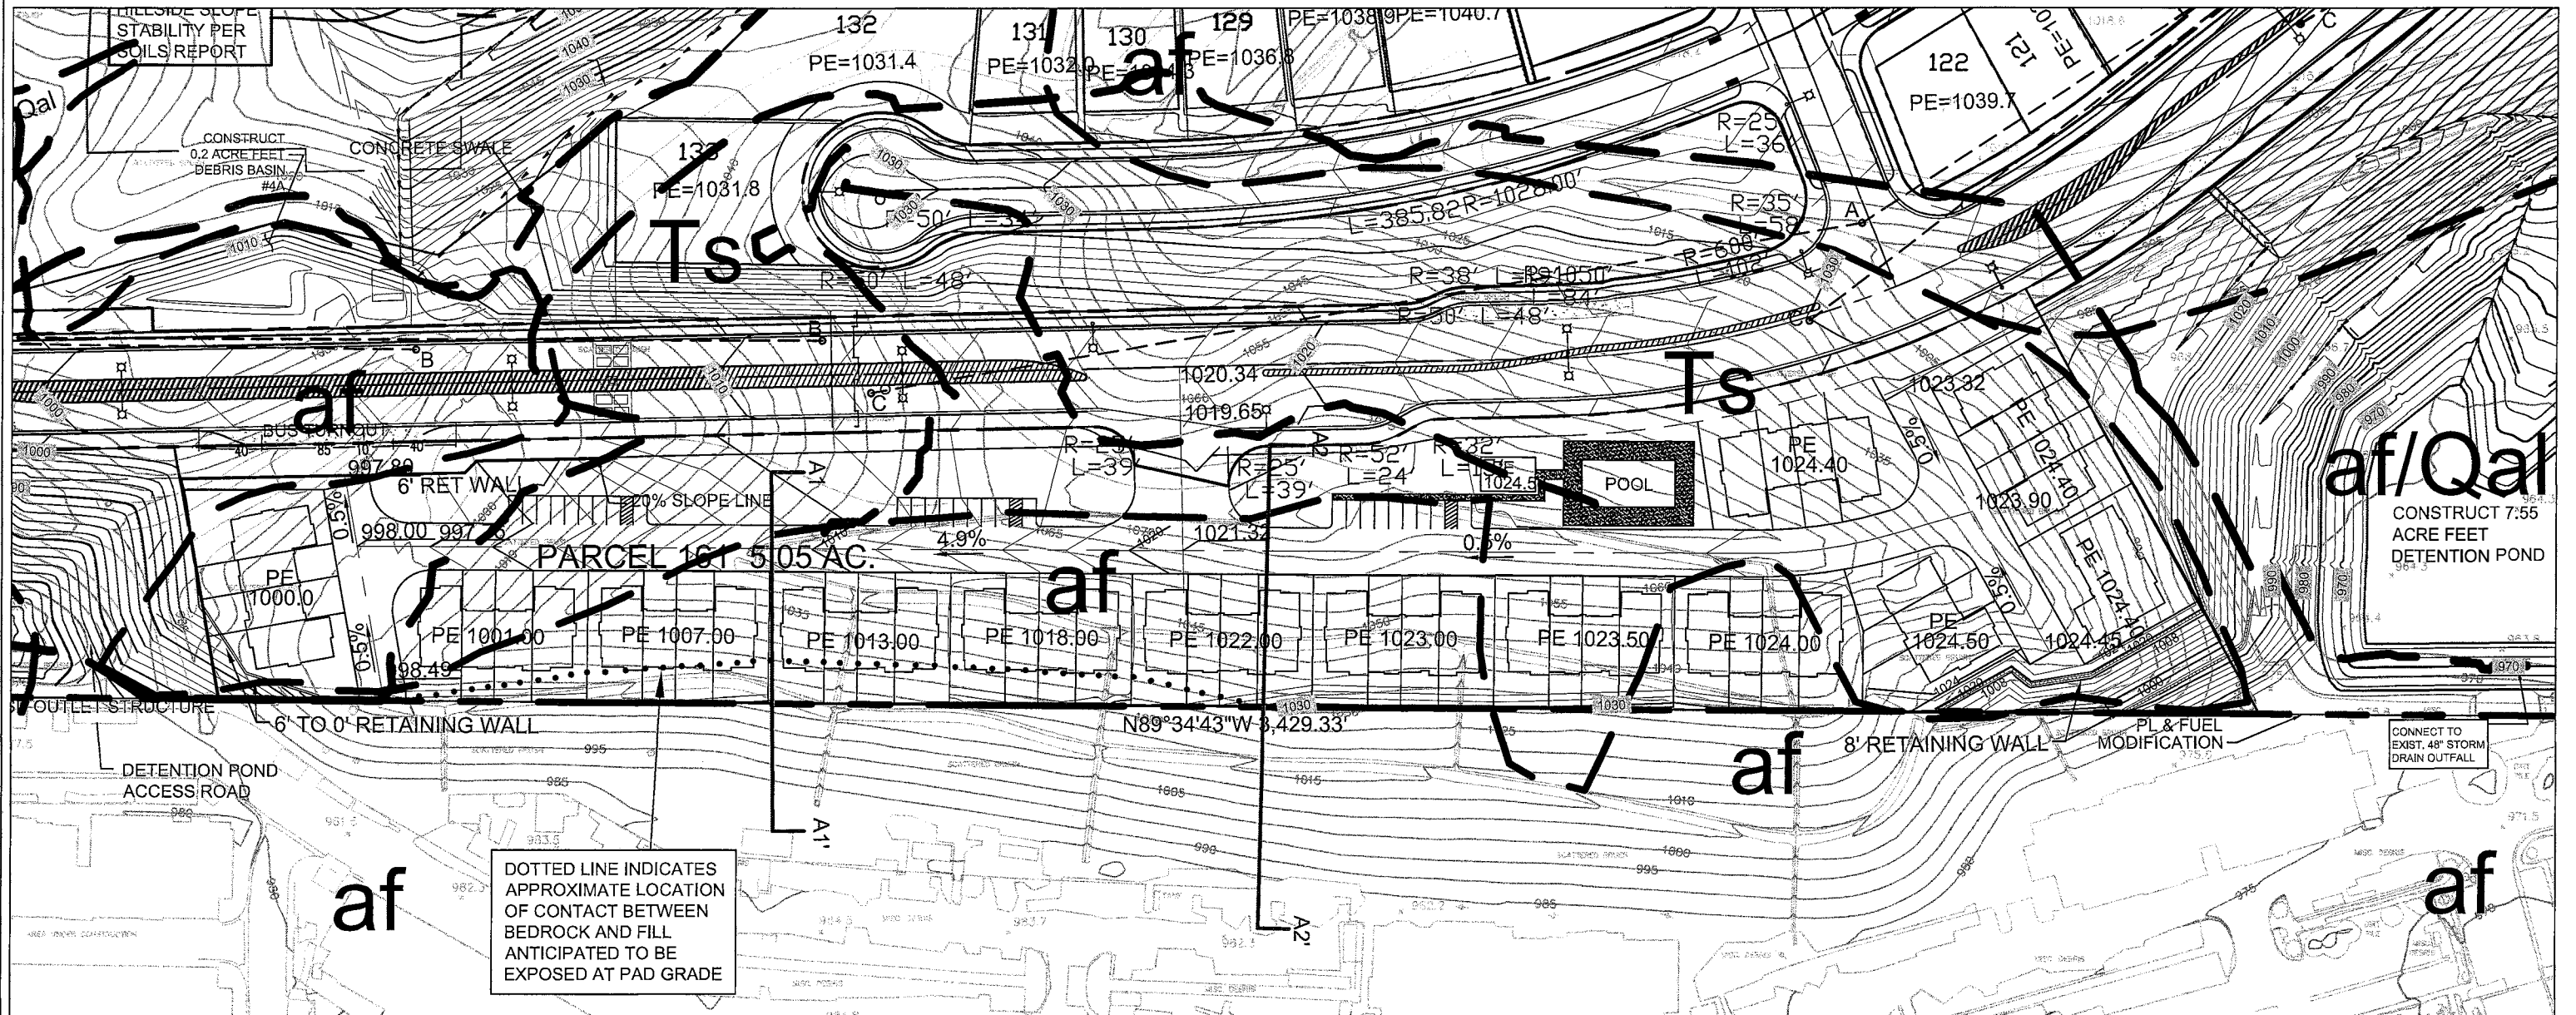
DOTTED LINE INDICATES APPROXIMATE LOCATION OF CONTACT BETWEEN BEDROCK AND FILL ANTICIPATED TO BE EXPOSED AT PAD GRADE
