A Report Prepared for:

**PHASE I
ENVIRONMENTAL SITE ASSESSMENT
435 EAST 3RD AVENUE
SAN MATEO, CALIFORNIA**

APRIL 22, 2021

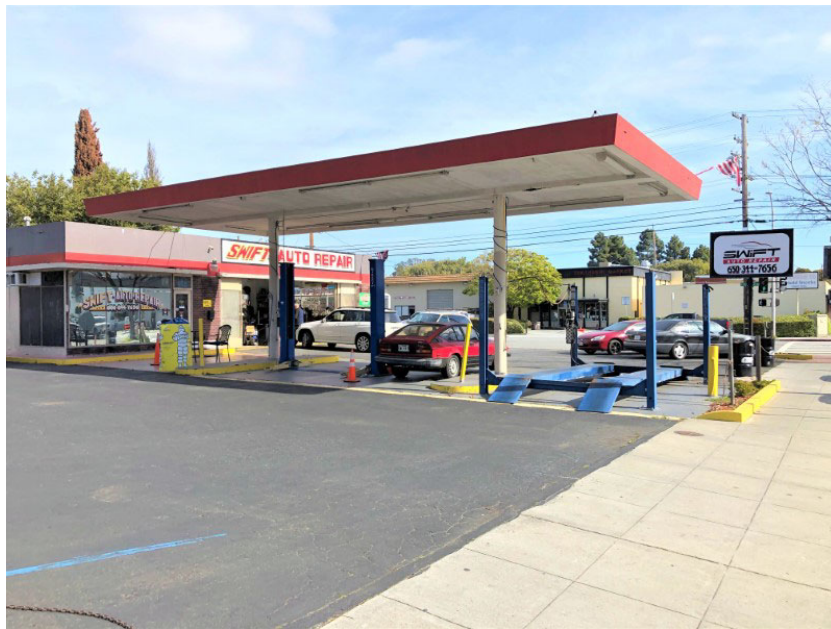
Photo 1.
View of subject property, facing north. Photograph taken March 16, 2021.

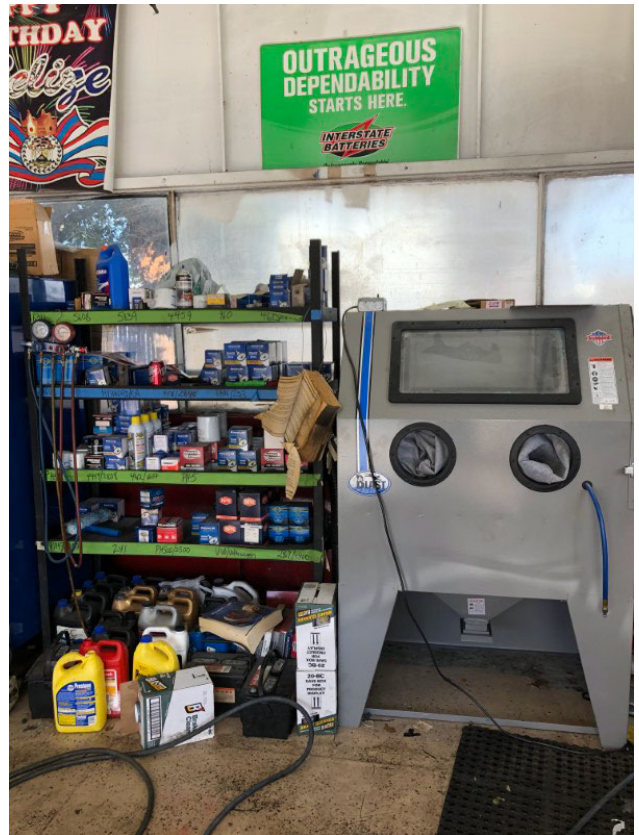
Photo 2.
Chemical storage inside auto repair shop. Photograph taken March 16, 2021.

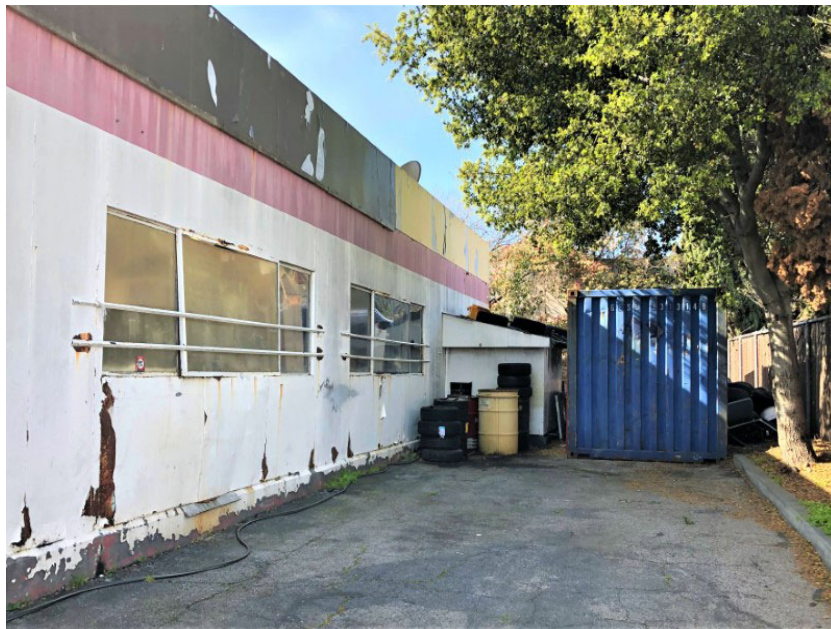
Photo 1.
View of deteriorating exterior back (northwest) wall of onsite building, facing west. Shipping container, used tires, and 55-gallon drums of used hazardous waste in background of photo. Photograph taken March 16, 2021.

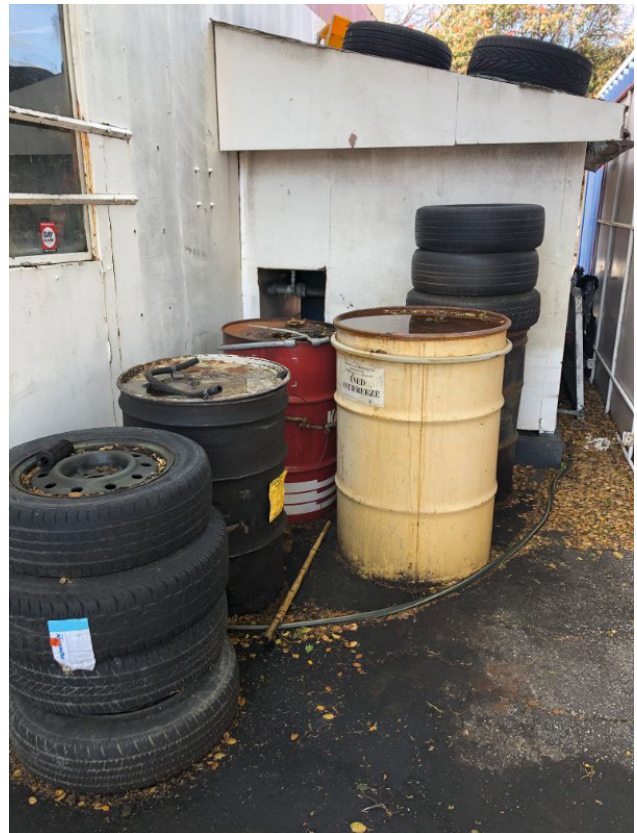
Photo 2.
Used tires and 55-gallon drums of used hazardous waste (one labelled used-anti-freeze and two with labels too faded to be legible). Photograph taken March 16, 2021.

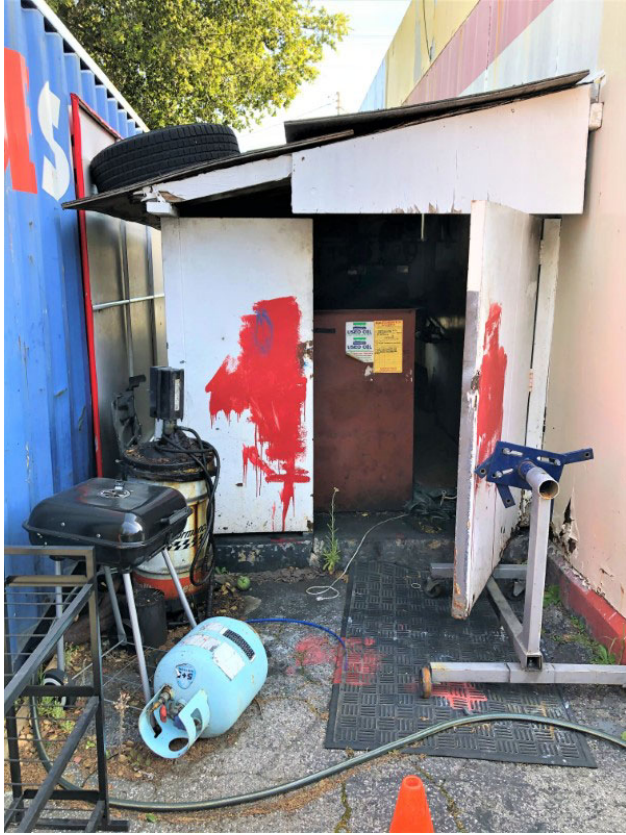
Photo 1.
Hazardous waste storage on backside (northwest) of onsite building – Shed and secondary containment for waste oil AST, 20-gallon mobile waste oil drain tank, and stained concrete in poor condition. Photograph taken March 16, 2021.

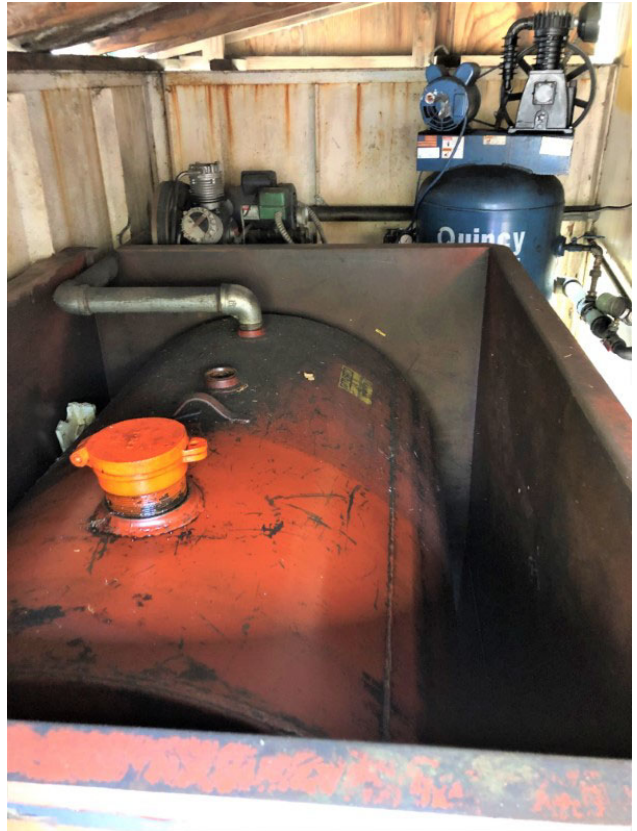
Photo 2.
220-gallon waste oil AST within secondary containment.
Photograph taken March 16, 2021.

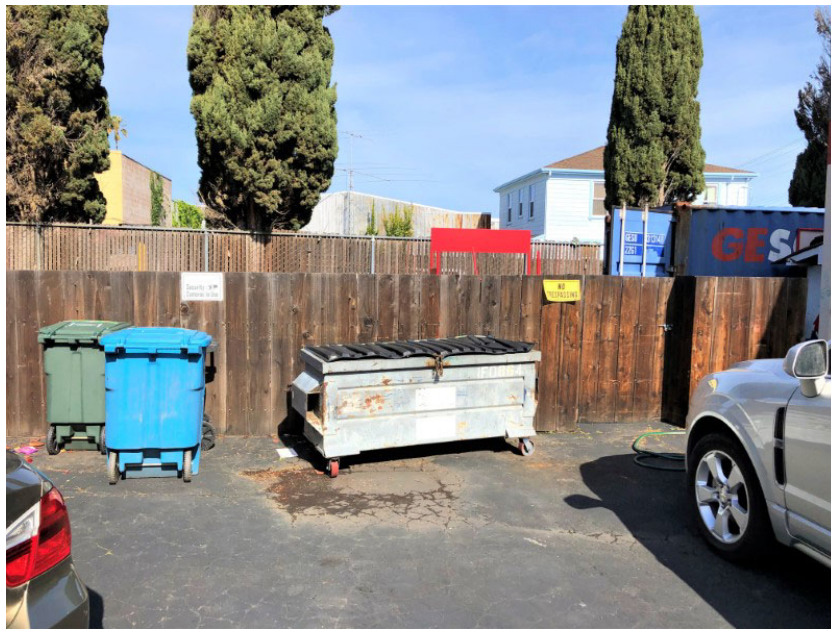
Photo 1.
Rubbish, recycle, and green waste bins on west side of subject property.
Photograph taken March 16, 2021.

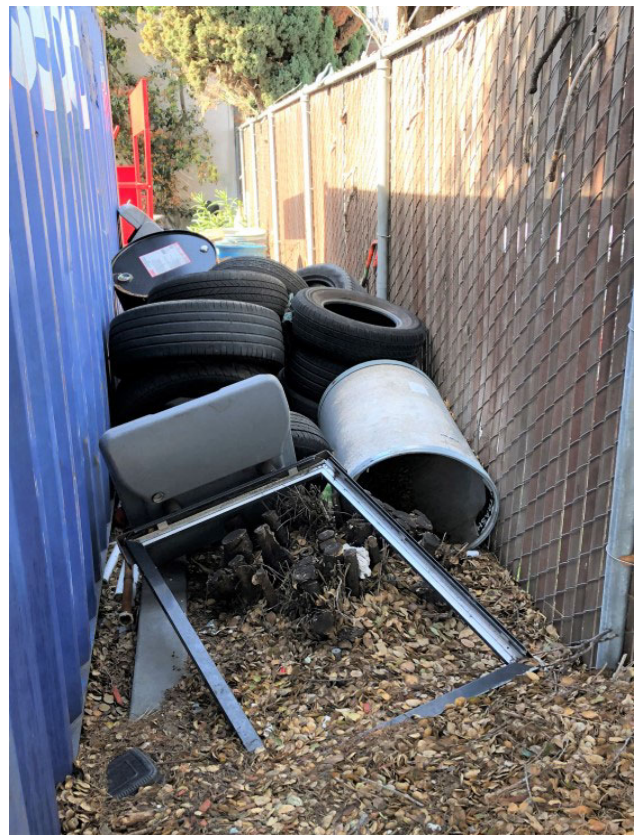
Photo 2.
Used tires, 55-gallon drums, and various rubbish between shipping container and northwest property boundary.
Photograph taken March 16, 2021.
