Channel Coast District Damage Assessment

Gaviota SP

Hot Springs Water Line Failure

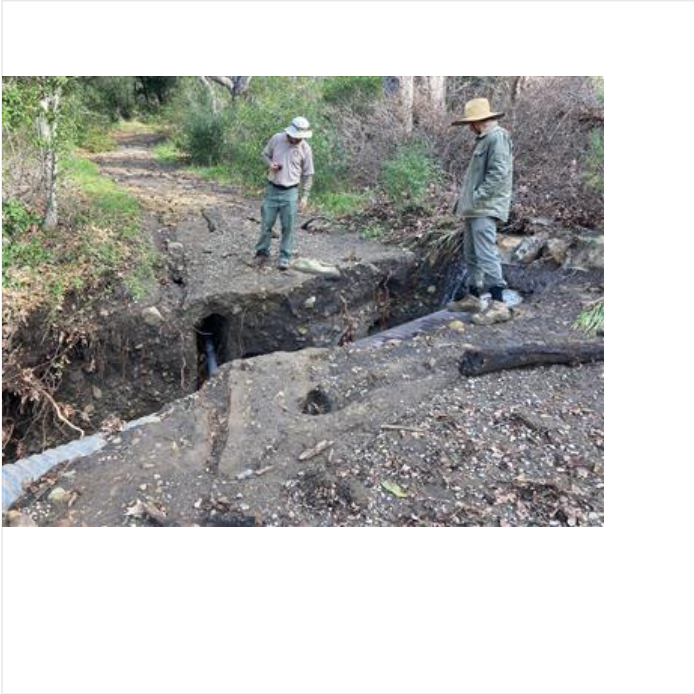
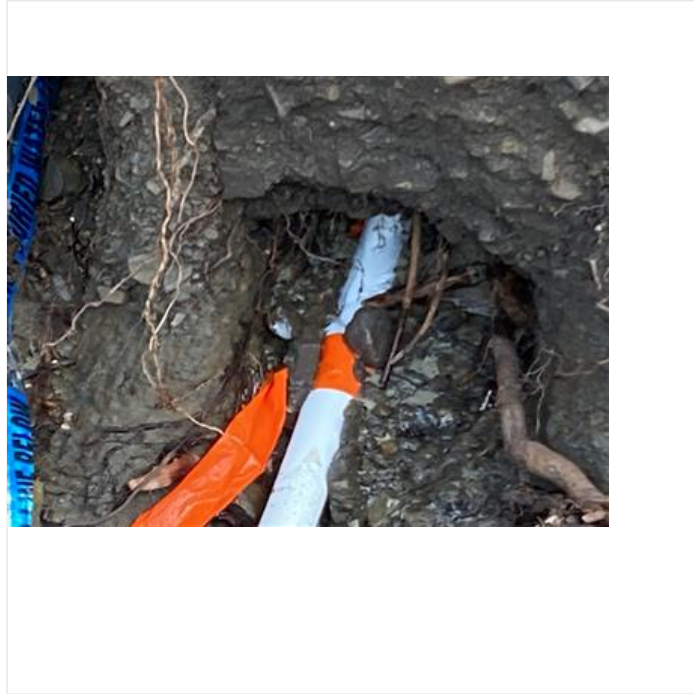
Waterline has been broken from damage caused from storm rainfall runoff in the Gaviota Creek watershed. The waterline culverts, and road bed is in need of repair and the road condition needs to be further evaluated. This waterline supplies water from our spring source to our water treatment facility and is the primary source of potable water for entire Gaviota State Park campground, public beach access day use area, Hwy 101 Caltrans rest area and several residences. Major public safety concern, loss of revenue, loss of public utility.
