Phase I Environmental Site Assessment Report

Area Y
10819 Valley Boulevard
El Monte, California

October 16, 2019 | Project No. 211175001

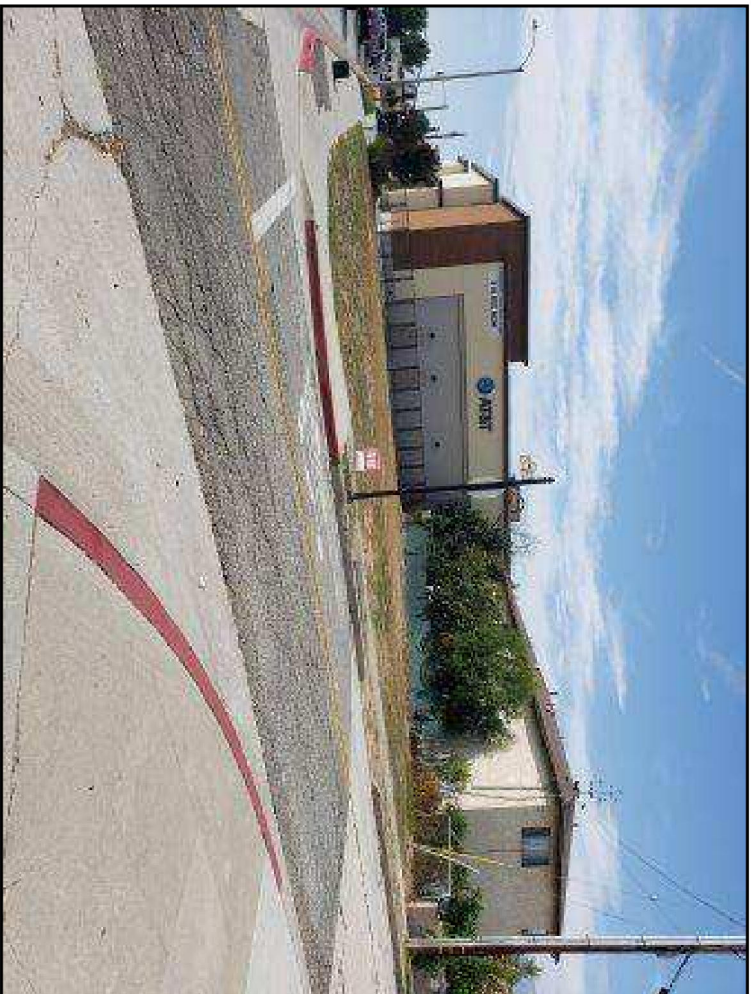
1 : Looking west towards the site, the southwestern vacant lot.

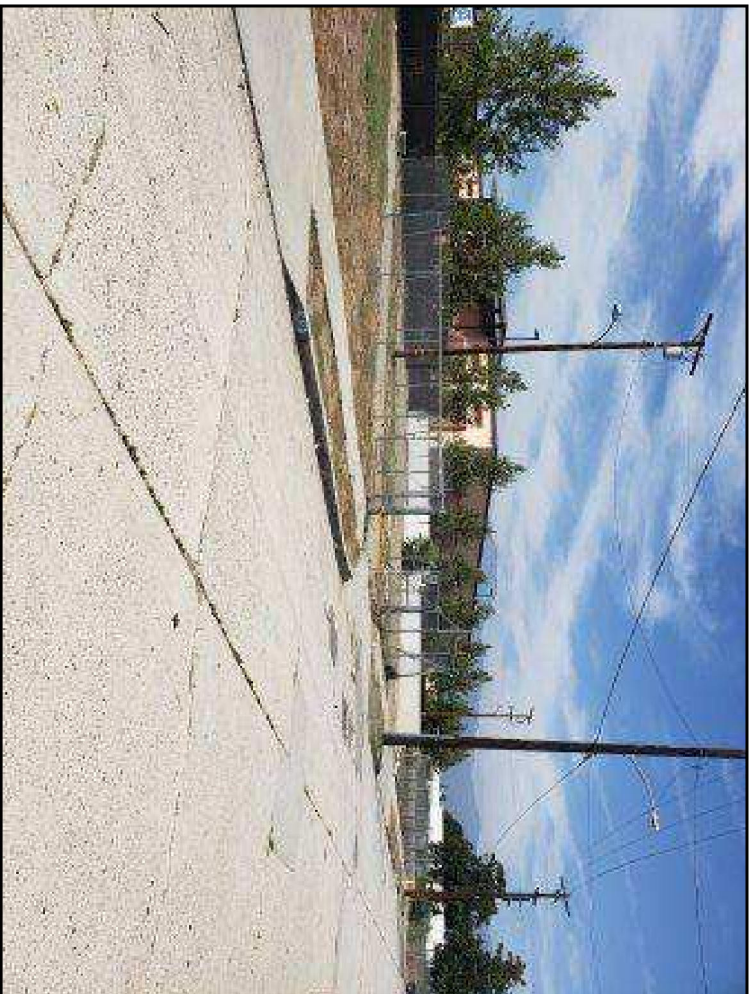
2 : Looking northwest towards the site and Monterey Avenue, the northwestern vacant lot.

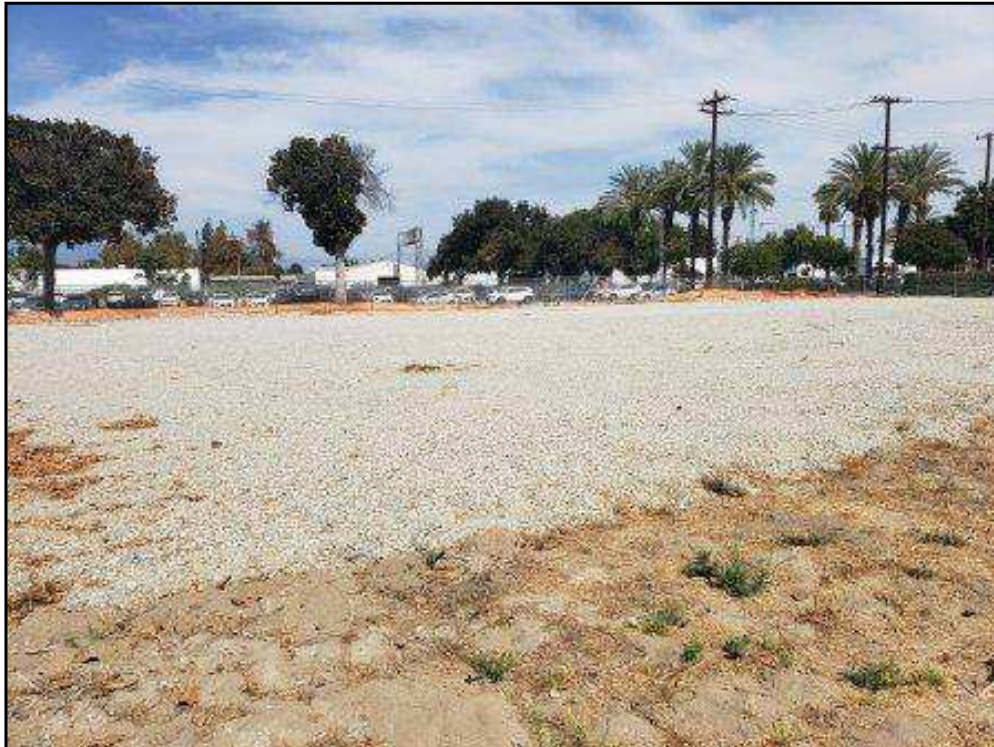
3 : Looking north on the central portion of the east vacant lot.

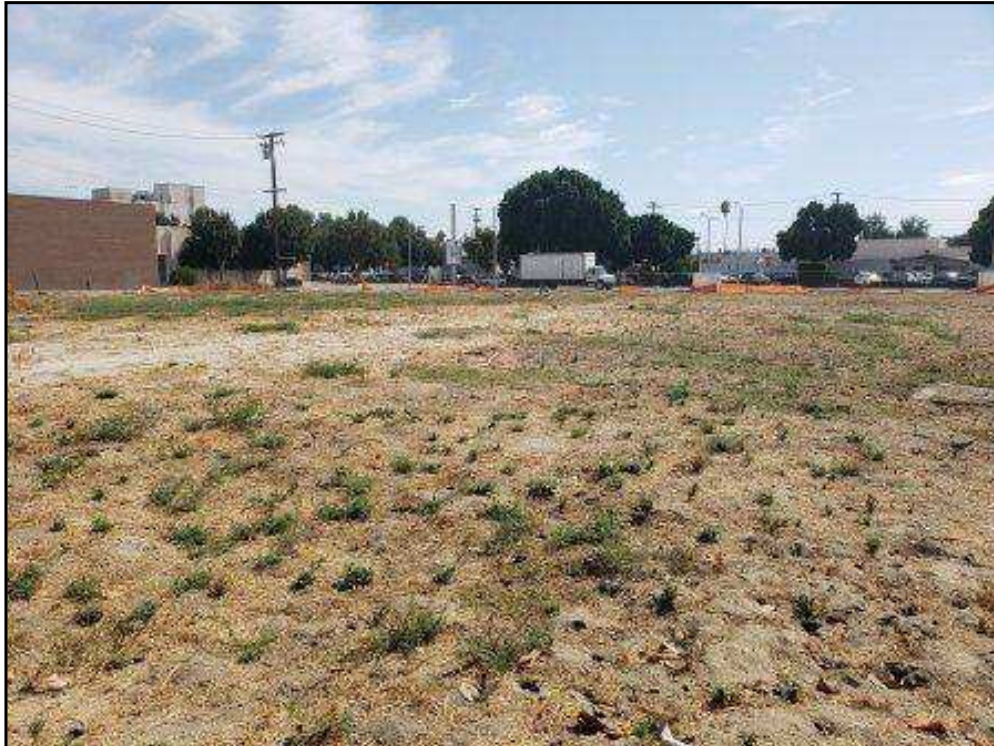
4 : Looking south on the central portion of the east vacant lot.

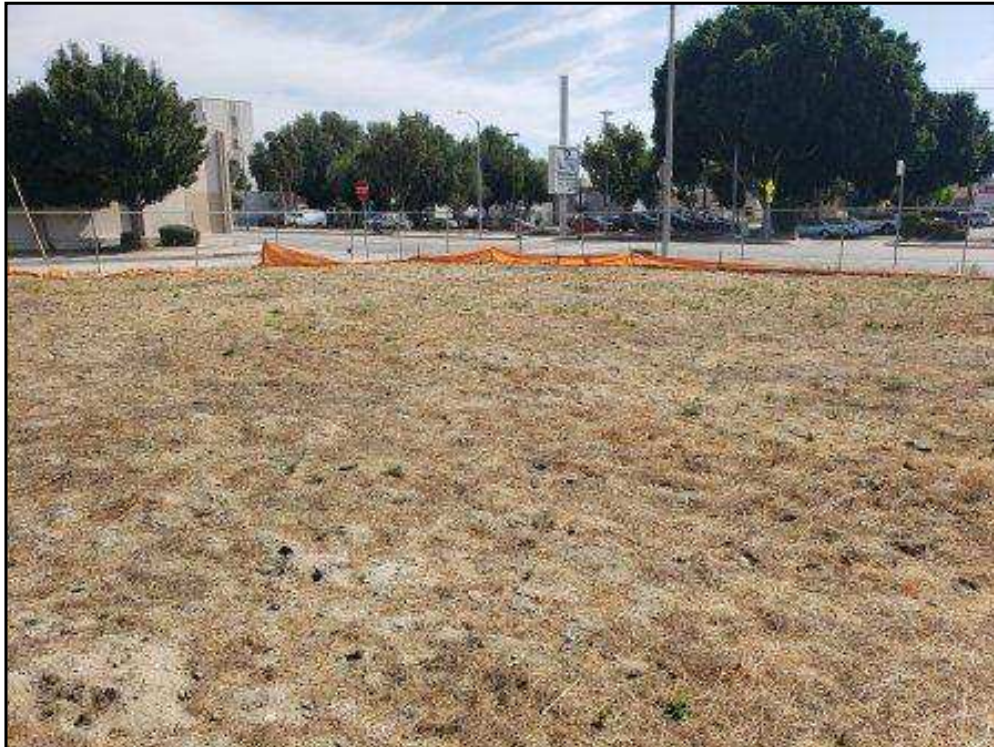
5 : Looking northwest of the former gas station on the southern portion of the east vacant lot

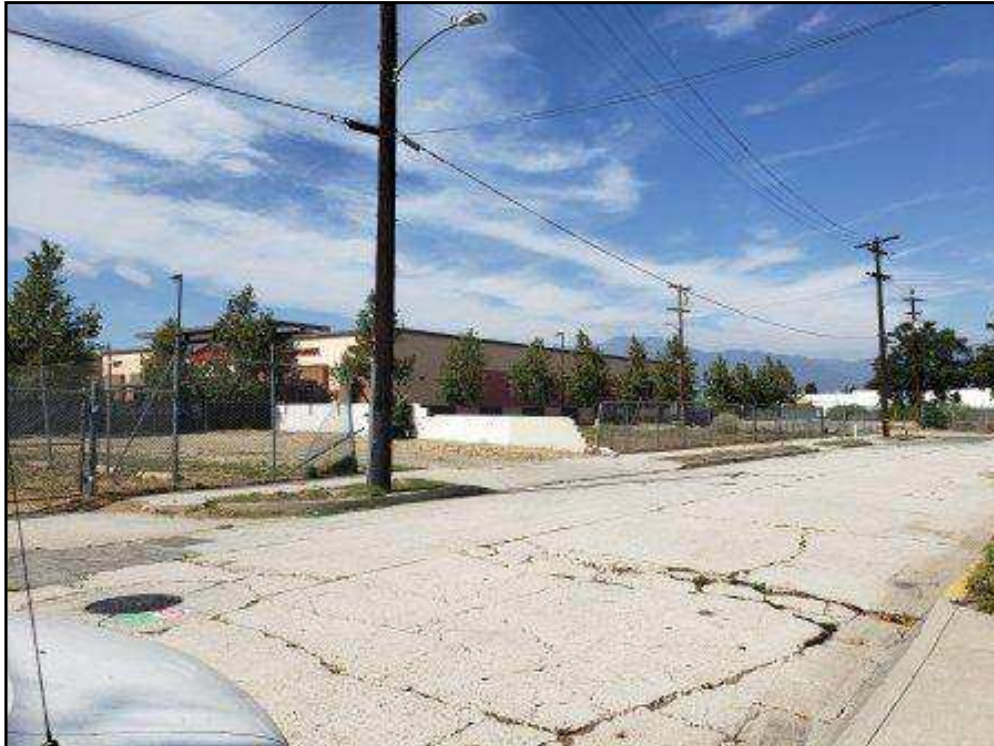
- Four pole-mounted transformers were observed on the site. Signs of leaks or staining were not observed.
- Review of an environmental database report obtained for this project indicated that the site is listed on several of the regulatory databases researched by Environmental Data Resources Inc. (EDR), including the HAZNET, RCRA-SQG, ECHO, FINDS, WIP, RCRA NonGen, LUST, SWEEPS UST, HIST CORTESE, CIWQS, CERS, and CA FID UST databases. The site is listed on the Leaking Underground Storage Tank (LUST) database for gasoline potentially contaminating the soil. The case was opened in November 1989, and after remediation and clean up activities were completed to the satisfaction of the regulatory agency, which included the excavation and disposal of the contaminated soil, the case was closed in July 1991. Due to the closed status of the case, and the absence of current contamination controls, the closed LUST case is considered an HREC.

6 : Looking northwest of the three pole-mounted transformers on the western portion of the site.

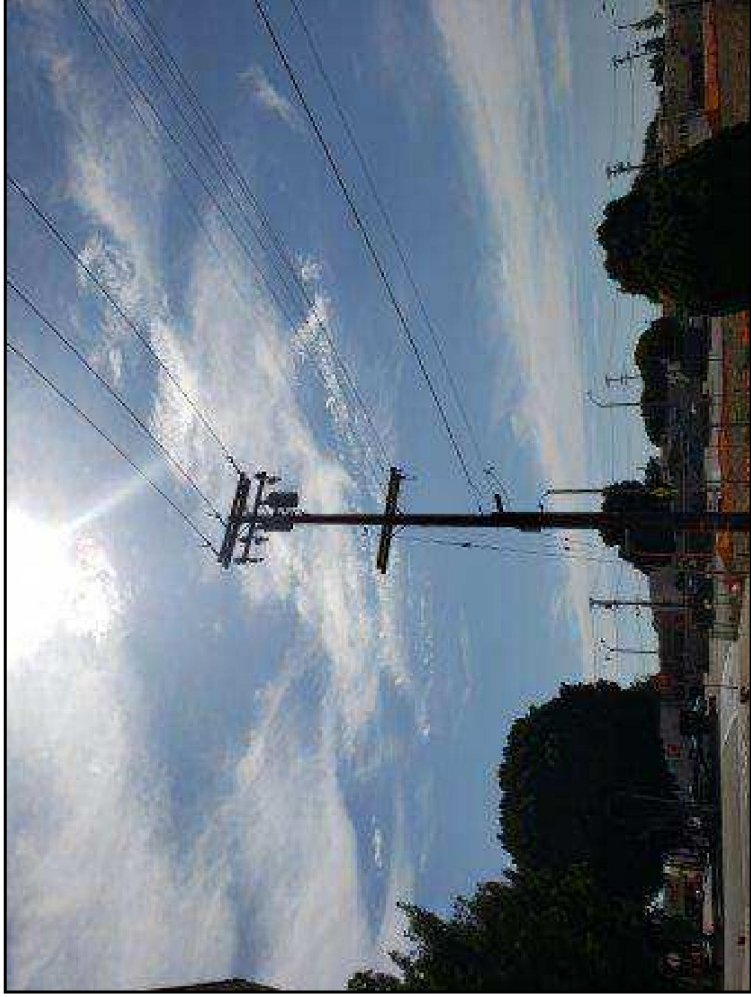
7 : Looking south of the one pole mounted transformer on the eastern portion of the site.

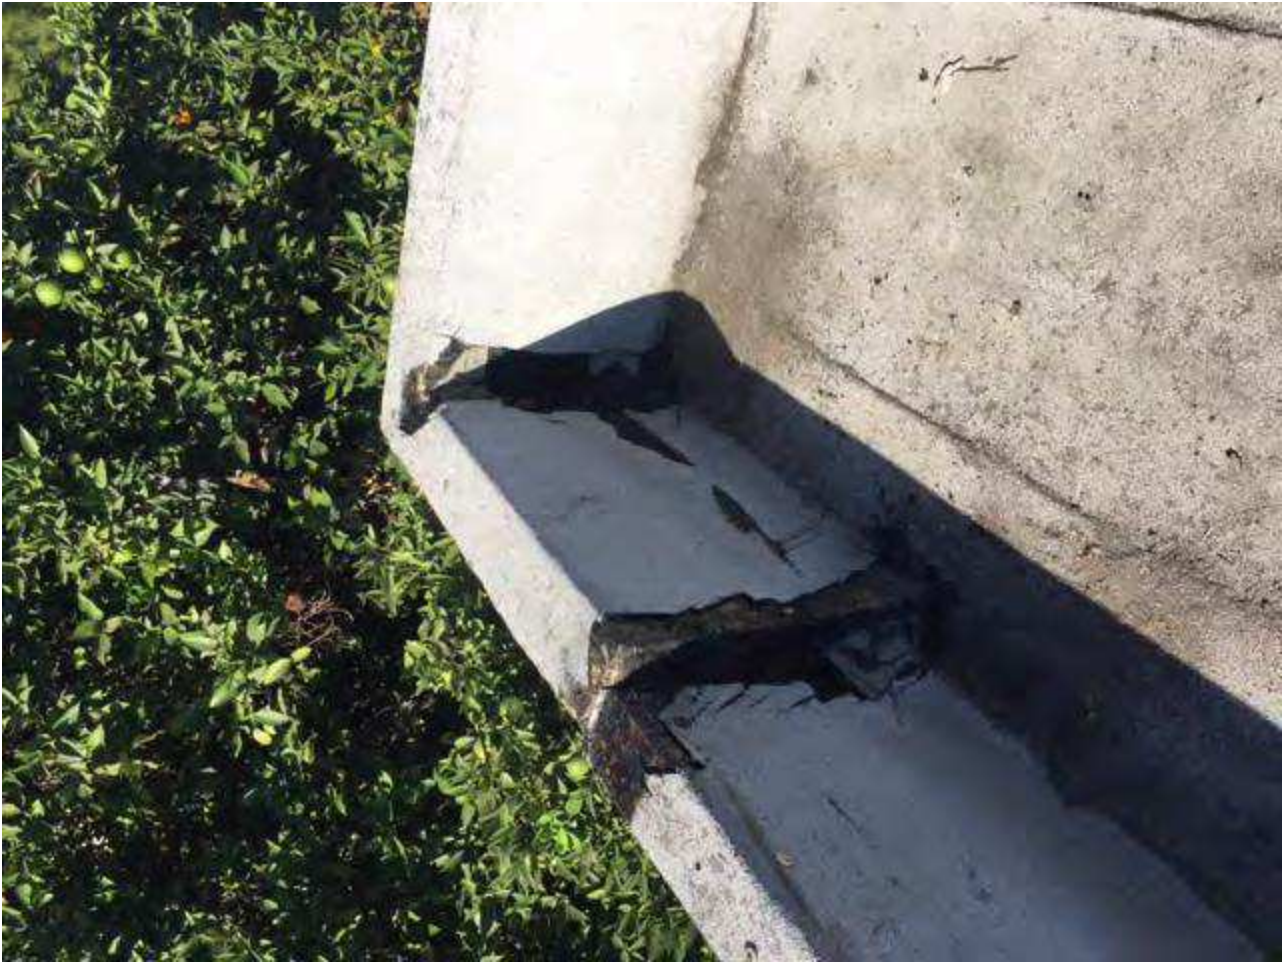
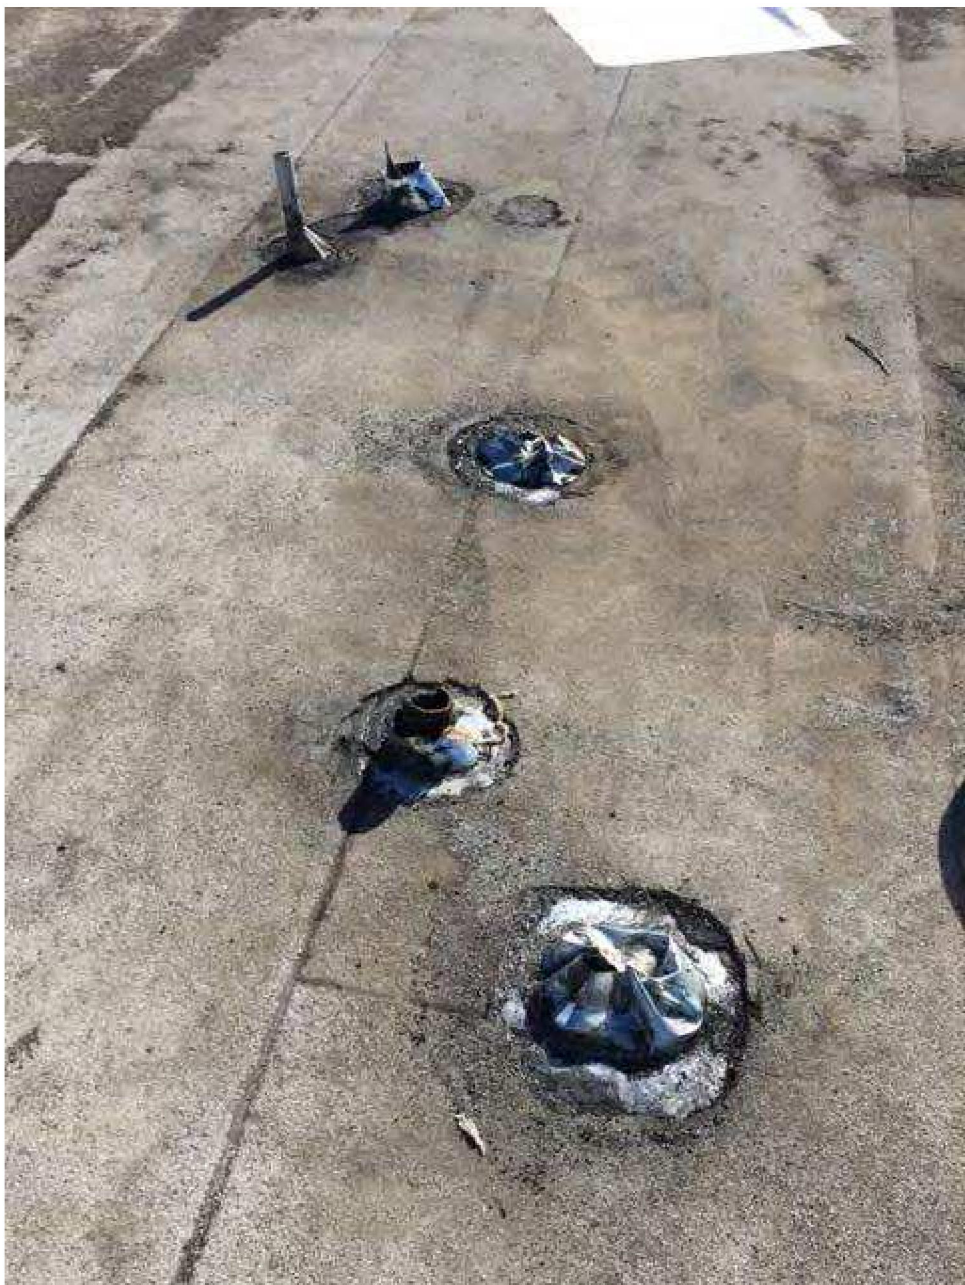
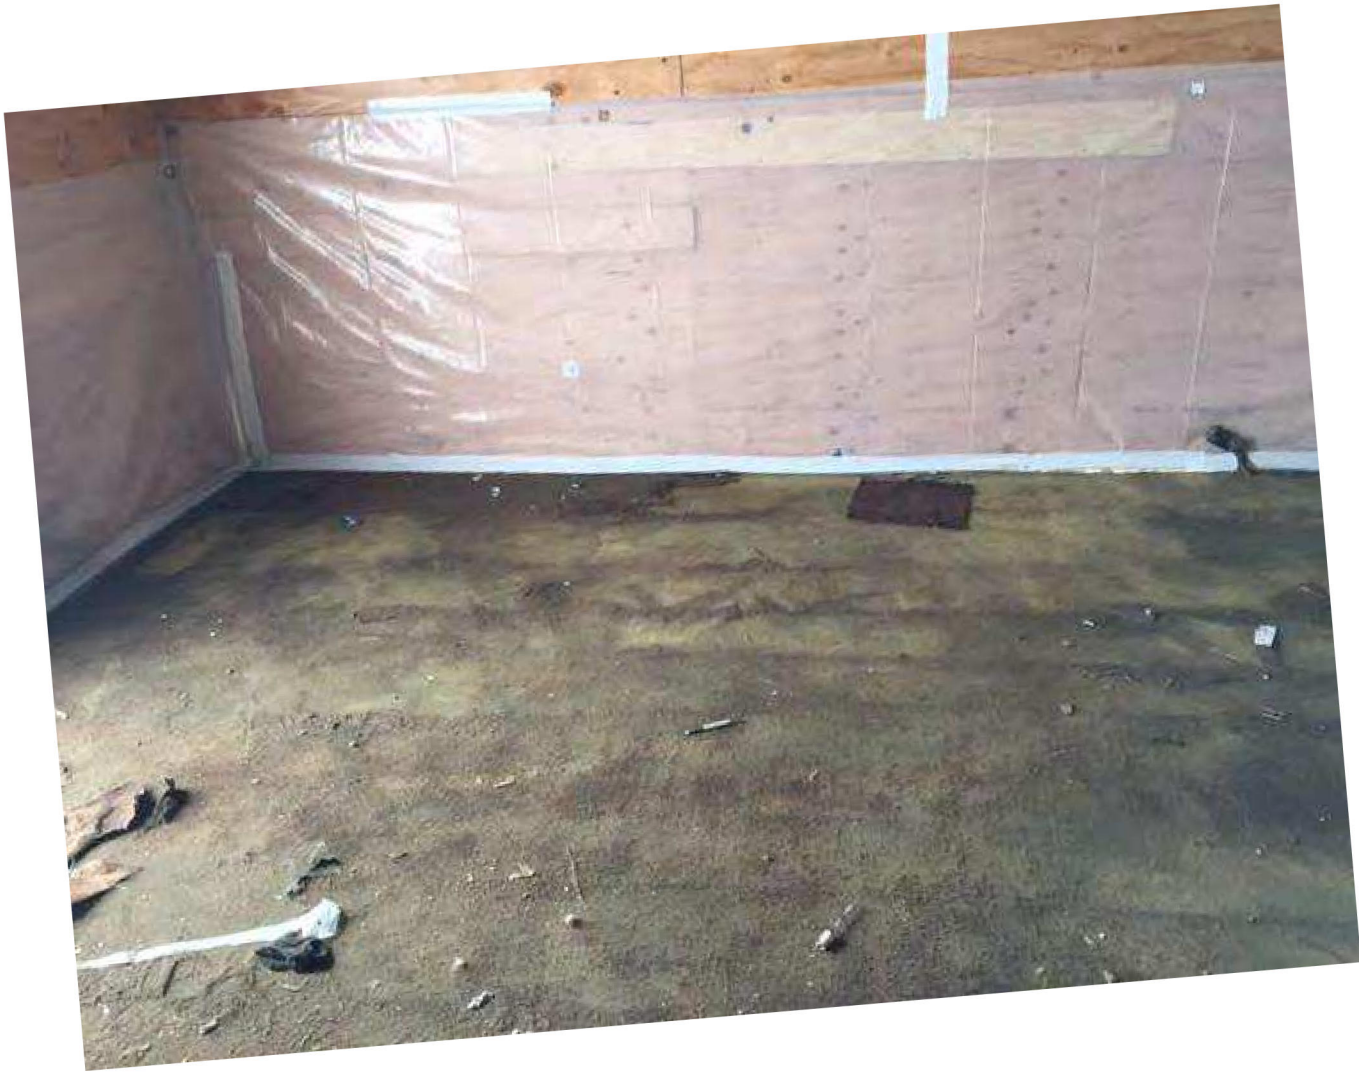
Additionally, roofing mastic and bull asbestos floor tile removal commence at 10819 Valley Blvd. The roof has received a passing visual inspection; floor tile will receive inspection and air clearance by tomorrow end of shift. 49 bags of non-HAZ asbestos waste generated and stored in onsite container. Resource revised the notification for this site as reported asbestos quantities were low (revised quantities to 600 SF of floor tile and 630 SF of mastic).

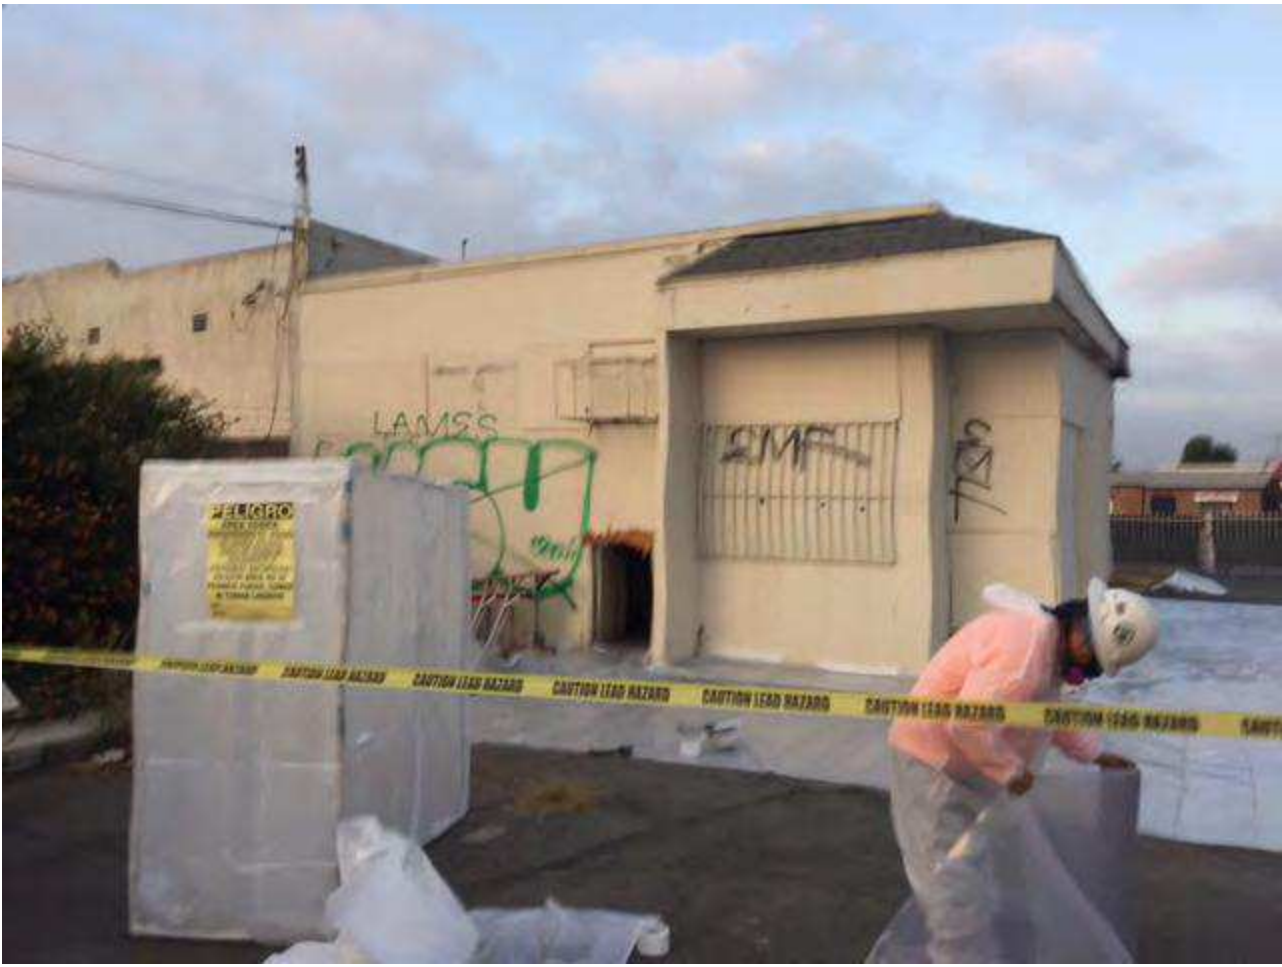
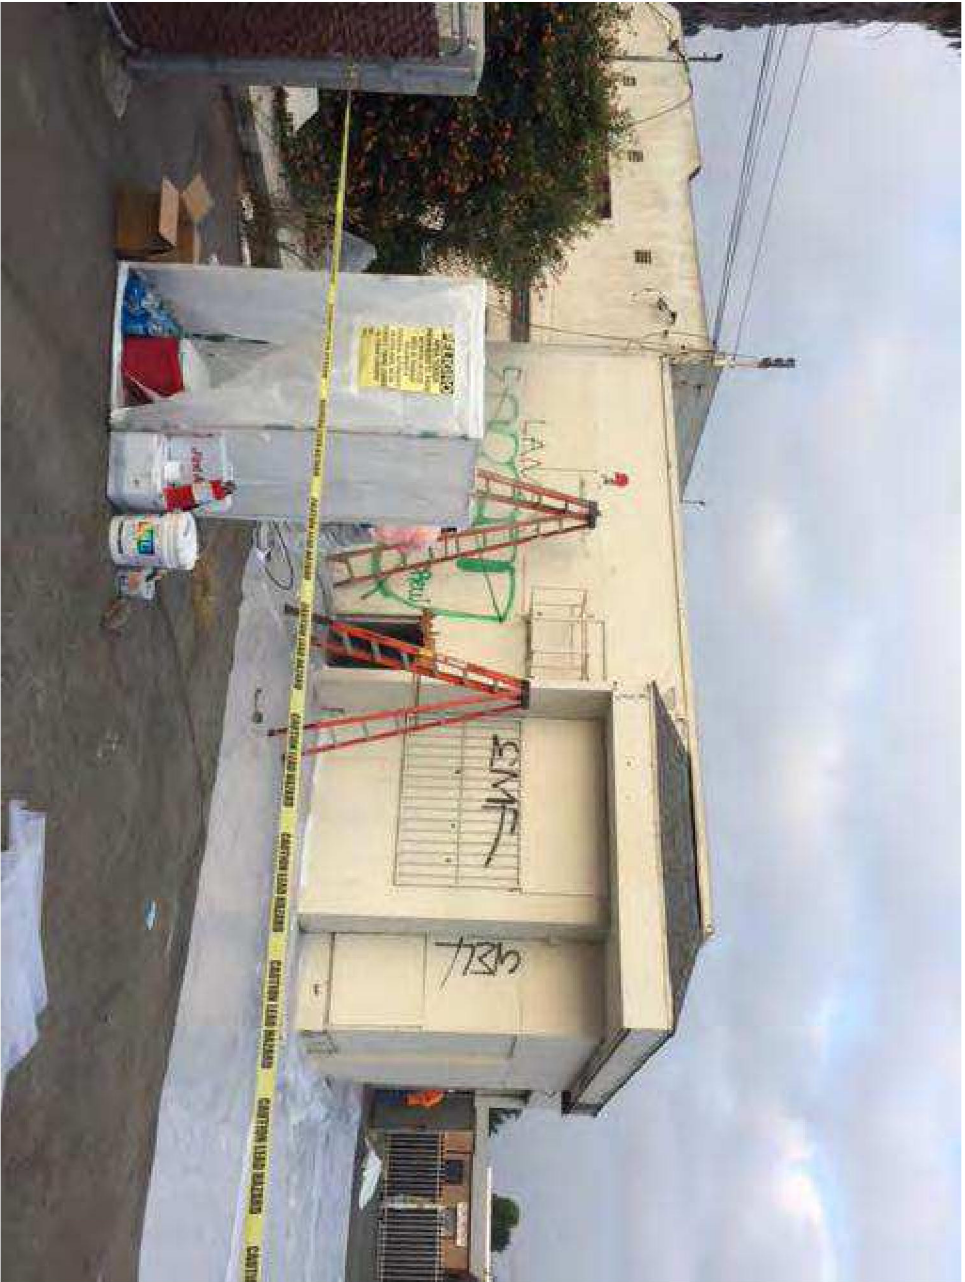
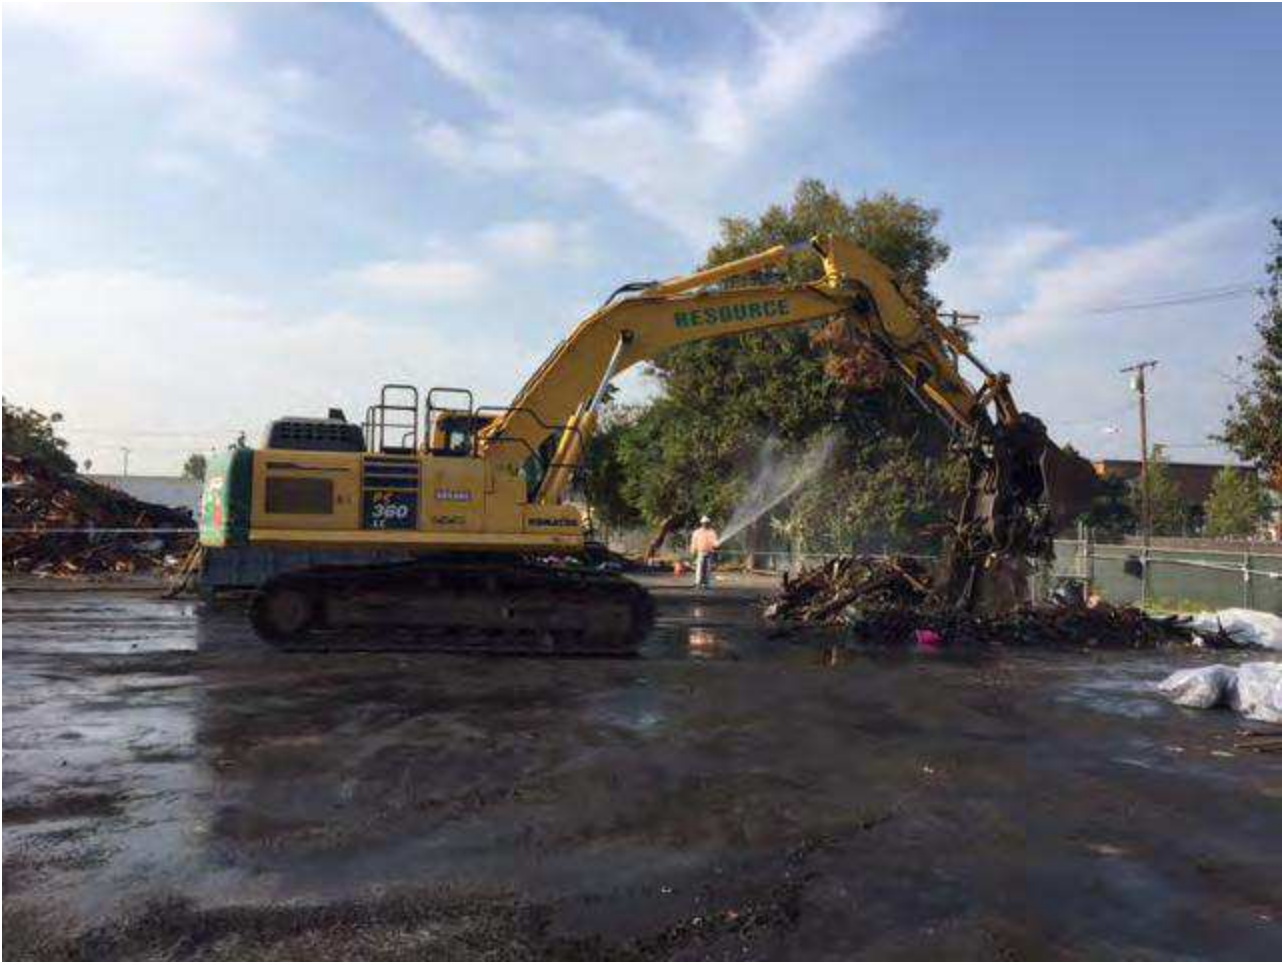
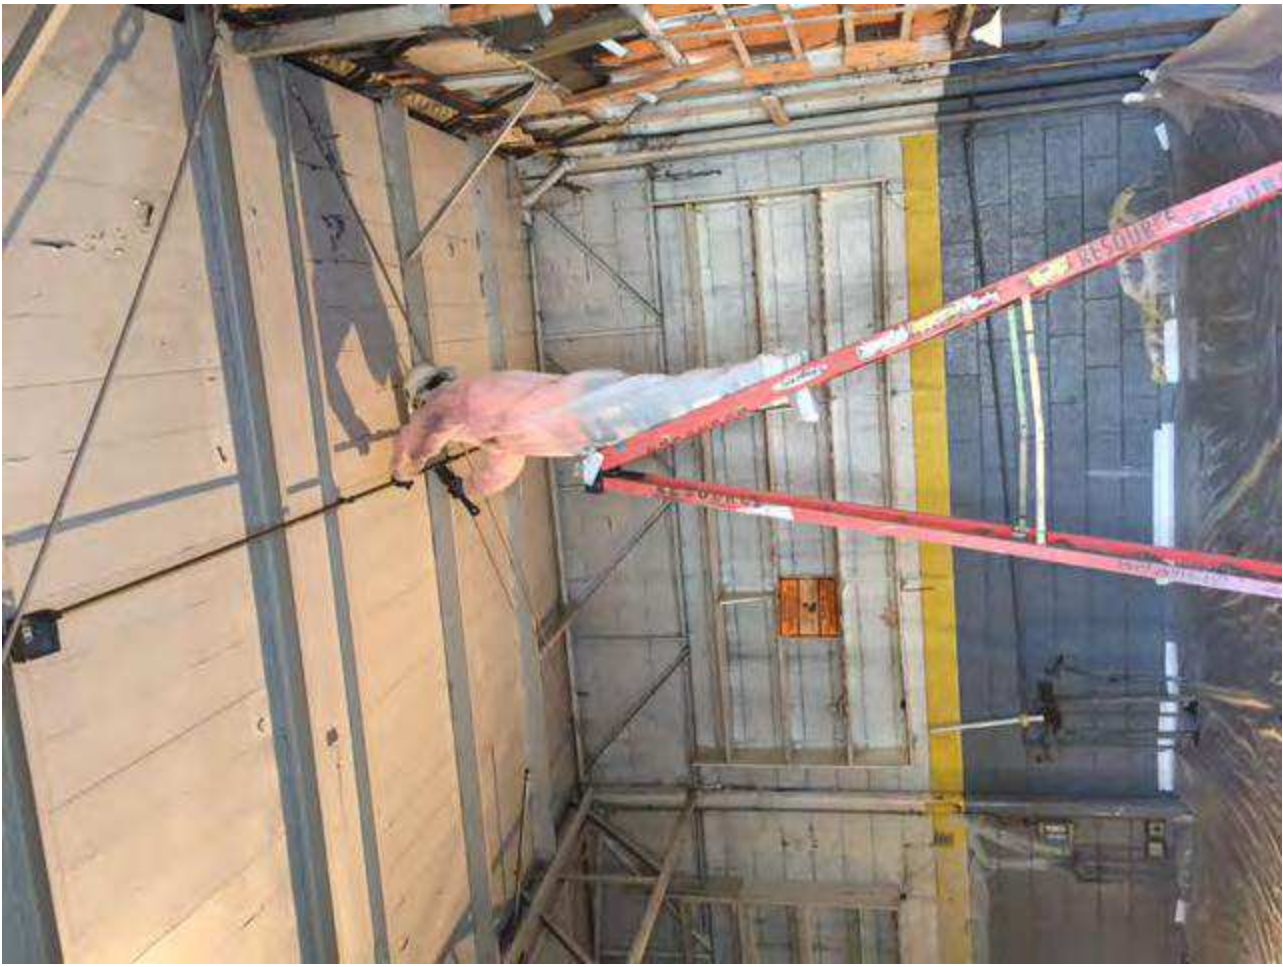
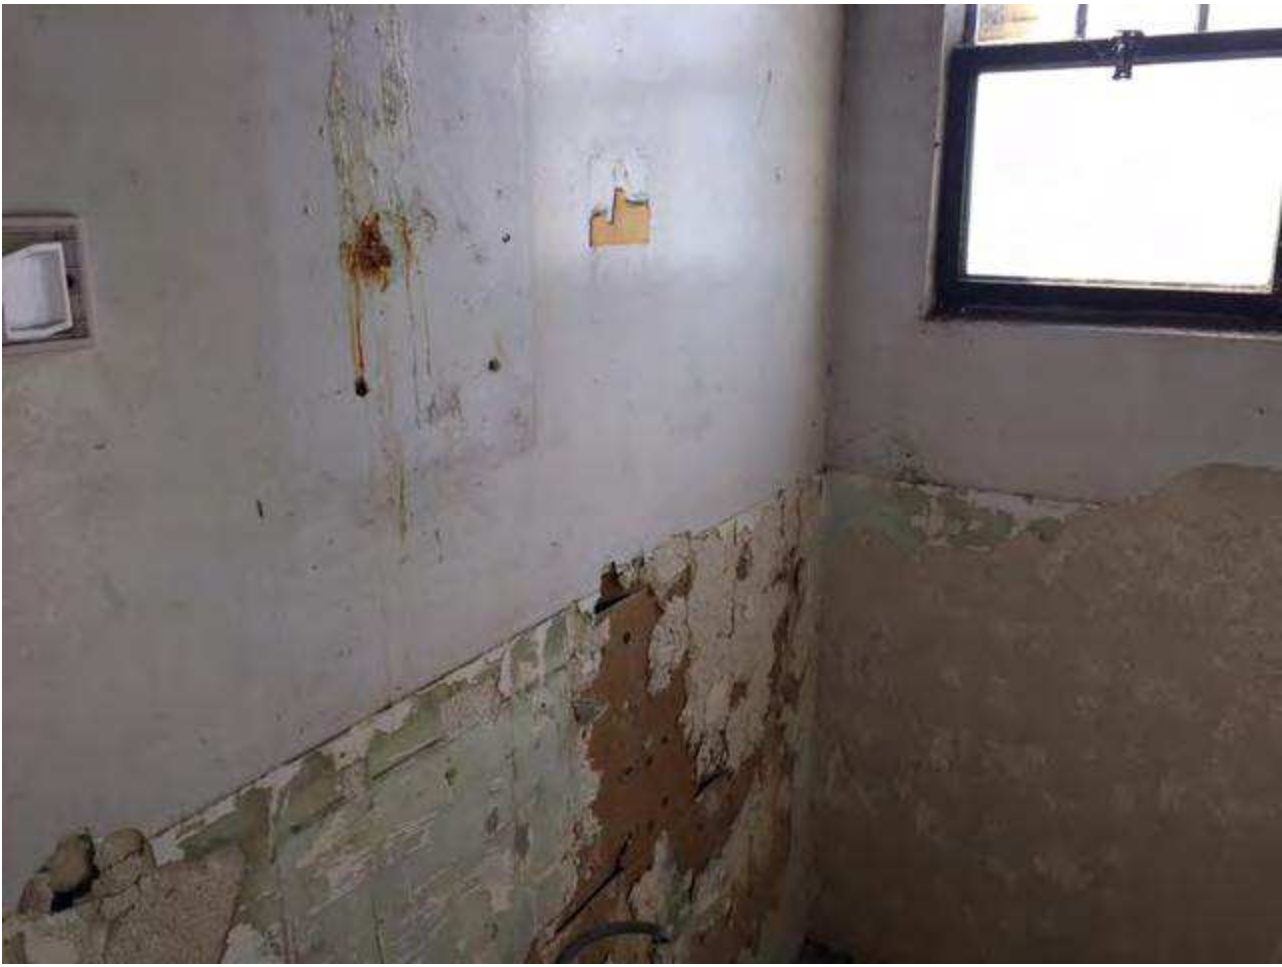
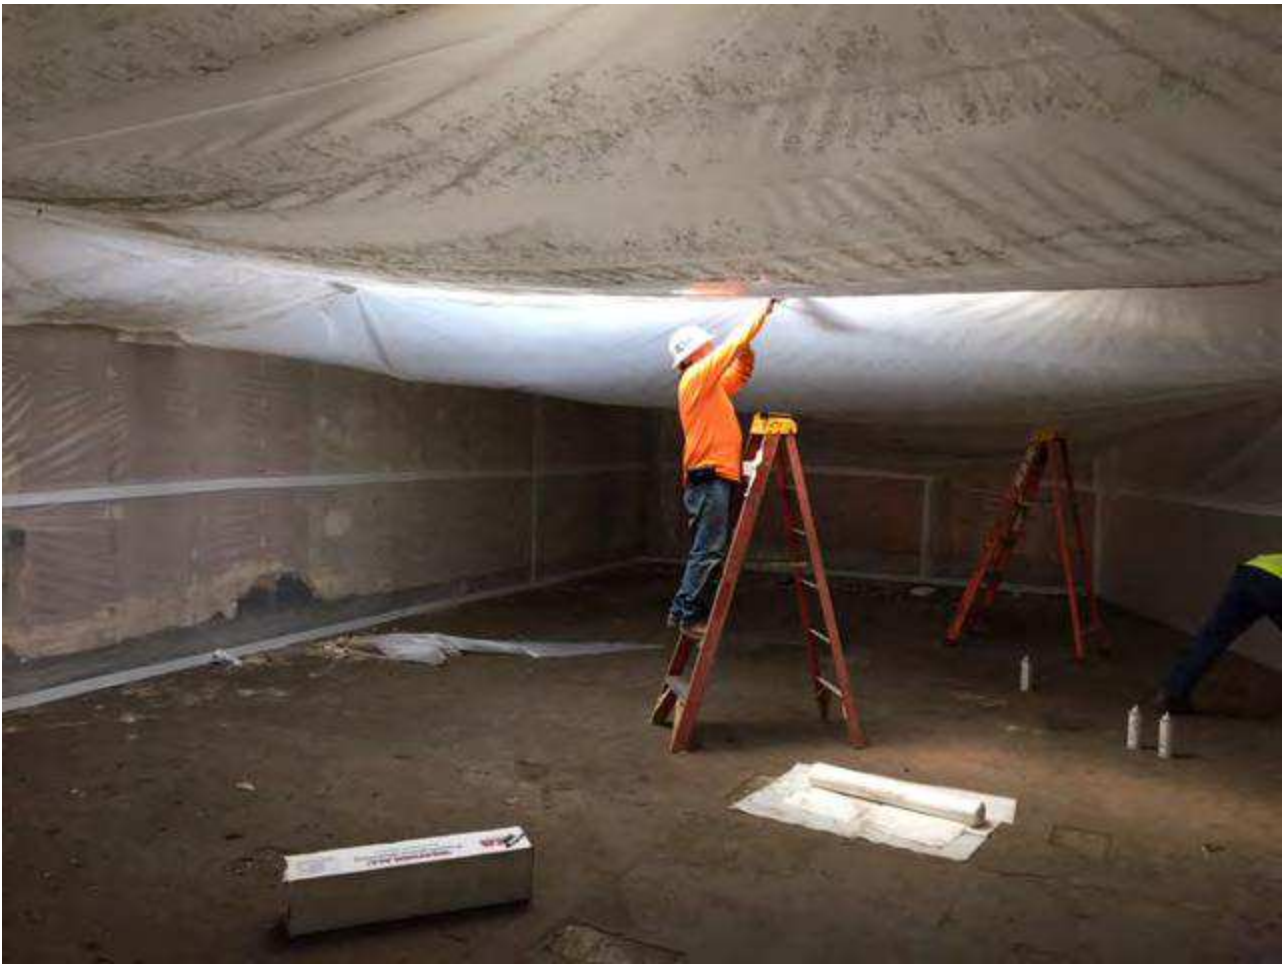
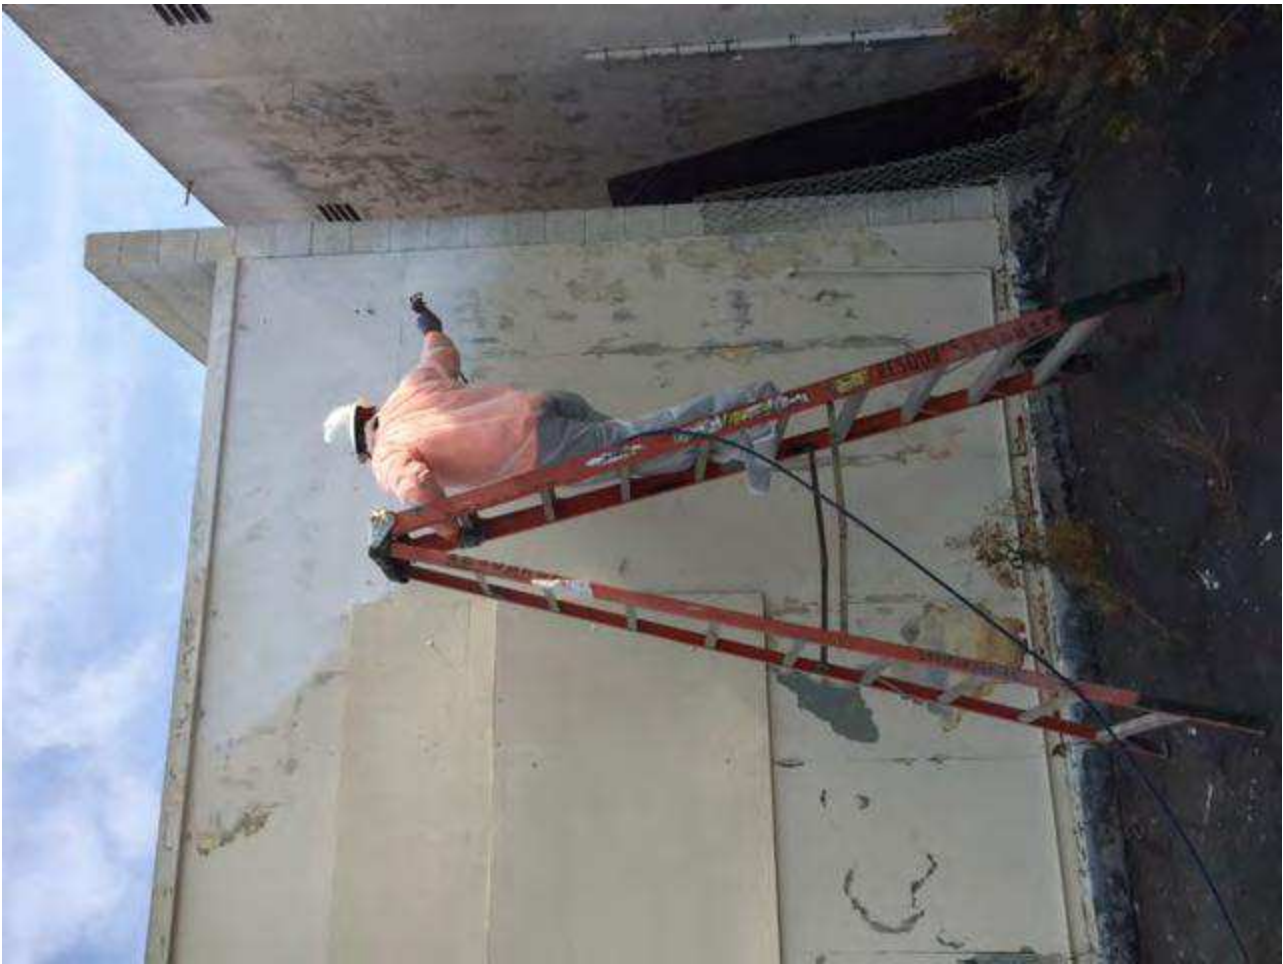
Containment set up (for floor tile abatement) completed and hand method removal began (expected to complete tomorrow). Results of additional sampling performed on Tuesday show that appx 35-40 sq ft of mastic will require abatement at the roof.

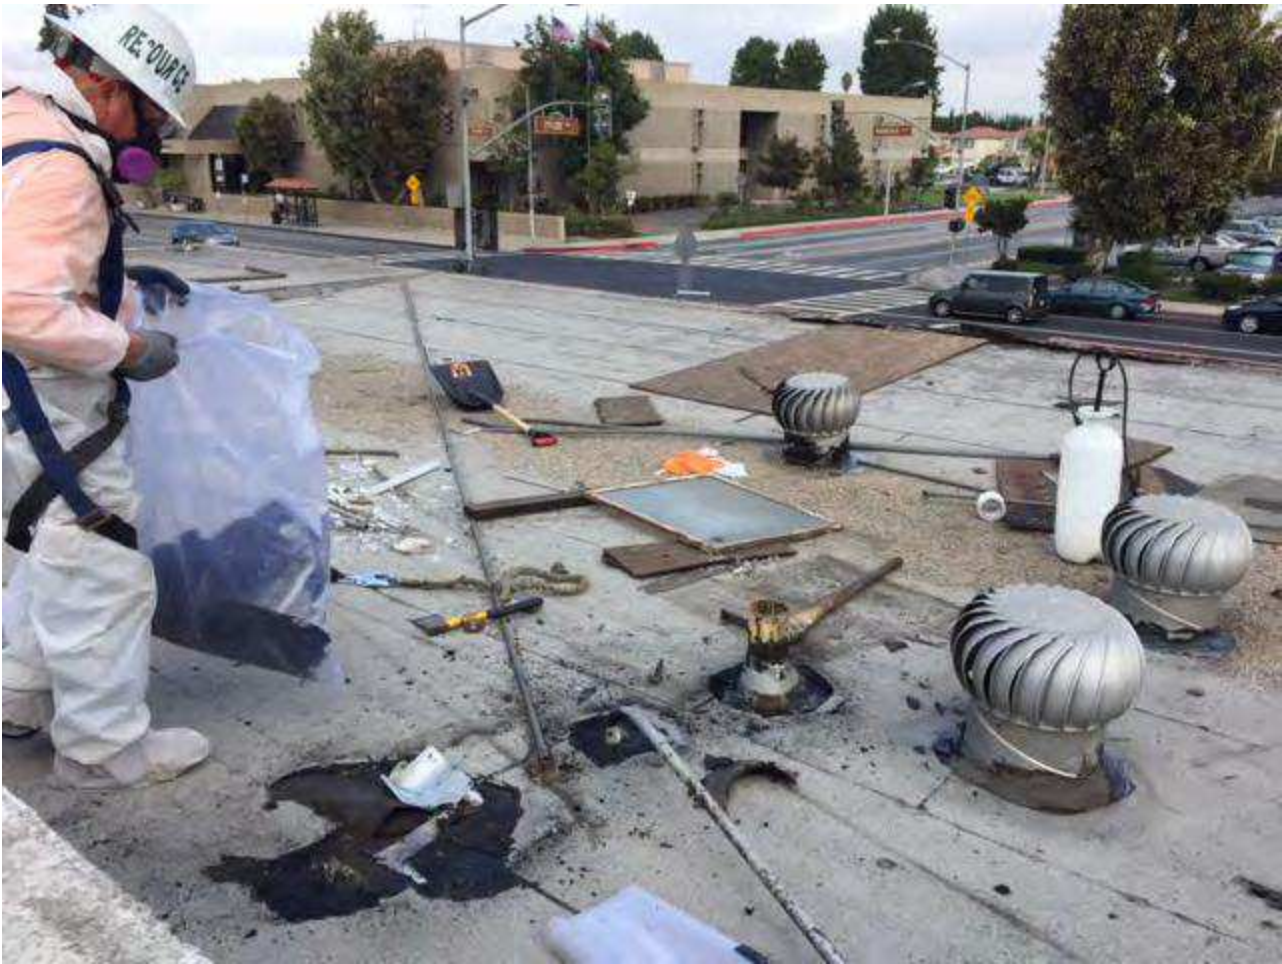
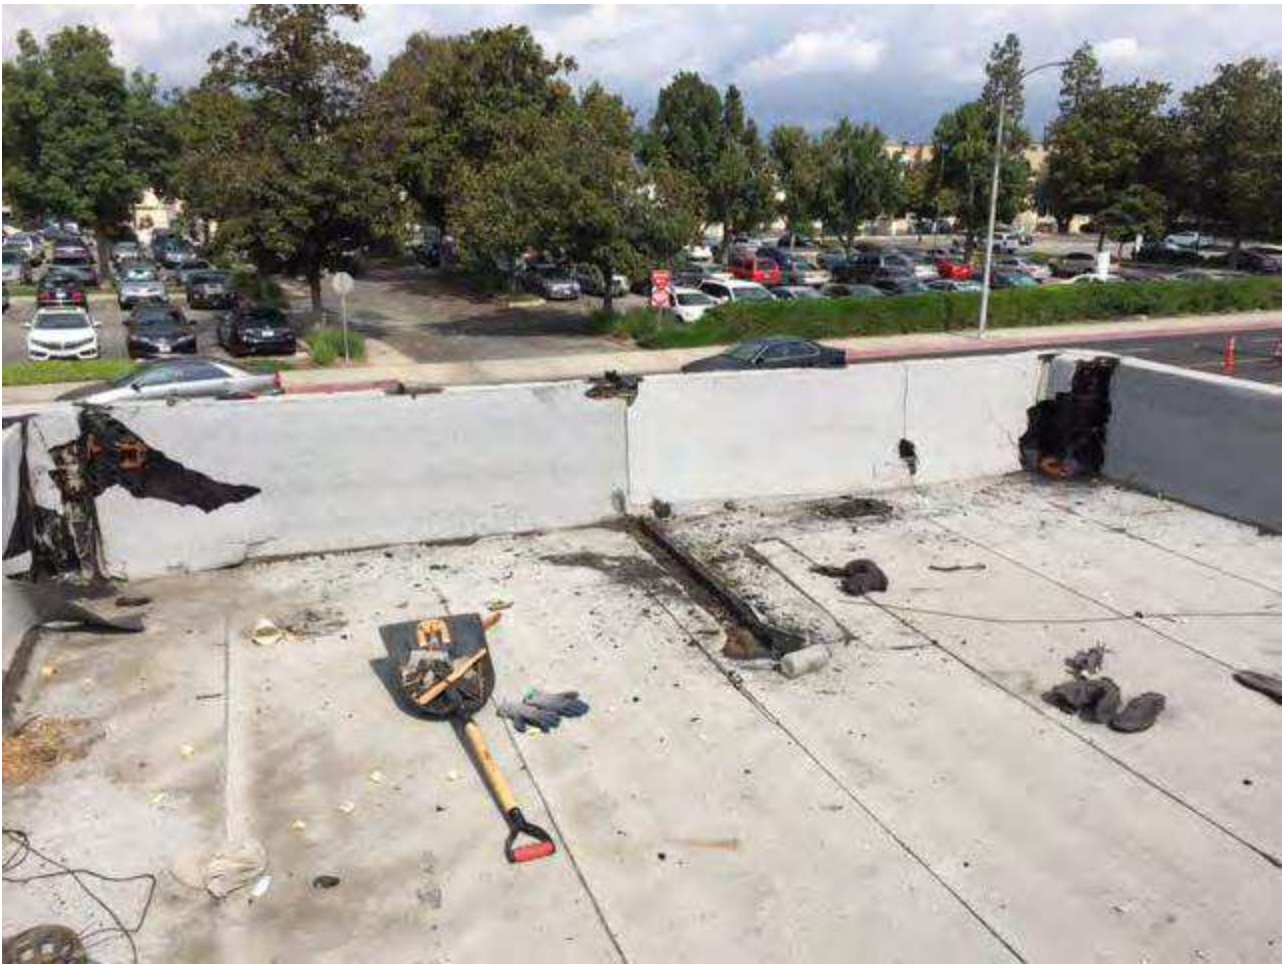
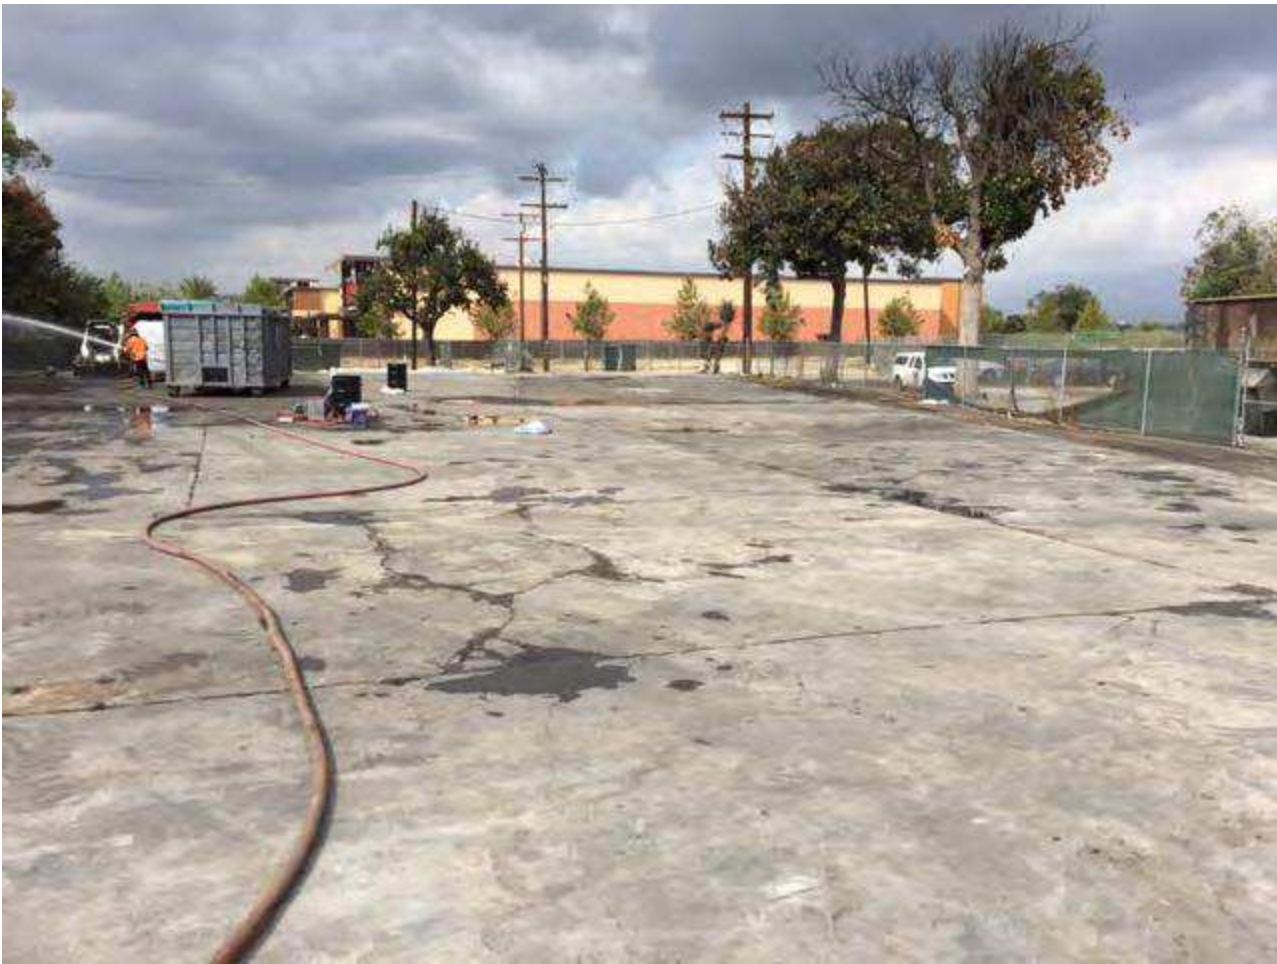
3454 Tyler

Abatement of floor tile completed during today's shift; the containment has been cleared. Roof penetration mastic was also abated during today's shift. This building is ready for demolition.
