Phase I Environmental Site Assessment Report

Area Y
10819 Valley Boulevard
El Monte, California

October 16, 2019 | Project No. 211175001

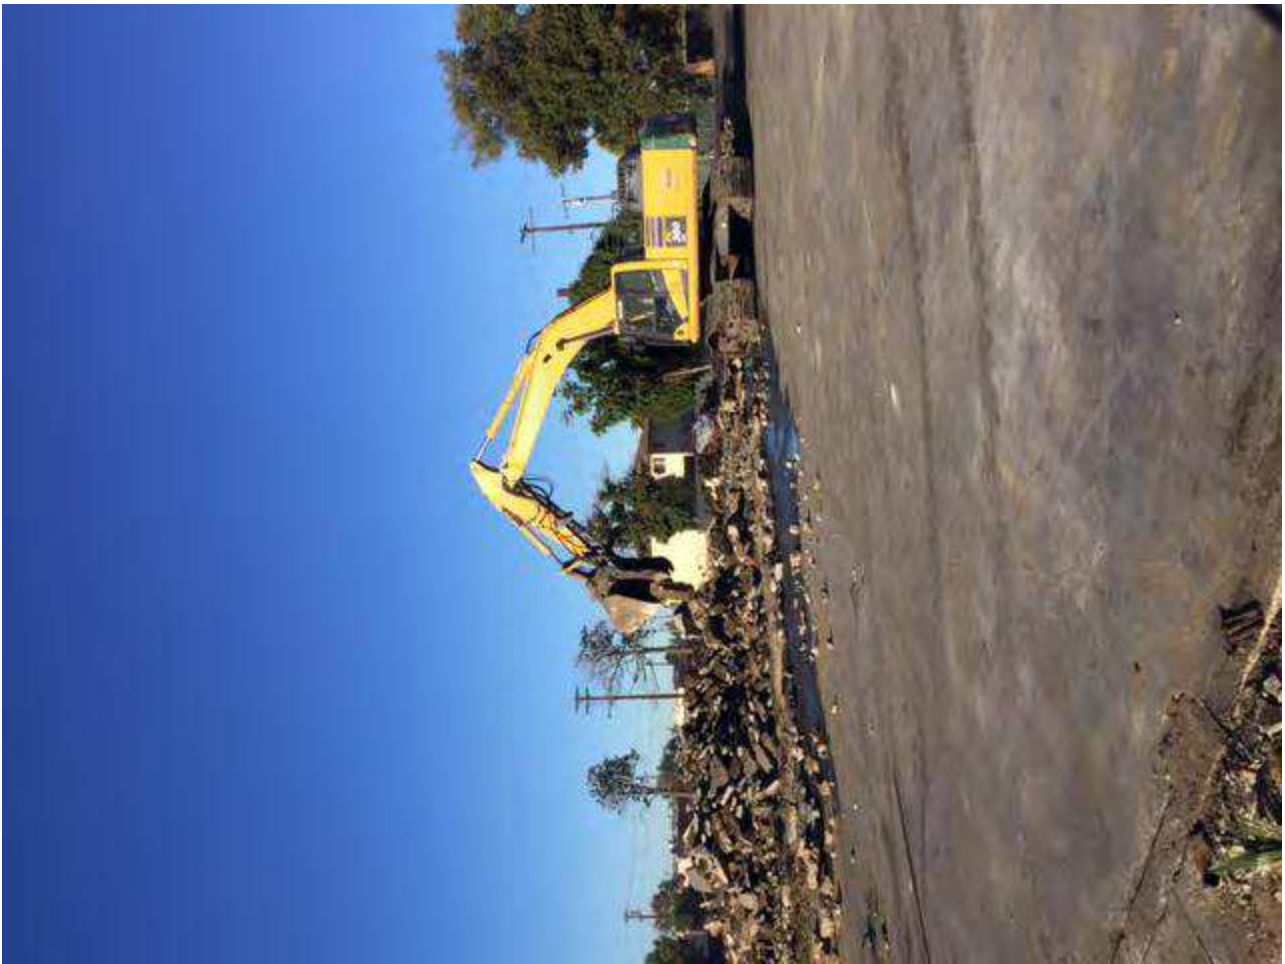
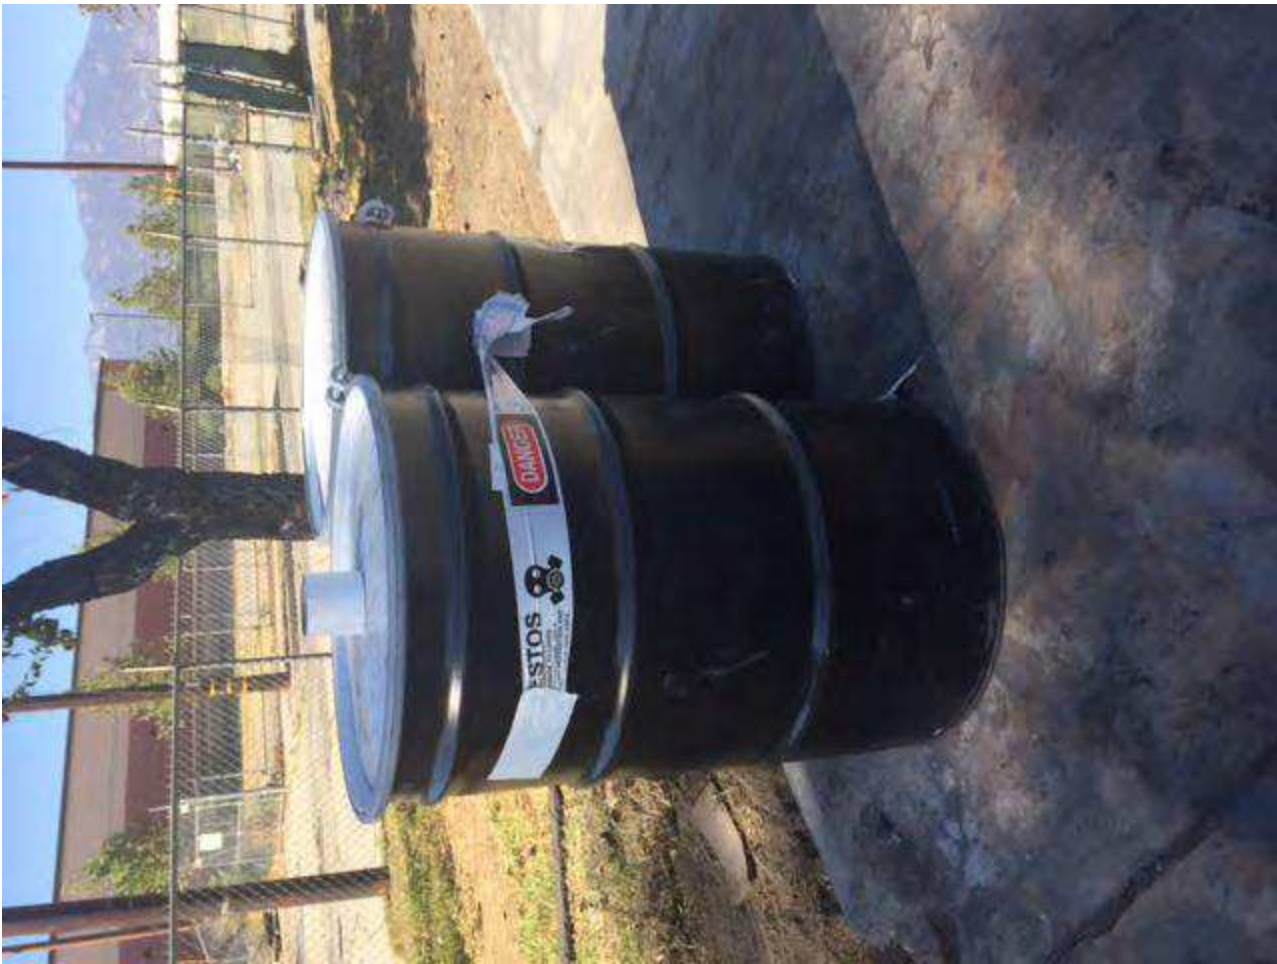
During today's shift, Resource continued with cleaning demo debris. Concrete slab removal started and is about 70% complete. Resource will continue on the remaining North corner tomorrow. 2 Haz waste bins left the site today, 2 55gal drums remain onsite. Ellis collected confirmational wipes and delivered them to the lab with a 24hr TAT. Resource will be back onsite tomorrow at 7AM.

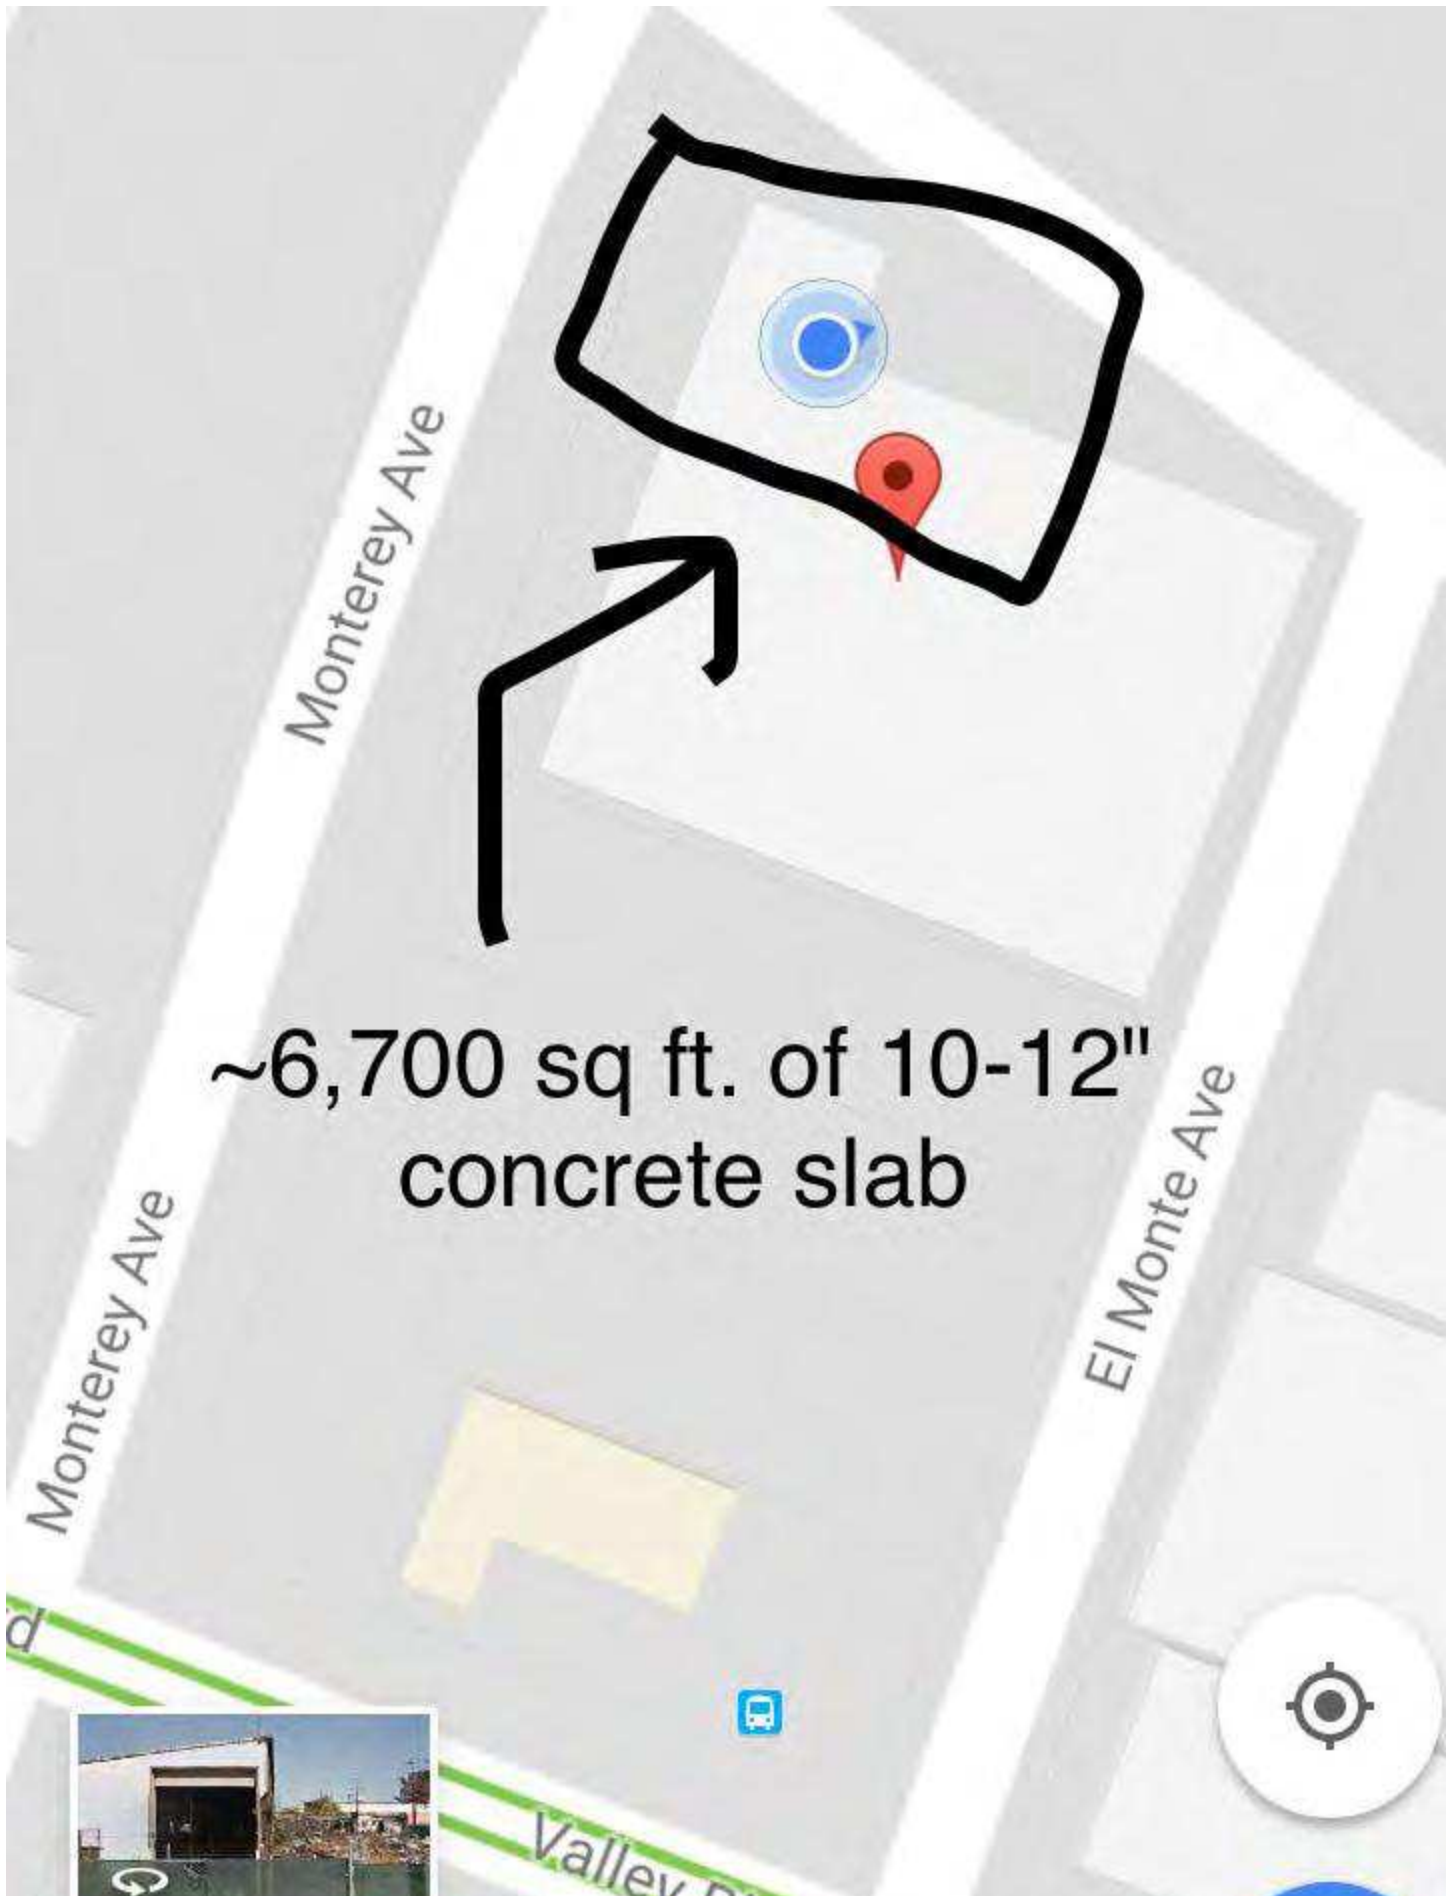
At your request, Ellis assisted Resource in field verifying with quantity/thickness of remaining concrete slab at 221 El Monte. Measured at 100' x 67' (~6,700 sq ft), approximately 30% of this corner slab is 12" in thickness and the remainder is about 10". See attached photos and location screen shot. The blue dot is the corner where concrete slab remains - the cutoff point between 10" and 12" layers won't be exact until Resource begins peeling this area.

~6,700 sq ft. of 10-12"
concrete slab

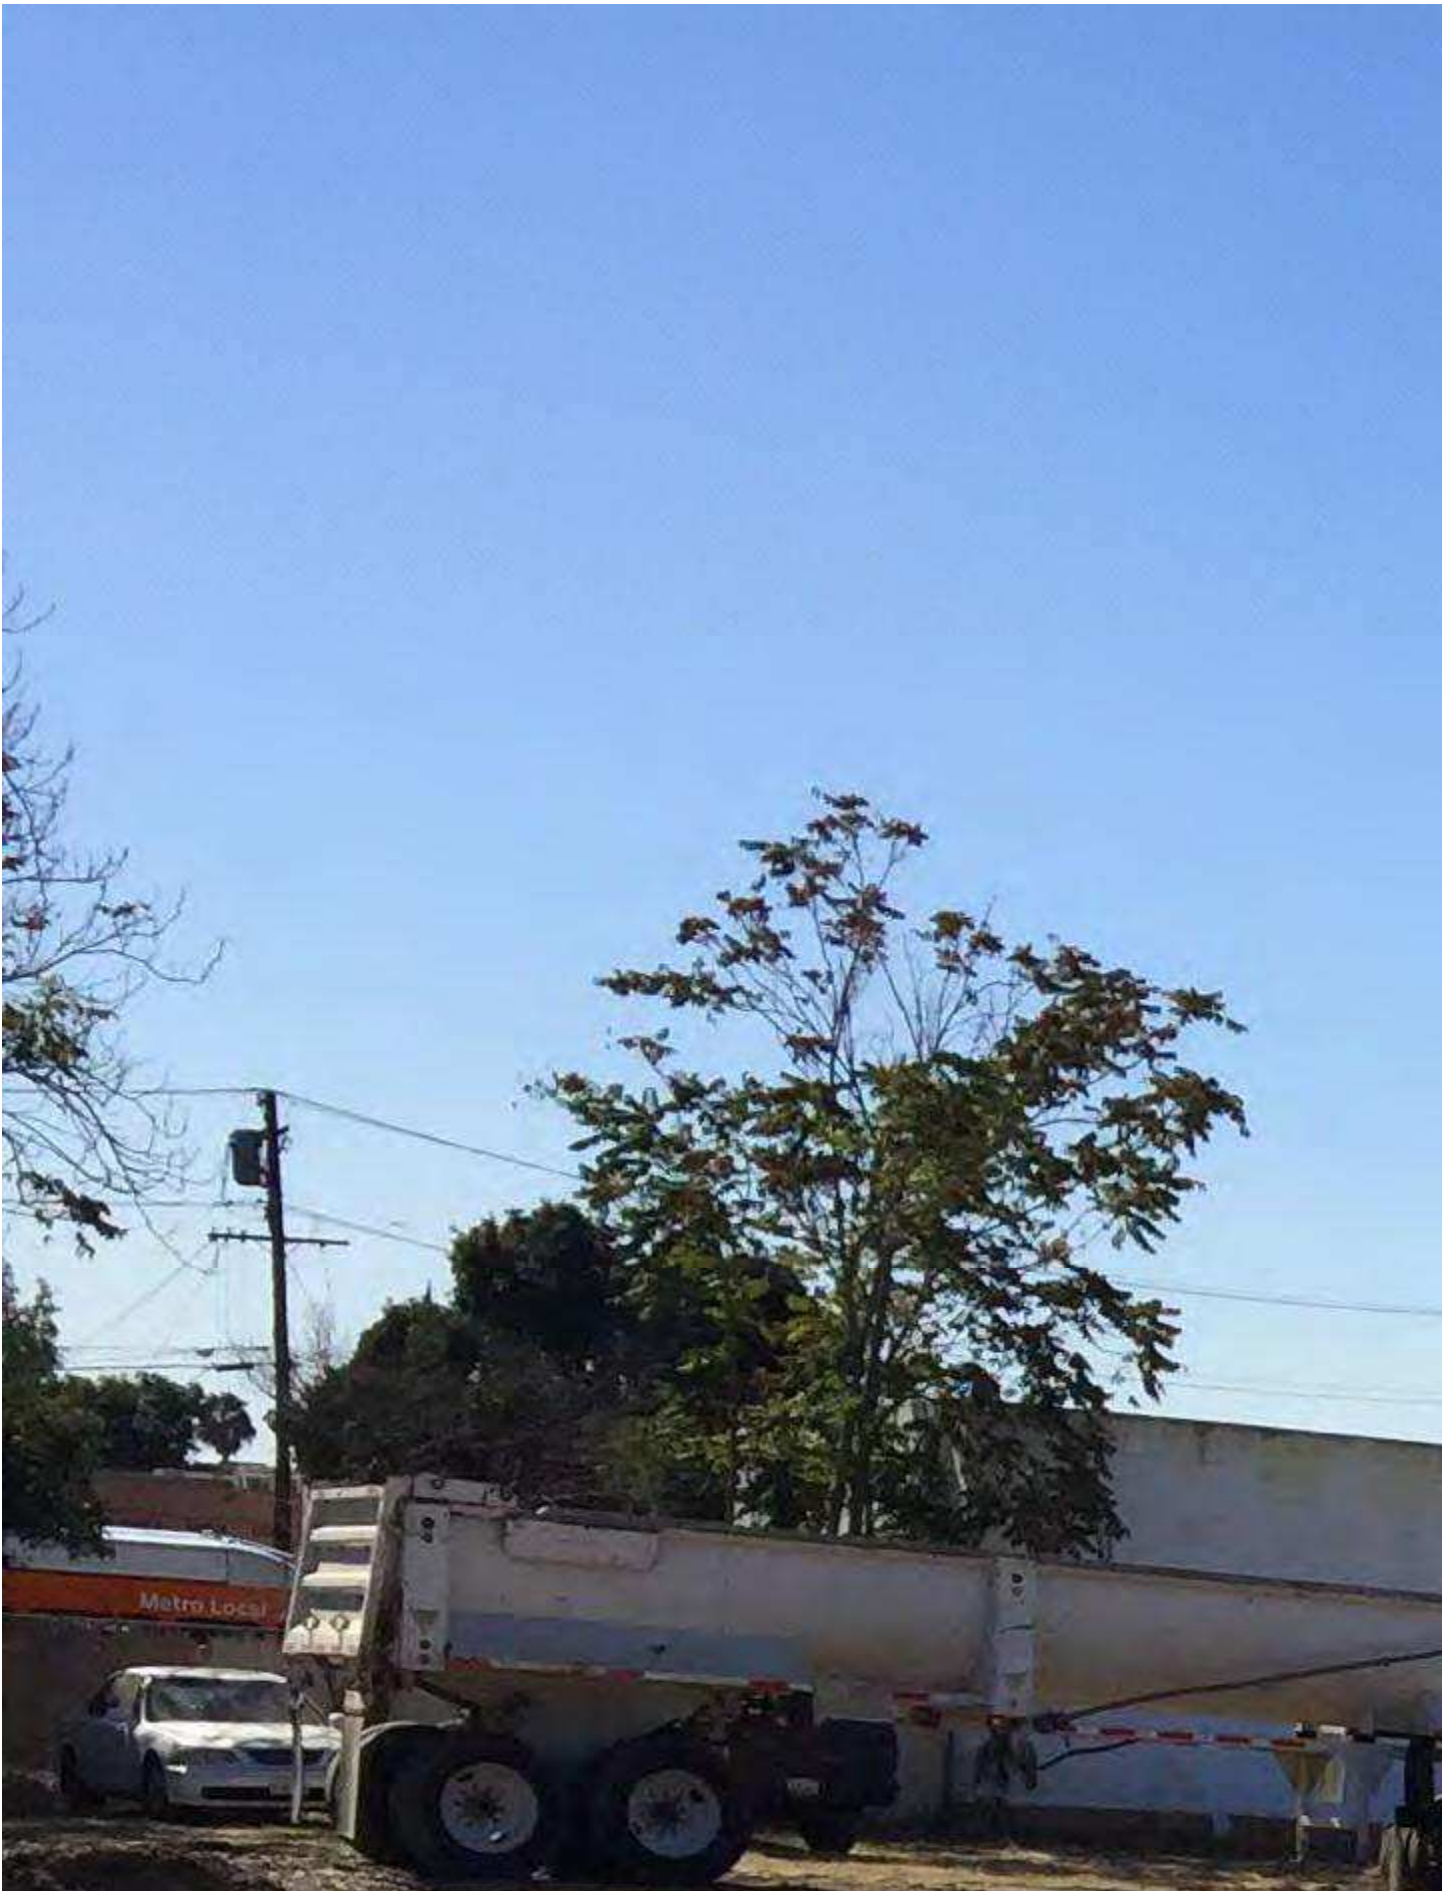
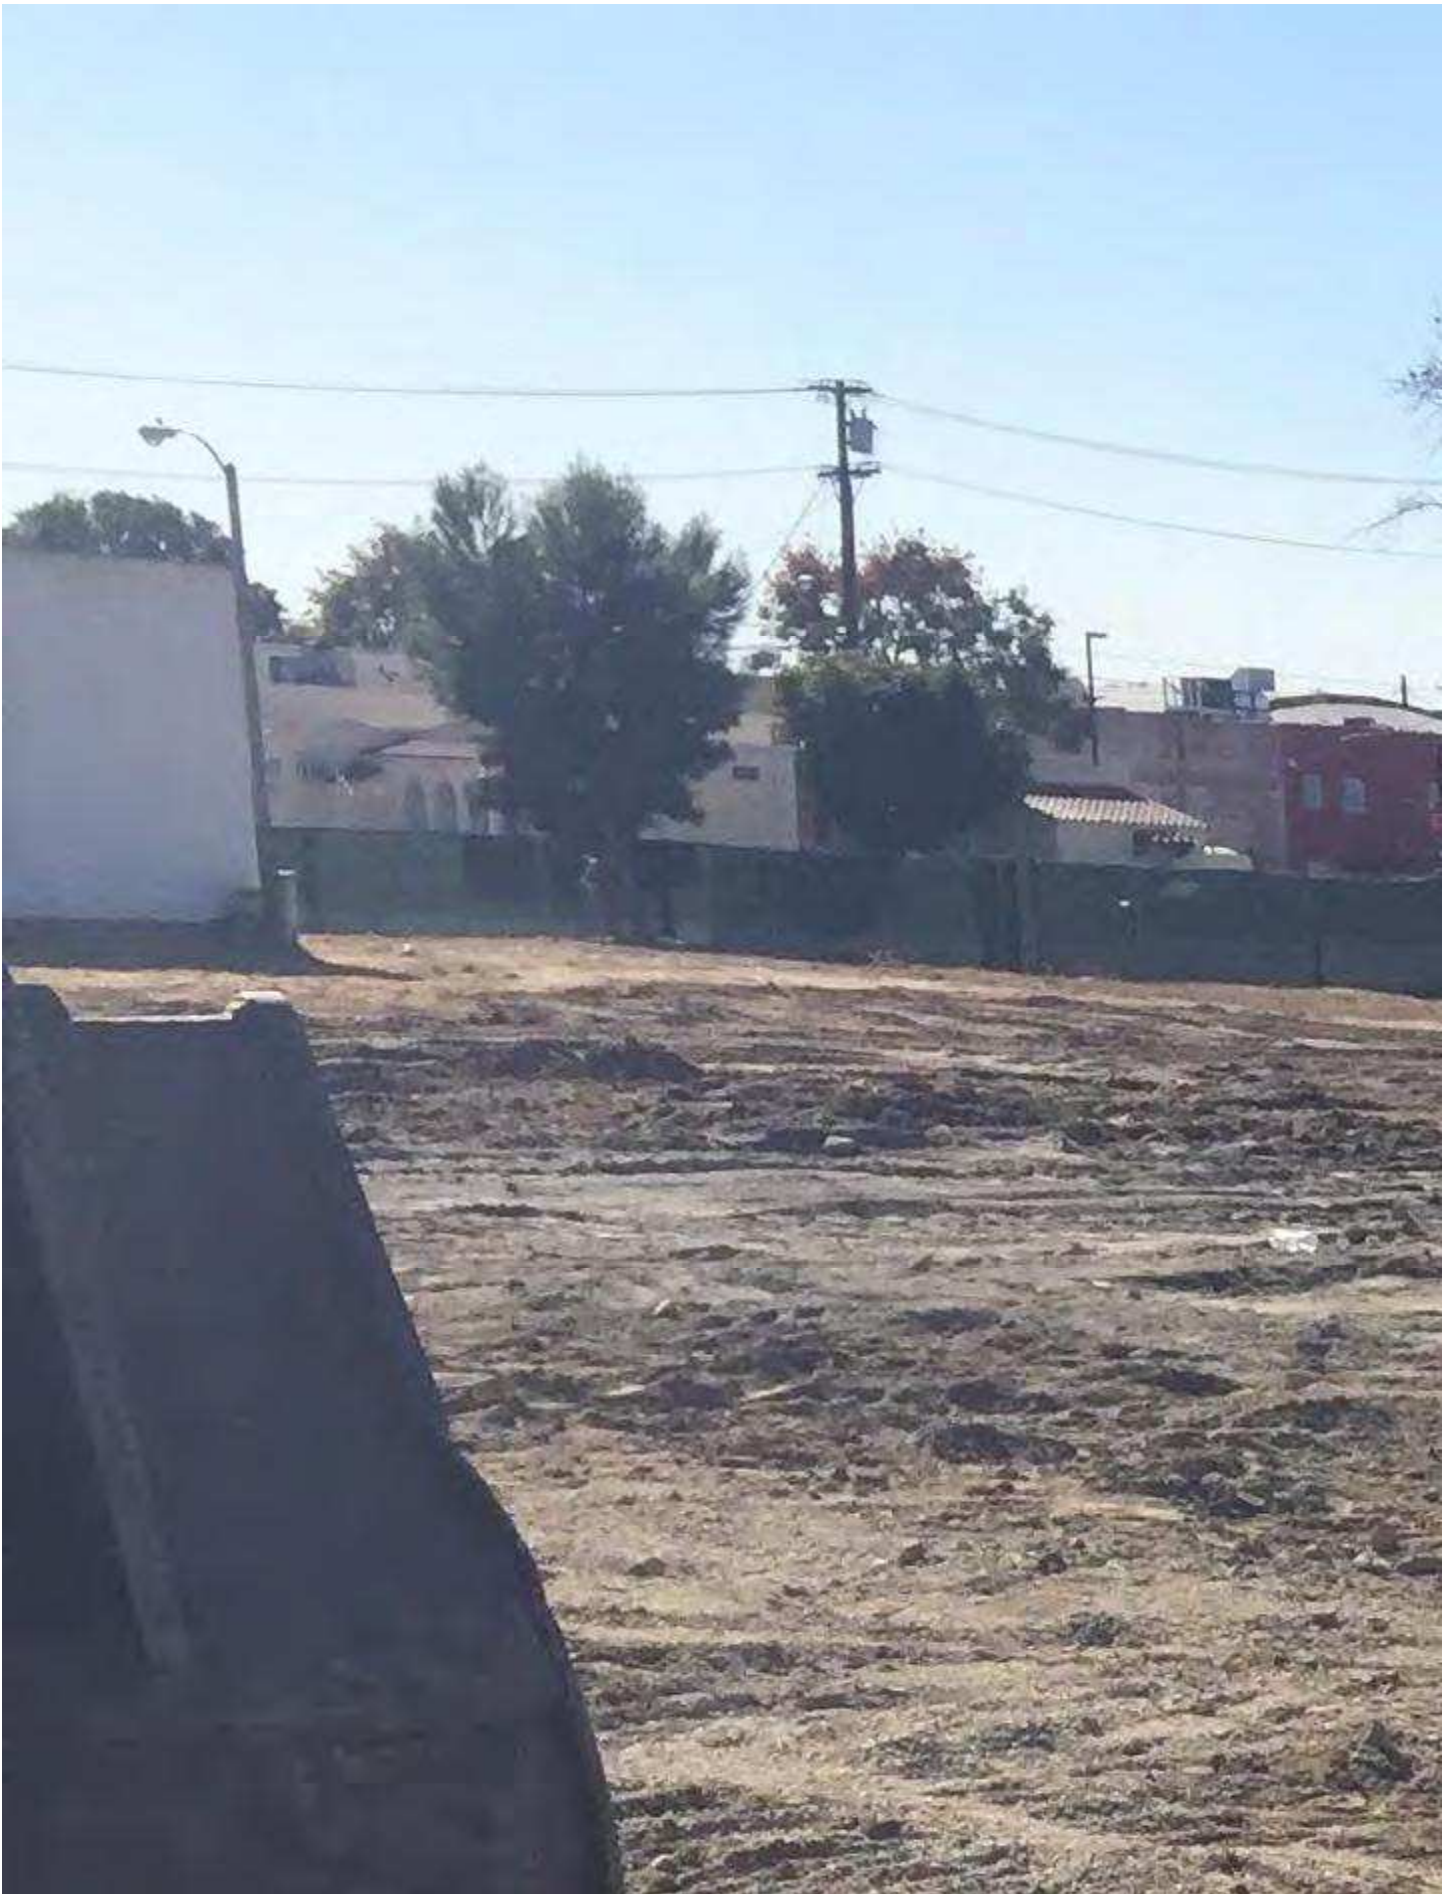
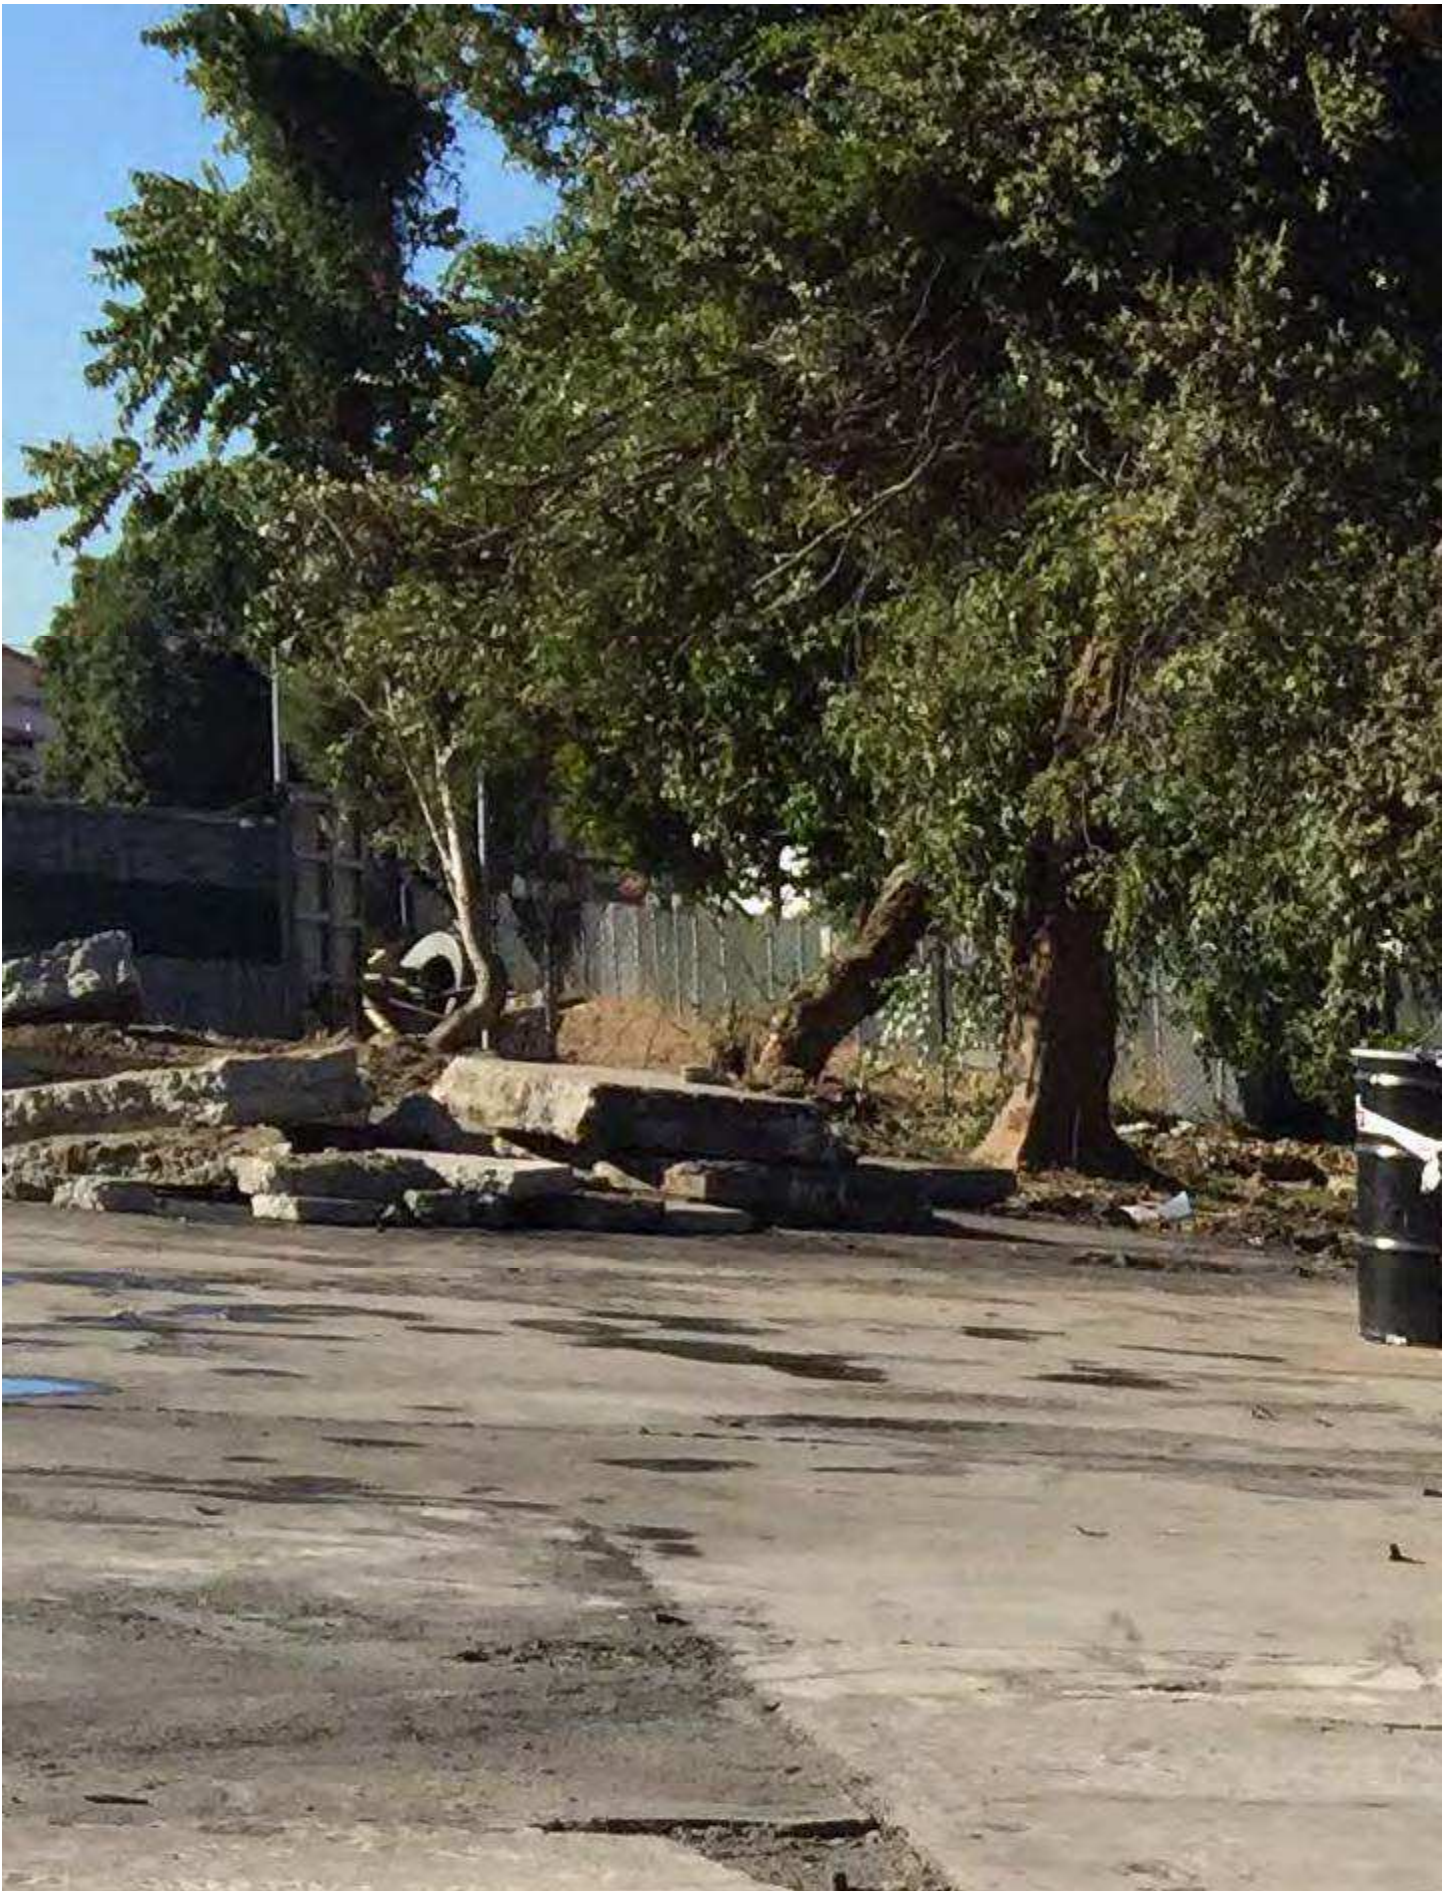
Resource continued removing concrete slab piles and hauling off site. The NW corner slab remains intact until Resource can make a decision on how they'll move forward. Three trees were also brought down. Tomorrow the crew plans on beginning demolition at 10819 Valley Blvd.

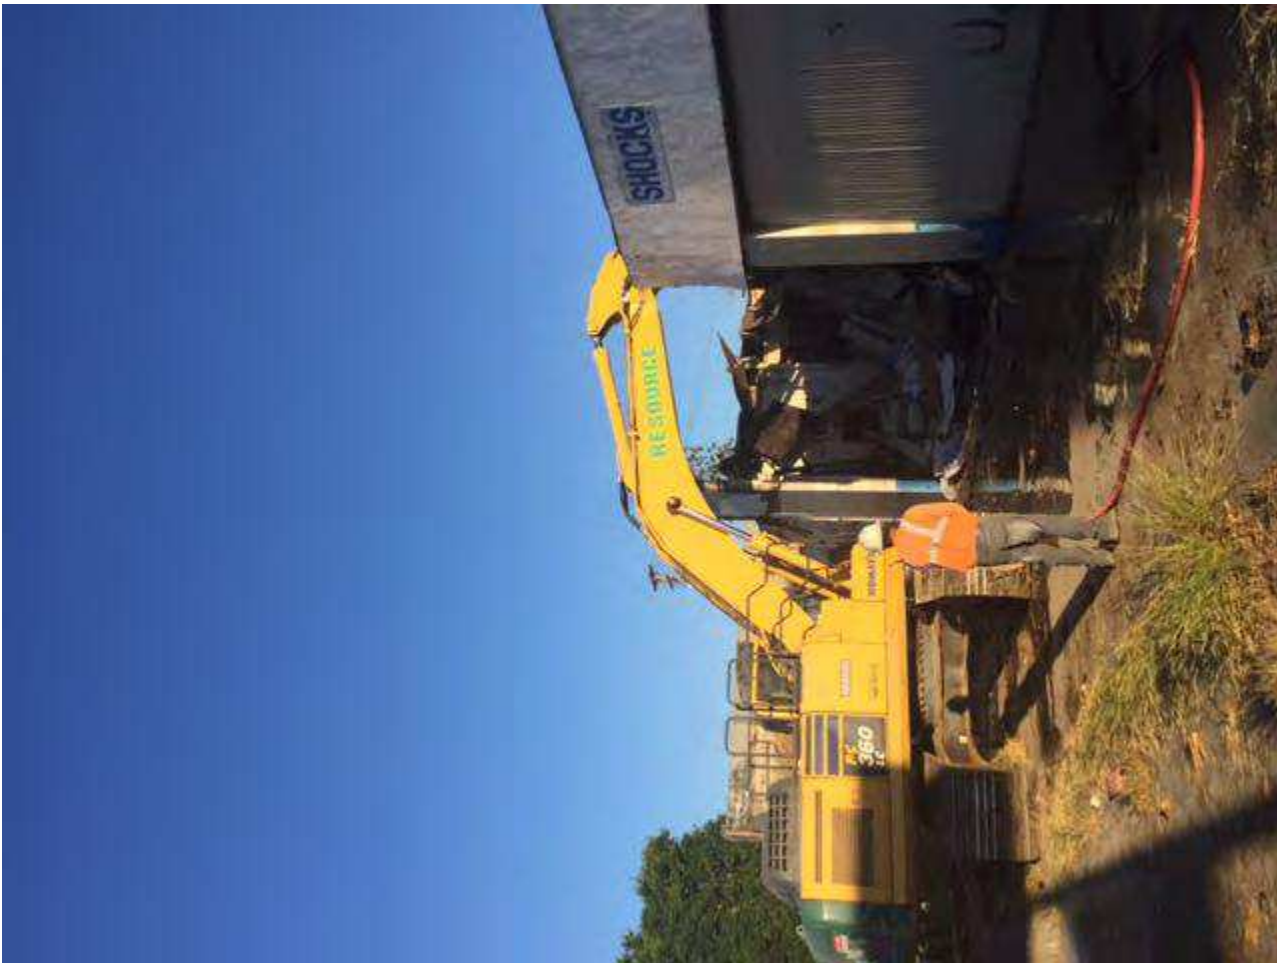
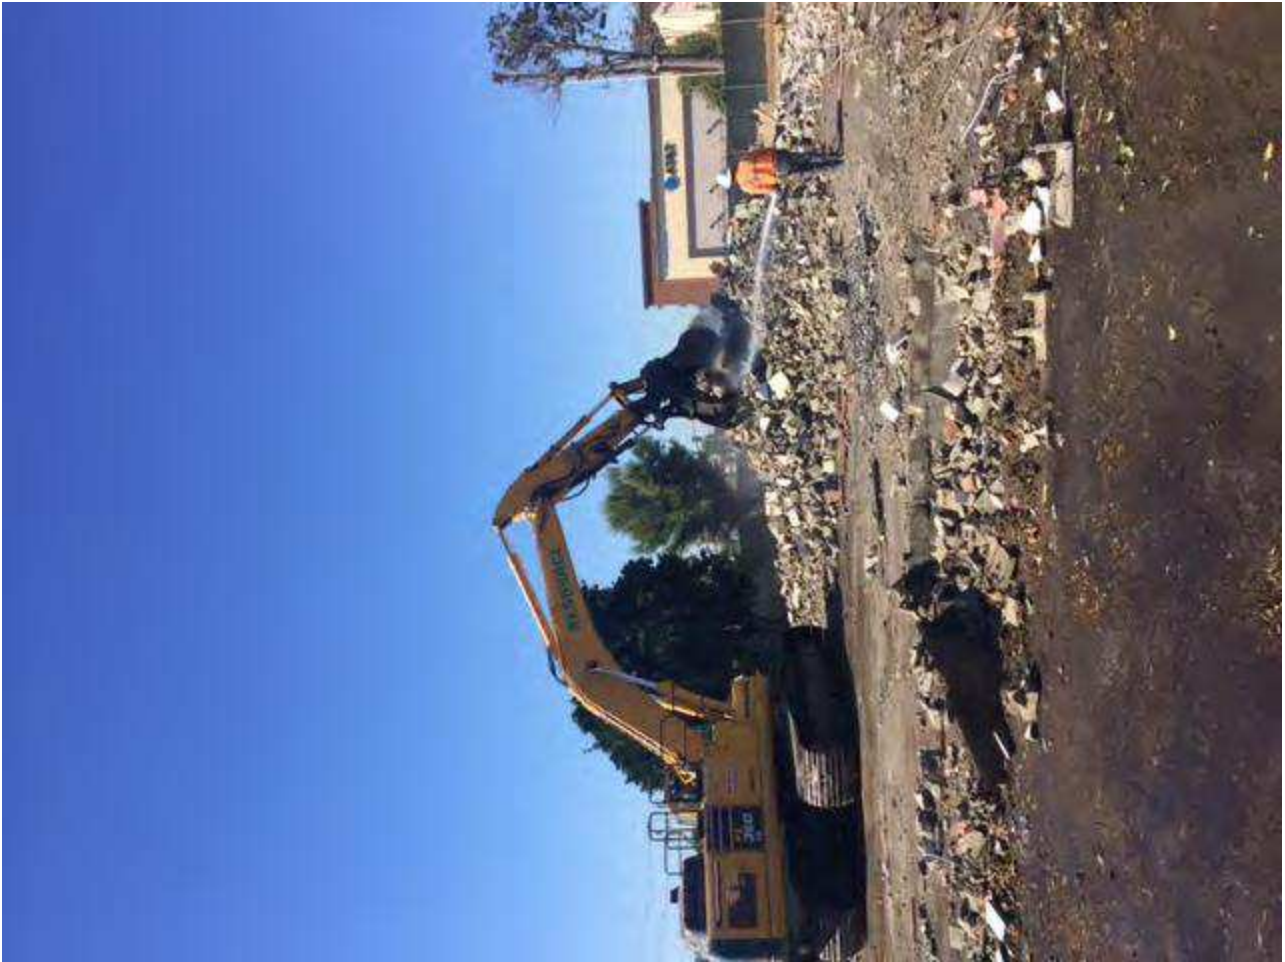
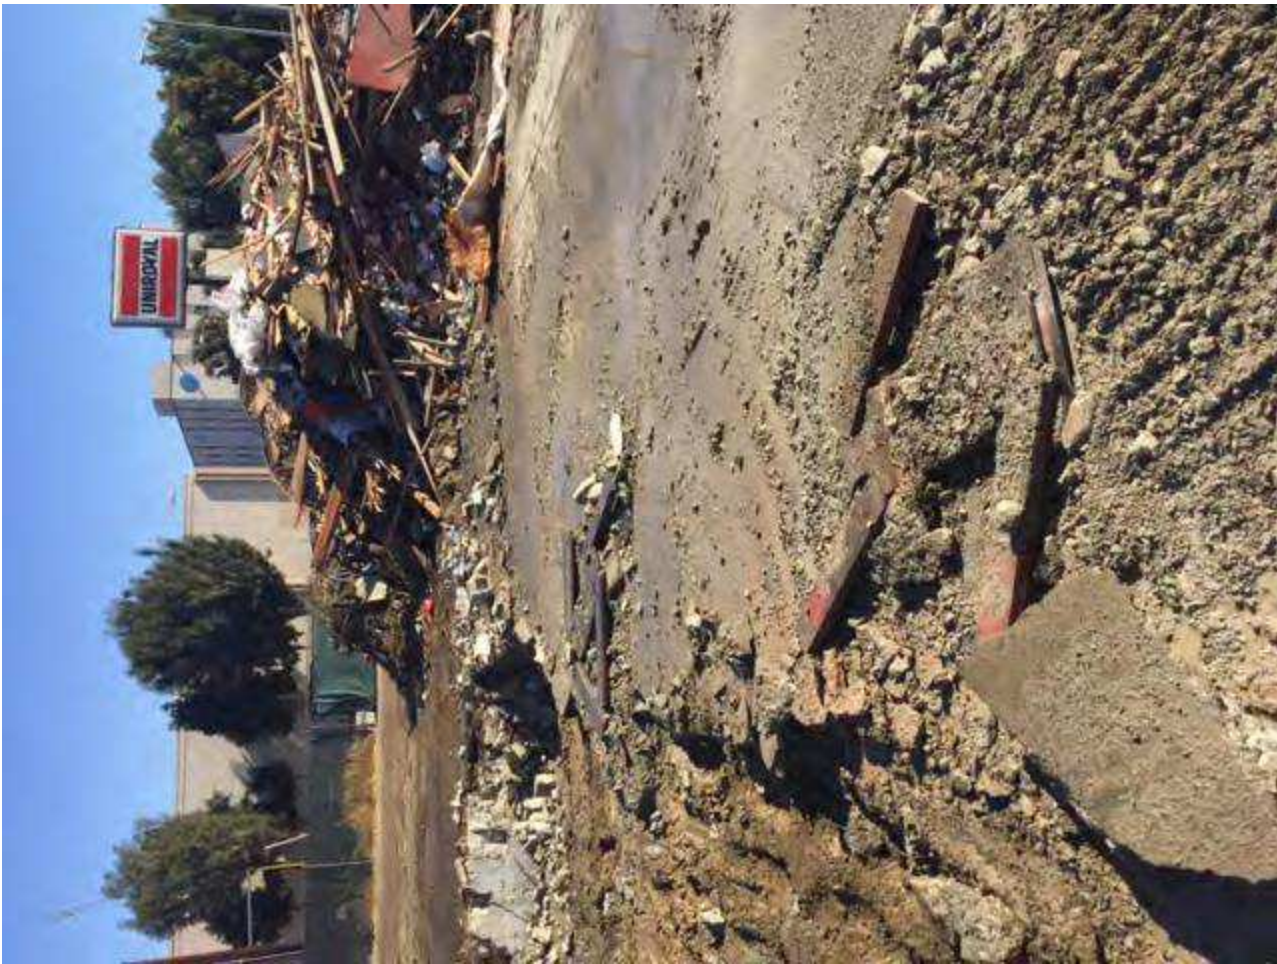
During today's shift Resource completed demo of the structure at 10819 Valley Blvd. All remaining trees were also brought down on the property. Tomorrow resource will return at 7AM to continue with demo of the concrete slab and hauling out generated debris. Pending further direction, concrete slab still remains on the North end of the lot.

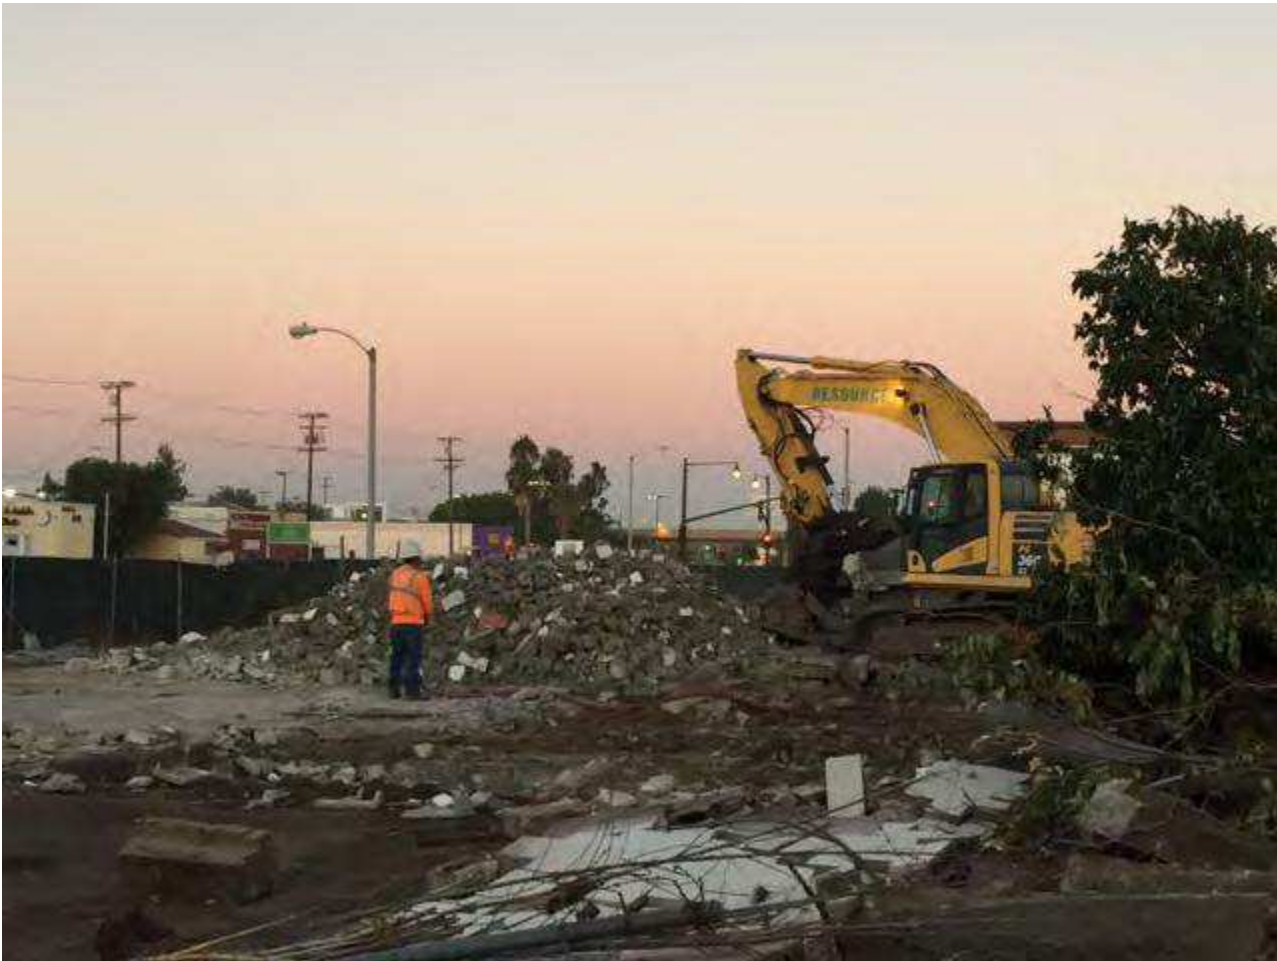
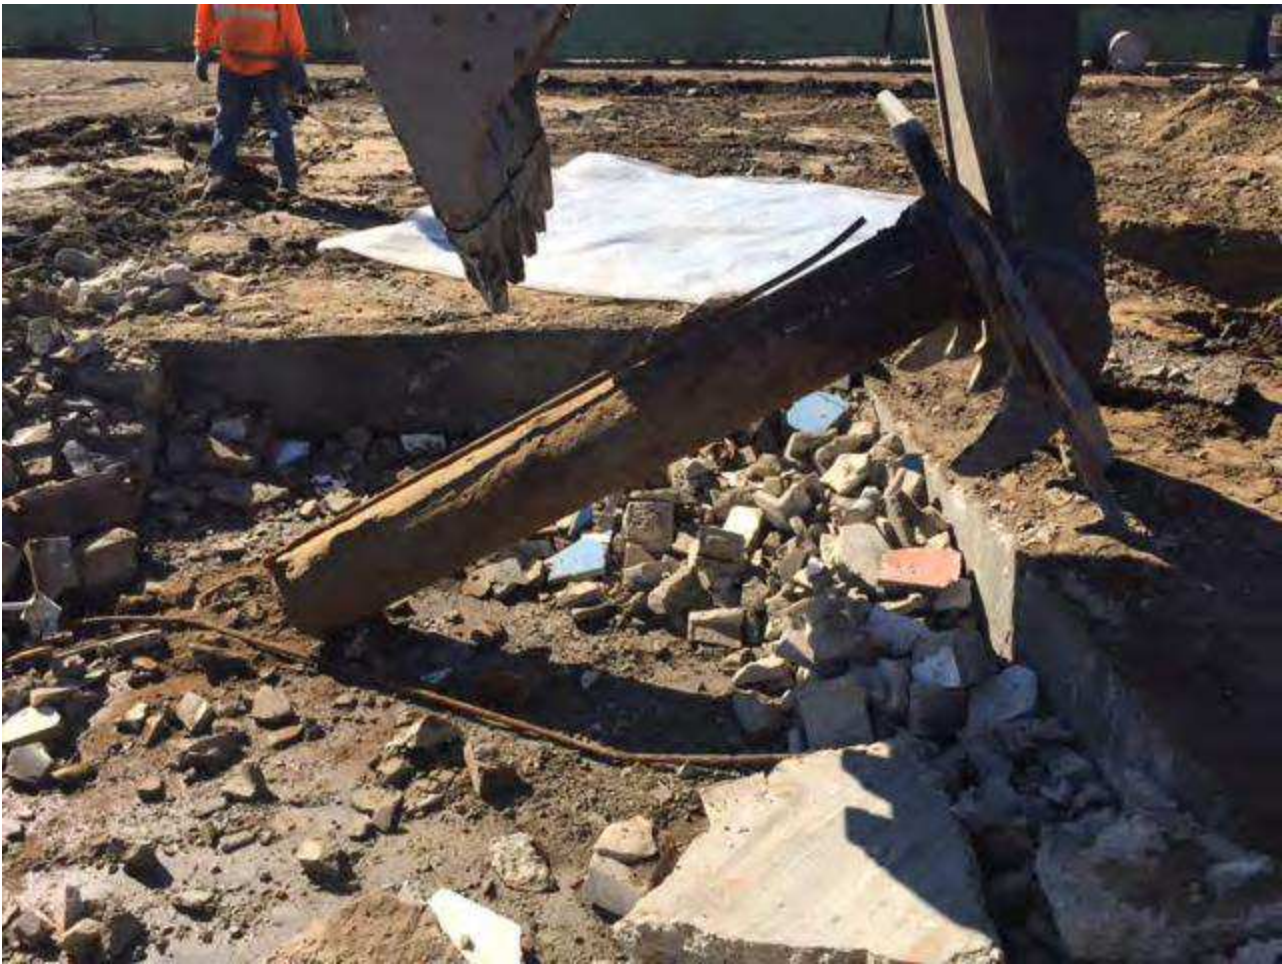
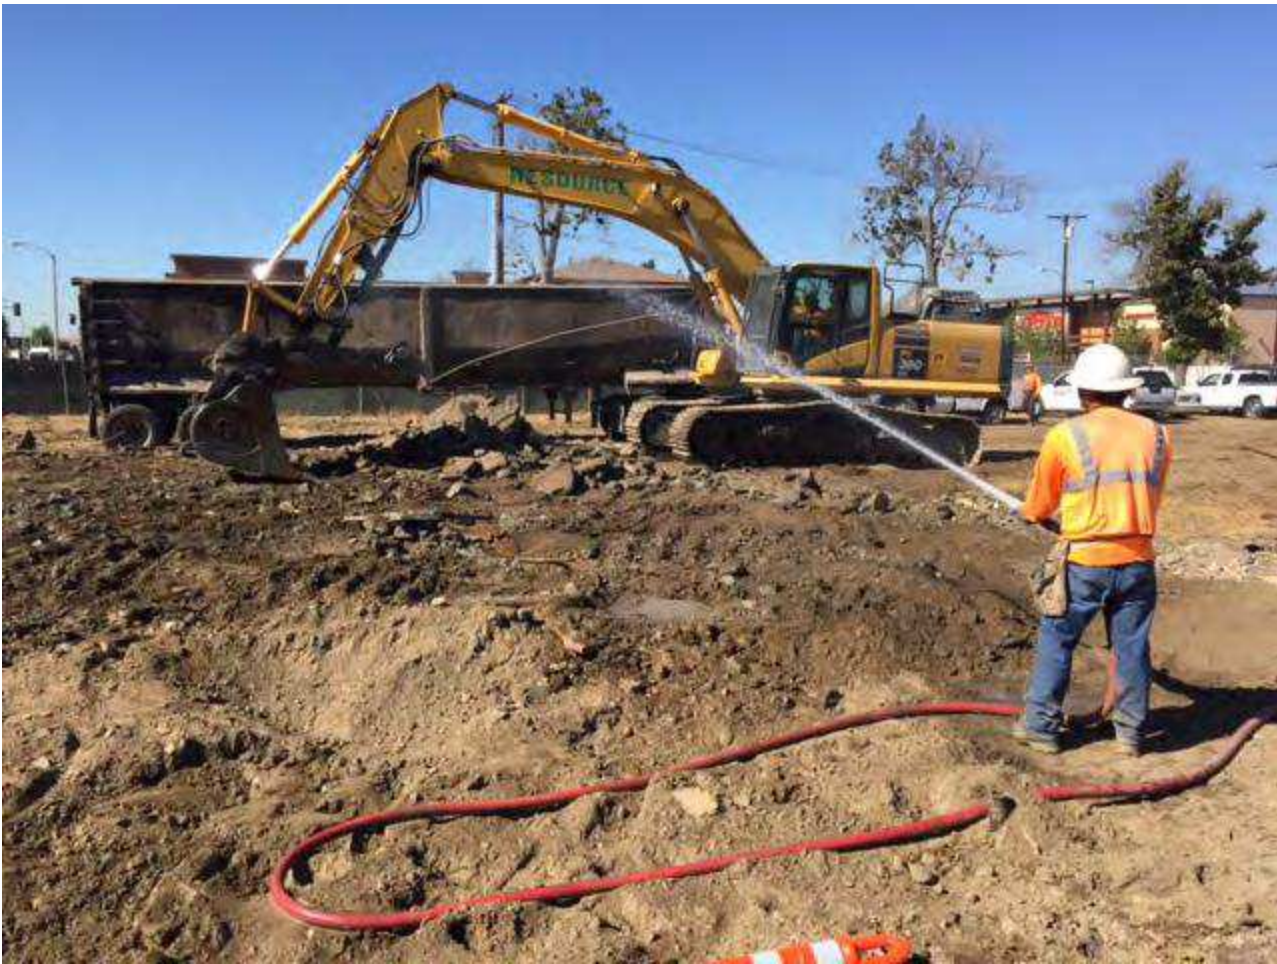
Resource completed the majority of slab demo and hauling at 10819 Valley Blvd during today's shift. World Wide Recovery (WWR) was onsite to inspect the hydraulic lifts; Resource will assist WWR in pulling the lifts, placing them on poly, and opening them so fluids can be drained tomorrow.
