Phase I Environmental Site Assessment Report

Area Y
10819 Valley Boulevard
El Monte, California

October 16, 2019 | Project No. 211175001

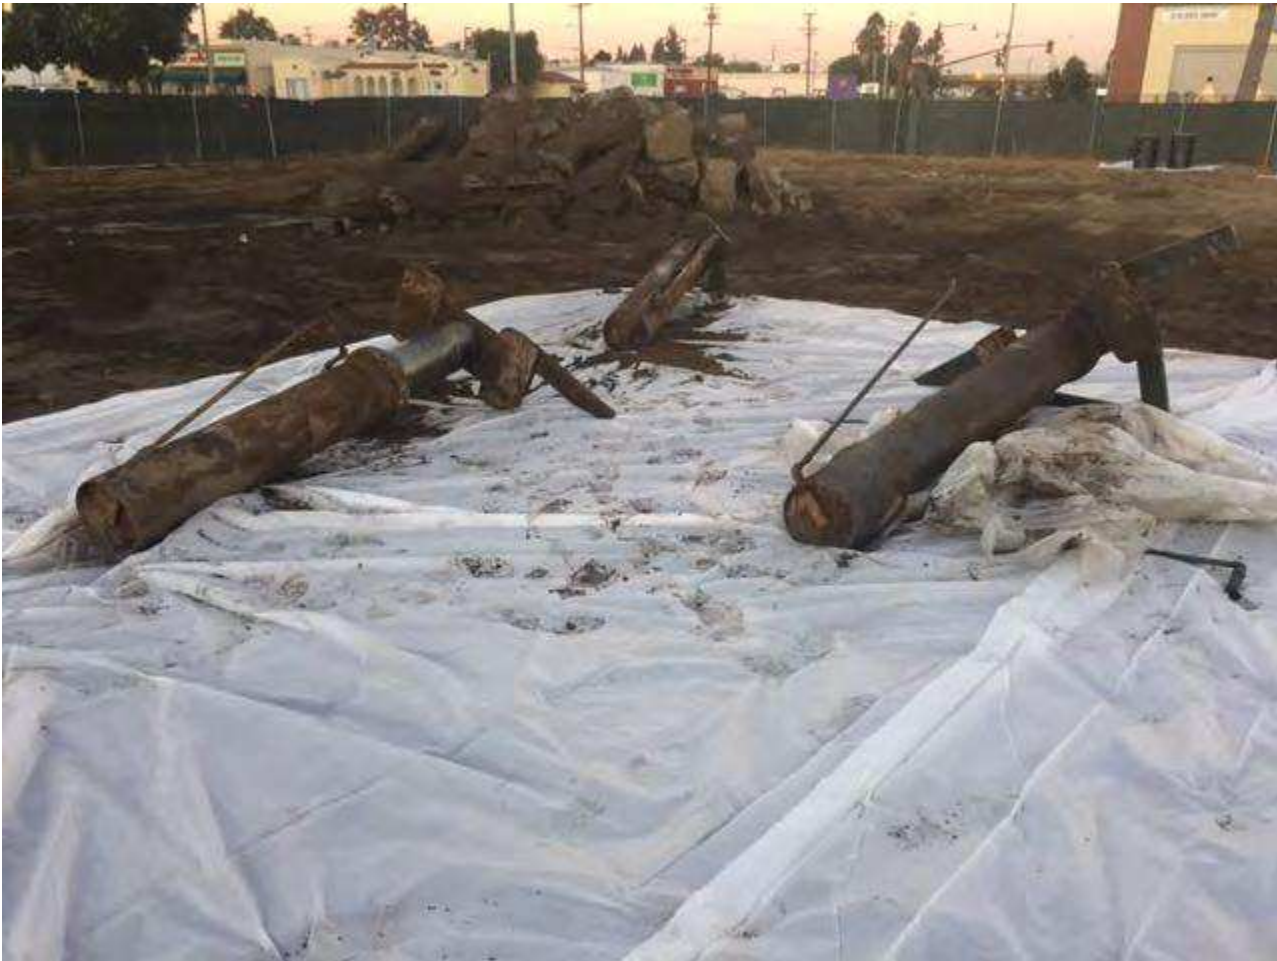
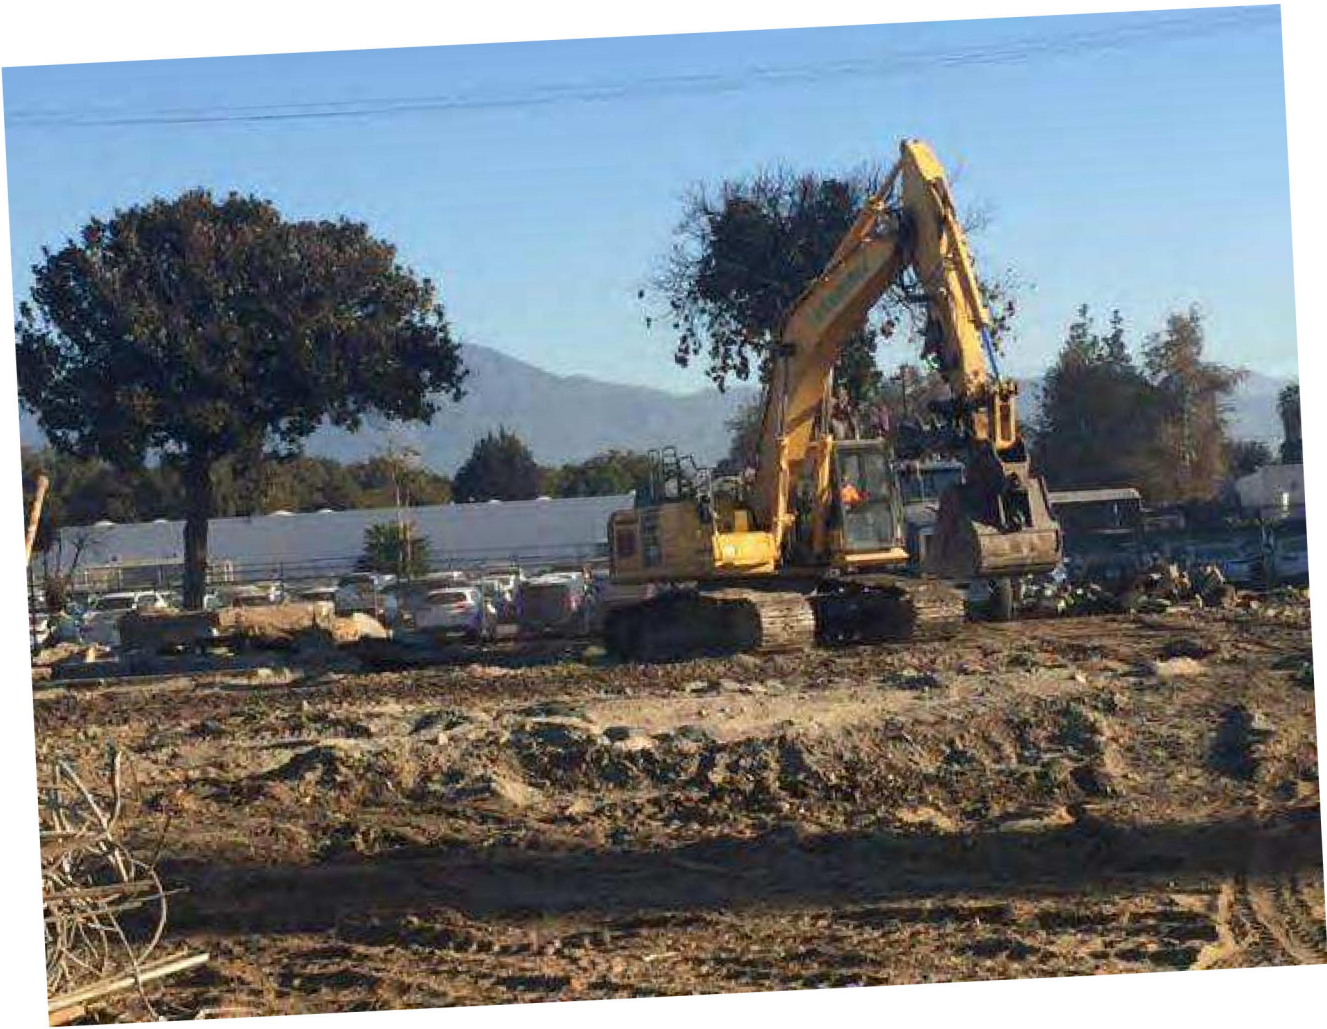
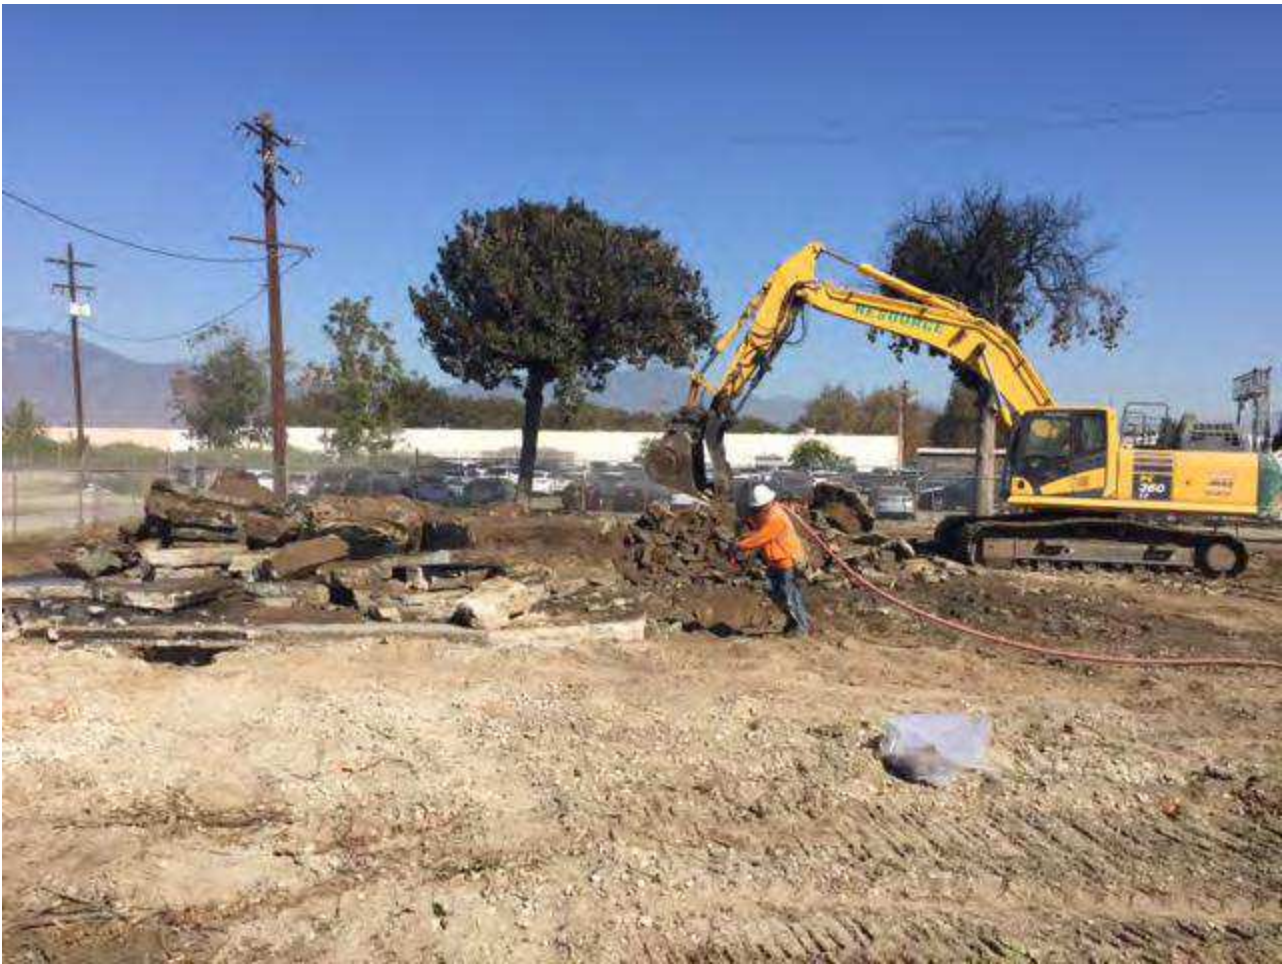
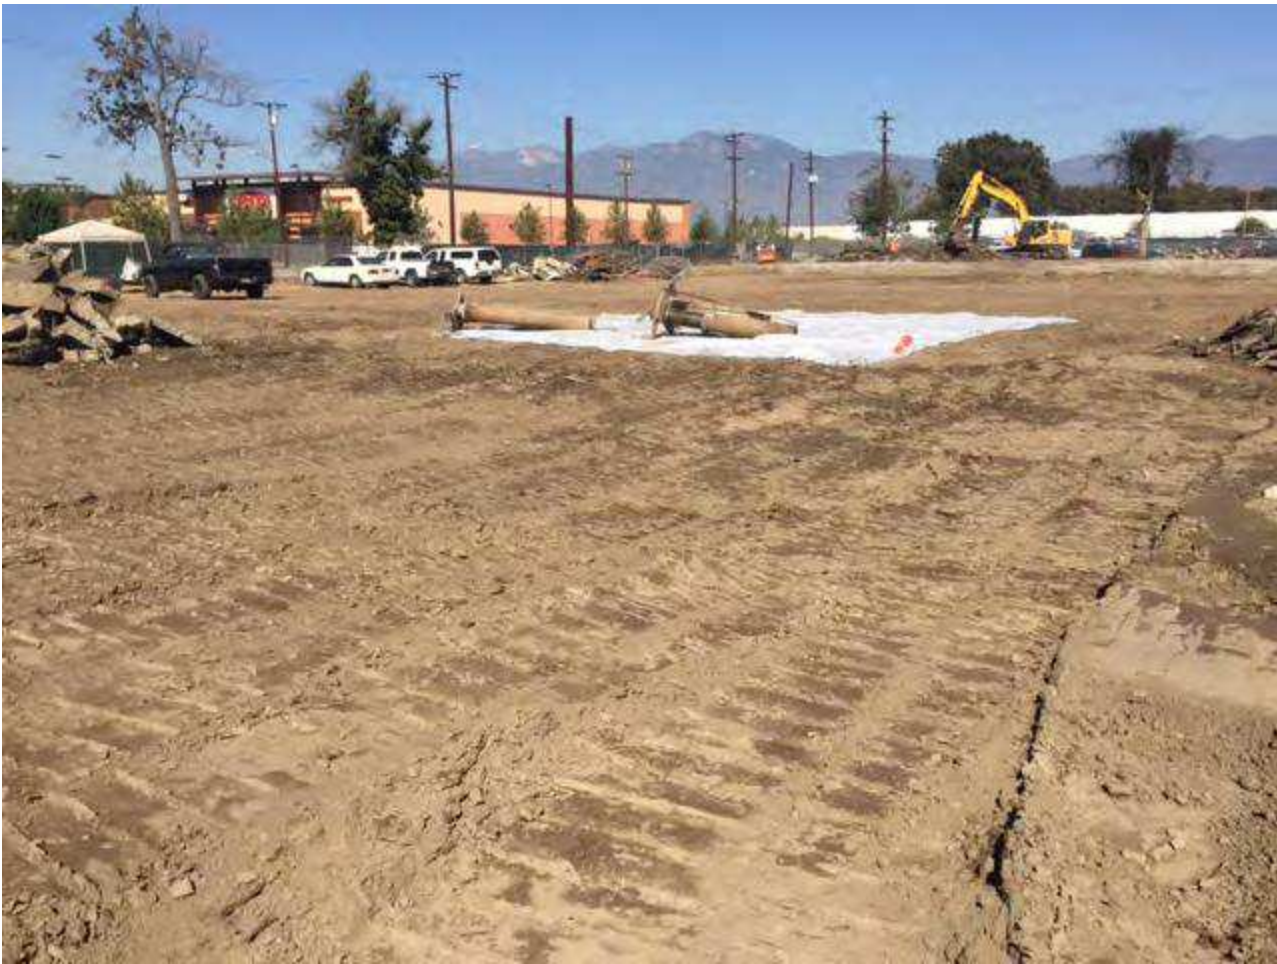
Resource completed slab demo at 10819 Valley Blvd and completed remaining "double thickness" slab removal at 221 El Monte during today's shift. World Wide recovery did not mobilize to remove hydraulic oil; this will take place Monday.

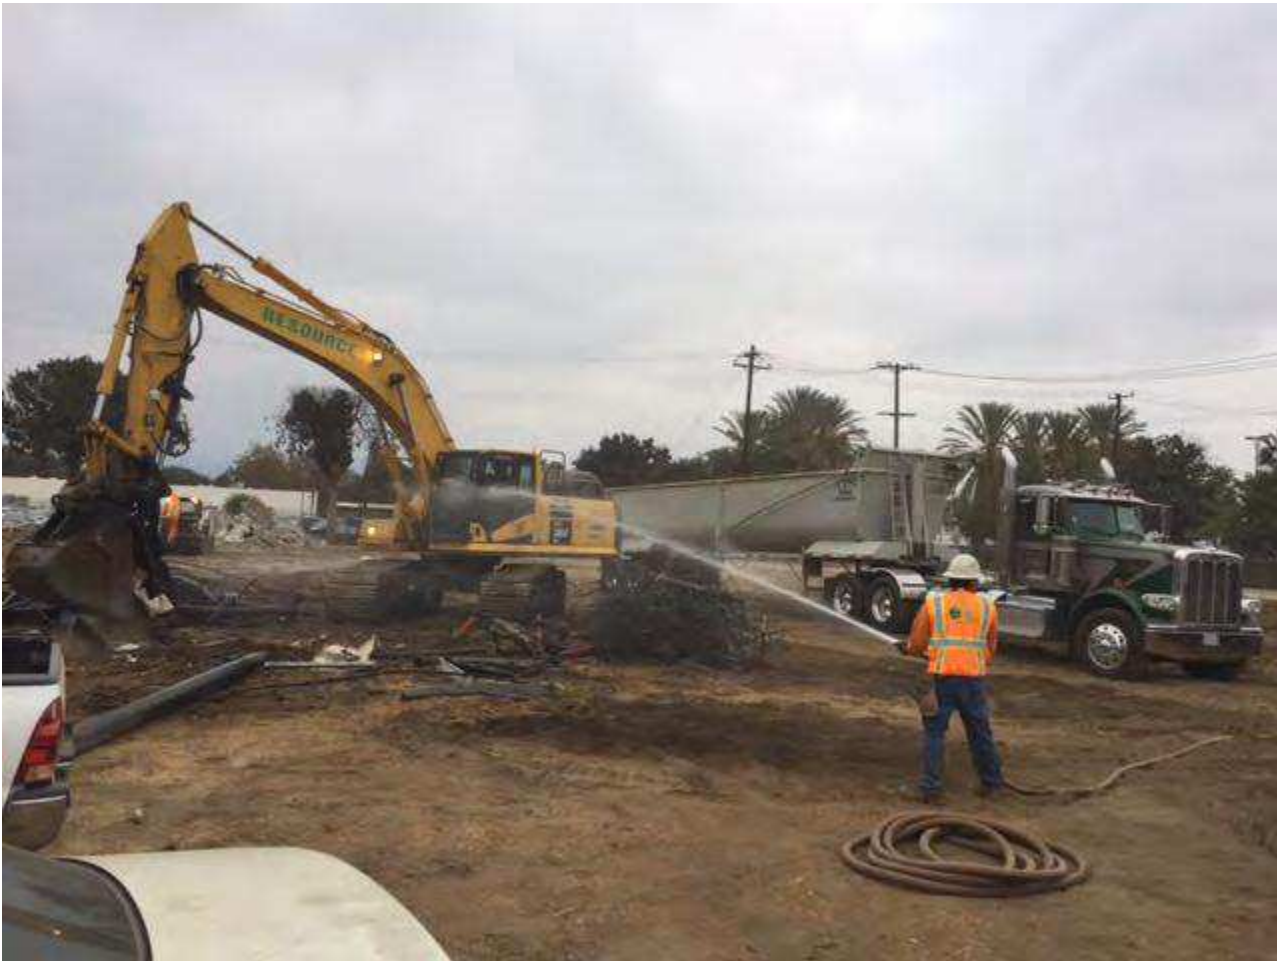
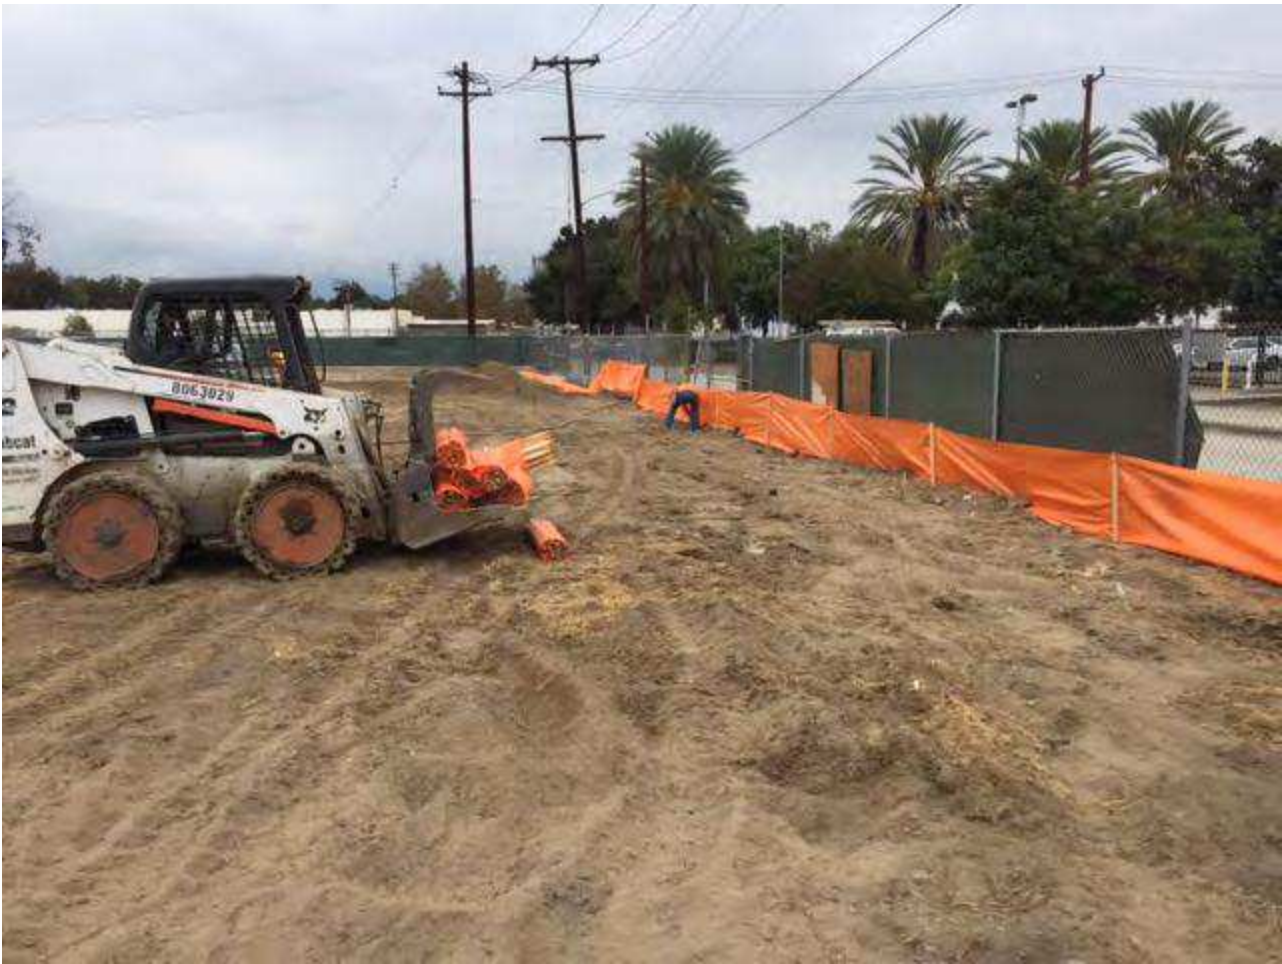
Resource hauled remaining concrete/metal waste from the El Monte/Valley Blvd site during today's shift. Grading activities are appx 90% complete. World Wide Recovery failed to mobilize to remove hydraulic fluid; their mobilization time is unknown.

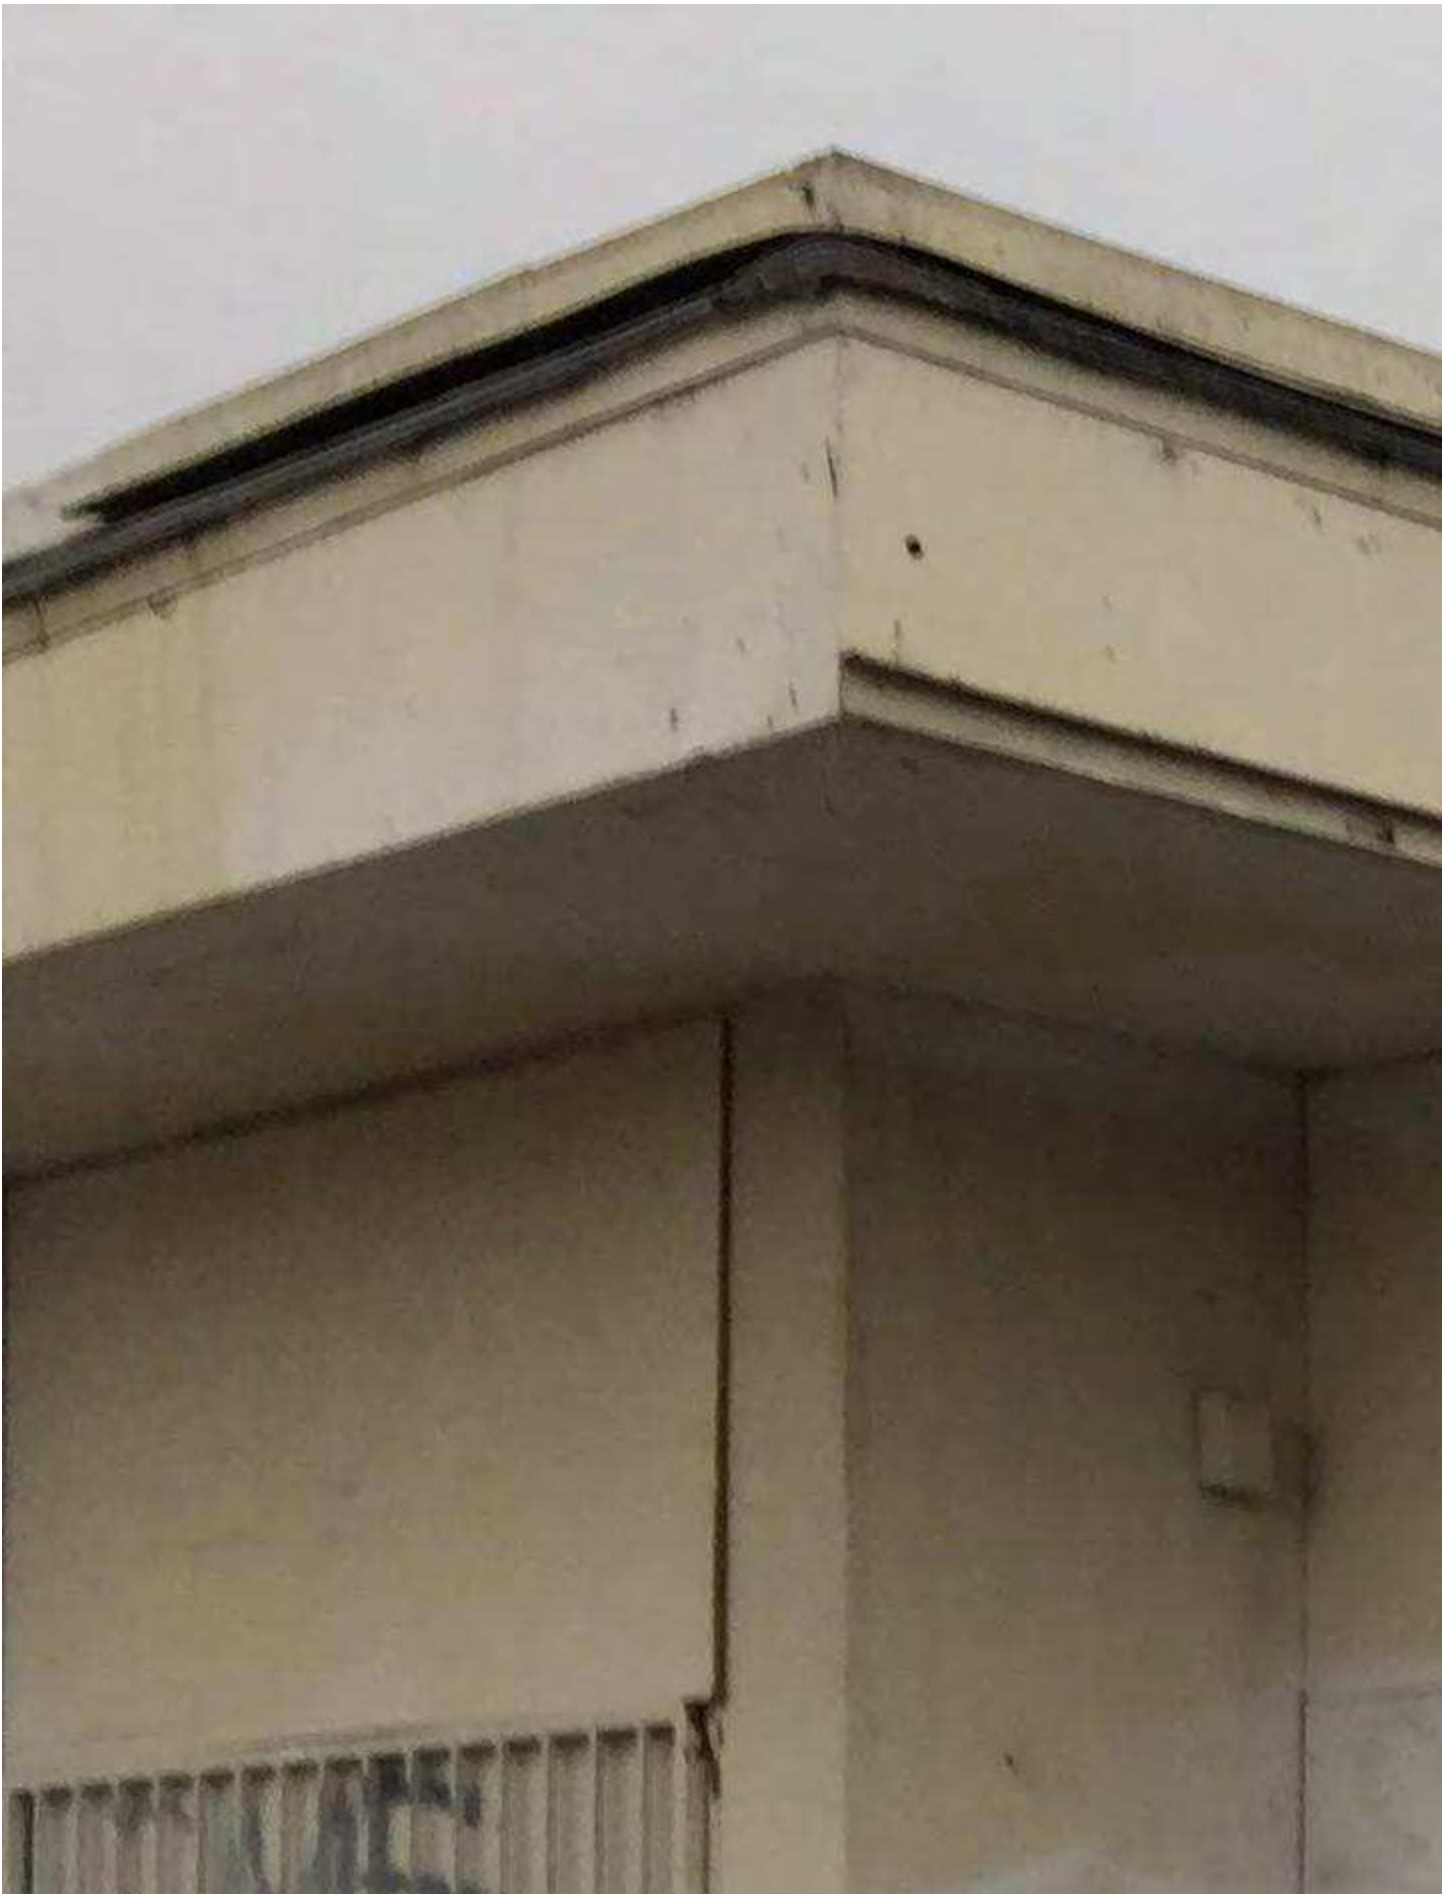
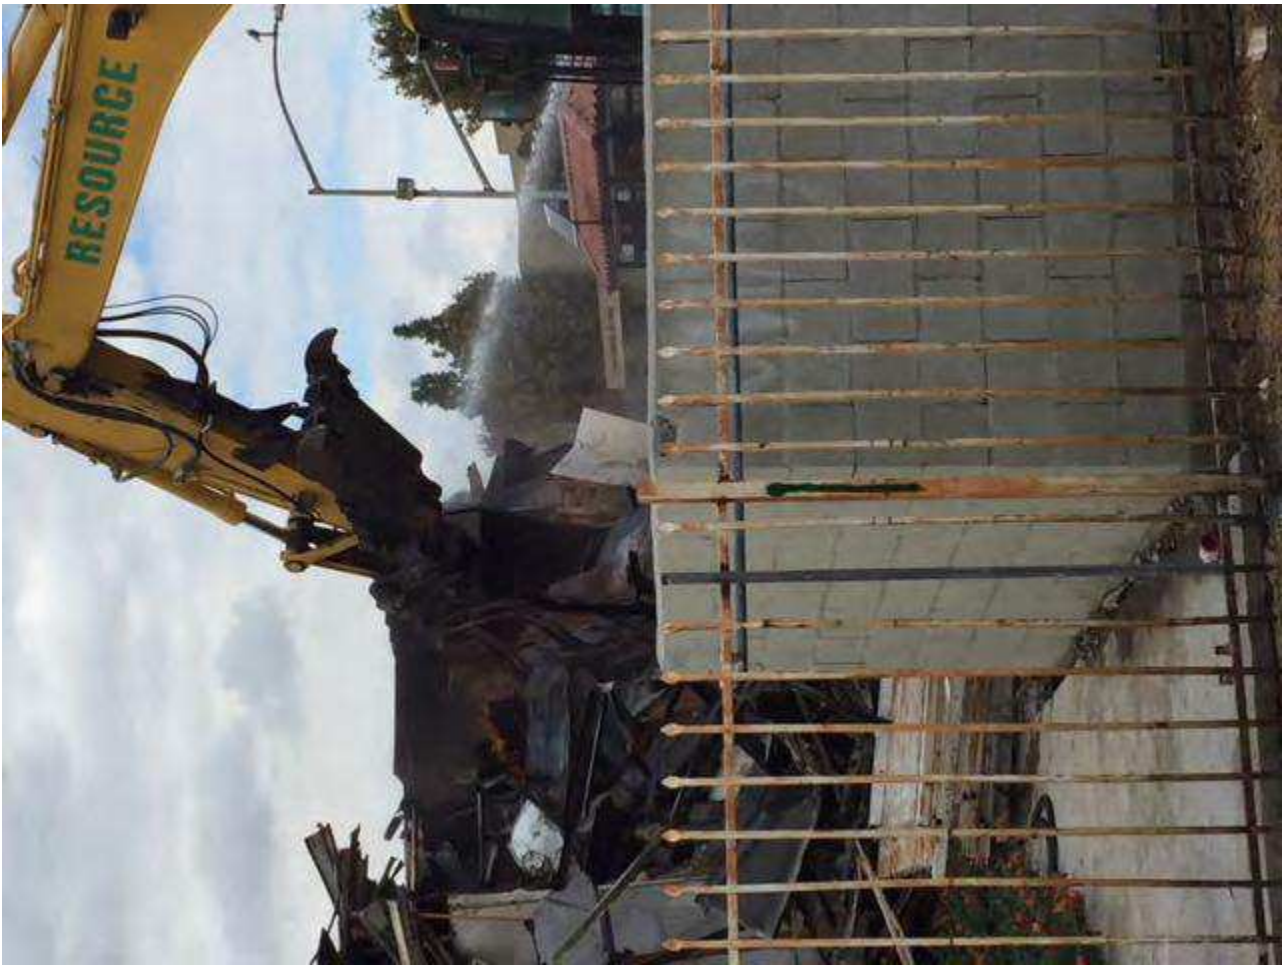
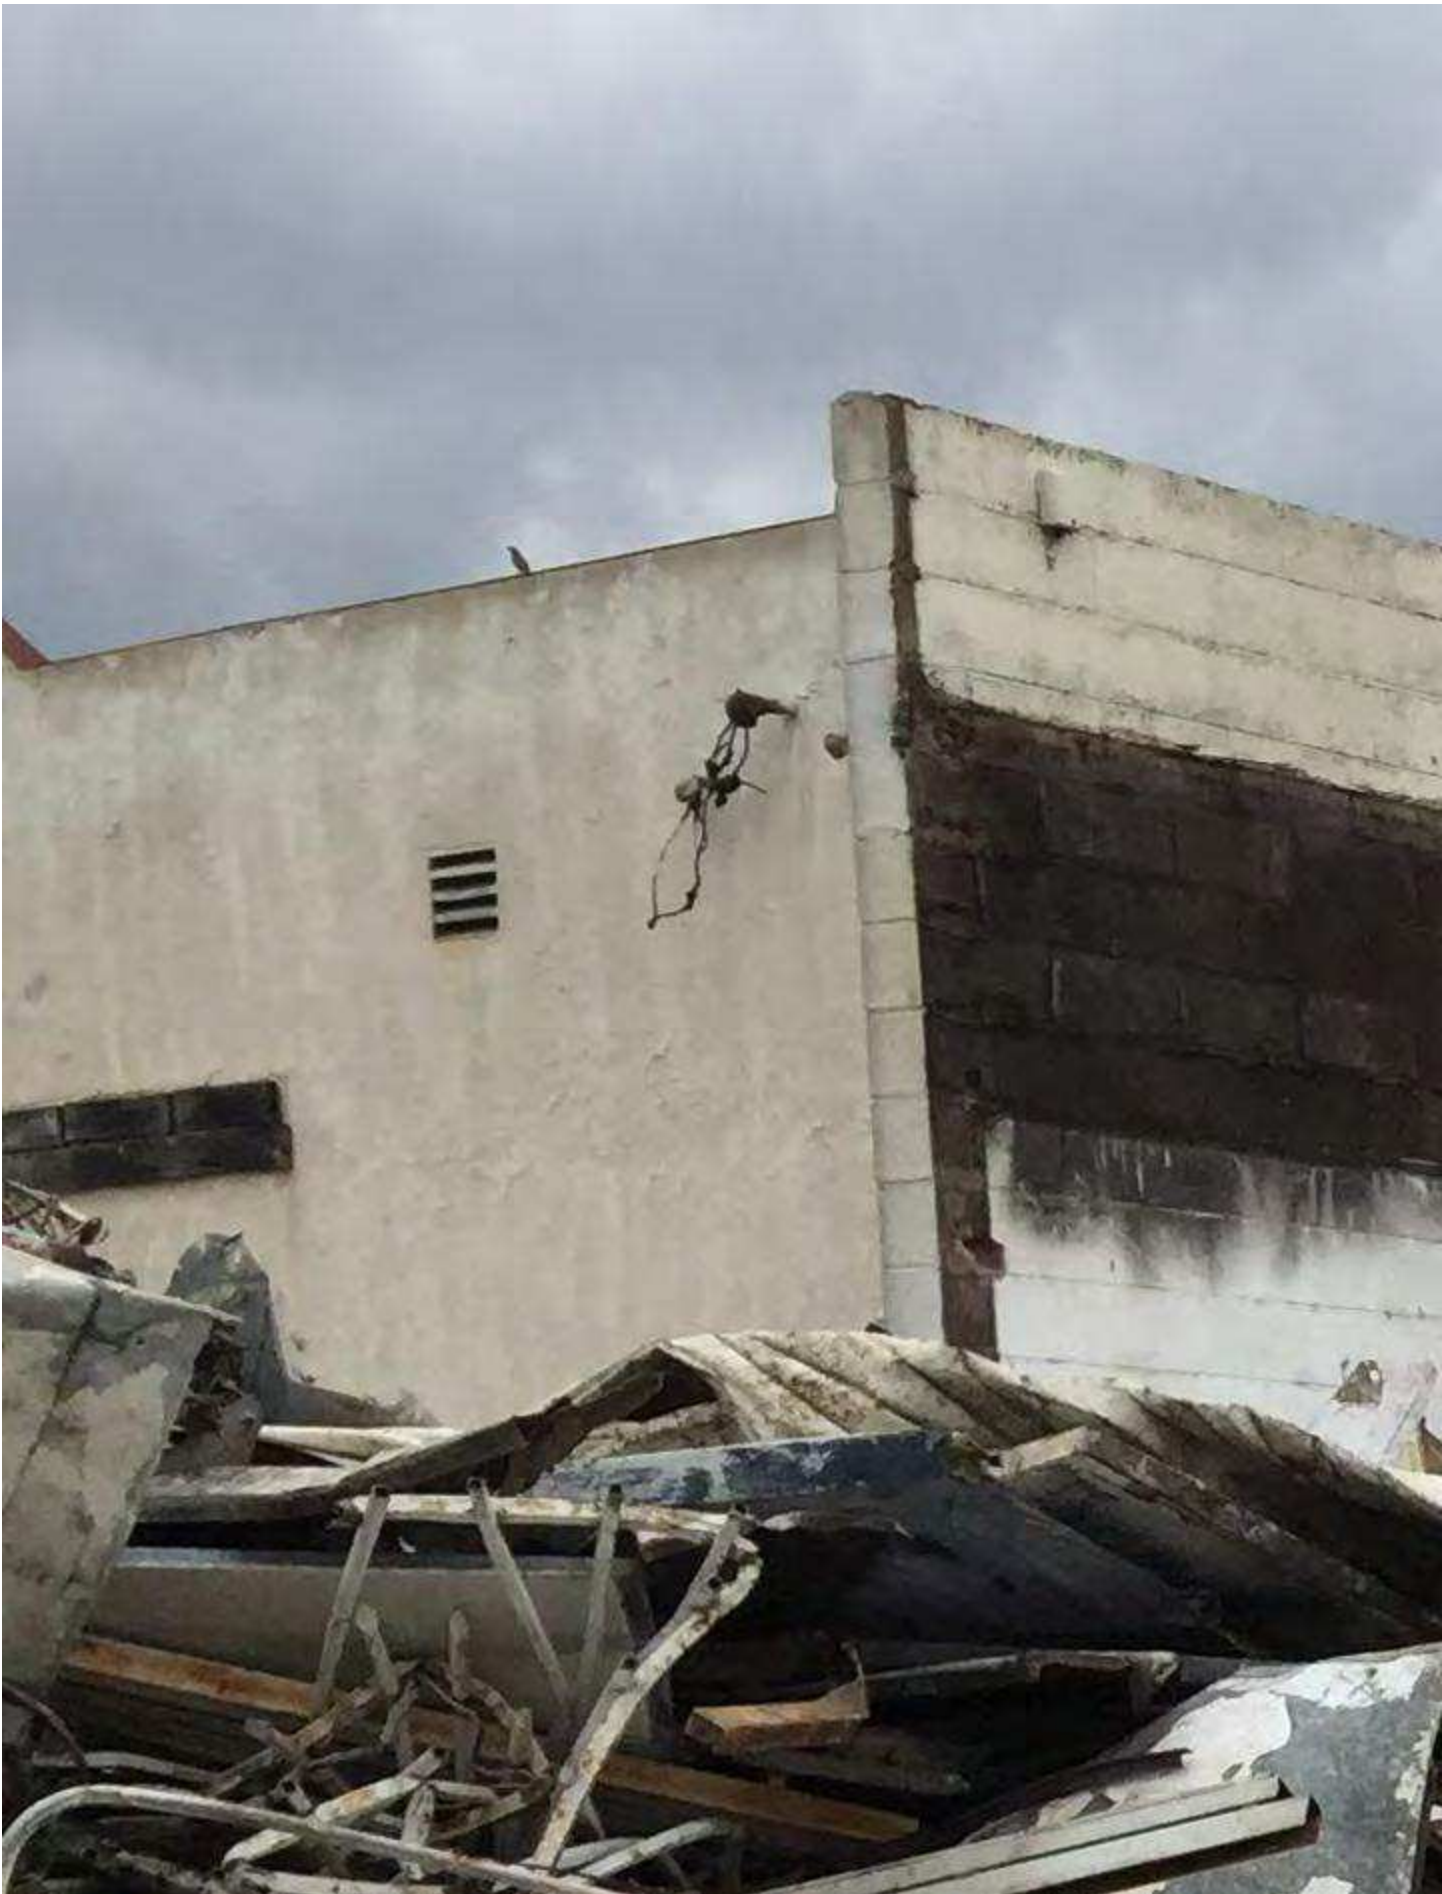
All, recourse was successful in demolition of 3448 Tyler building. Area has been fenced off. World wide recovery was not on site. Recourse currently looking for new company to remove hydraulic fluid. Resource will be back on site at 7am for further demolition and separate waste. Thank You.

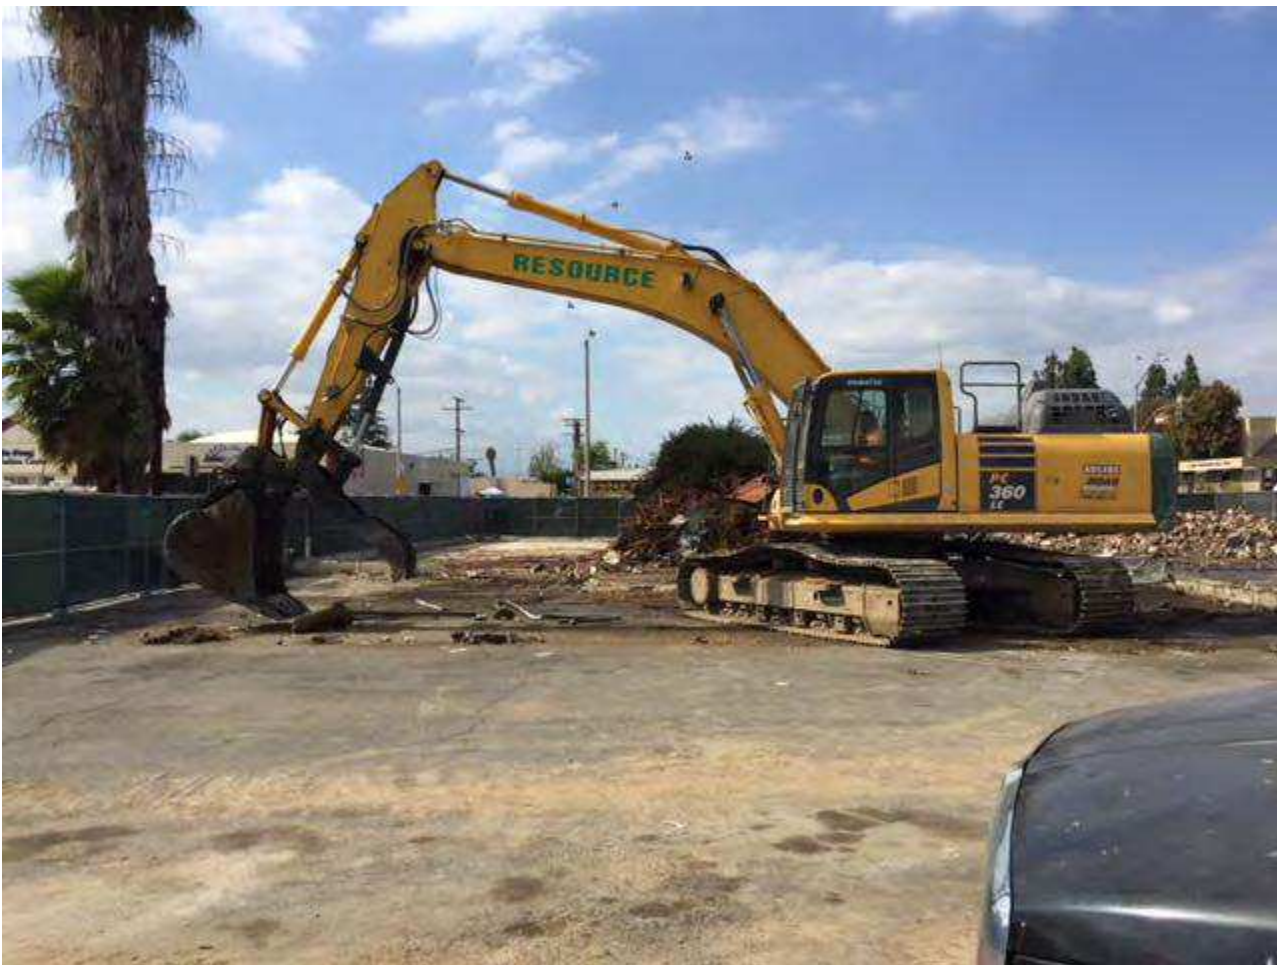
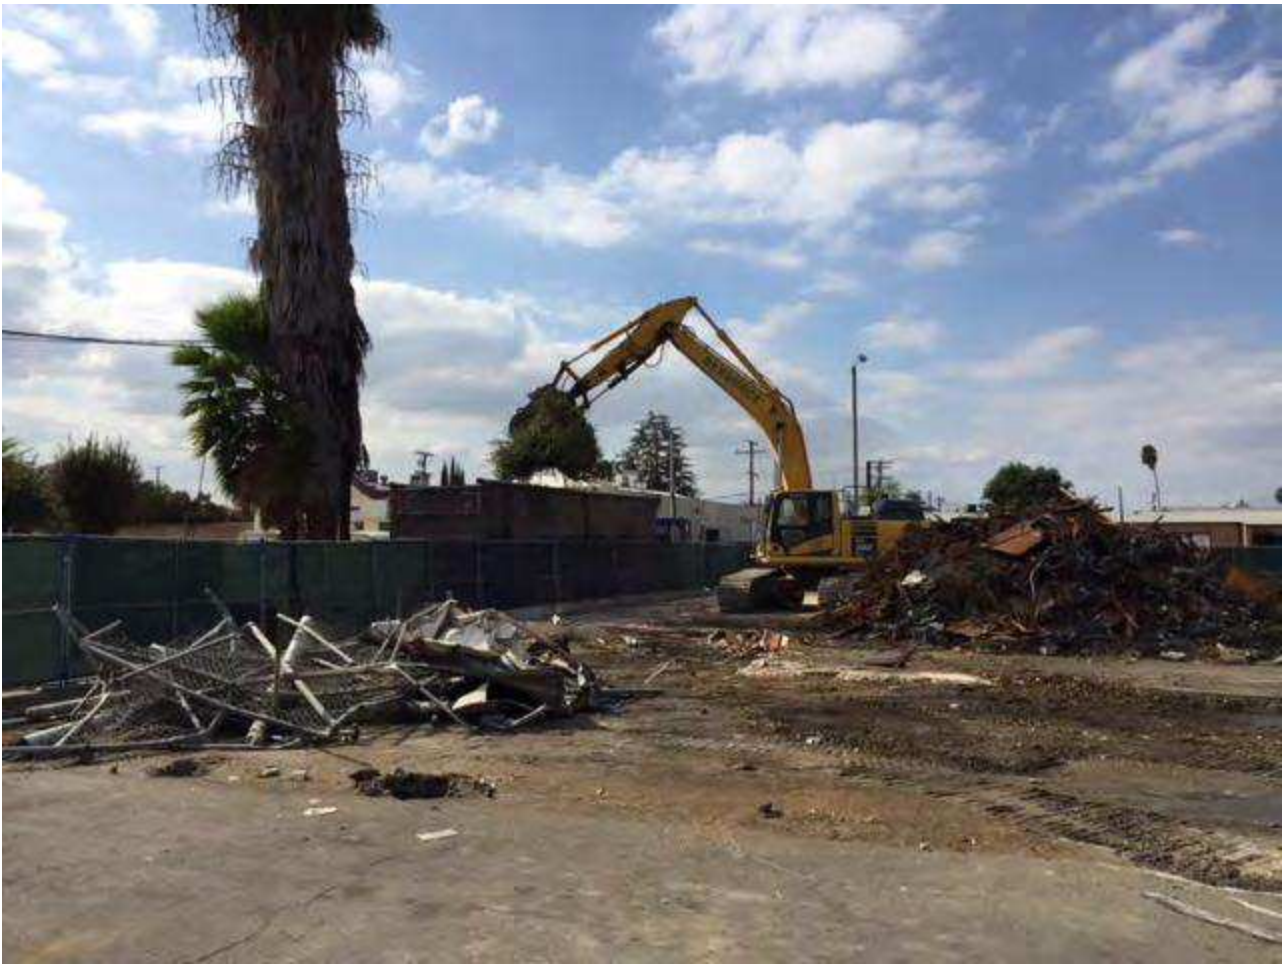
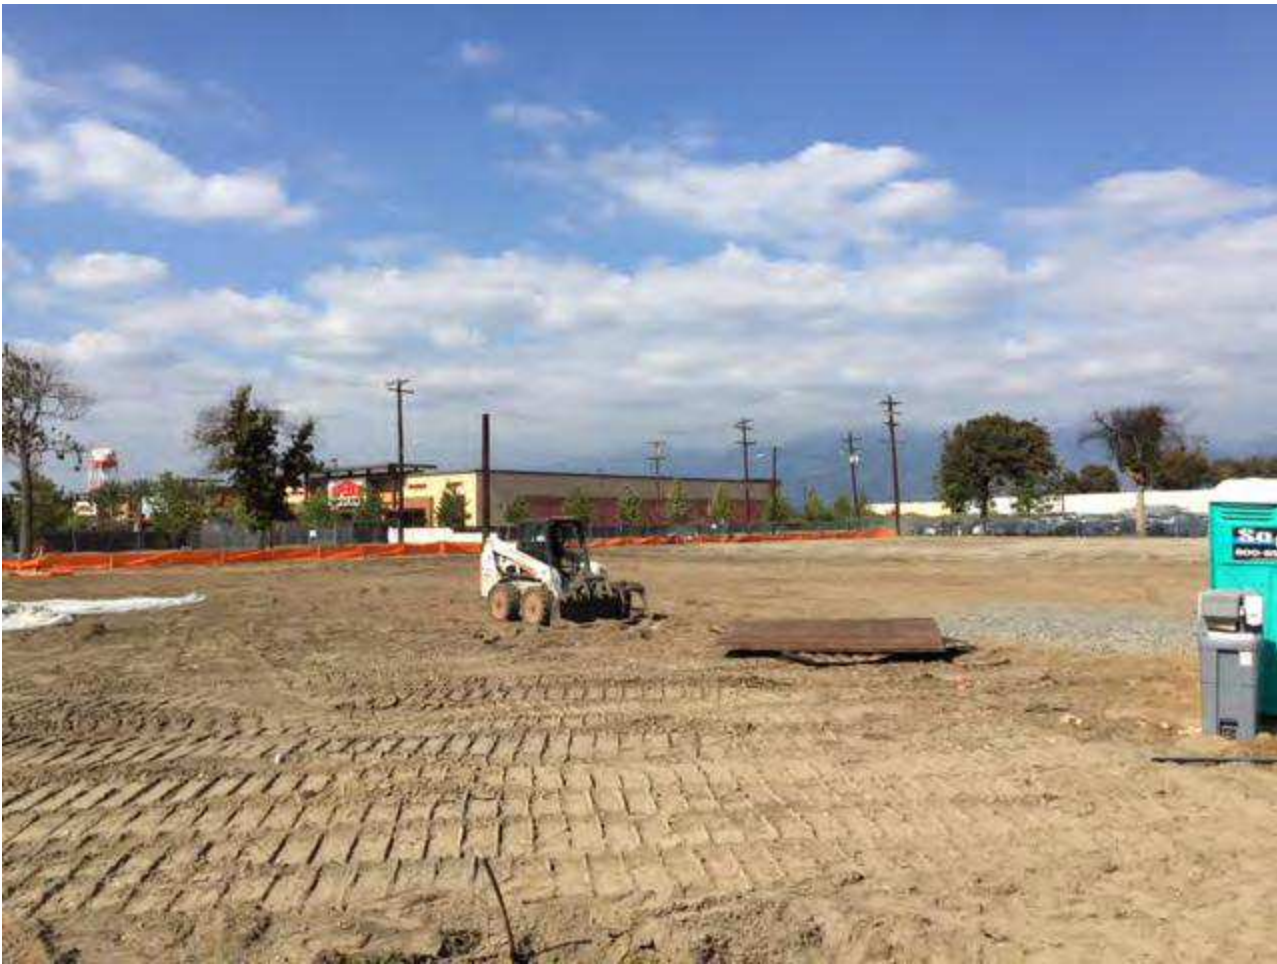
All, Resource was successful in demolition of 3454 Tyler st. Building. AG transport was there hauling off waste. Still no word from world wide recovery on the hydraulic fluid. Resource will be back onsite tomorrow for further demolition and to separate waste, Thank You.
