Type of Services	Phase I Environmental Site Assessment
Location	APNs 220-32-057 & 220-32-058 3017-3157 El Camino Real Santa Clara, California
Client	Bayview Development Group, Inc.
Client Address	60 South Market Street, Suite 450 San Jose, California 95113
Project Number	958-4-1
Date	June 19, 2018

Prepared by **Sarah E. Kalika, P.G.**
Senior Project Geologist

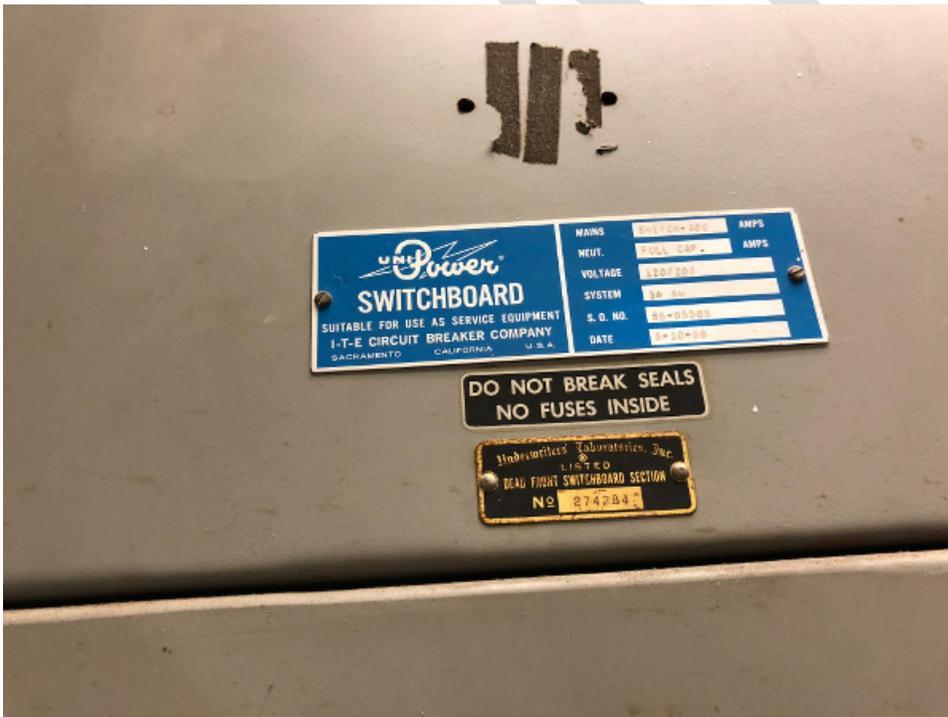
Photograph 6. Electrical switchboard, dated 1969.

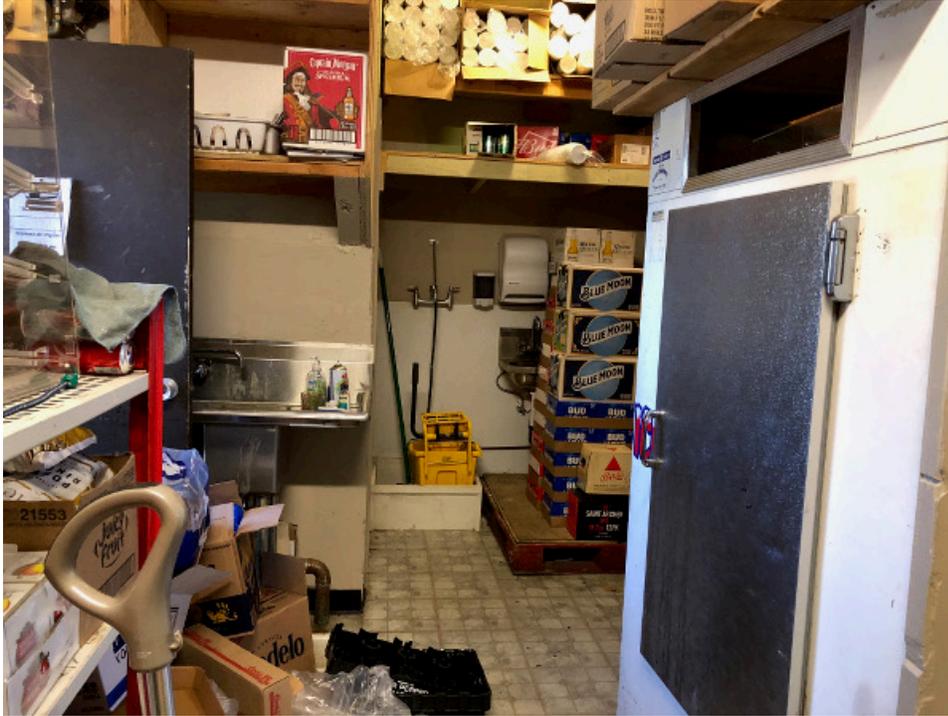
Photograph 15. Cleaning supplies, sink, and door to walk-in cooler unit within convenience store.

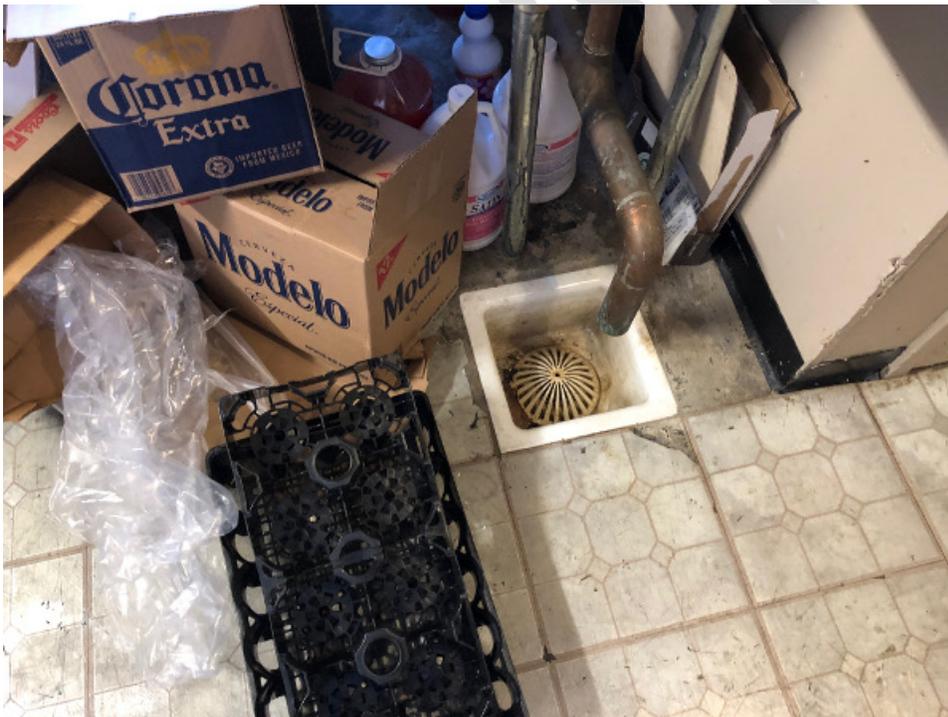
Photograph 16. Floor drain within convenience store unit.

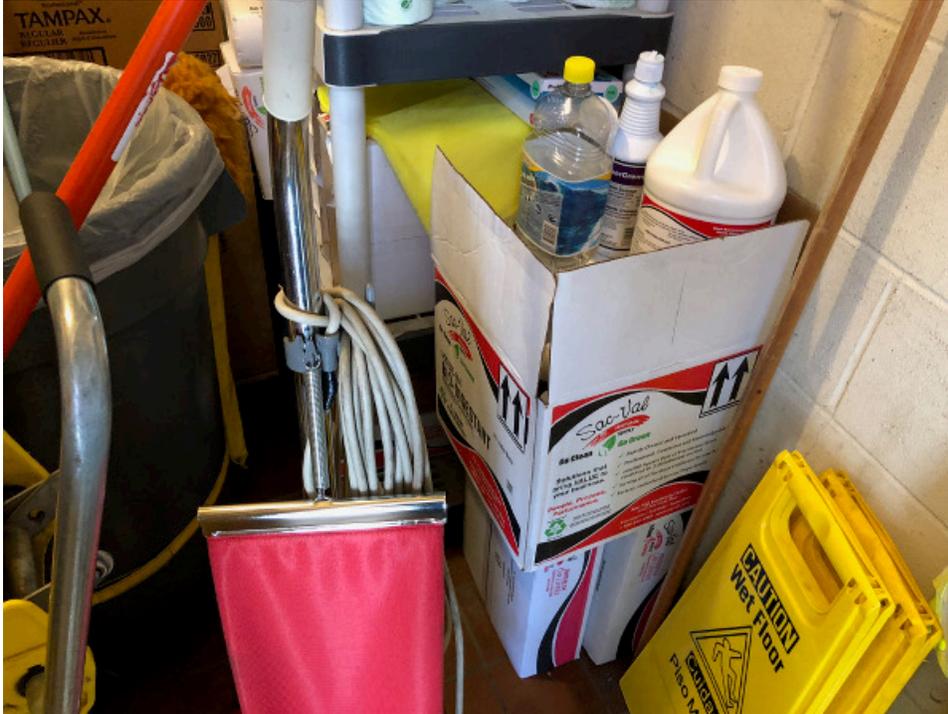
Photograph 29. Additional view of cleaning chemicals and supplies within ground floor office lobby custodial closet.

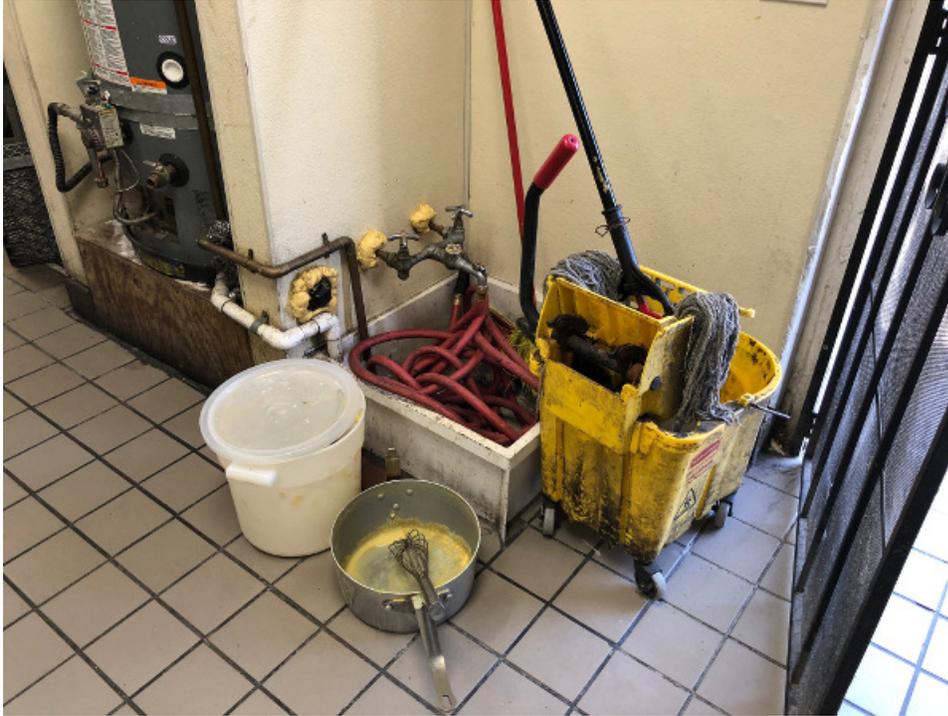
Photograph 37. Closer view of cleaning supplies and drain on north side of structure.

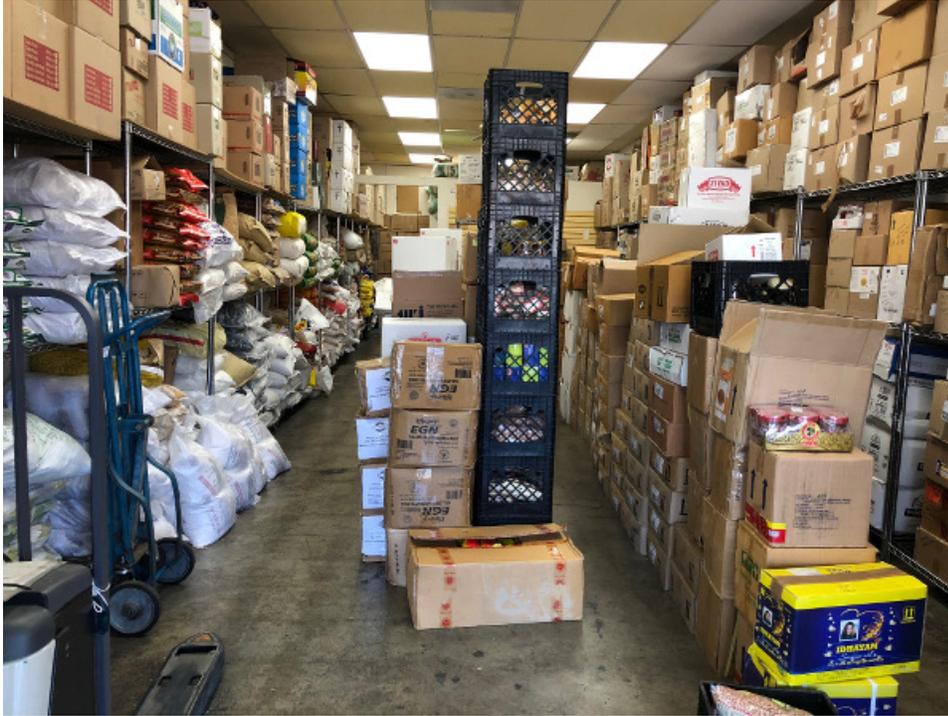
Photograph 44. Additional market storage space.

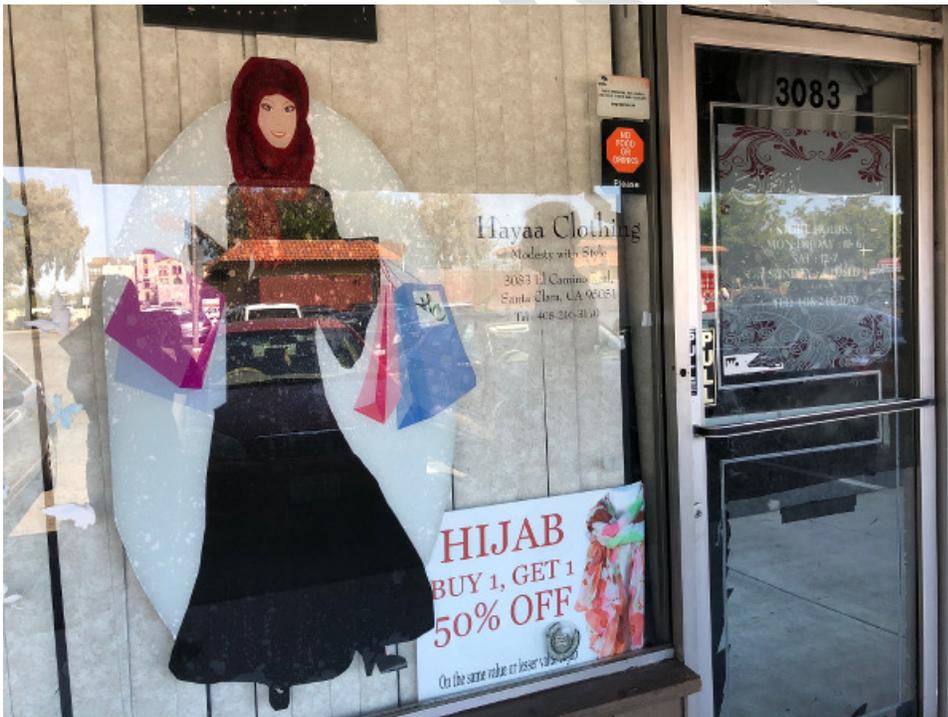
Photograph 45. Exterior view of clothing store tenant space.

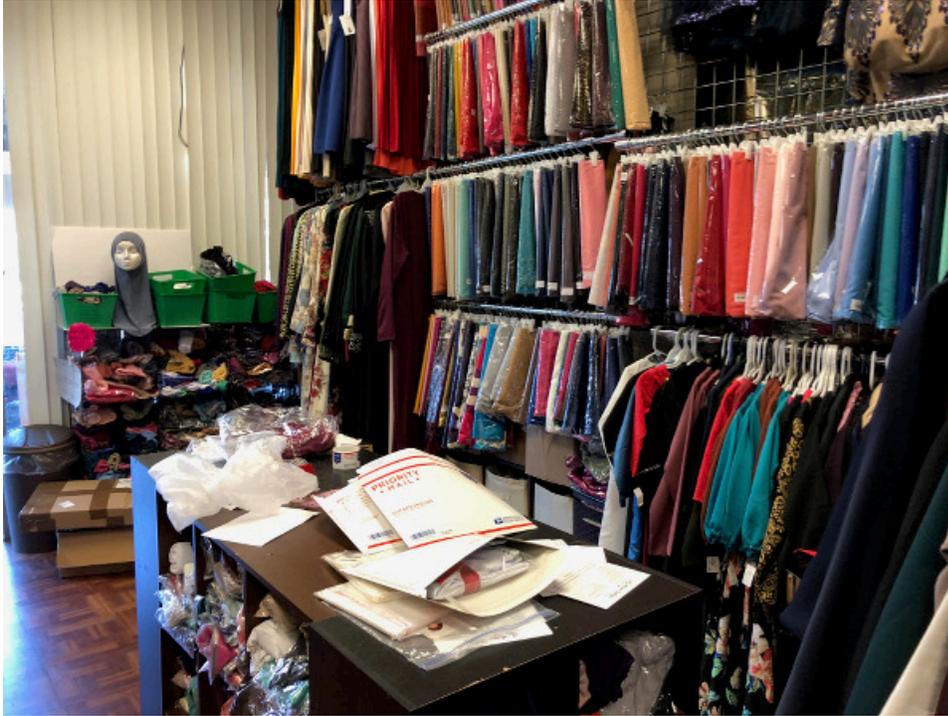
Photograph 46. Interior of clothing store tenant space.

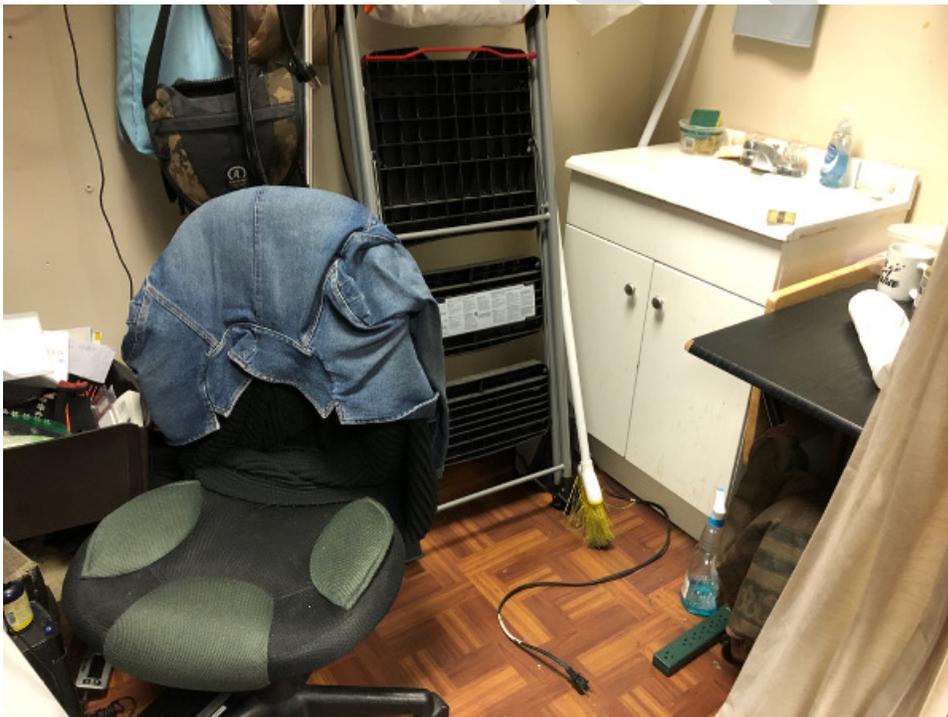
Photograph 47. Office and sink area within clothing store.

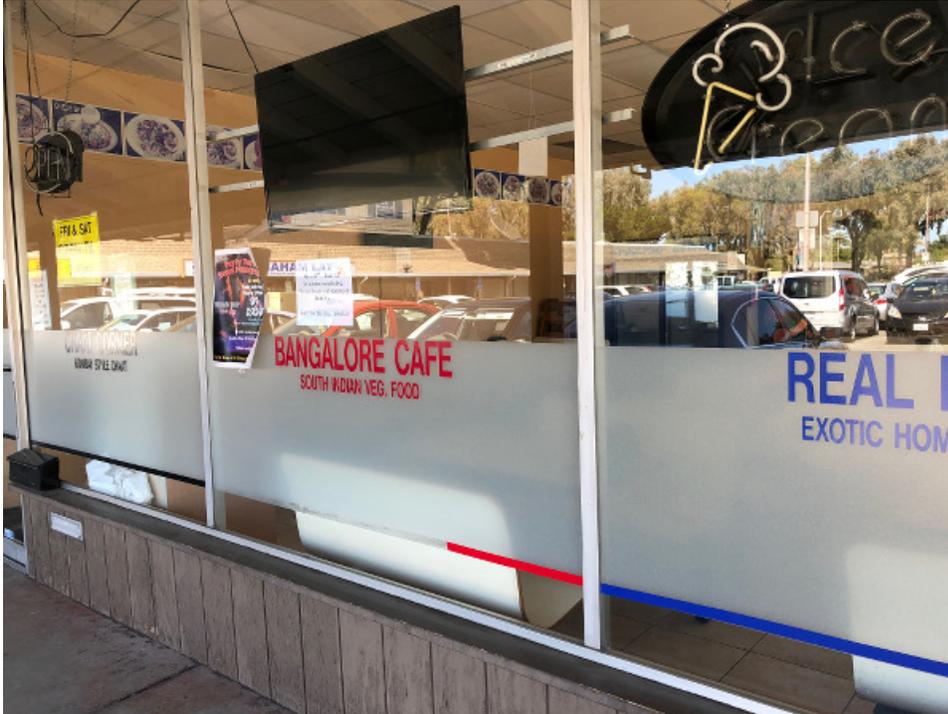
Photograph 48. Exterior of additional restaurant and ice cream shop (unable to enter interior, closed for renovations).

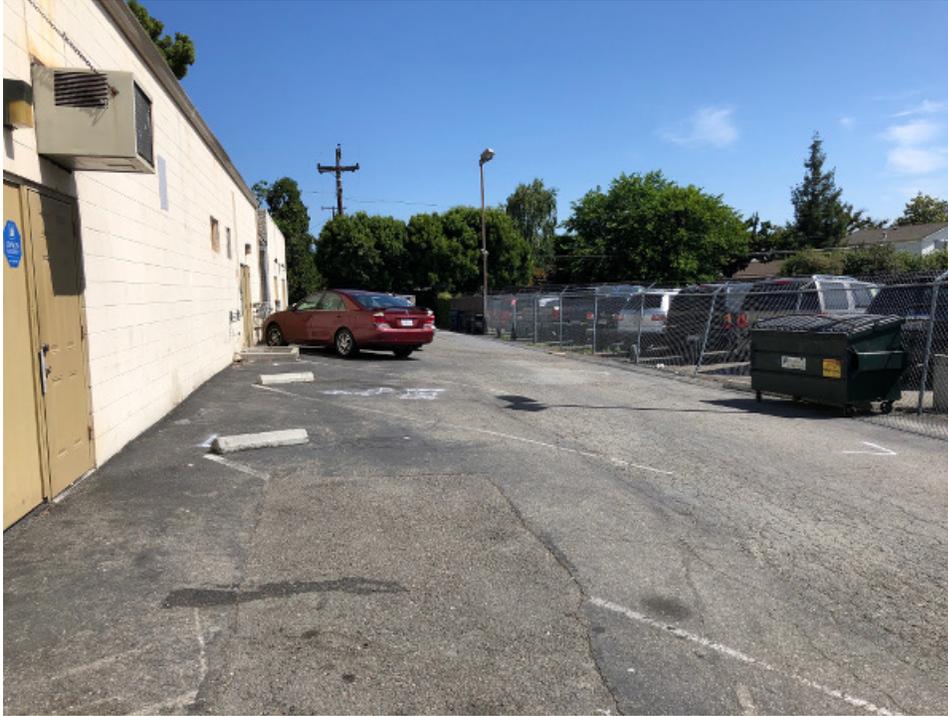
Photograph 50. View looking north along eastern side of shopping center structure. Chain-link fence is apparent property line.

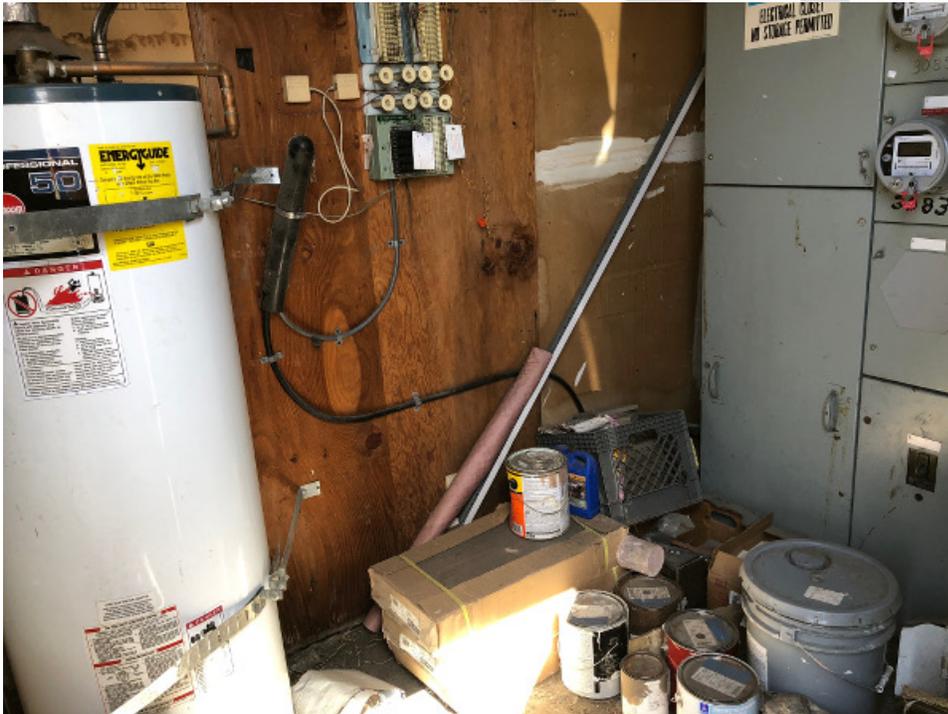
Photograph 51. Electrical and water heater property management space, also storage location of paints and maintenance supplies, located along eastern side of shopping center structure.

Minor quantities of household and commercial-grade cleaners, paints, and cooking oils were observed within the various tenant spaces and maintenance storage areas.

No additional spills or leaks were noted around the hazardous materials observed. We recommend requiring the property owner and tenants to remove all hazardous materials for proper disposal prior to purchasing the Site.

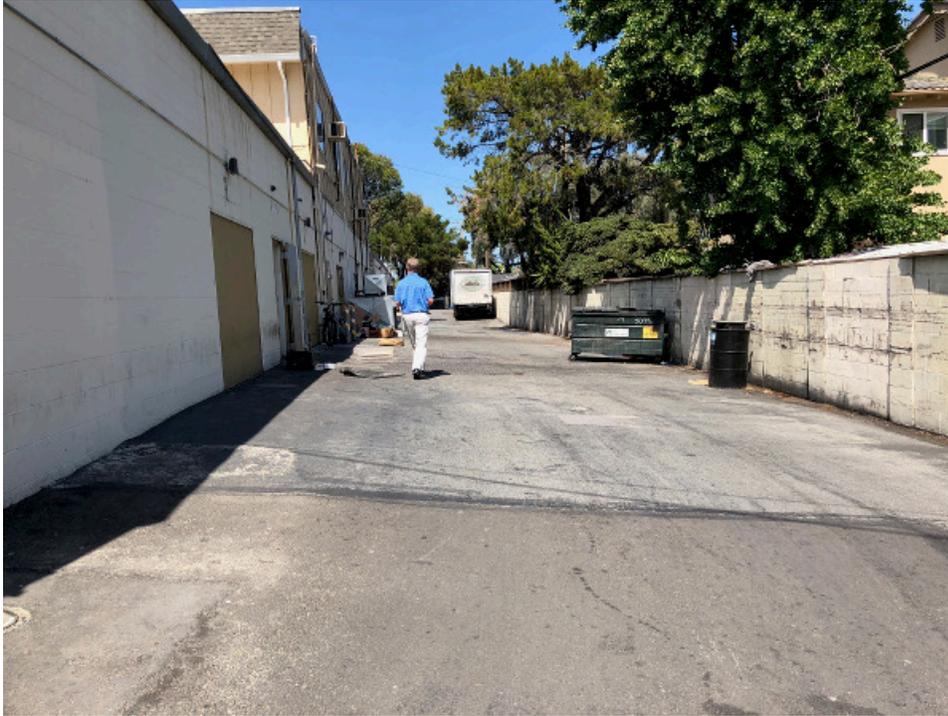
Photograph 54. View looking west along northern boundary of Site.

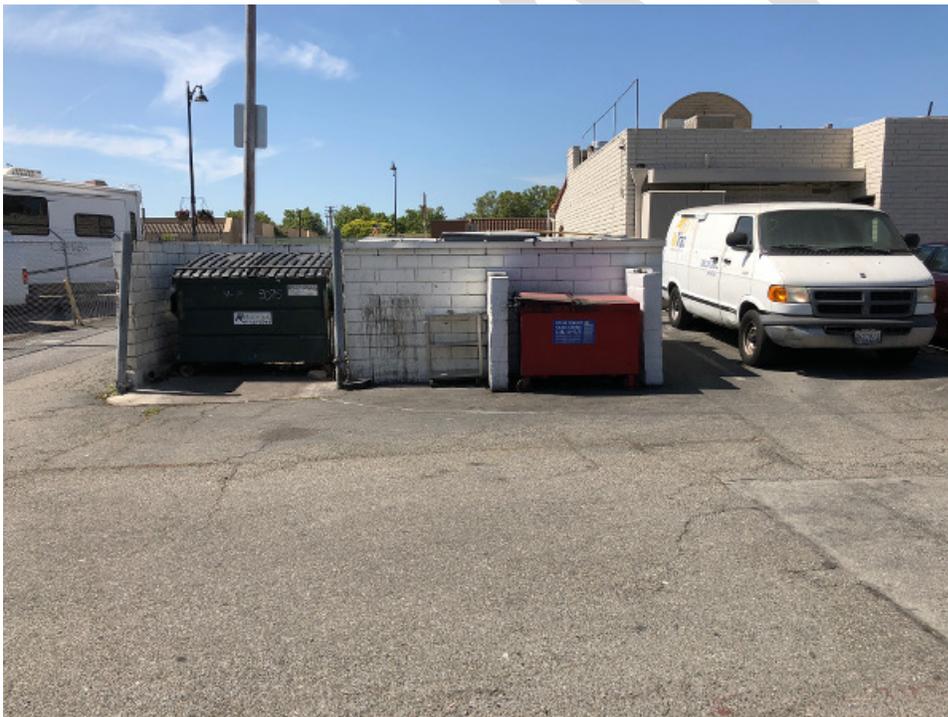
Photograph 55. View looking south at trash enclosure and cooking oil disposal between shopping center structure and detached restaurant in southeast corner of Site.

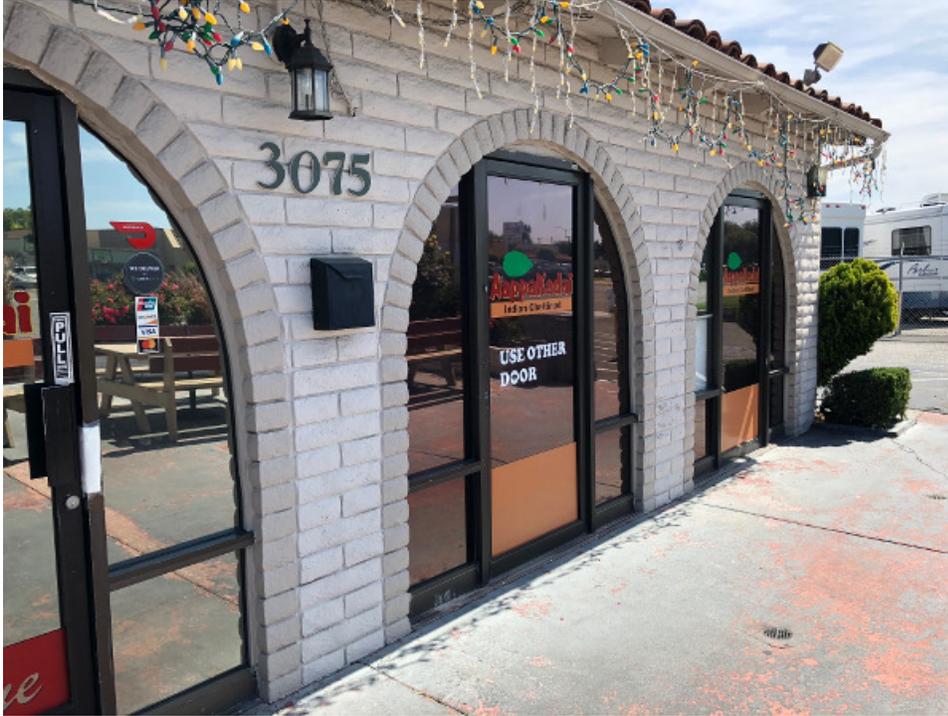
Photograph 56. View looking north at entry to detached restaurant structure in southeast corner of Site.

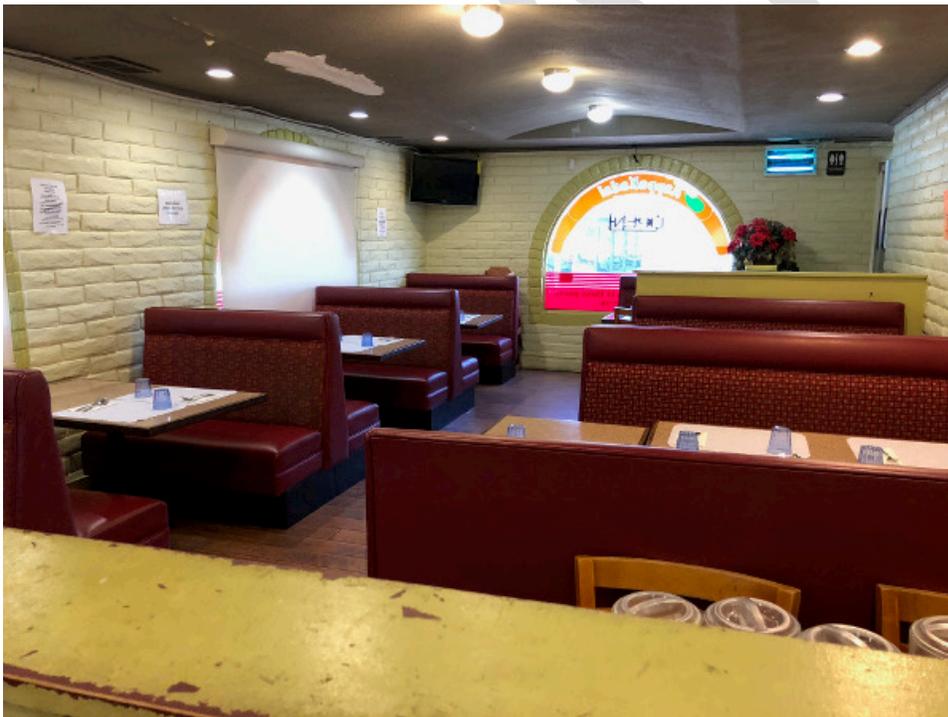
Photograph 57. Interior dining area of restaurant.

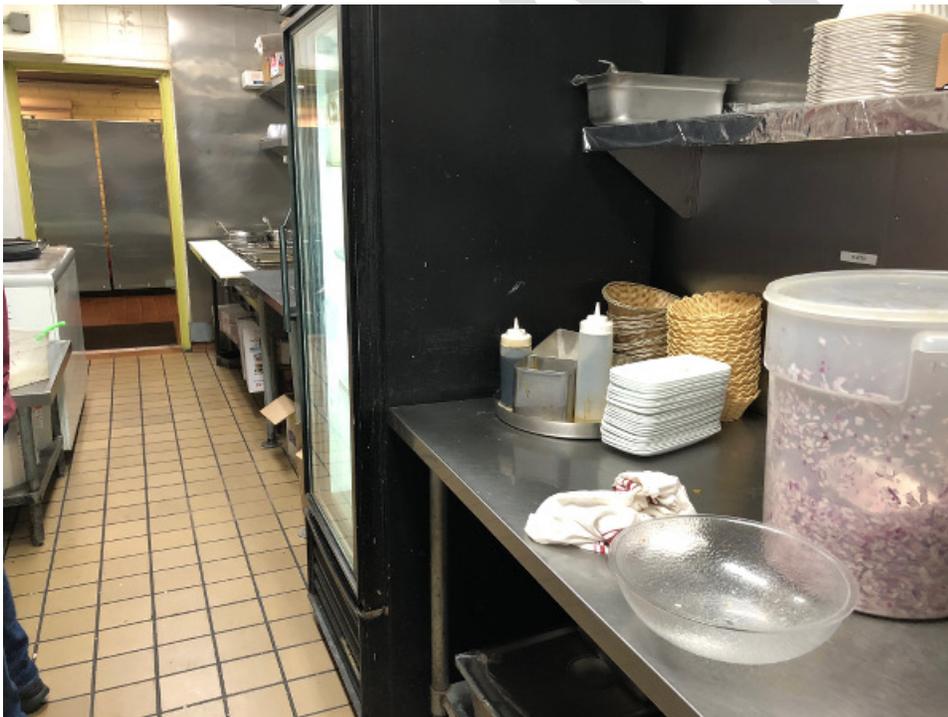
Photograph 59. Kitchen of restaurant.

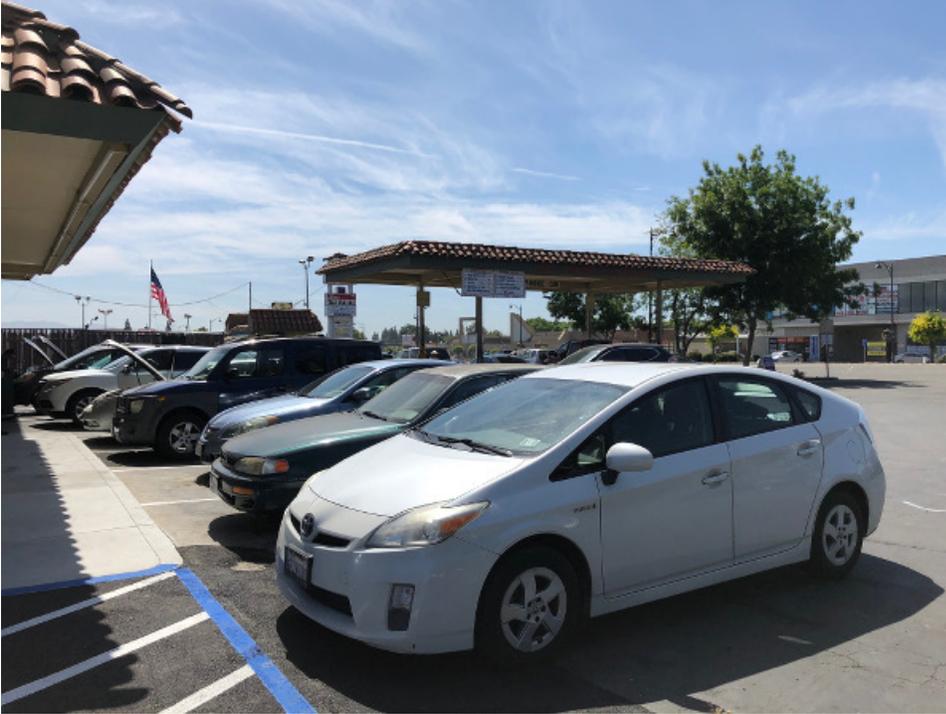
Photograph 60. View looking southeast across automobile service business and car wash (former Mobil service station).

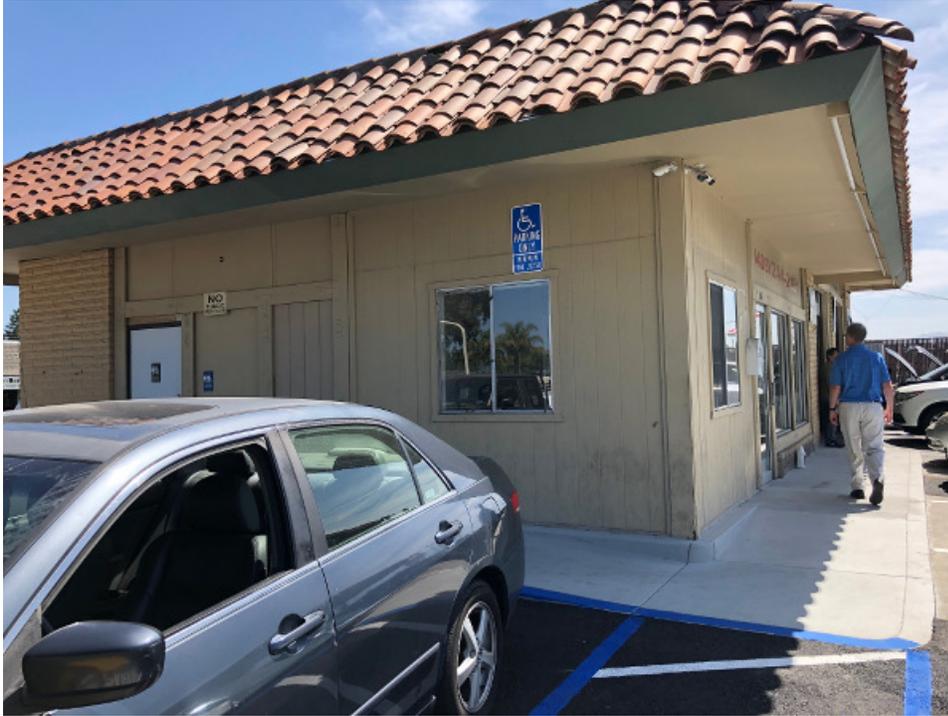
Photograph 62. View looking east at automobile service structure.

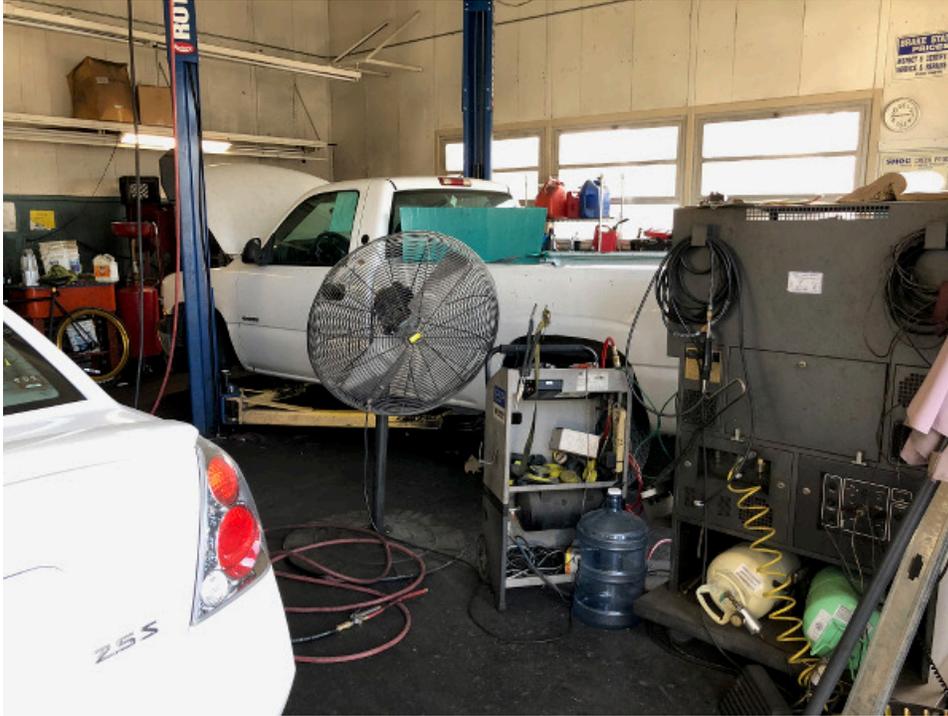
Photograph 64. View looking northeast at eastern service bay.

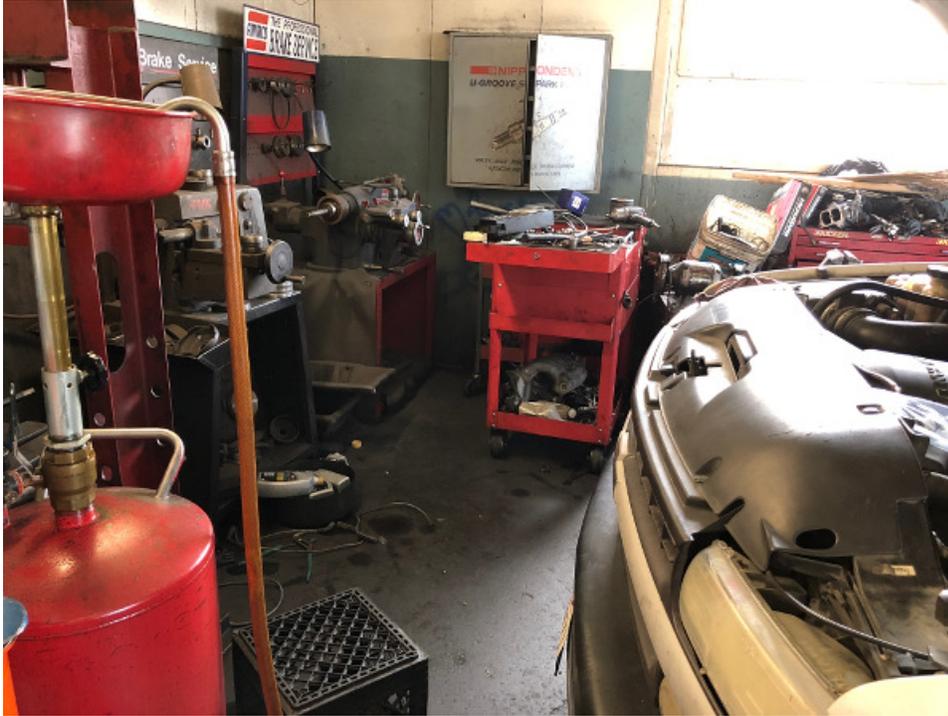
Photograph 66. Sanding / brake service machinery in northeast corner of structure.

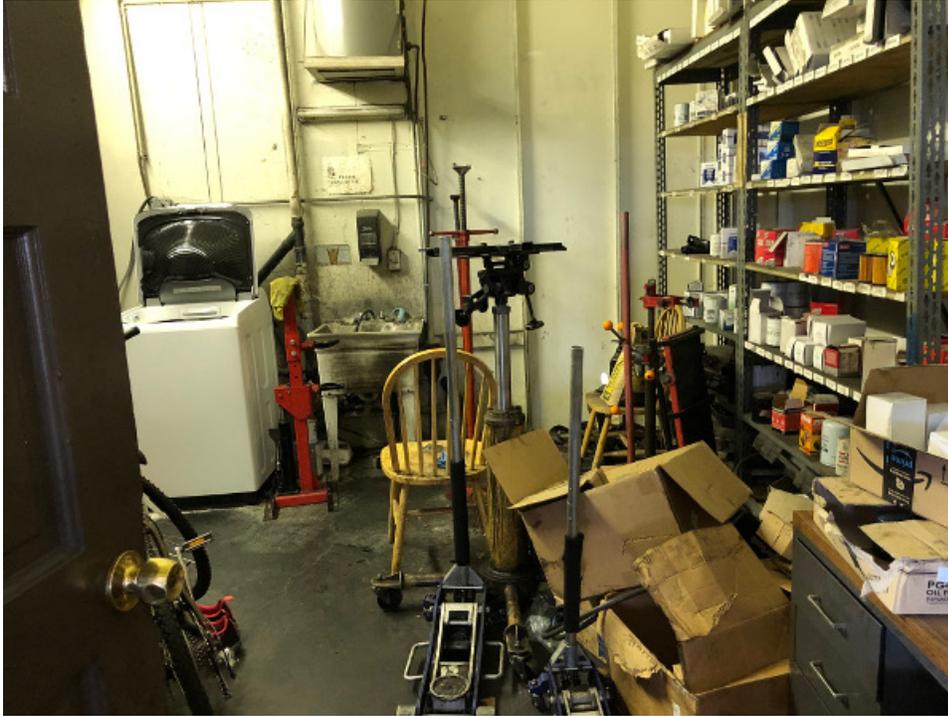
Photograph 68. Storage room with washer and dryer in northwest corner of automobile service structure.

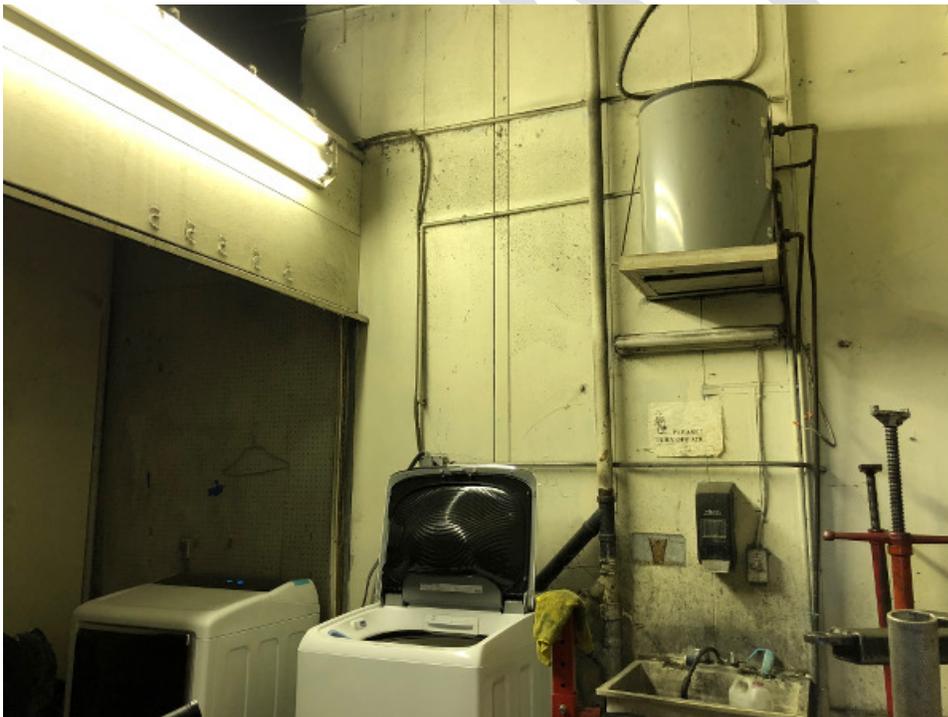
Photograph 69. Additional view of washer, dryer, and water heater equipment in northwest corner of automobile service structure.

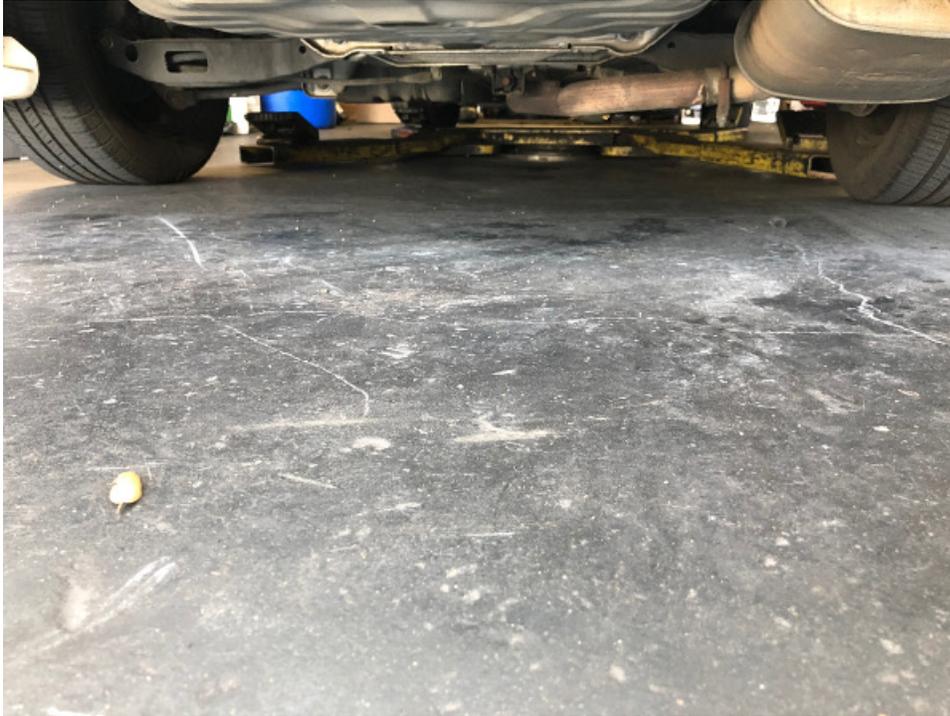
Photograph 72. Additional lift system.

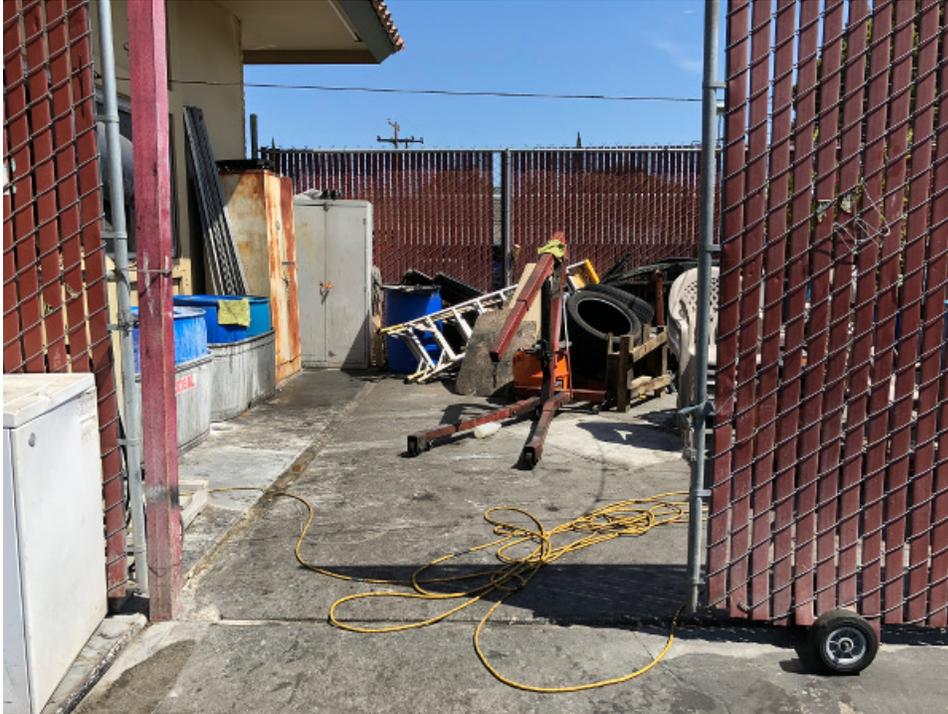
Photograph 74. Additional storage area with empty flammables cabinets, tire storage, and various equipment.

Hazardous materials, including waste oil, oil filters, tires, automotive fluids, Freon gas, lubricants, and 55-gallon drums were observed during our Site visit within the former Mobil service station space, now operated by US Auto, who performs automobile service. Surface staining typical of automobile repair businesses was observed on concrete and asphalt within the service center space and surrounding asphalt pavement and storage areas. No exposed soil was observed in these areas.

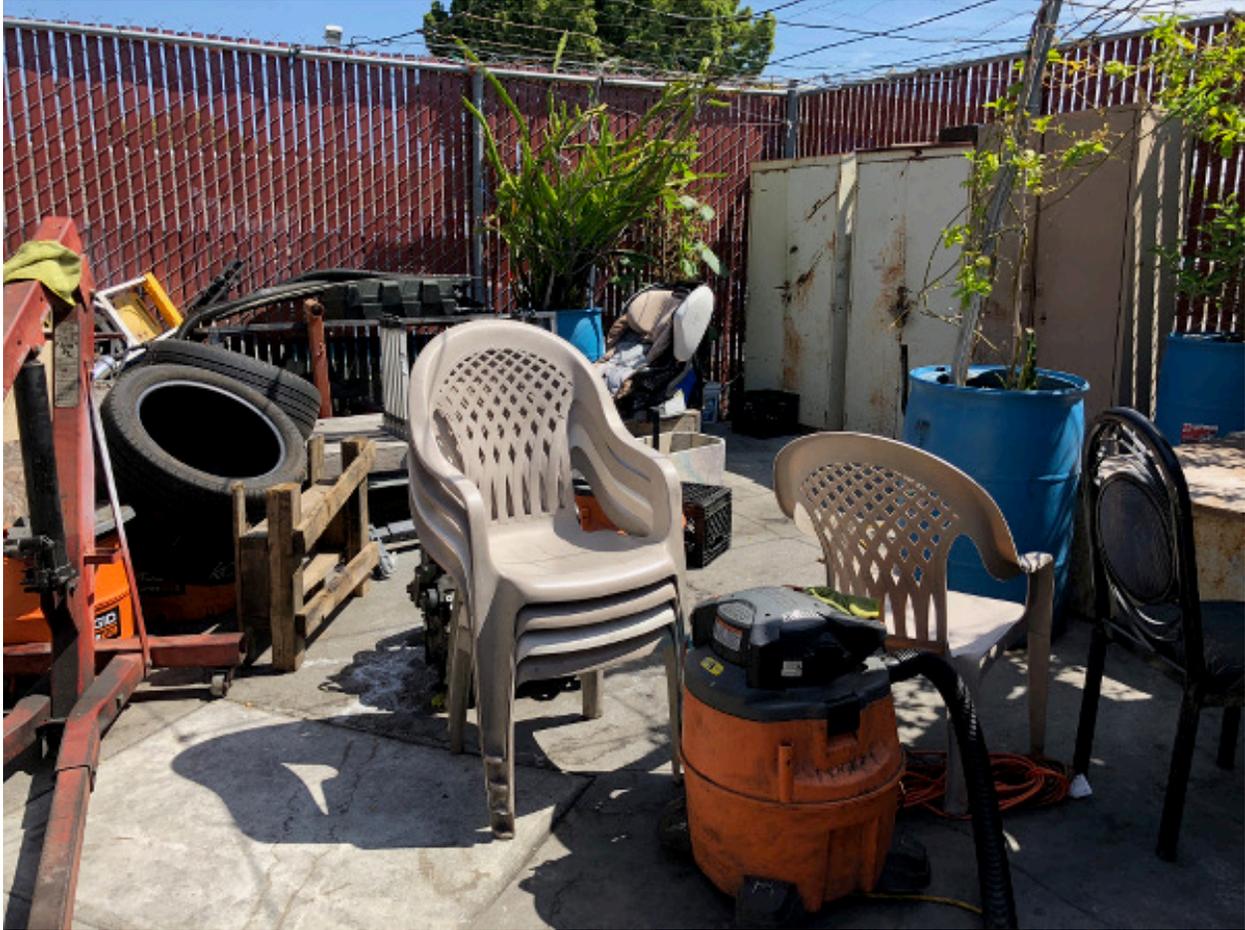
Photograph 76. Additional view of storage area.

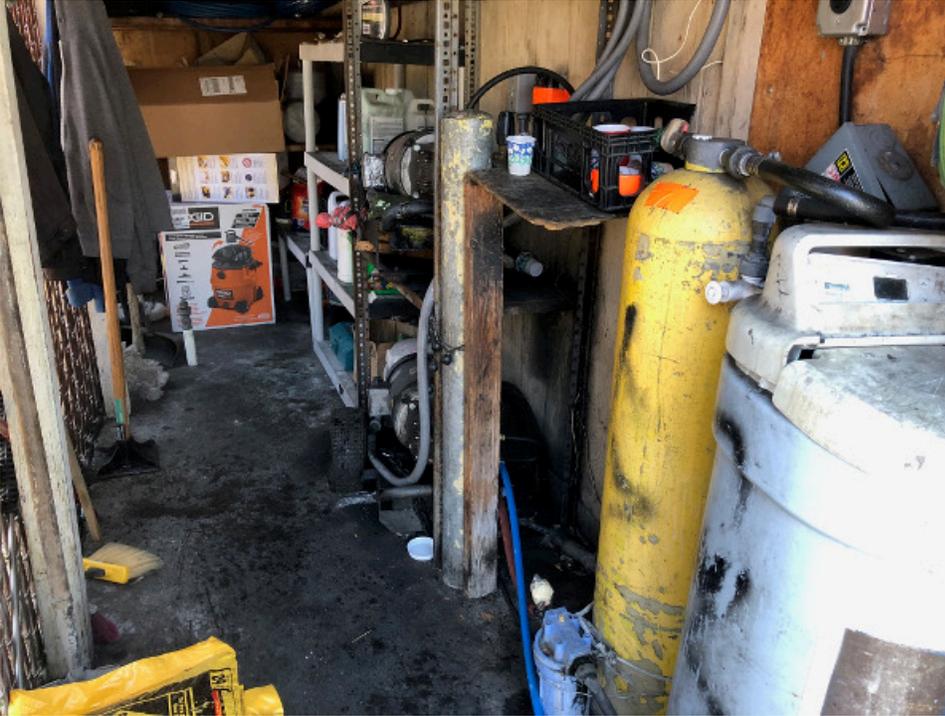
Photograph 79. Car wash related equipment alongside fenced area and car wash office.

Additional staining was observed on asphalt and concrete pads in the car wash equipment area.
