SUMMARY

I was contacted by Nuvis Landscape Architecture to provide a Tree Protection Assessment for the Sunset Complex Reservoir project. The existing reservoir tanks will be removed and replaced with new tanks. The parking area on the west side will also be lowered, a retaining wall installed, and the entire parking area will be repaved. Around the edge of the complex are trees, many of which are Protected Species. The trees need to be evaluated and Tree Protection Recommendations provided. Nuvis has requested an independent Arboricultural opinion on the trees near or within the Work Limits. The Scope of this written Report will include:

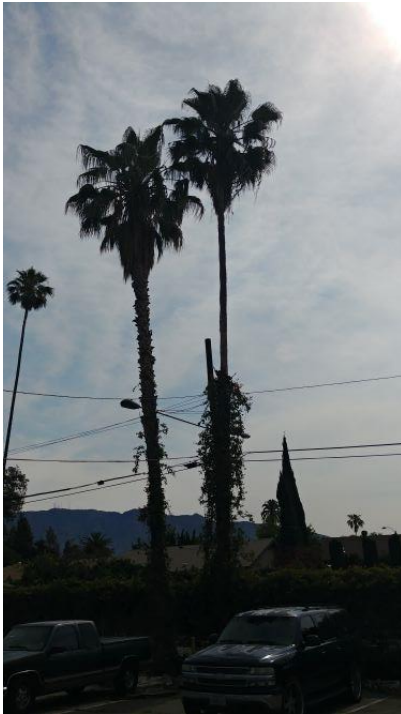
2, 3. The two Fan Palms (WR1-2). They should not be in conflict with repaving activities.

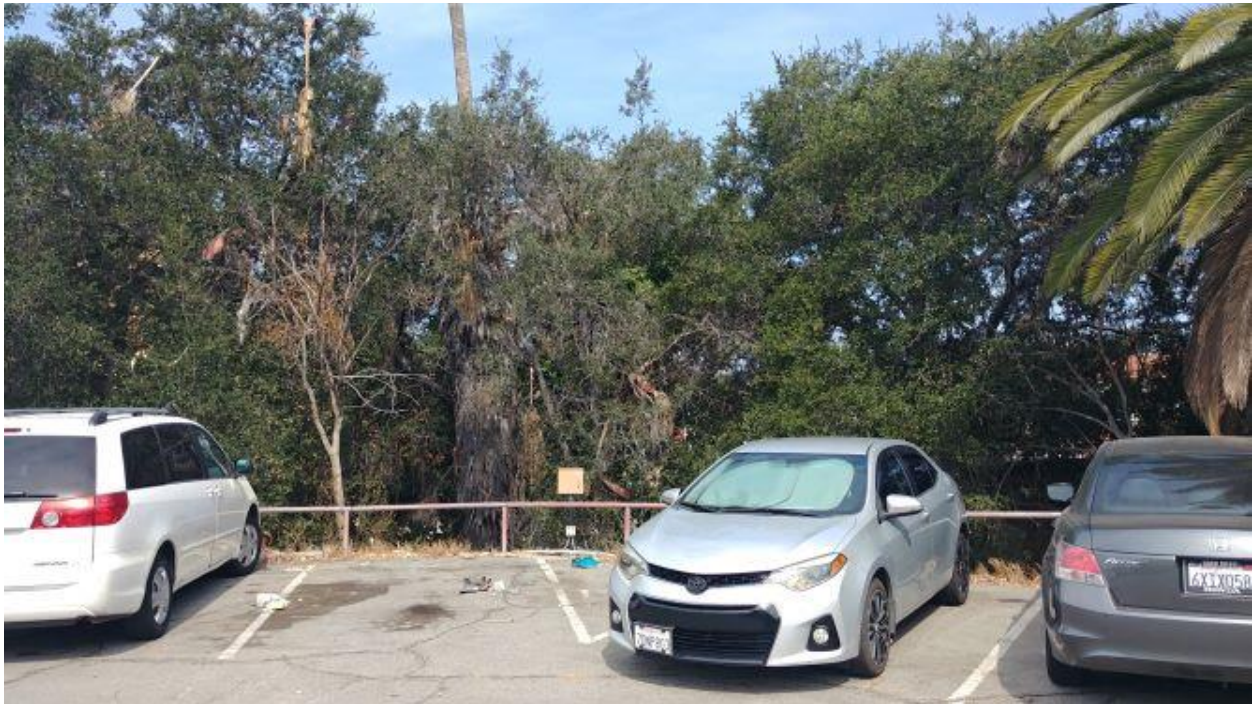
9. Trees south of CP1 will likely not be in conflict with paving operations.

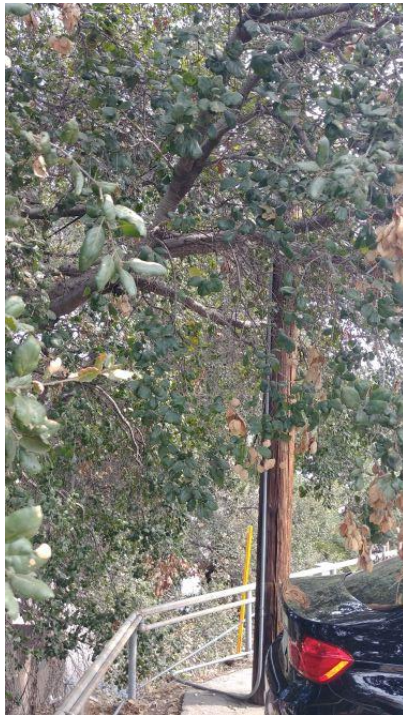
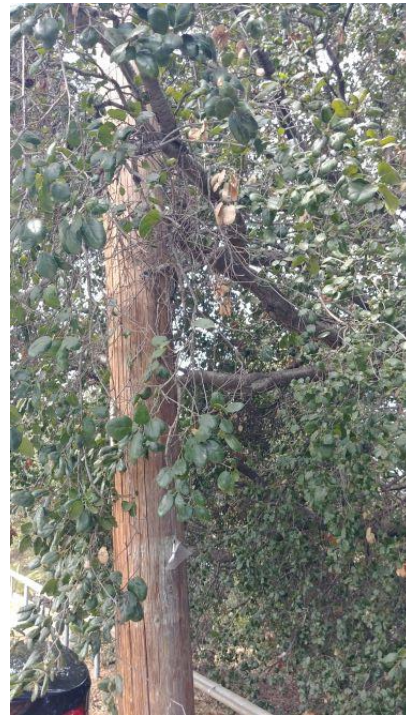
At the northwest corner are 1-2 in. Oak branches (#2) that may be raised. Roots should not be affected. This is near where the retaining wall will be installed per Plan pg. C-010,⁵ and approx. where the grade reduction will begin. In the west median is a Crape Myrtle (CM1) that is dead and may be removed. The center median to the east has a multi-stem Crape Myrtle (CM2) that could be retained. Per the Paving Plan C-007 this median is redesigned. Retention of the tree is recommended.

18. Looking north and south at the branches to be pruned on #2. The railing is the approx. location of the work limits.

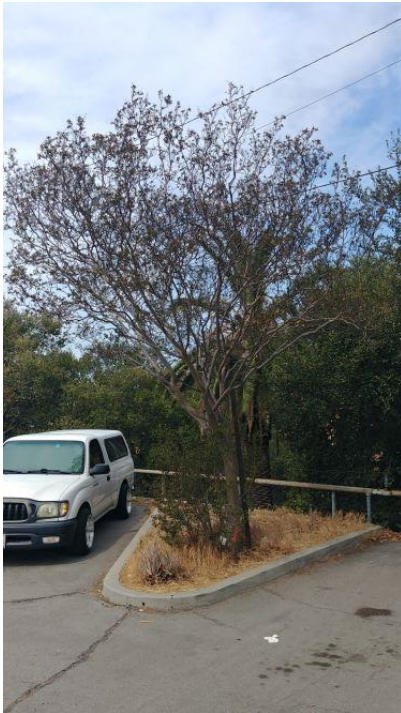
20. CM1 is dead.

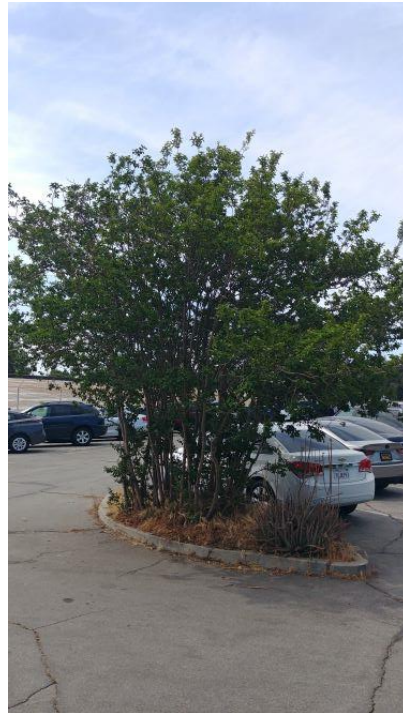
21. CM2 may be retained.

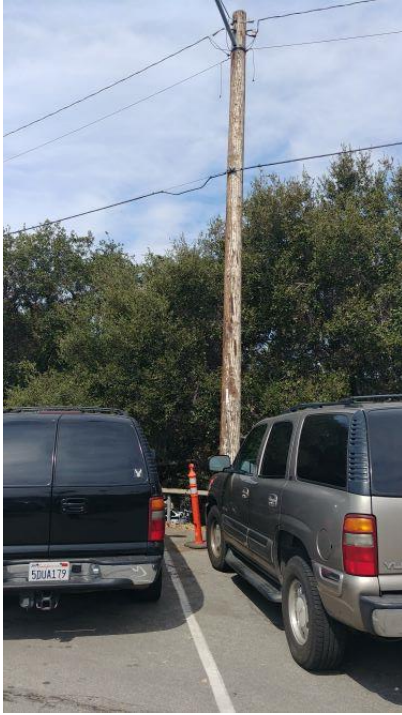
22, 23. #3 location and the small stems to be pruned.

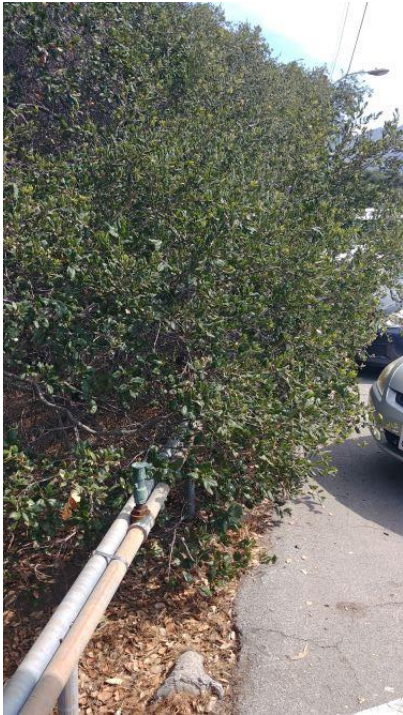
24, 25. The tips of small branches from #4.

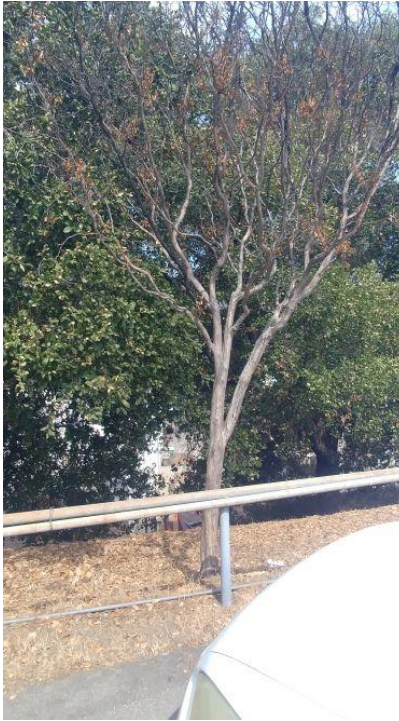
26. CM3 is dead.

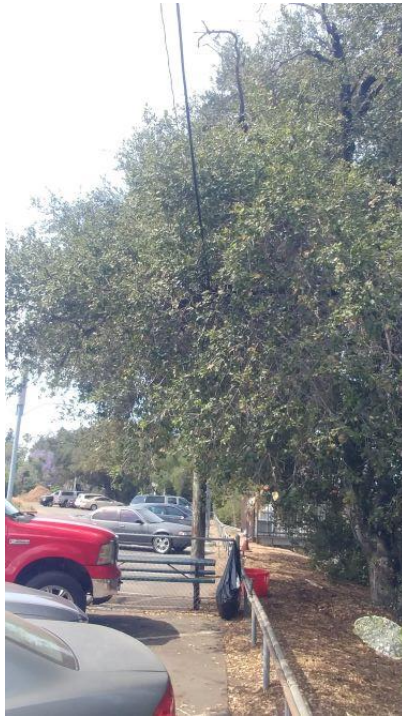
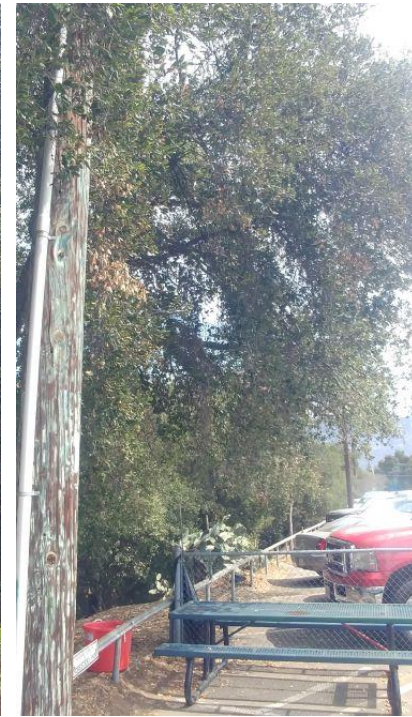
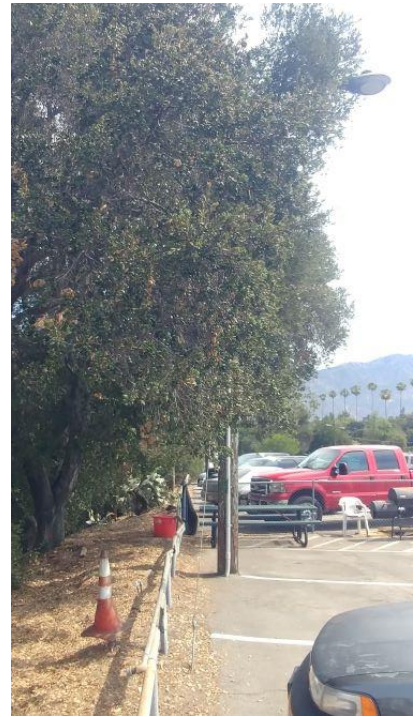
31-33. Branches potentially to be pruned on #5-7.

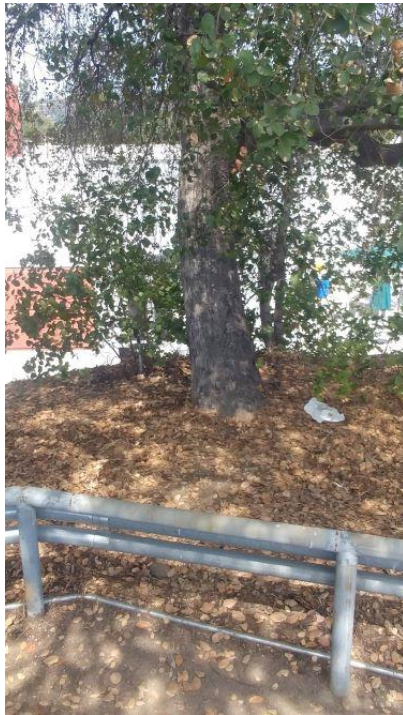
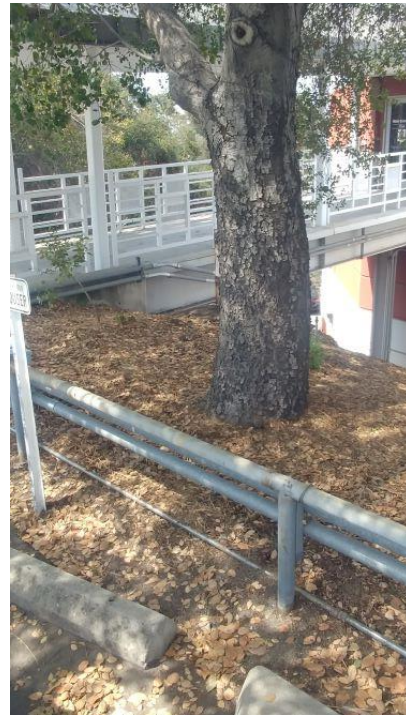
35, 36. Trees #8-9, 6 and 3 ft. back of WL respectively.

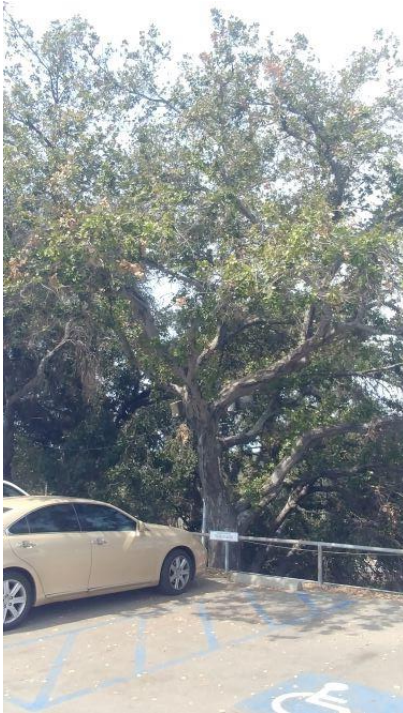
38, 39. Tree #10.

South of the bridge are 3 Oaks (#10-12, tags #1621-1623) that are 2 ft., 6 ft. and 7 ft. back of WL respectively. The crowns have been raised and should not be in conflict. There will be root issues, especially with #10. These are upslope holding roots, and the tree is in Fair condition. Additionally, per Plan sheets C-008, -011, -016 show an access ramp to be installed immediately east of this tree. Tree #10 should be considered for removal due to holding and support roots being removed. There will be no Tree Protection procedures that will adequately protect its roots. Trees #11-12 should be evaluated for potential significant root loss.

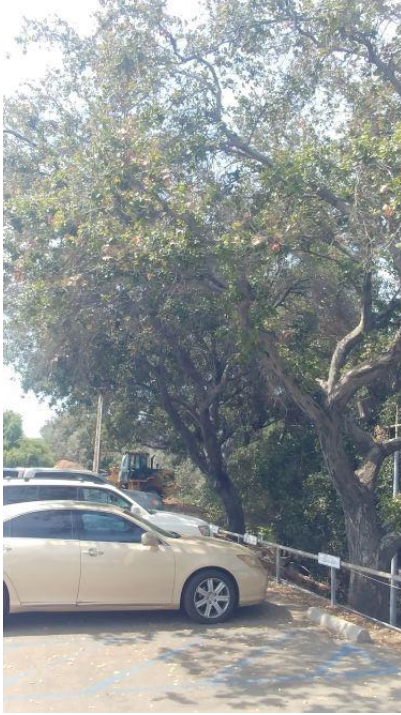
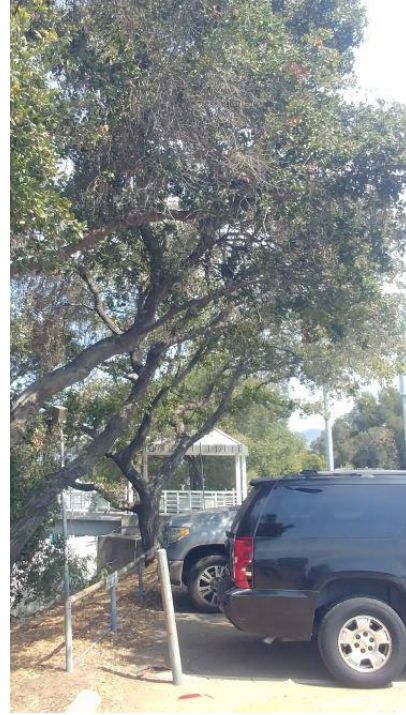
44, 45. Trees #10-12. Crowns should not need clearance pruning.

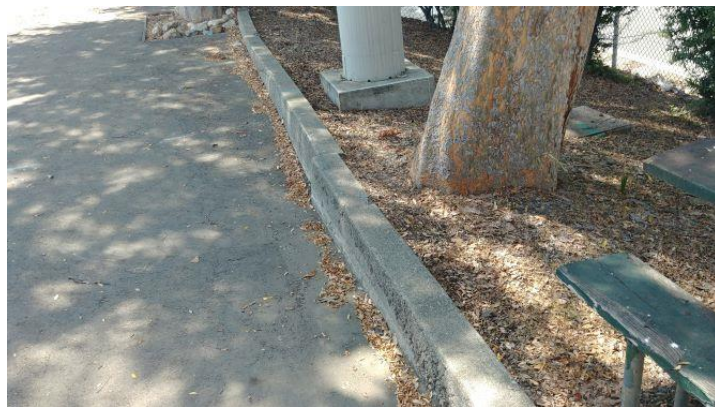
55, 56. Note significant lean of #19, and close proximity to curb.

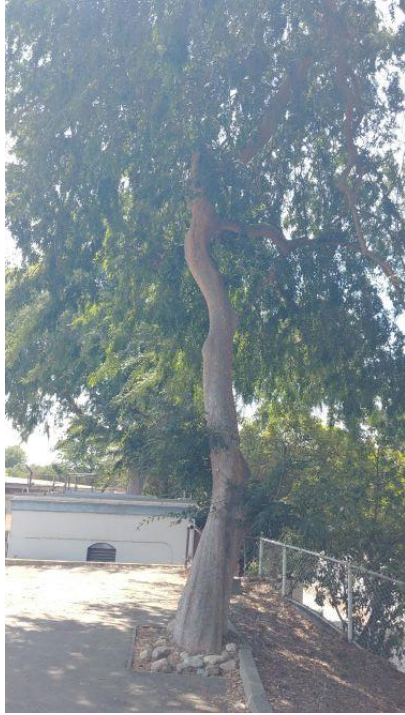
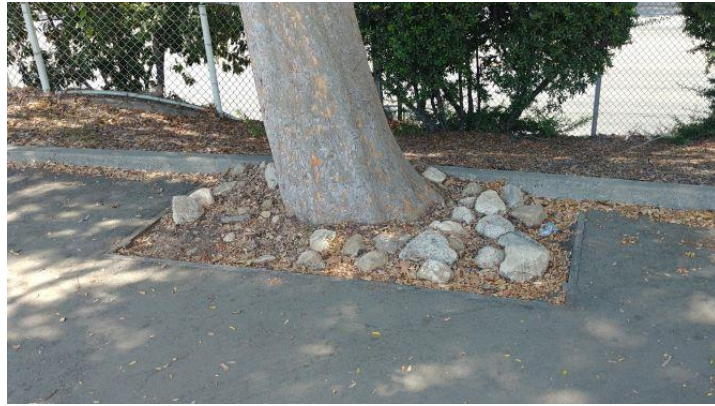
57, 58. Tree #20. Note slight lean to east and tree well.

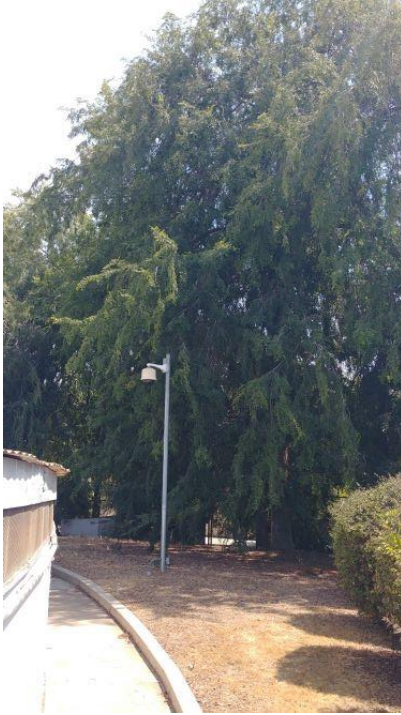
65. Chinese Elms in Southeast corner.

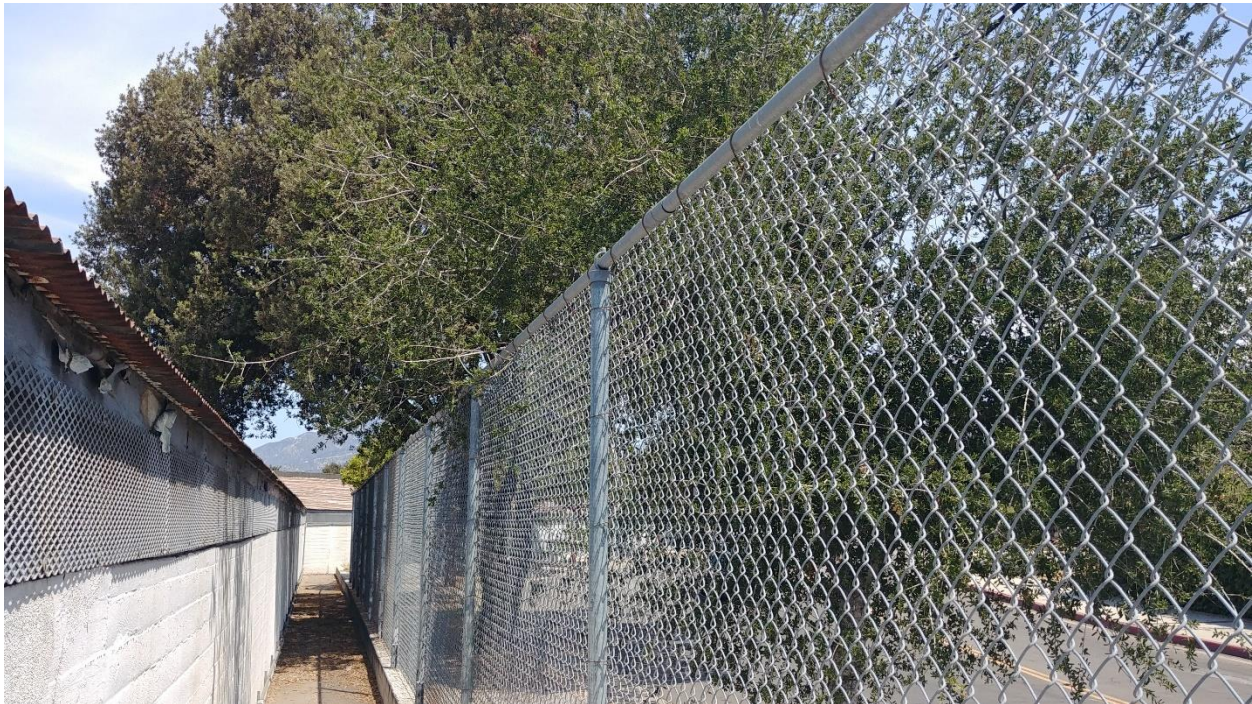
73. Tree #27 with #28 in the background.

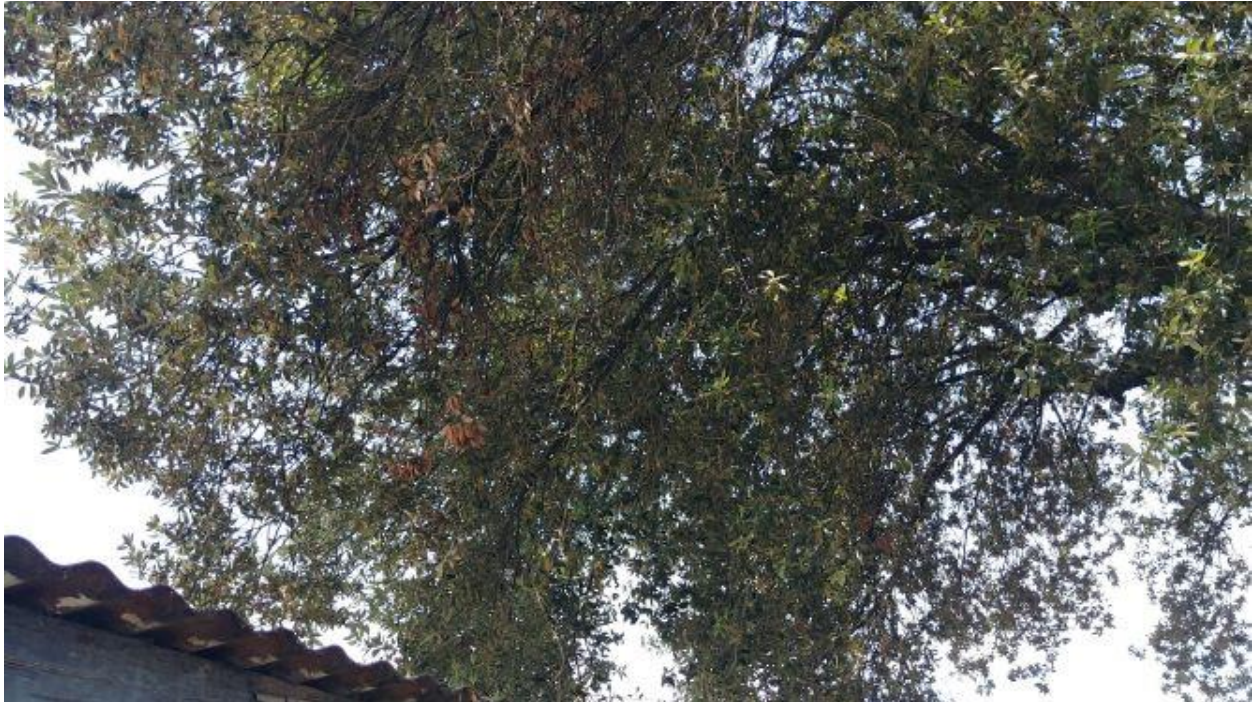
75. Looking up at crown of #28.

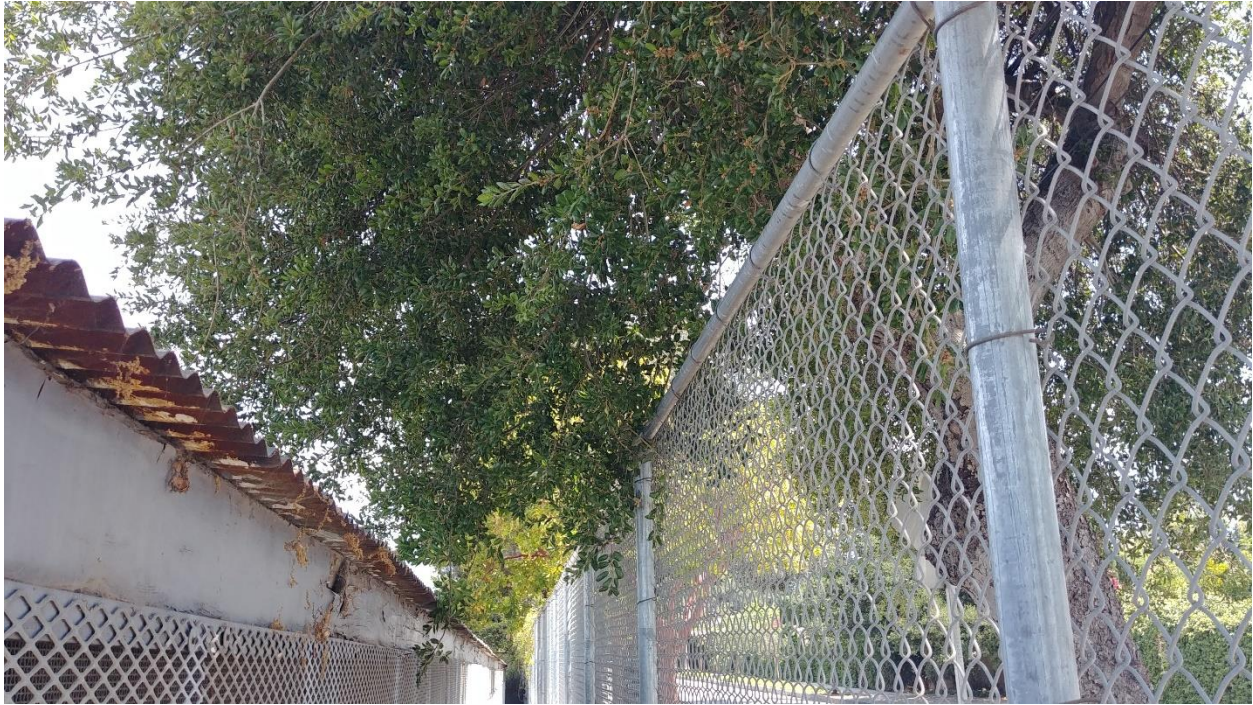
78. Closer view of #30.

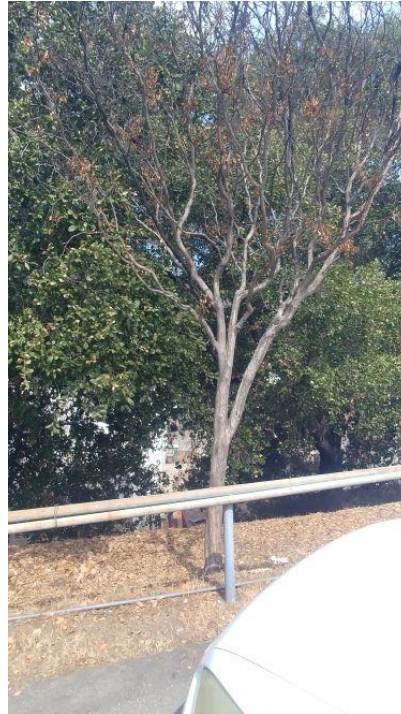
(a). Correct photo of #CM4.
